MICROWAVE PATH SURVEY REPORT

RADIO FREQUENCY INTERFERENCE (RFI) MEASUREMENT REPORT

ViaSat

**Transmit and Receive Earth Station
17-21 GHz and 27-31 GHz**

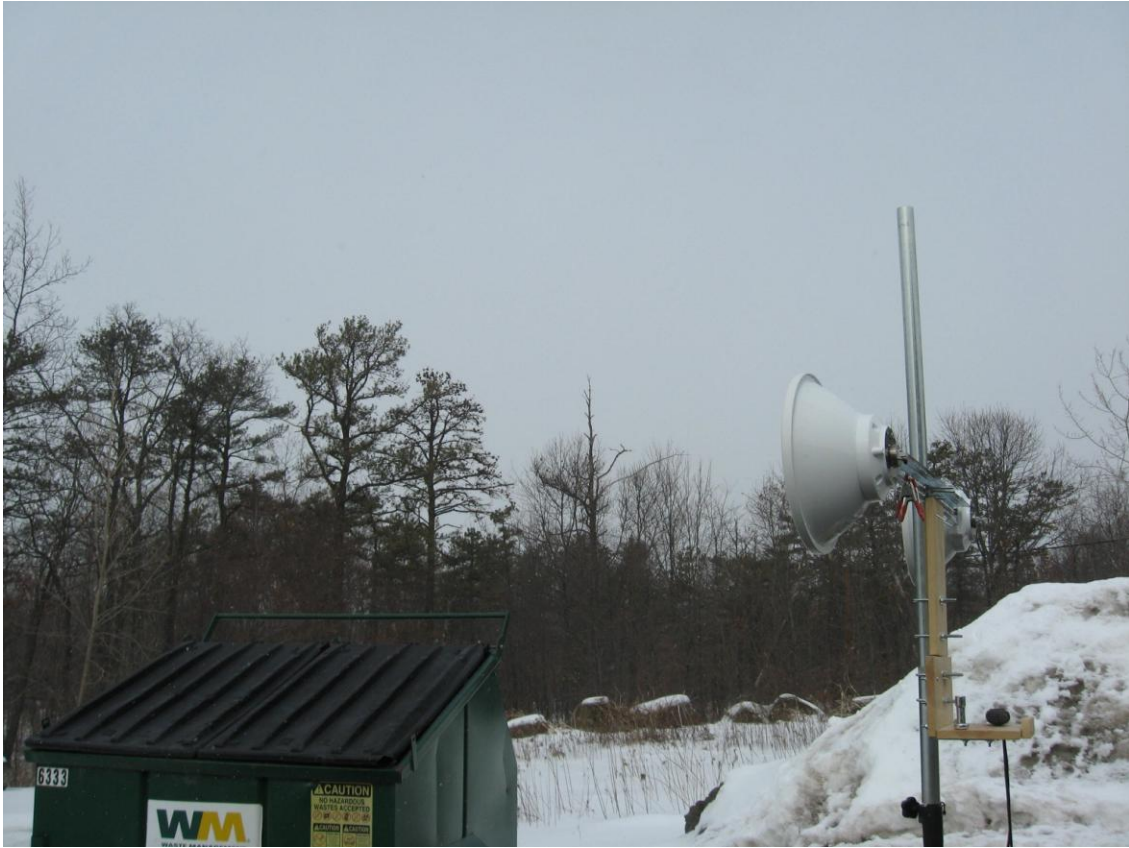
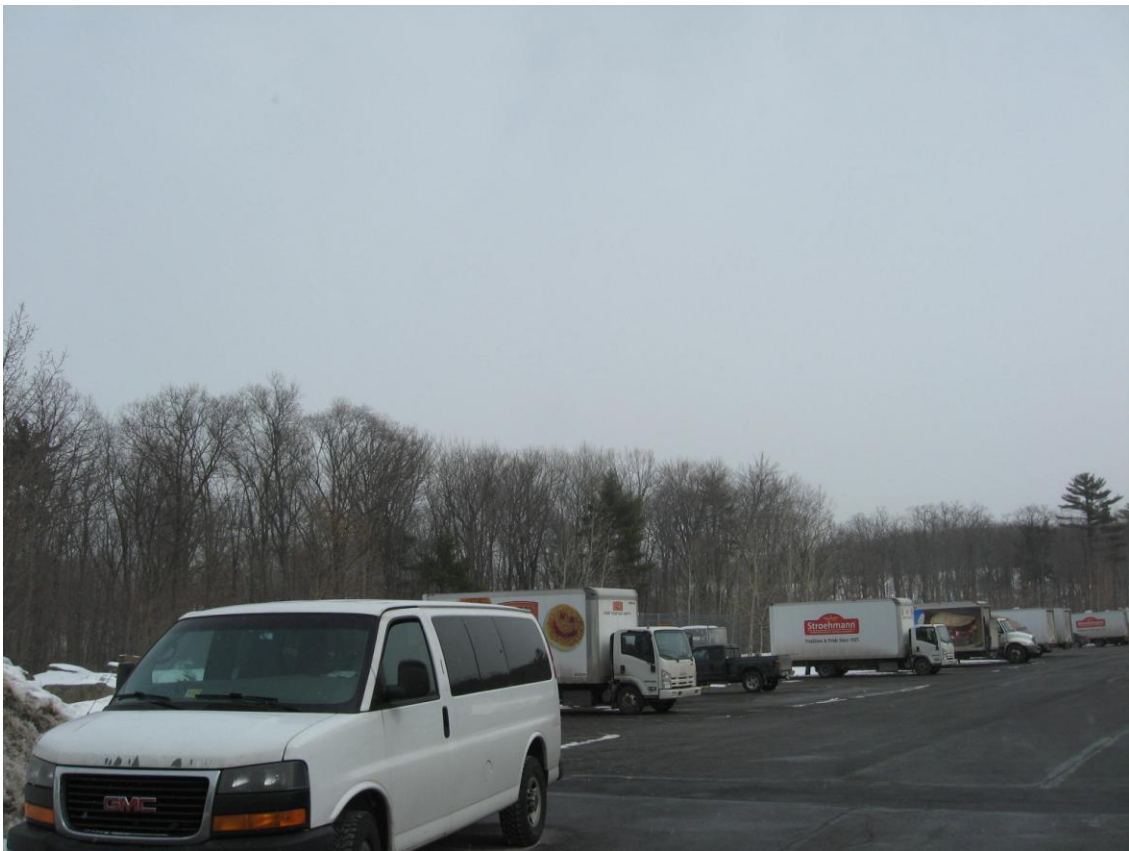
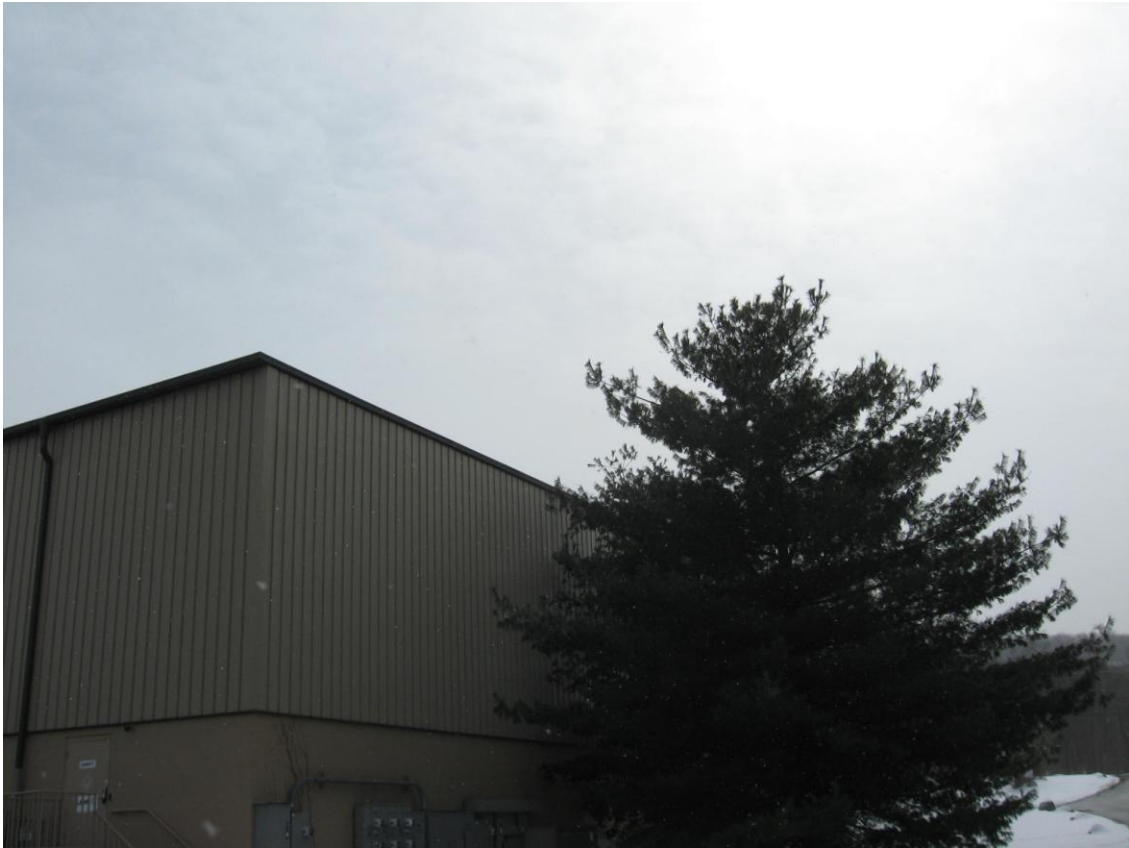
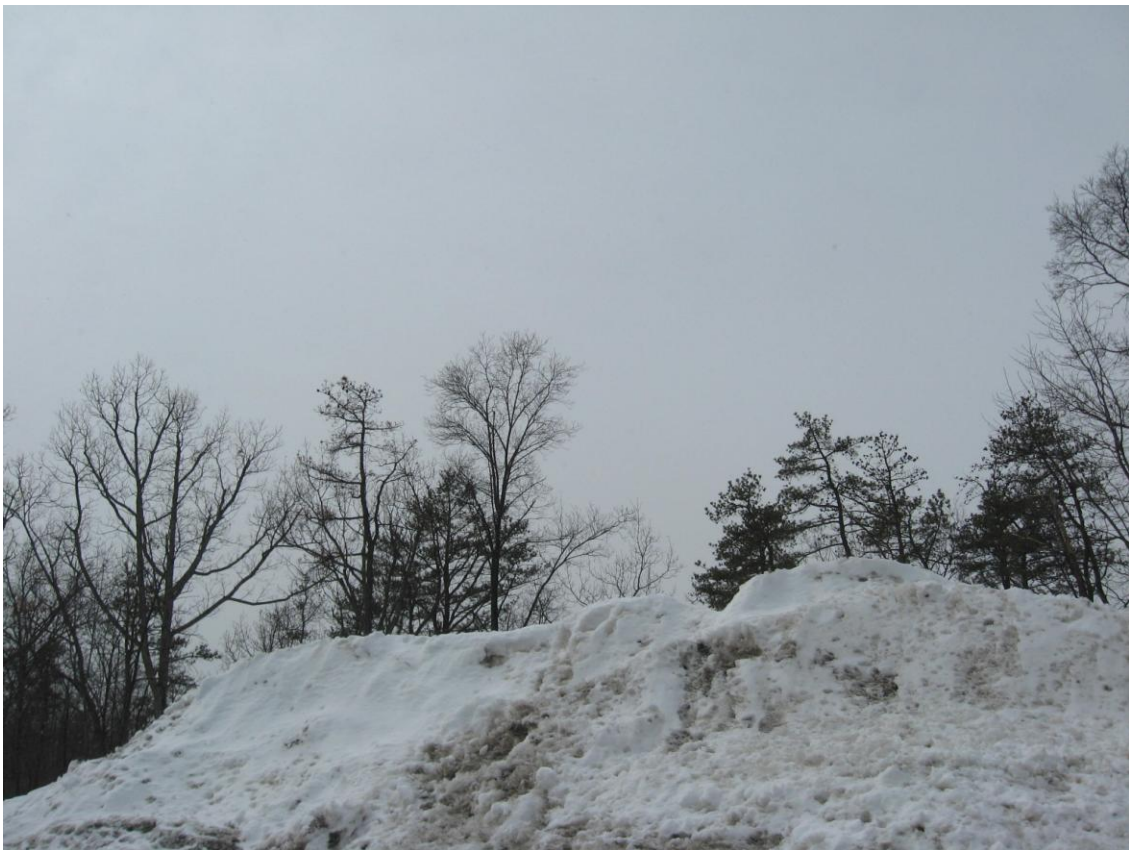
Figure 3.1-1 Earth Station Site Photographs

- Table 3.1-1 presents a site data sheet including all pertinent site information.
- Figures 3.1-1 and 3.1-2 are the photographs depicting the existing earth station site and satellite arc.
- Figures 3.1-3 through 3.1-10 are the RF spectrum photographs depicting the interference environment at the test site.

| 8. GEOSTATIONARY ARC VISIBILITY: | Satellite arc has no blockage at this time |

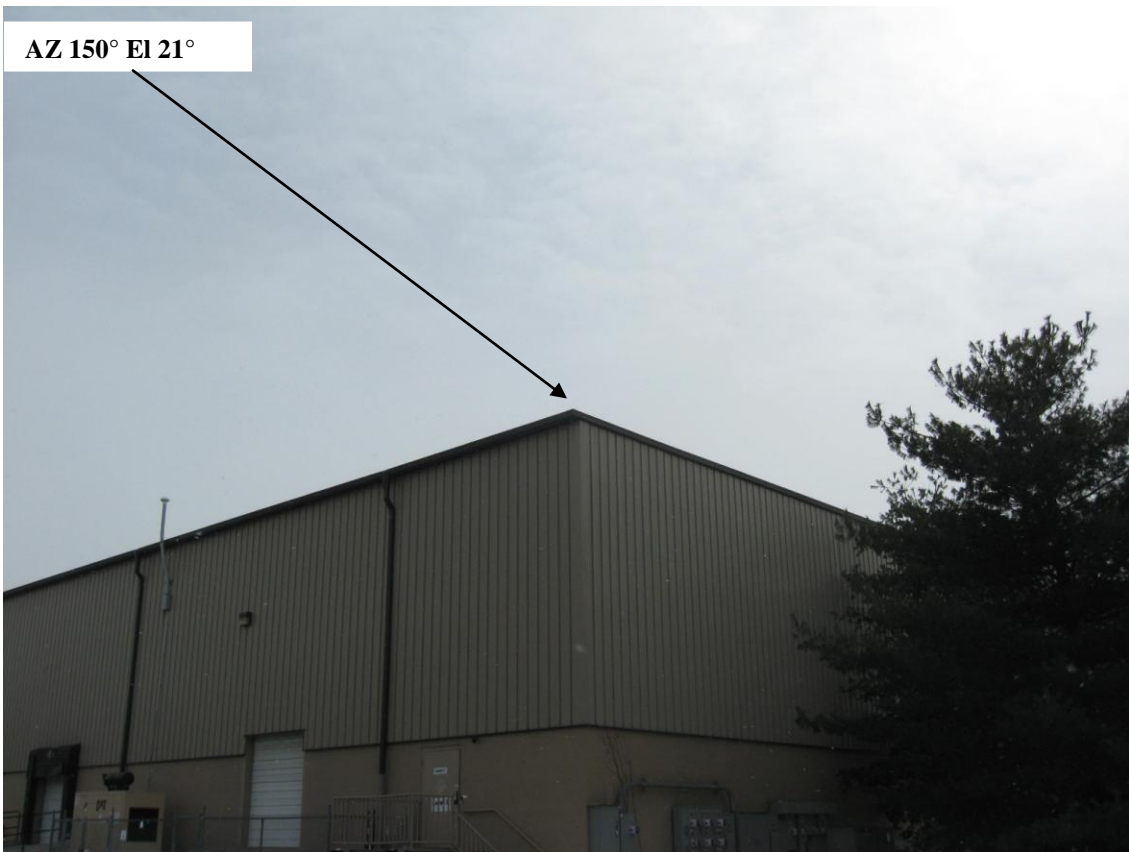
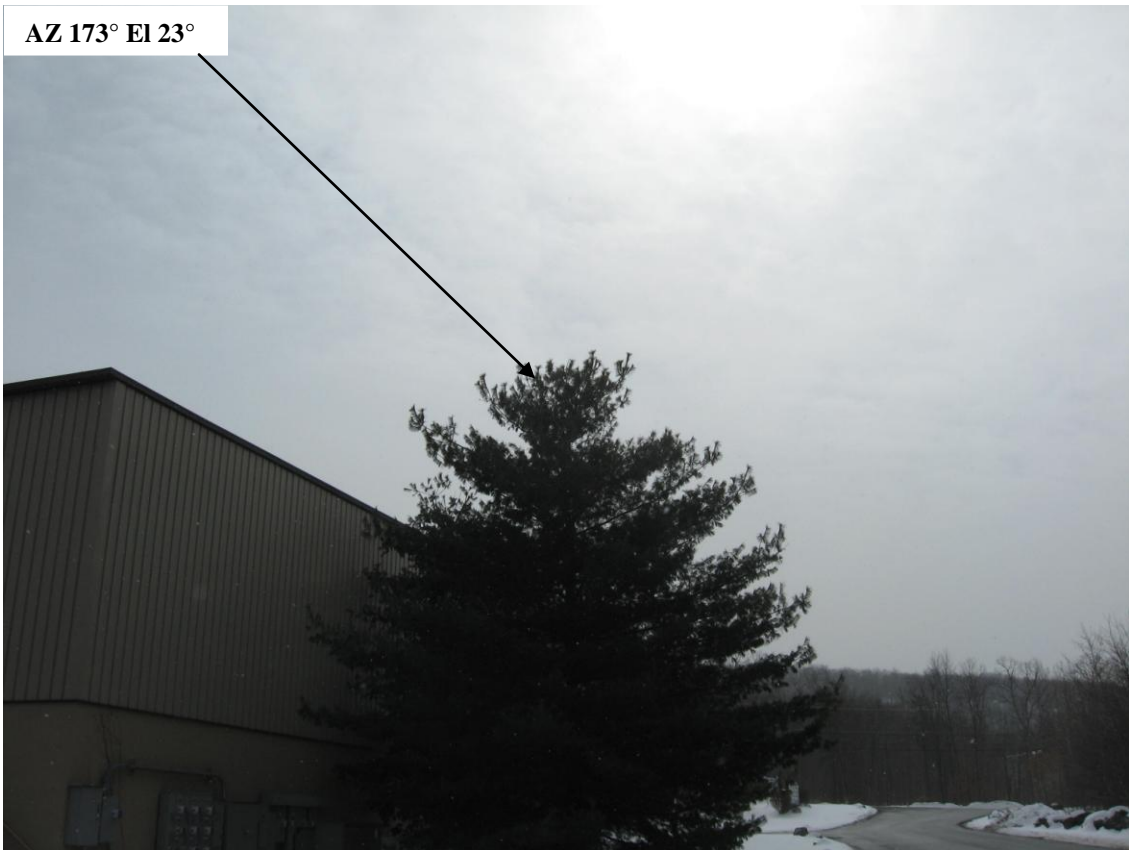
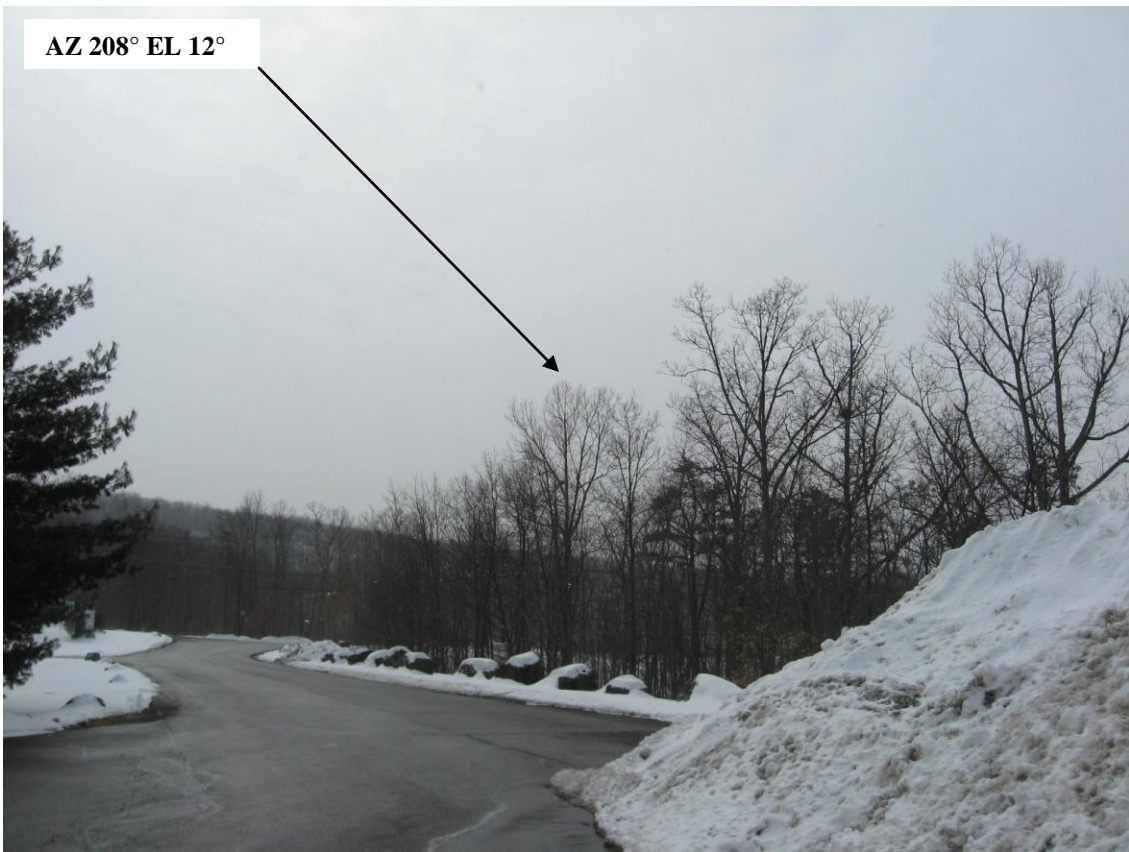
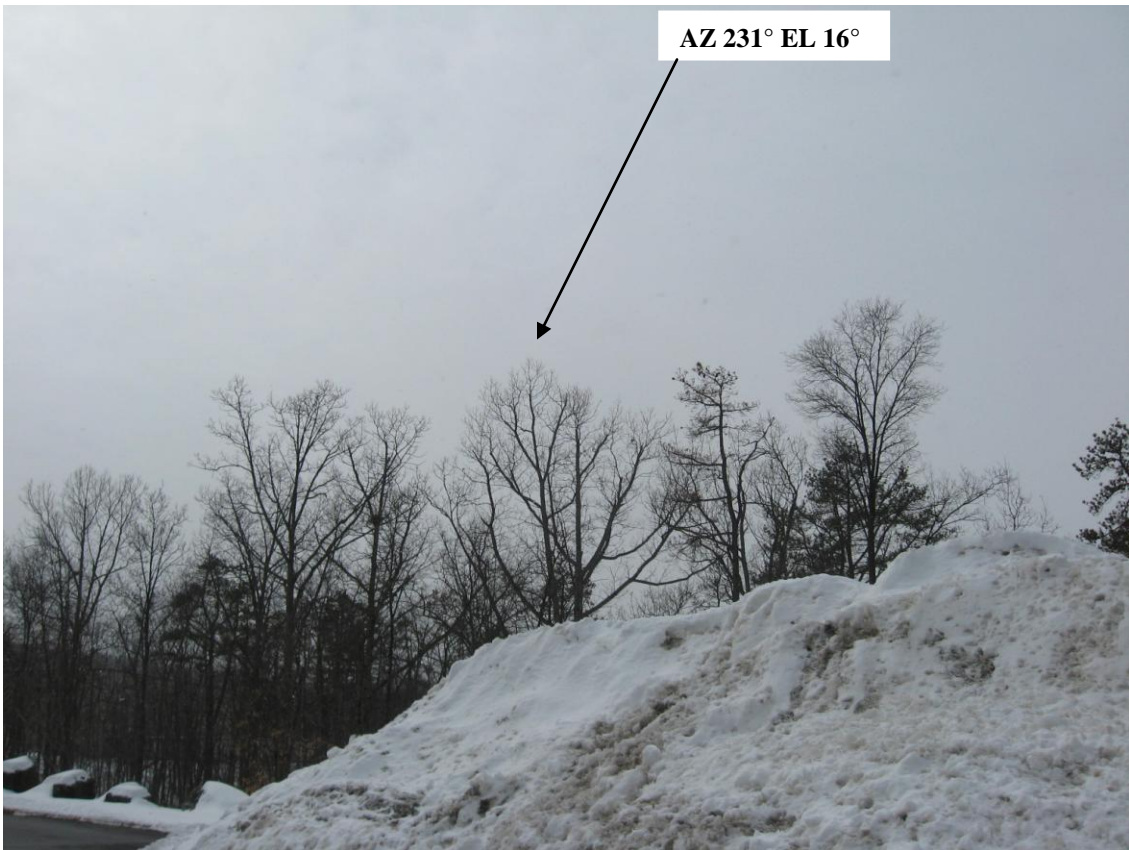
Figure 3.1-2 Horizon Photographs of Earth Station Site

There is no potential satellite arc blockage at this site. Final arc clearance will depend on antenna placement.

The satellite arc has no potential blockage from 55W through 115W.
