# **MICROWAVE PATH SURVEY REPORT**

## **RADIO FREQUENCY INTERFERENCE (RFI) MEASUREMENT REPORT**

ViaSat

**Transmit and Receive Earth Station**  
17-21 GHz and 27-31 GHz

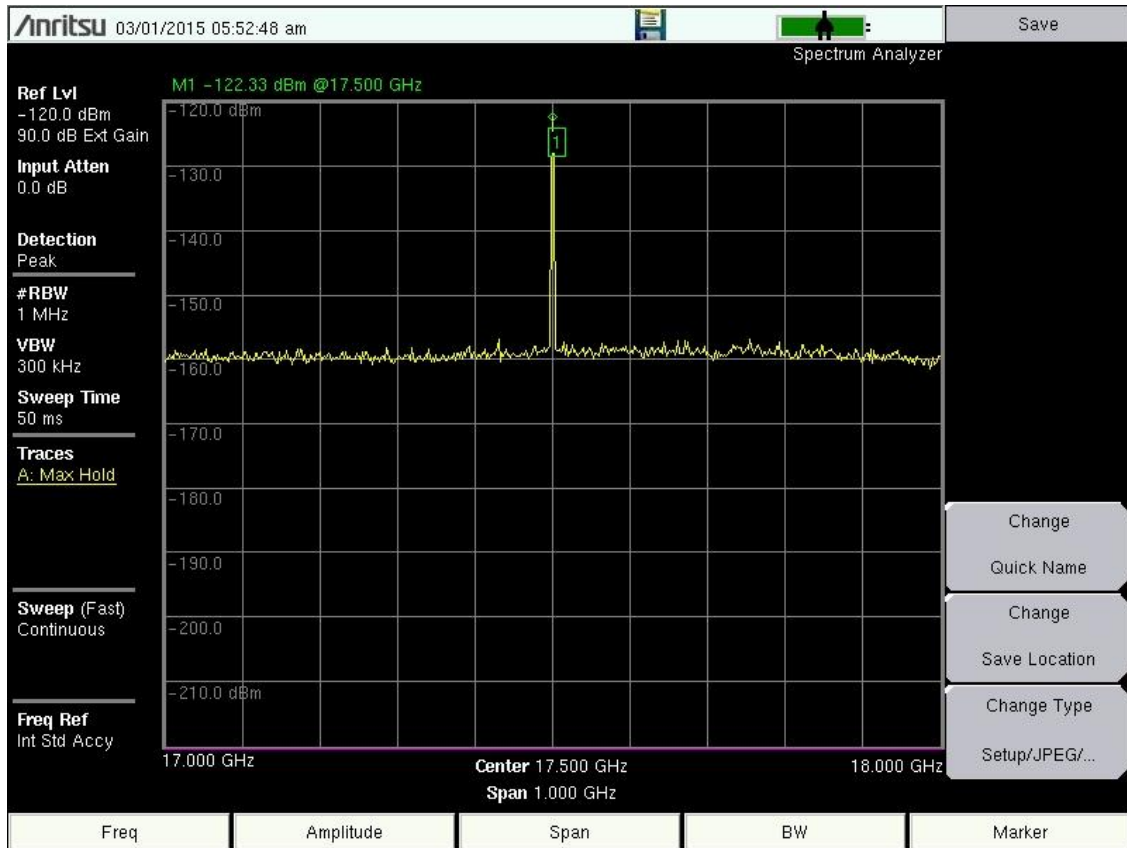
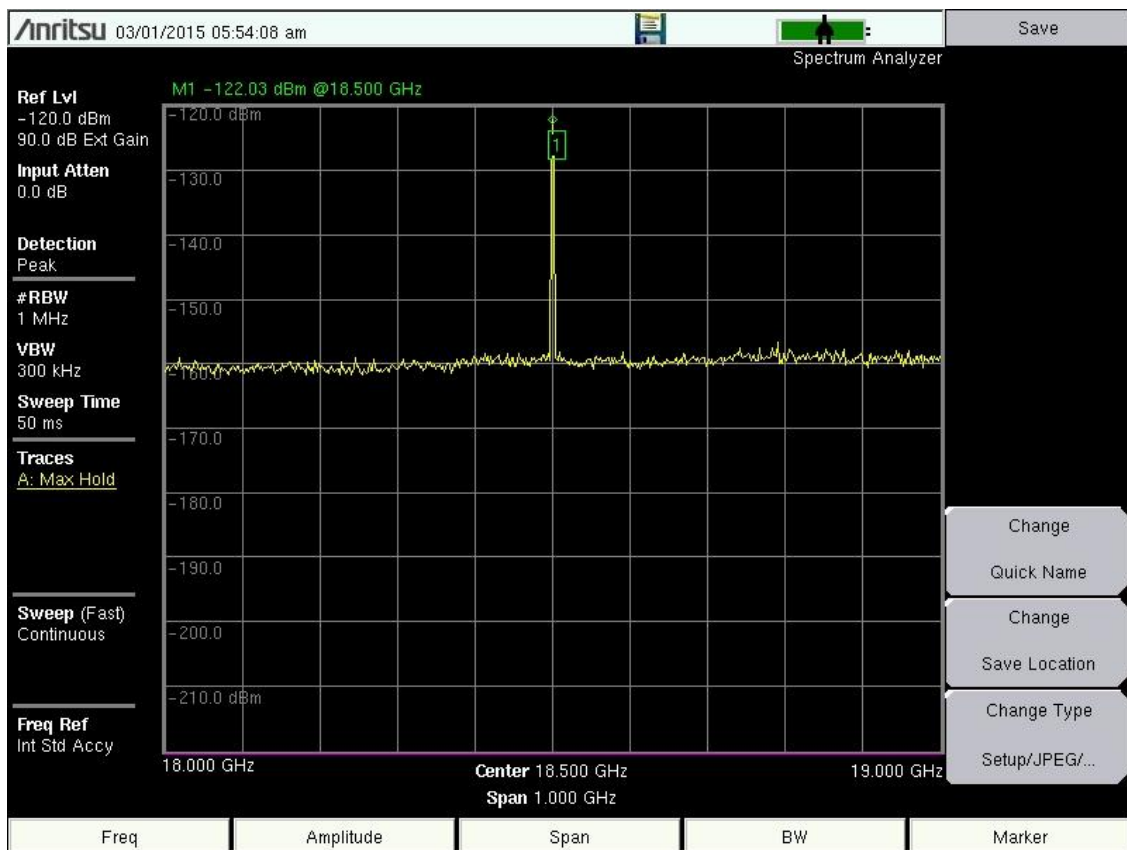
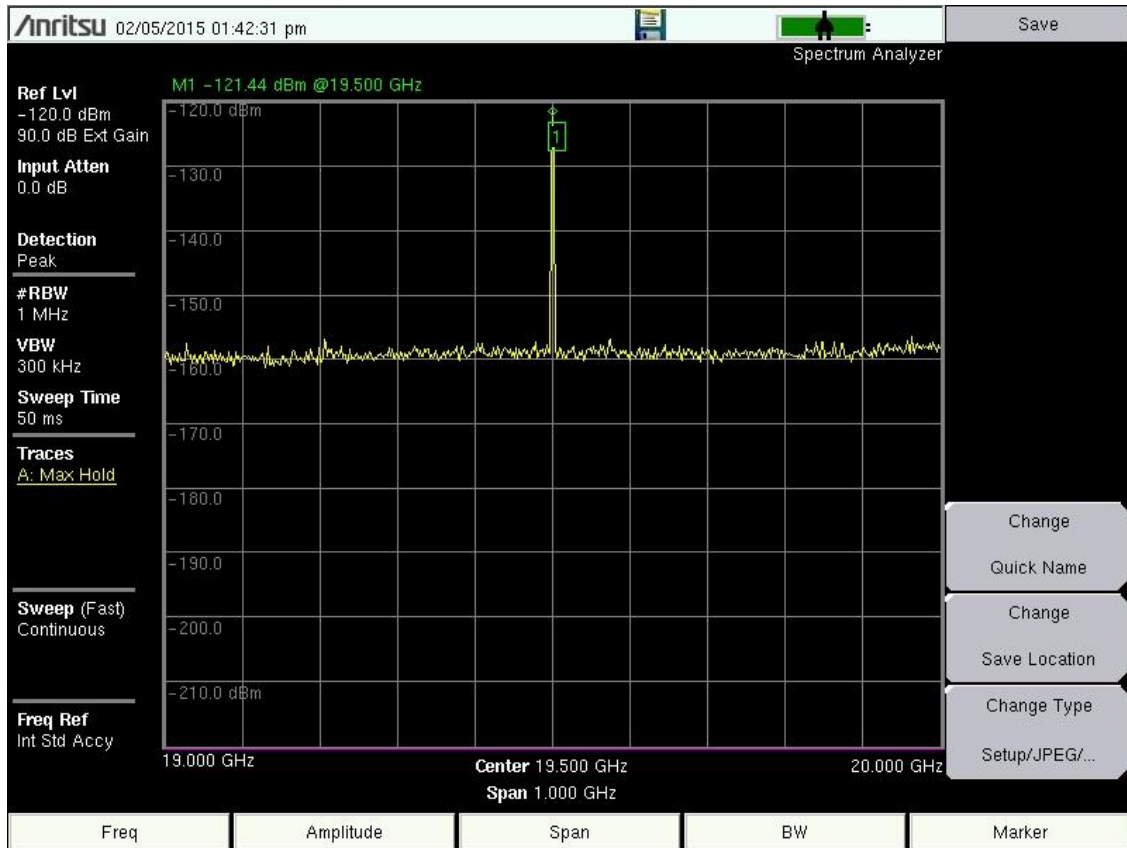
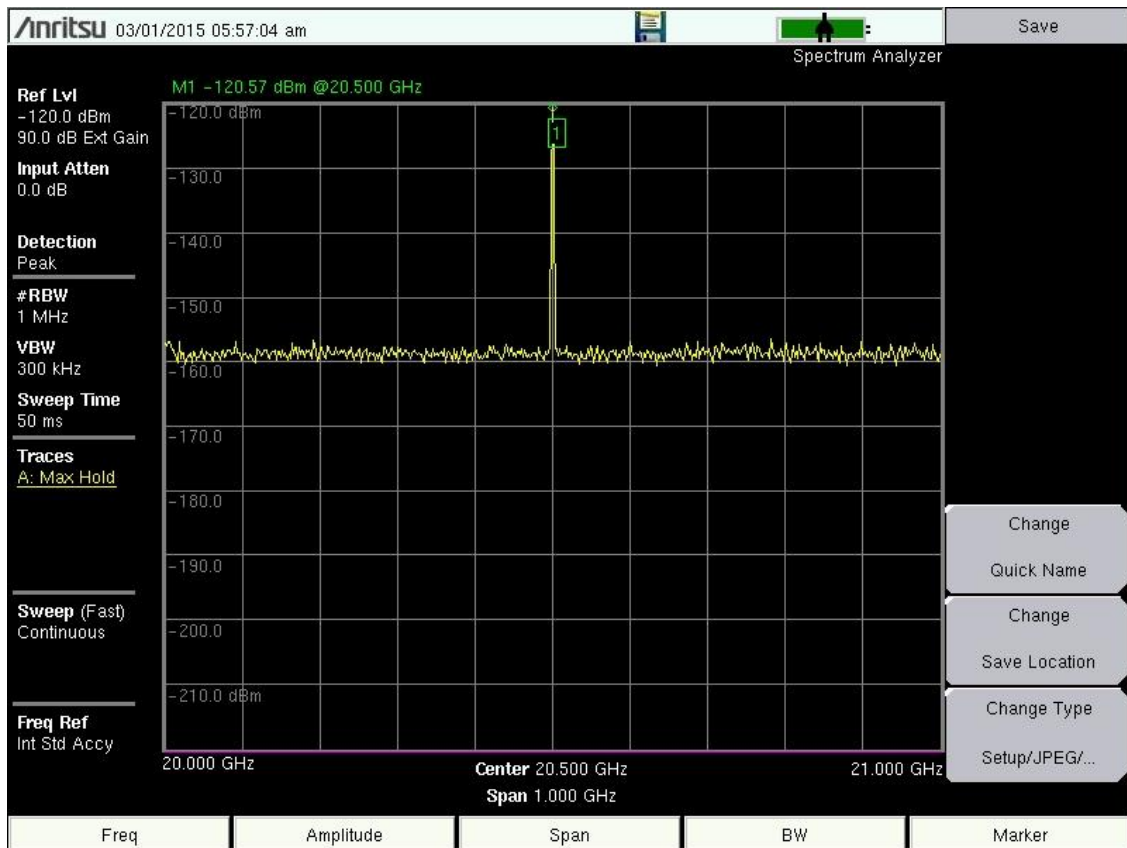
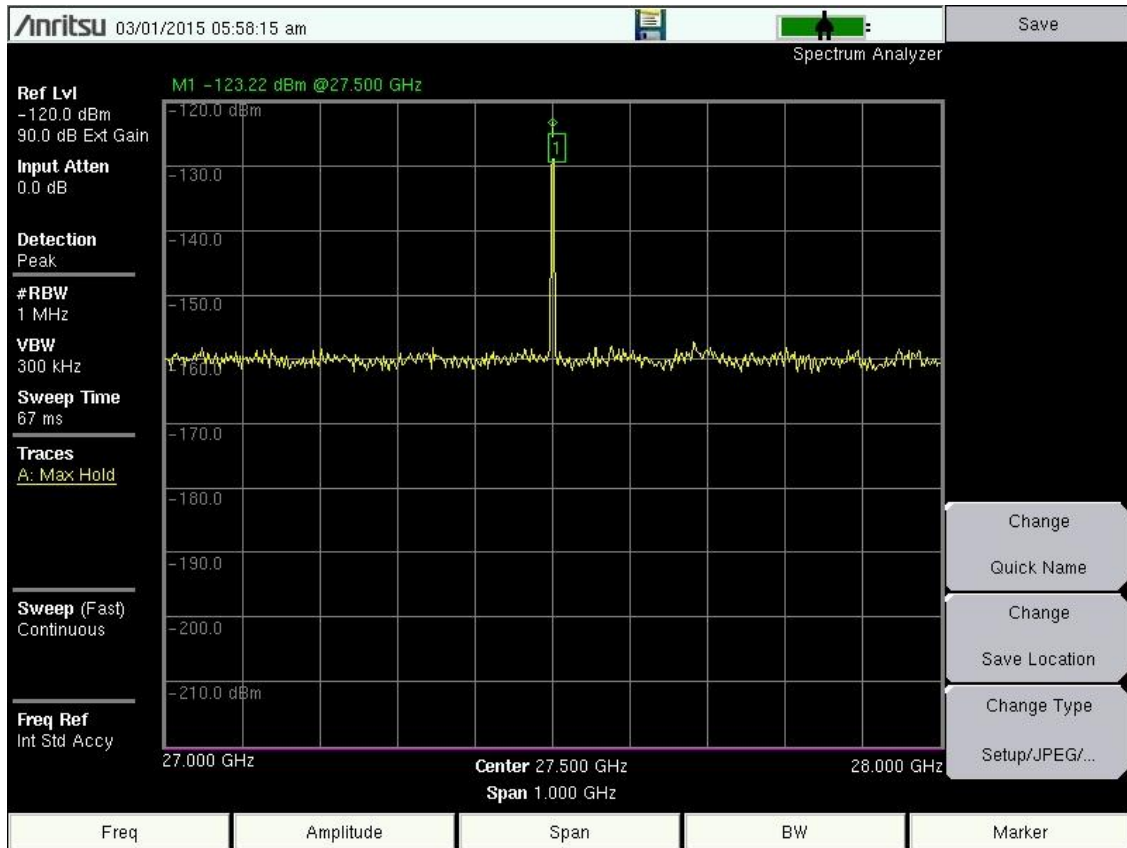
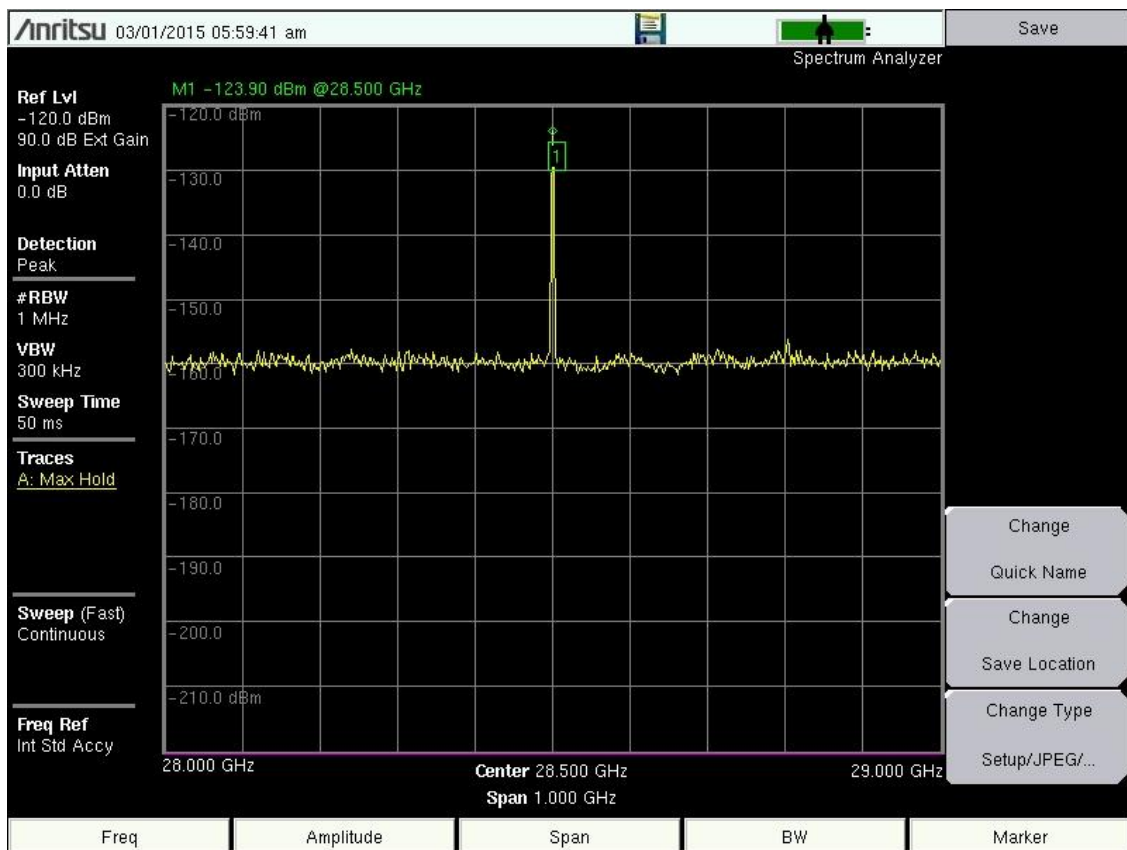
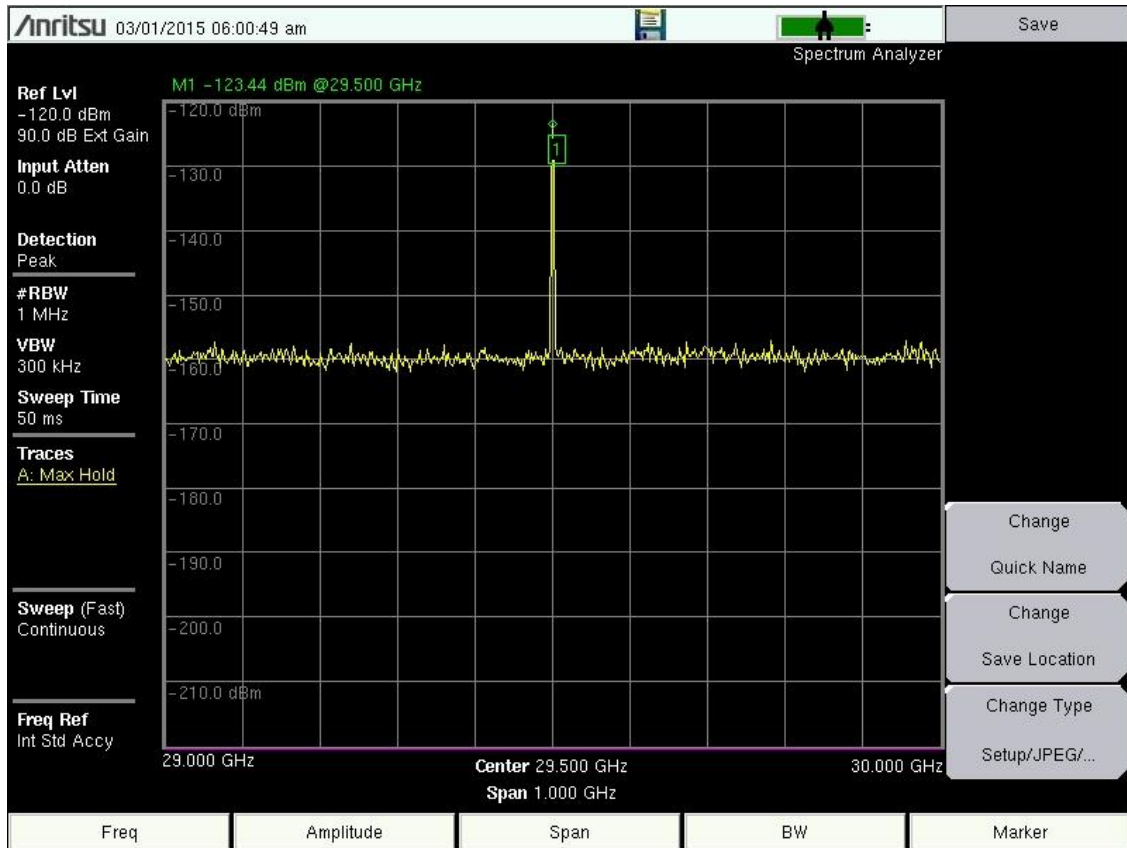
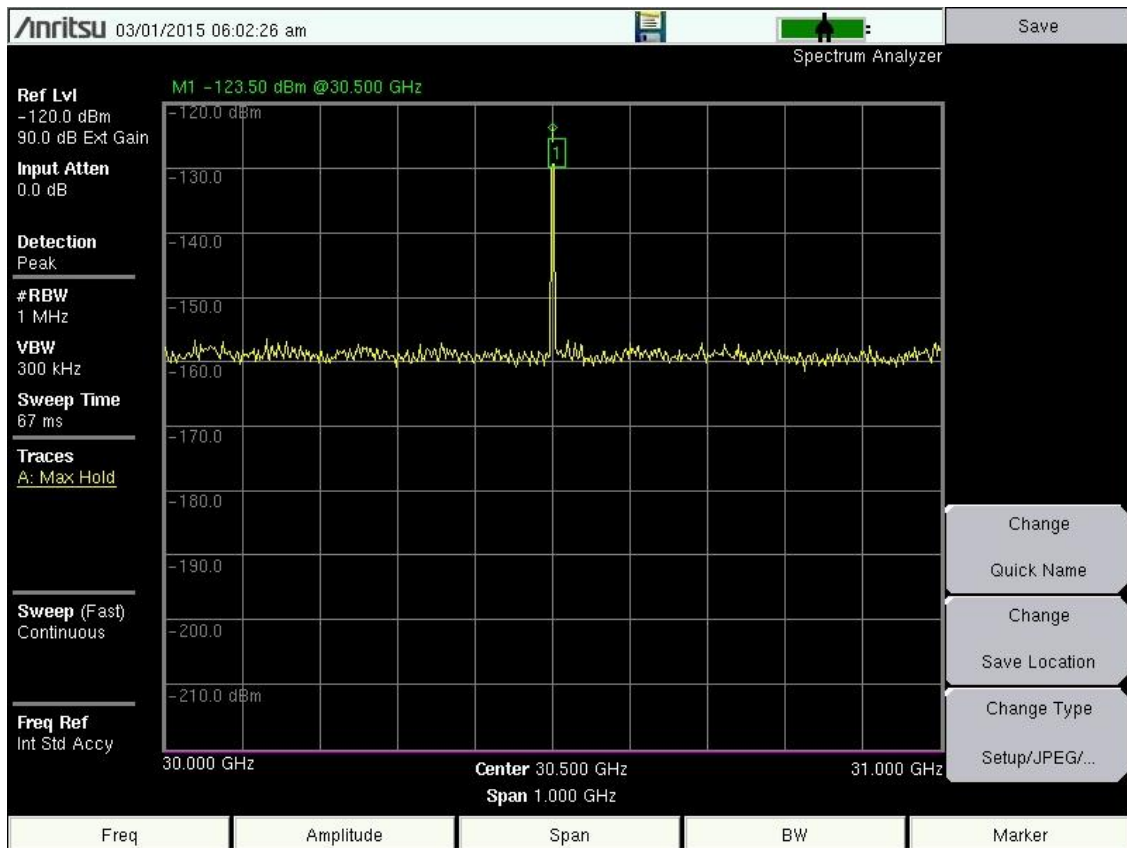
Figures 2.1-2(A-H) displays the spectrum photographs of the described calibration procedure employed during these measurements.

$$\begin{aligned} \text{at 19.5 GHz: } \quad \text{dBW}_I &= -60 \text{ dBm} - 30 \text{ dB} - 30 \text{ dB} \\ &= -120 \text{ dBW}_I \end{aligned}$$

In this instance, the spectrum analyzer displayed measured signal level of -60 dBm equates to an isotropic signal level of -120 dBW<sub>I</sub>.

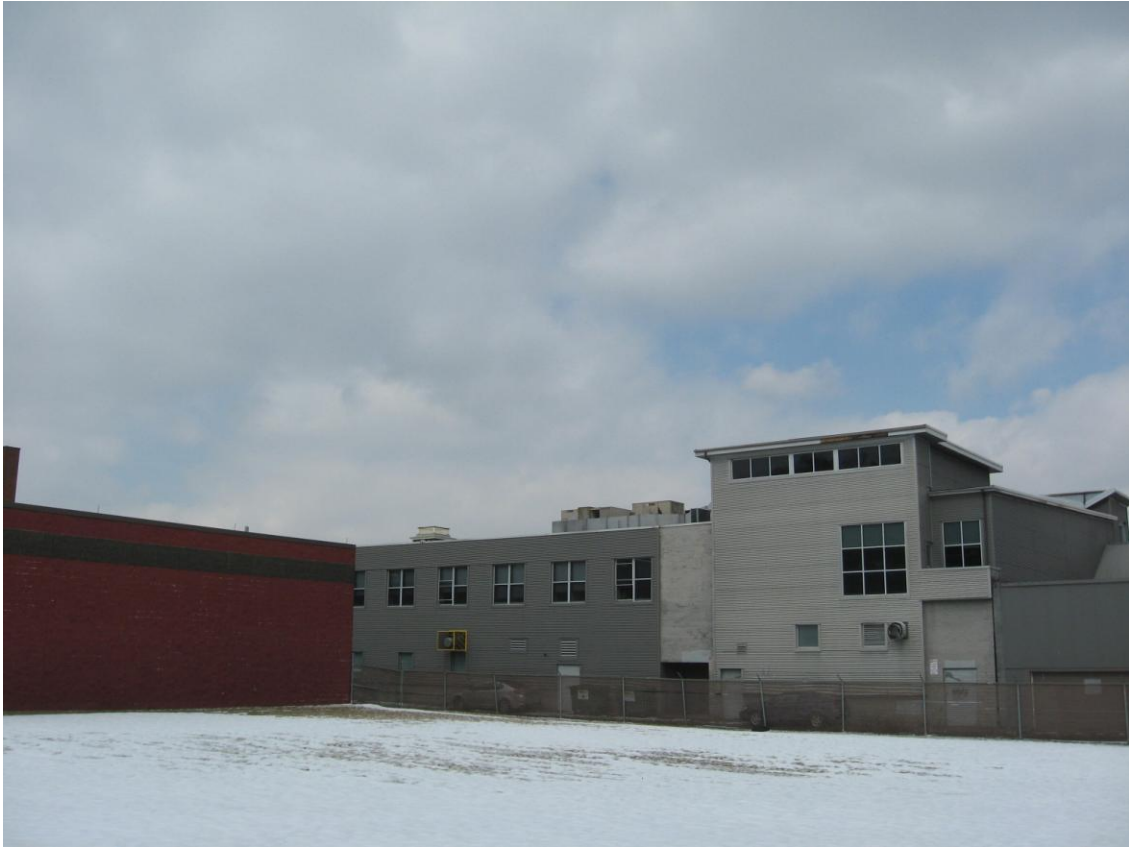
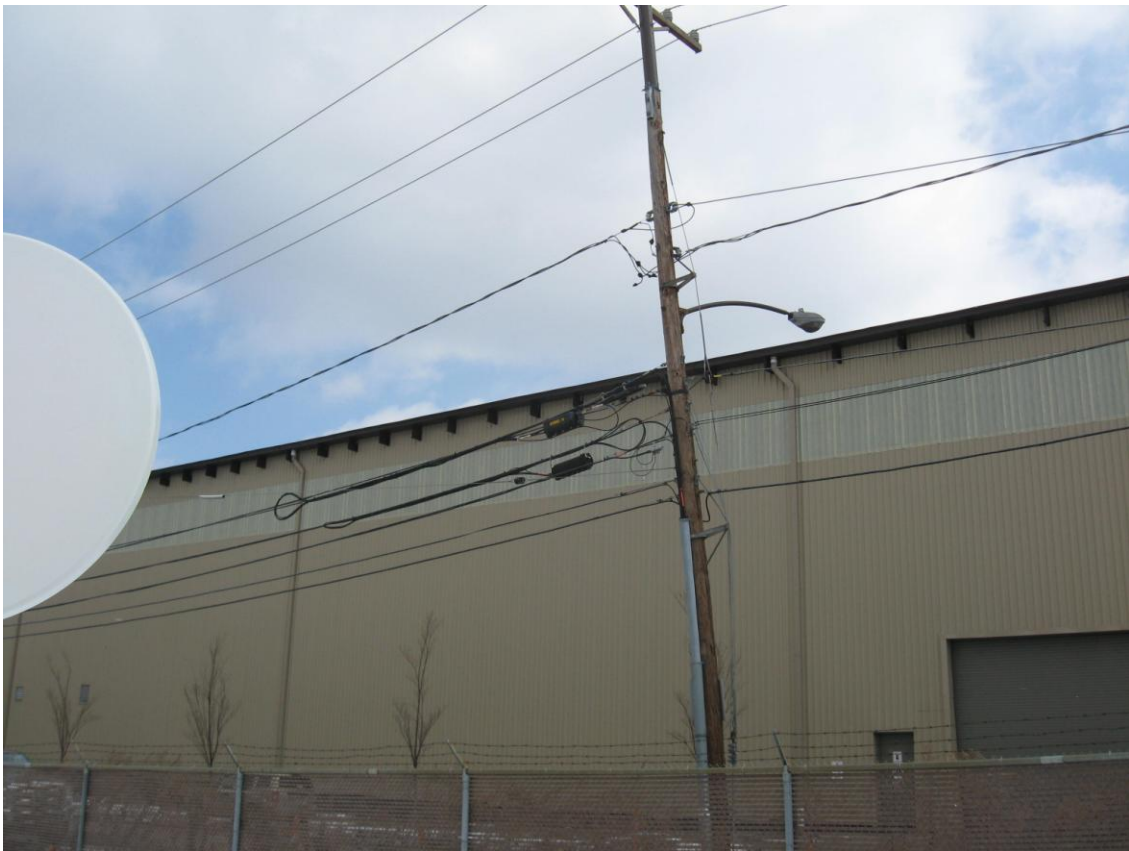
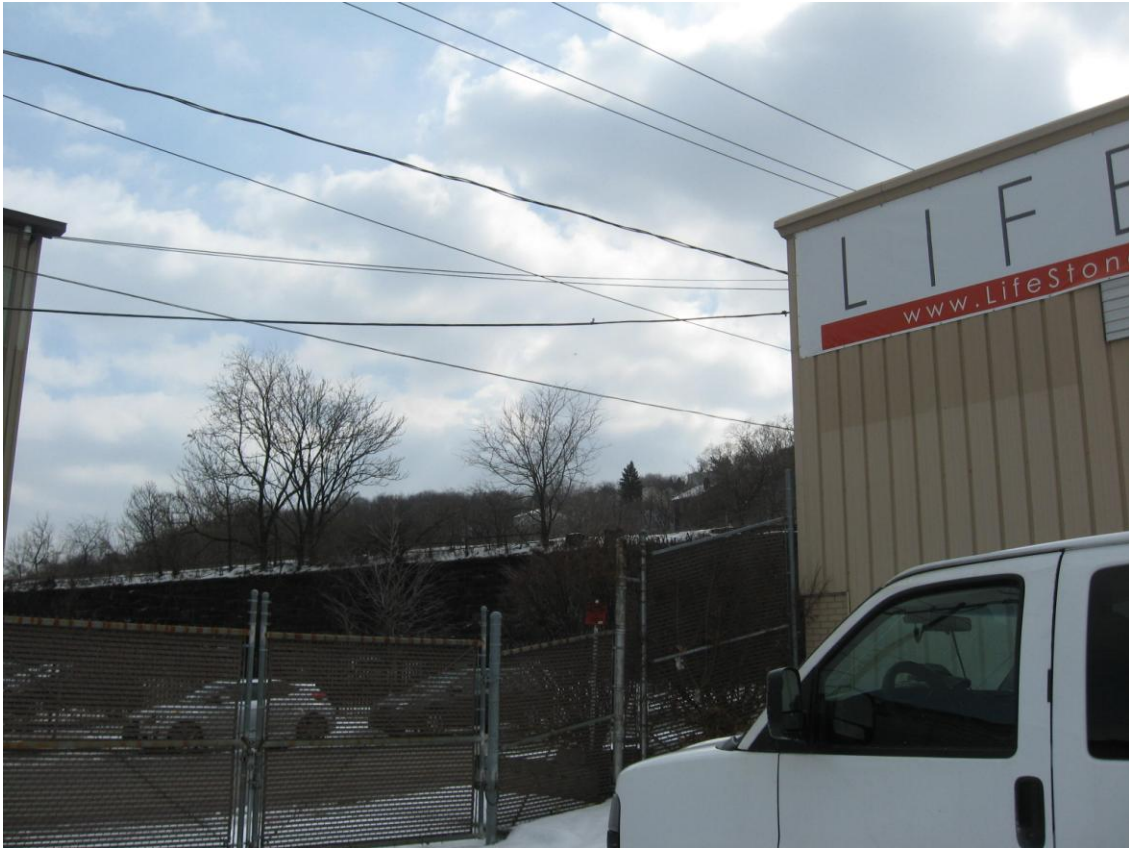
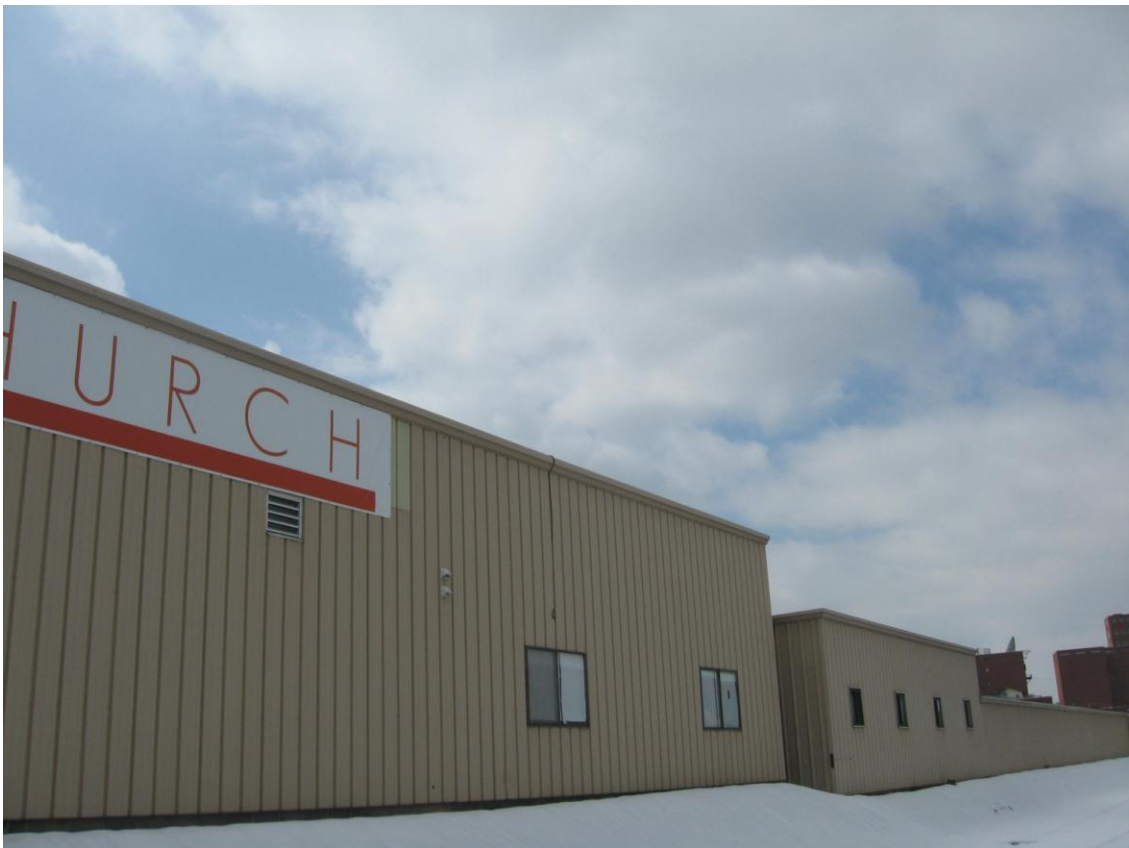
**Figure 3.1-1 Earth Station Site Photographs**

| 8. GEOSTATIONARY ARC VISIBILITY: | Satellite arc has no blockage at this time |

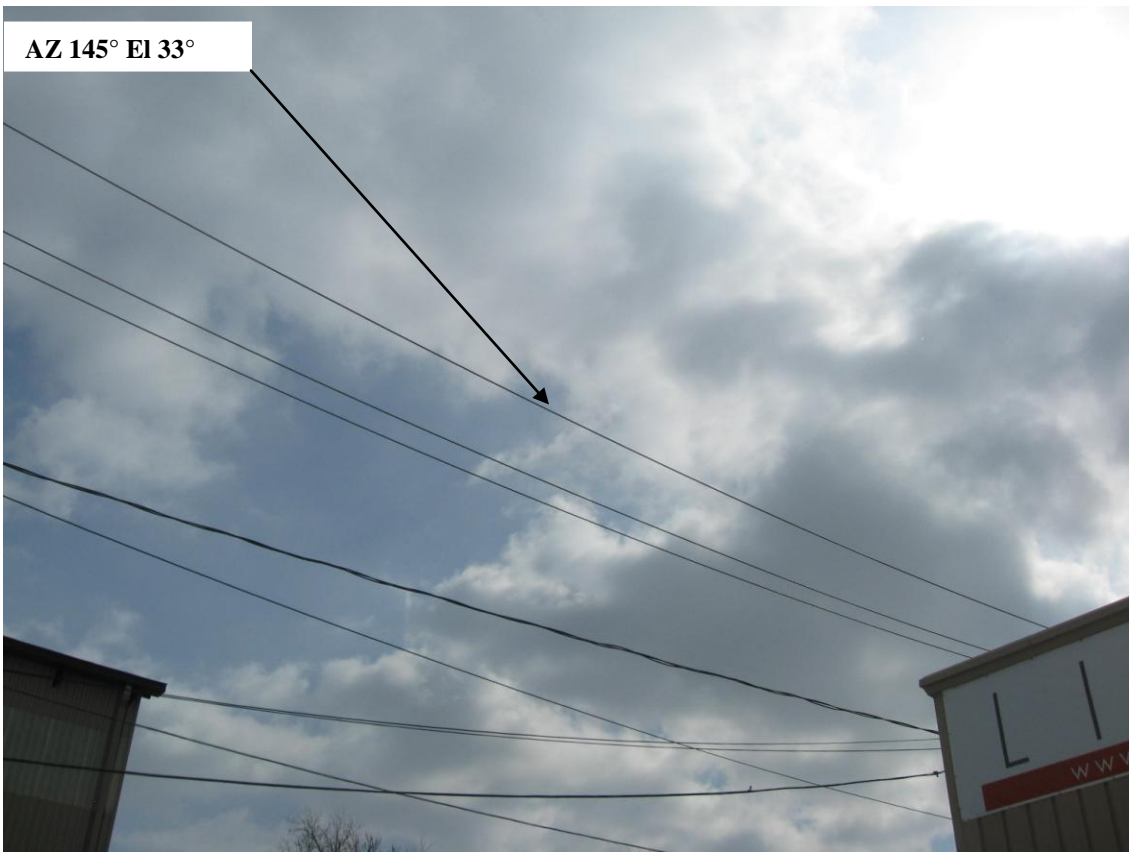
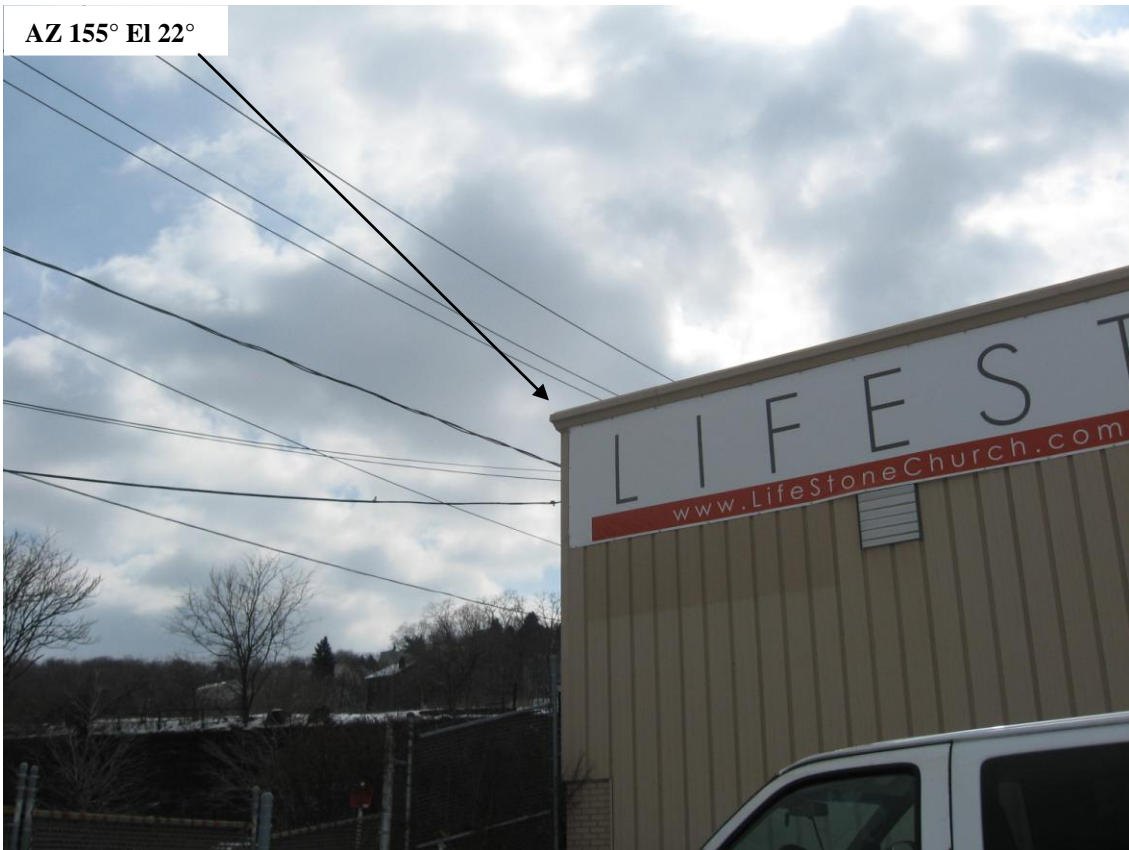
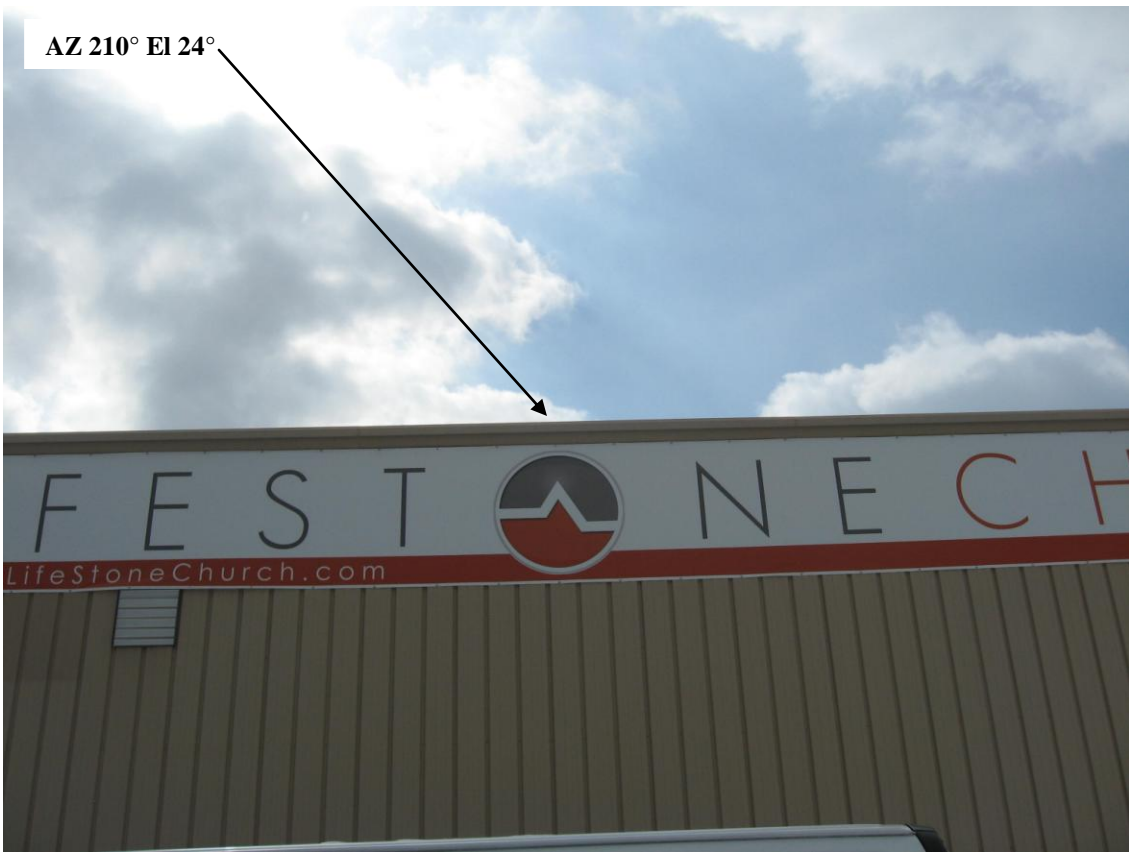
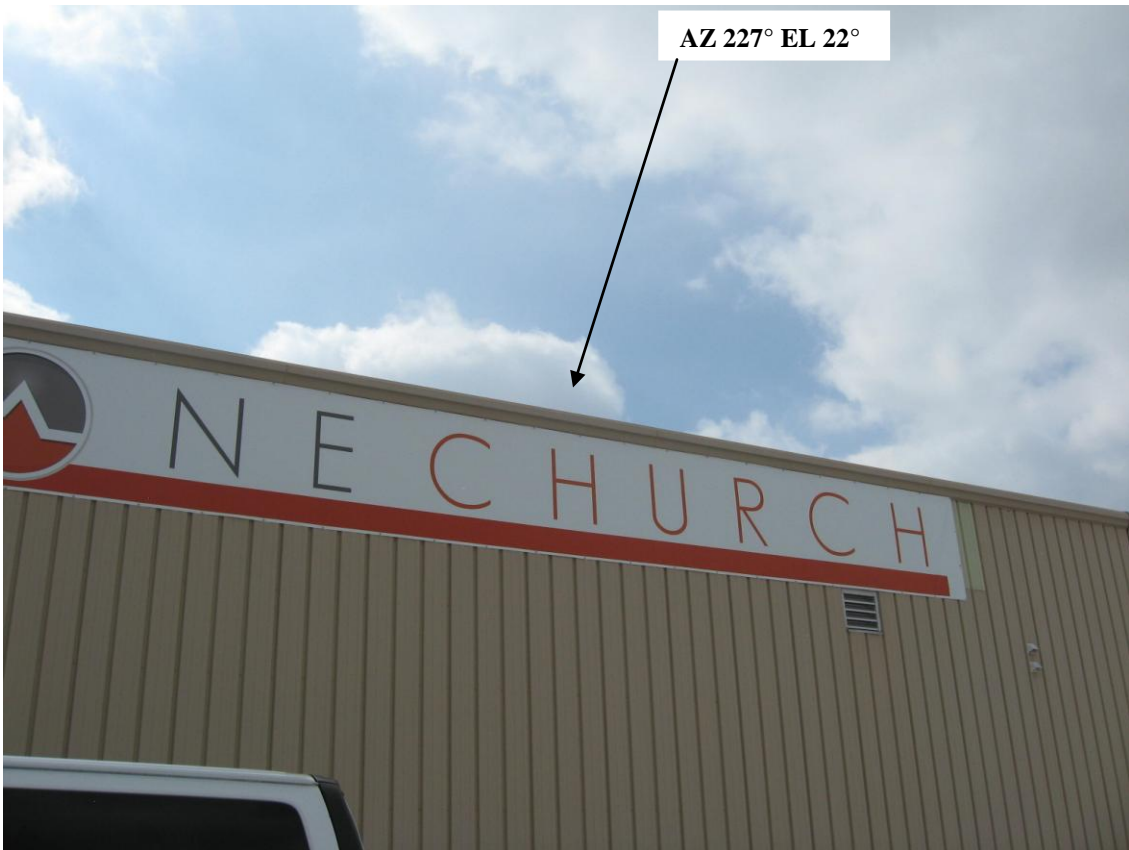
Figure 3.1-2 Horizon Photographs of Earth Station Site

There is no potential satellite arc blockage at this site. Final arc clearance will depend on antenna placement.

The satellite arc has no potential blockage from 55W through 115W.

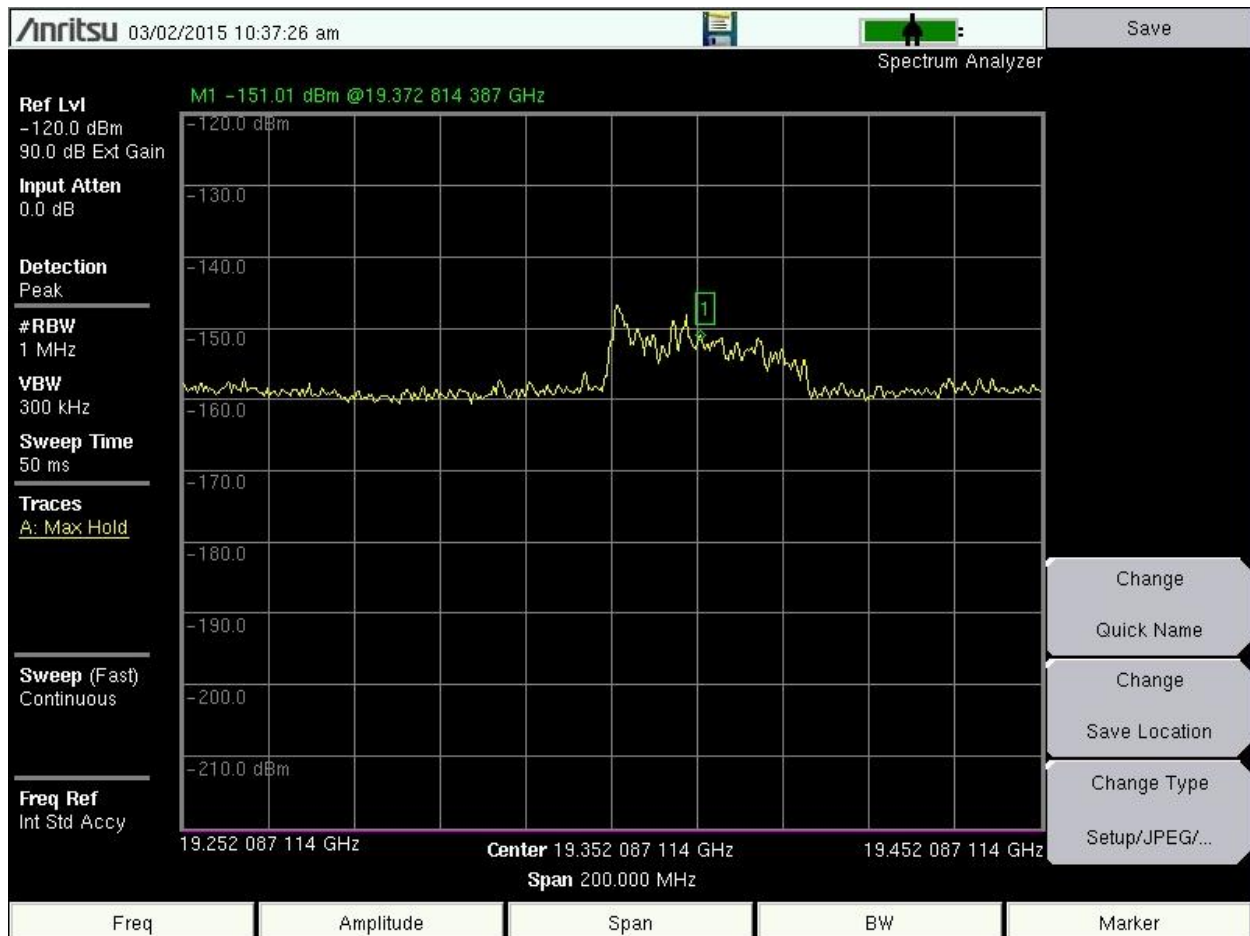
**Case #2 from interference analysis report. Transmitter Call Sign WQMA583. The signal originates at an azimuth 114.3° and a distance of 3.6 km from test location. Highest recorded signal is -147 dBW.**

There was one signal measured above the  $-156$  dBW/ 1 MHz interference objective for digital reception at this site. The signal has a call sign WQMA583 and is at an Azimuth of  $114.3^\circ$ . The site is surrounded by multiple two-four story buildings. ViaSat will need to review their link budget and determine if this signal would cause interference to the expected system installed at this location.

It is recommended that frequency coordination of this site be initiated to protect this location at the more stringent digital receive interference objective.
