MICROWAVE PATH SURVEY REPORT

RADIO FREQUENCY INTERFERENCE (RFI) MEASUREMENT REPORT

Columbus (Williams Rd), Ohio

Transmit and Receive Earth Station
17-21 GHz and 27-31 GHz

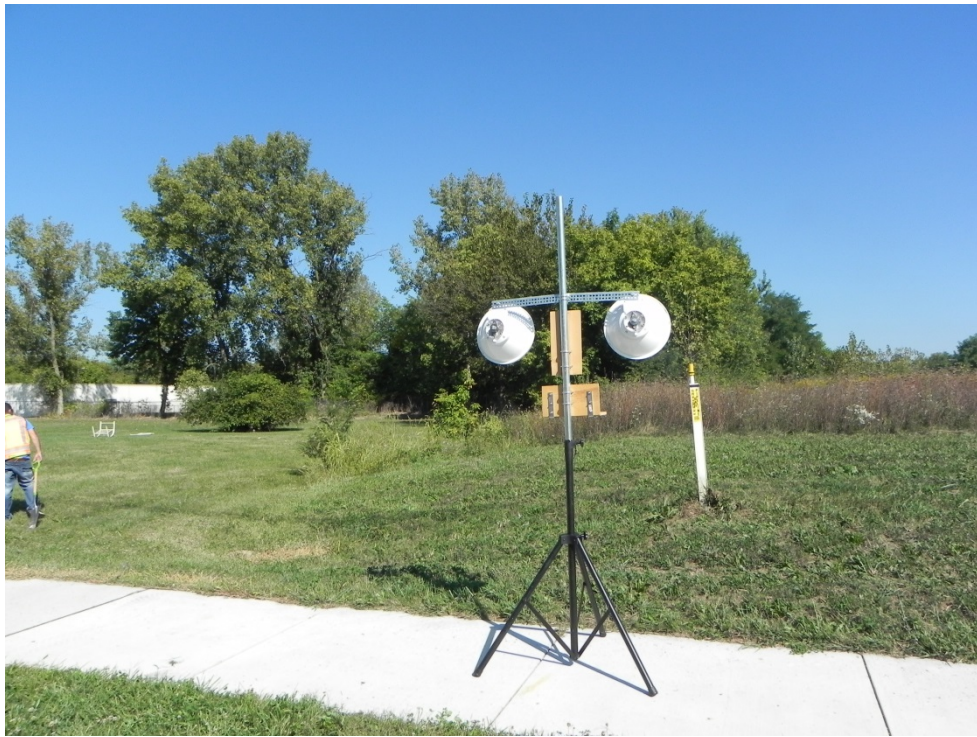
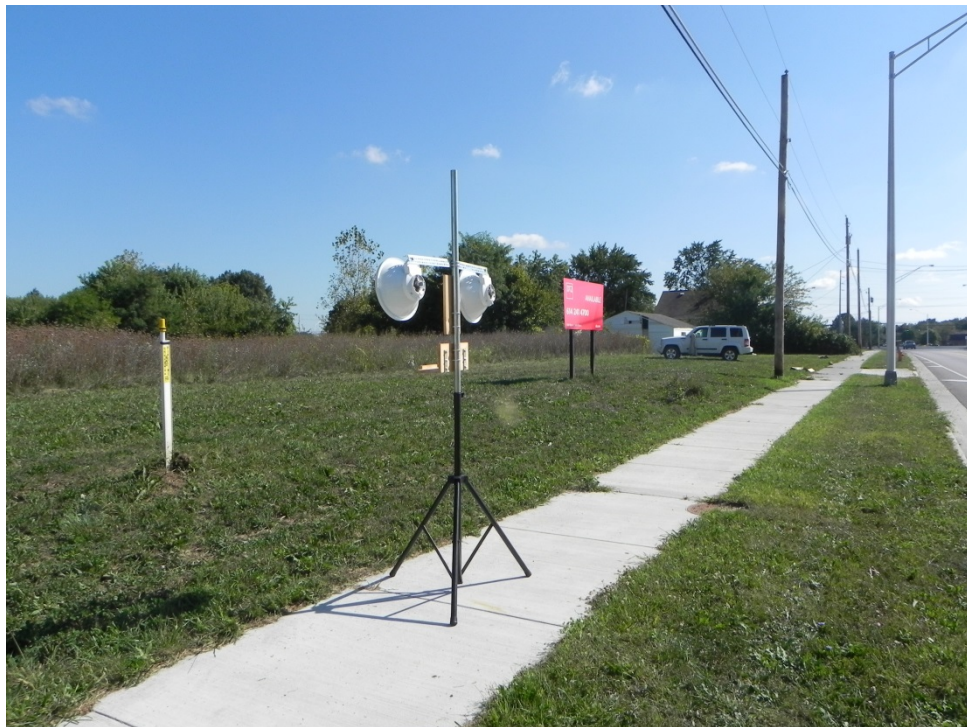
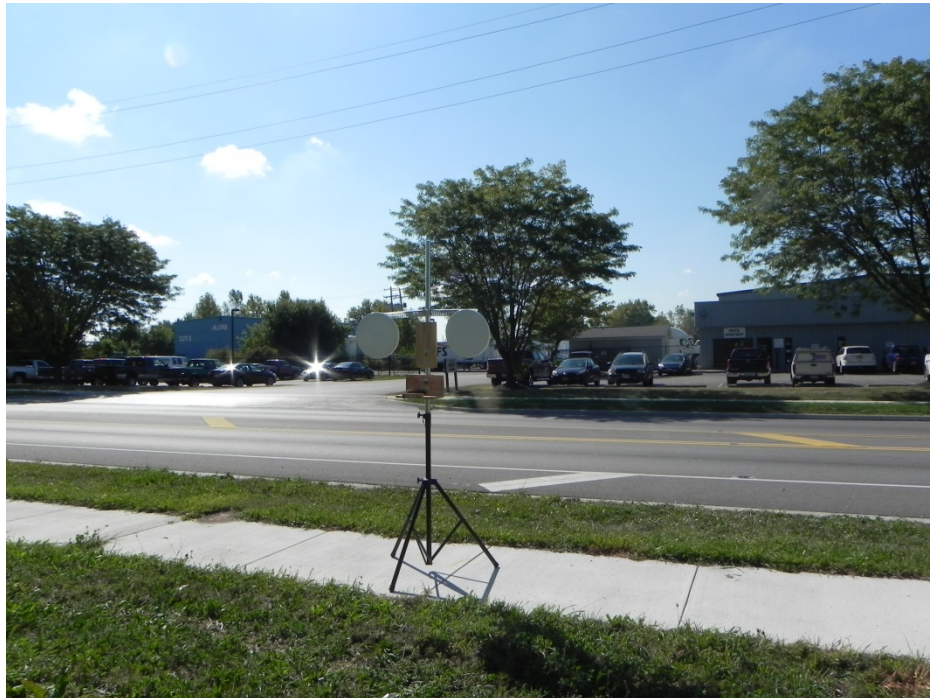
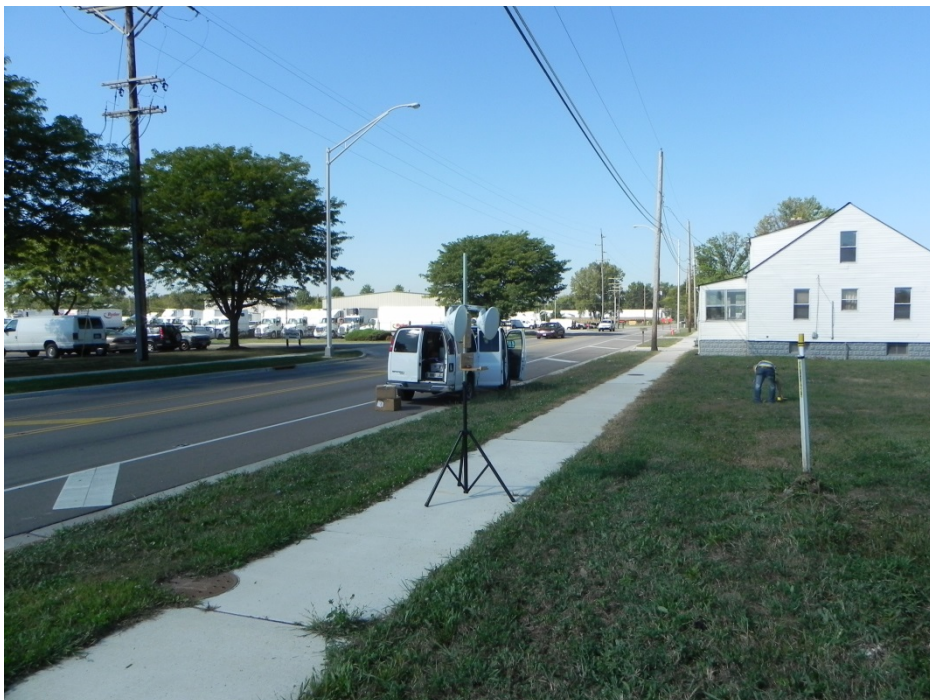
Figure 3.1-1 Earth Station Site Photographs

- Table 3.1-1 presents a site data sheet including all pertinent site information.
- Figures 3.1-1 and 3.1-2 are the photographs depicting the existing earth station site and satellite arc.
- Figures 3.1-3 through 3.1-10 are the RF spectrum photographs depicting the interference environment at the test site.

| 8. GEOSTATIONARY ARC VISIBILITY: | Satellite arc has no blockage at this time |

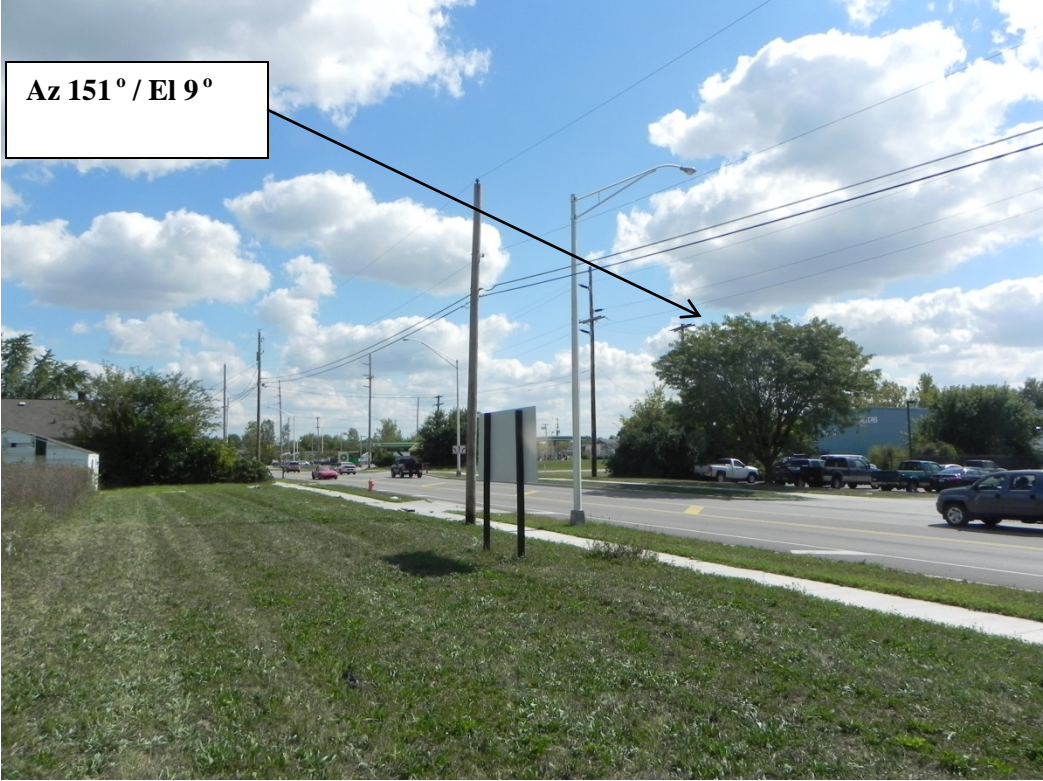
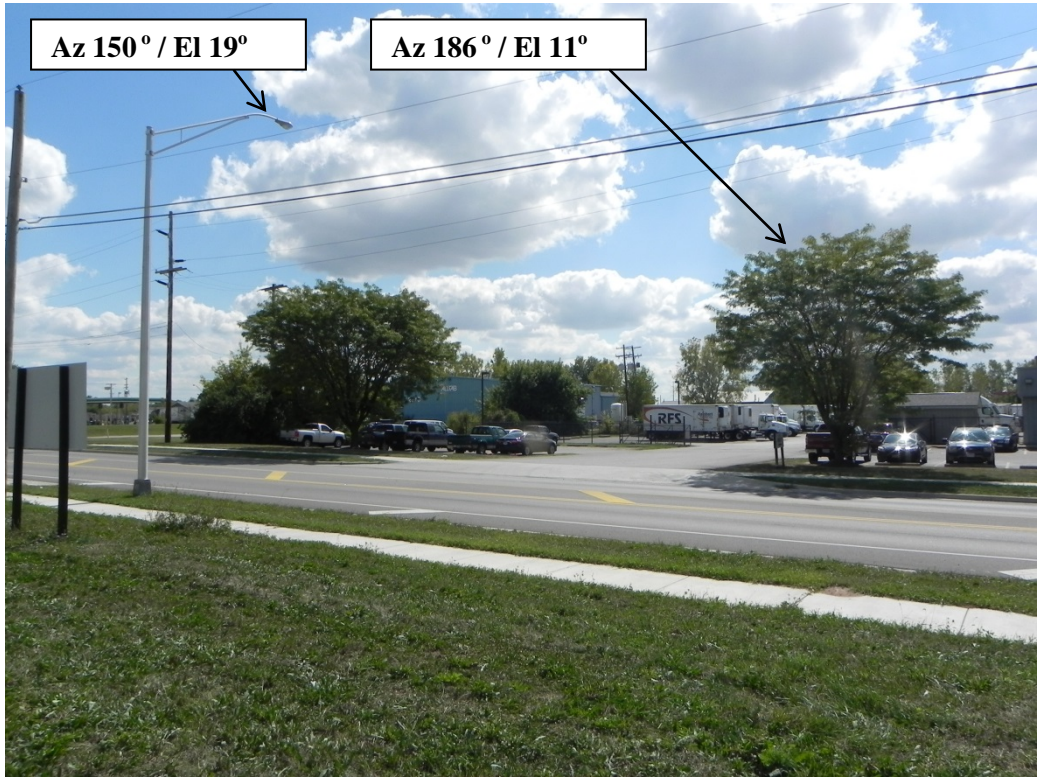
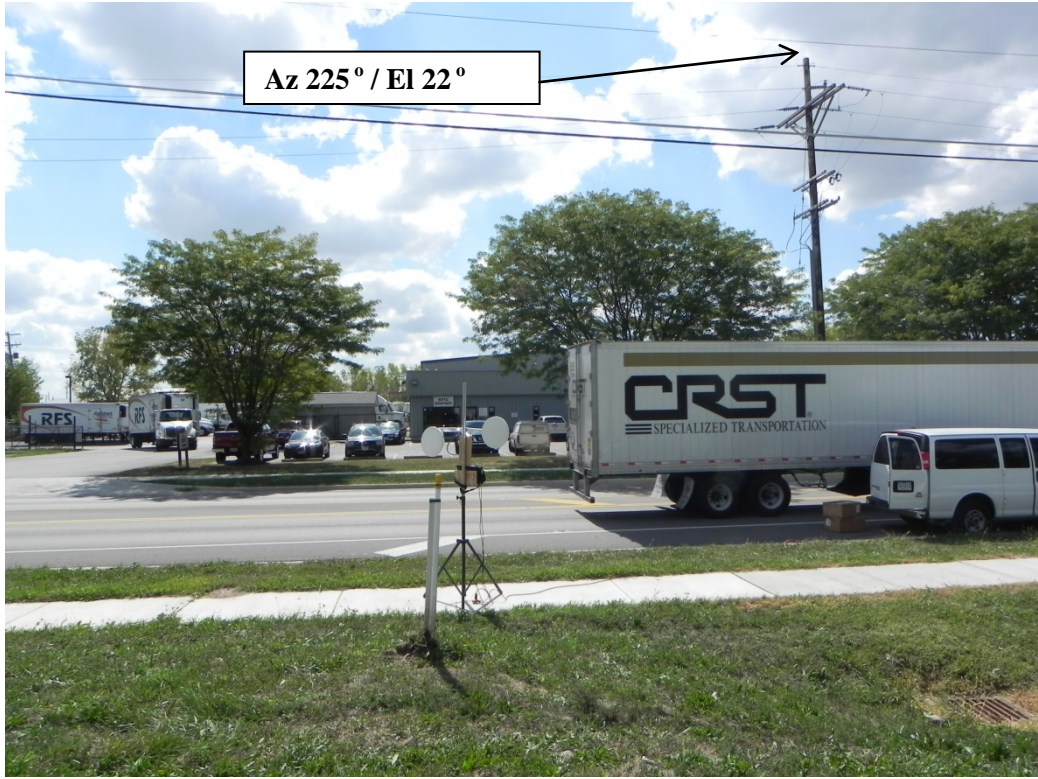
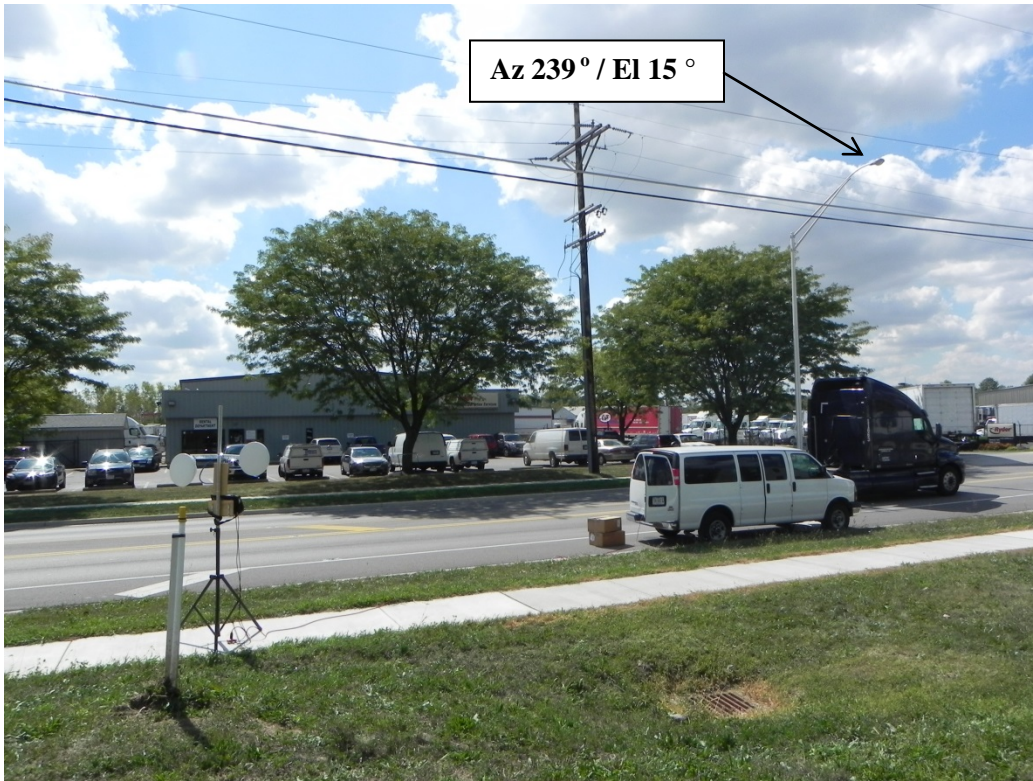
Figure 3.1-2 Horizon Photographs of Earth Station Site

There is no potential satellite arc blockage at this site. Final arc clearance will depend on antenna placement.

The satellite arc has no potential blockage from 55W through 115W.
