MICROWAVE PATH SURVEY REPORT

RADIO FREQUENCY INTERFERENCE (RFI) MEASUREMENT REPORT

ViaSat

Transmit and Receive Earth Station
17-21 GHz and 27-31 GHz

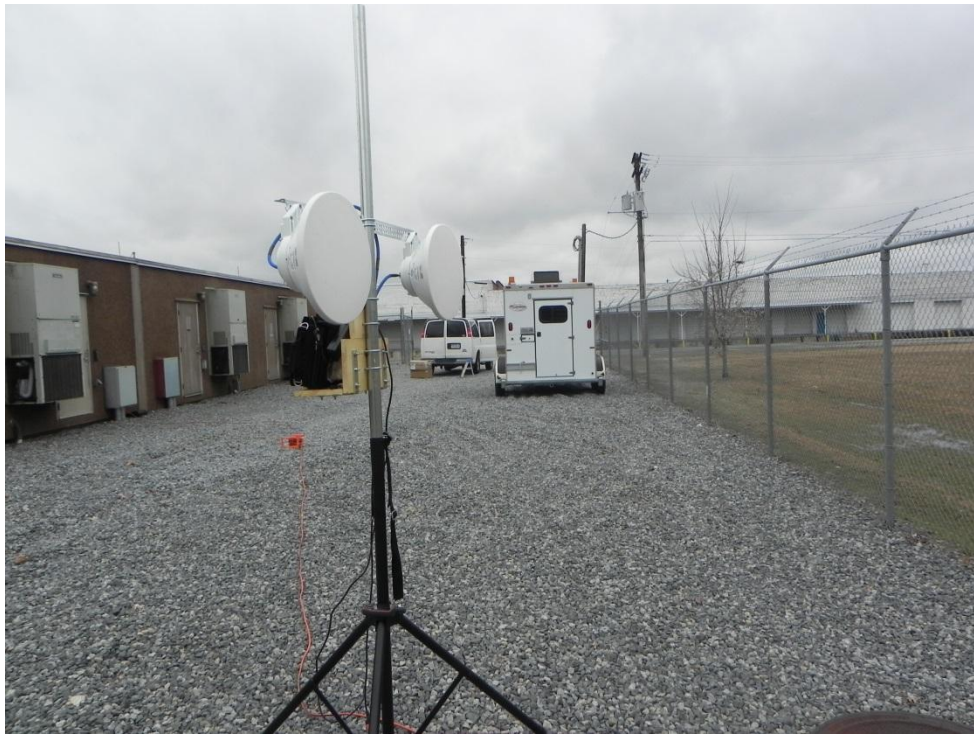
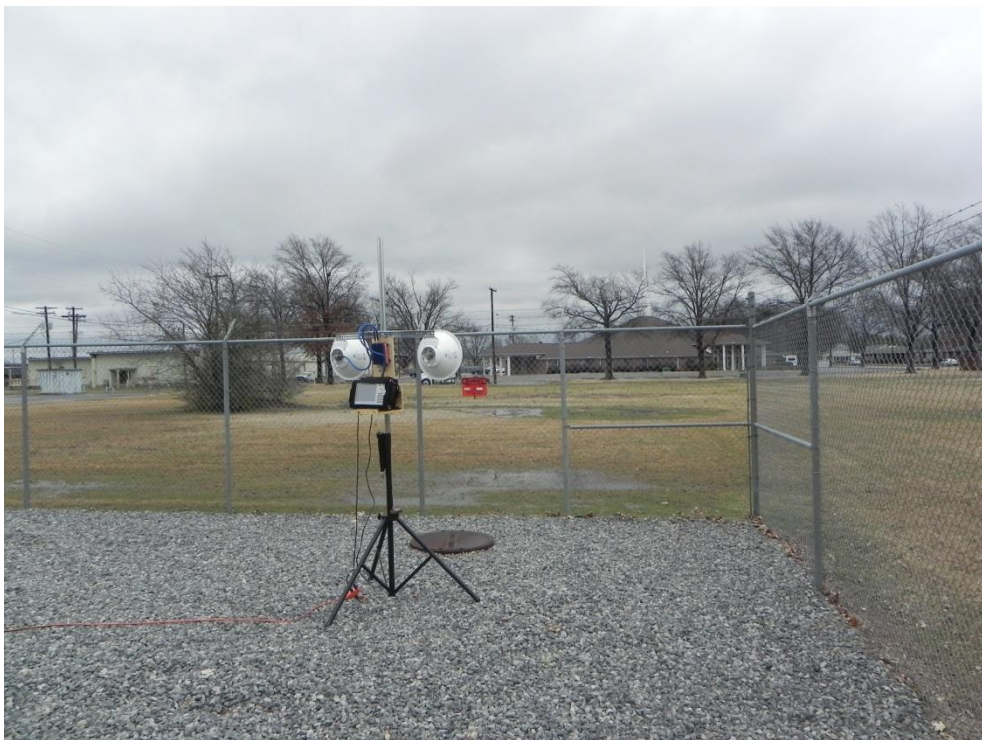
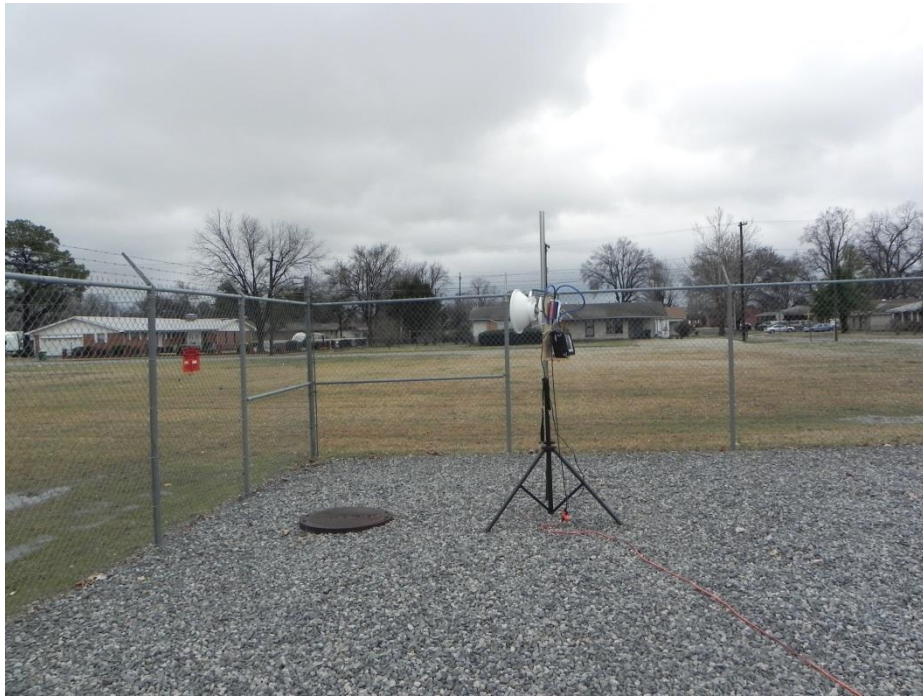
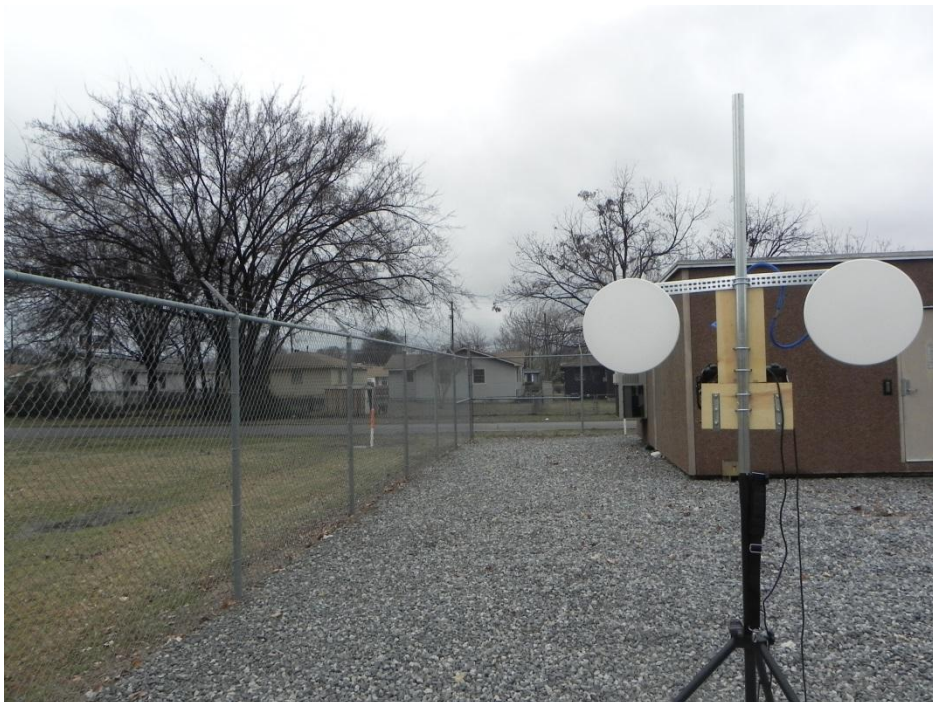
Figure 3.1-1 Earth Station Site Photographs

- Table 3.1-1 presents a site data sheet including all pertinent site information.
- Figures 3.1-1 and 3.1-2 are the photographs depicting the existing earth station site and satellite arc.
- Figures 3.1-3 through 3.1-10 are the RF spectrum photographs depicting the interference environment at the test site.

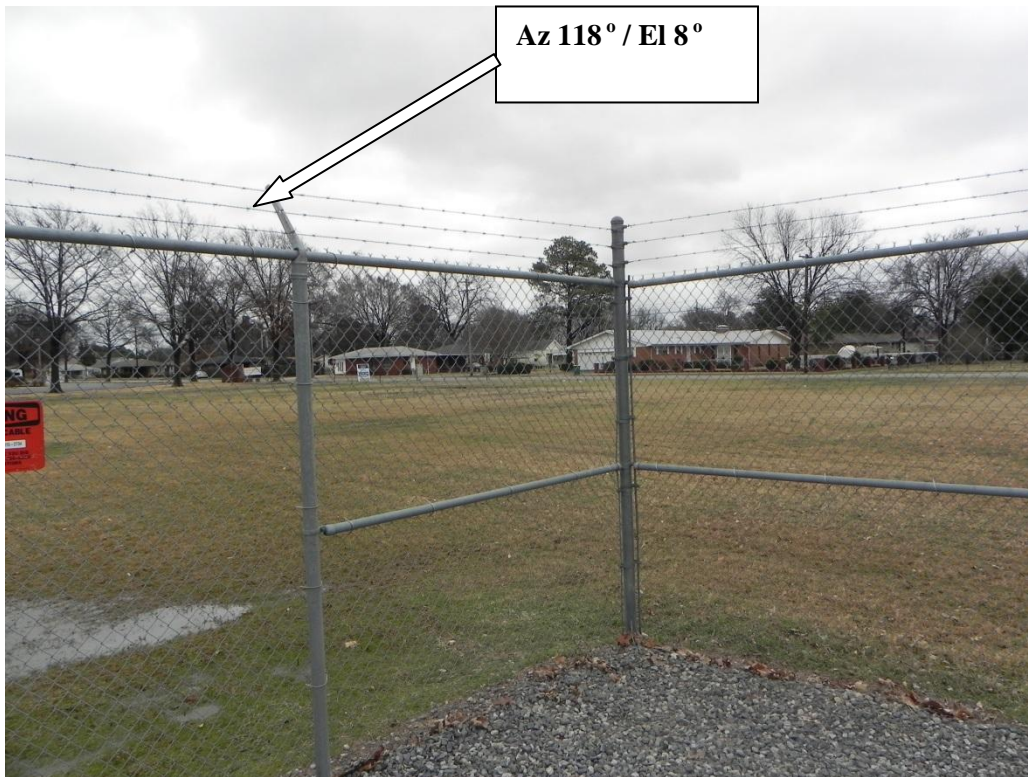
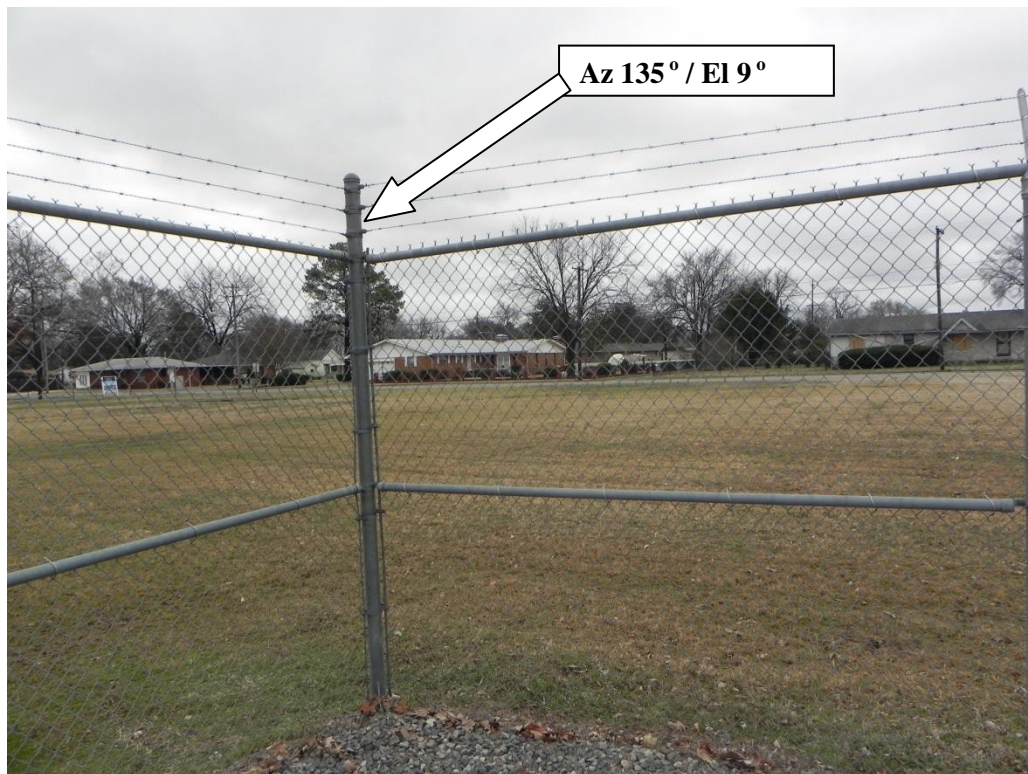
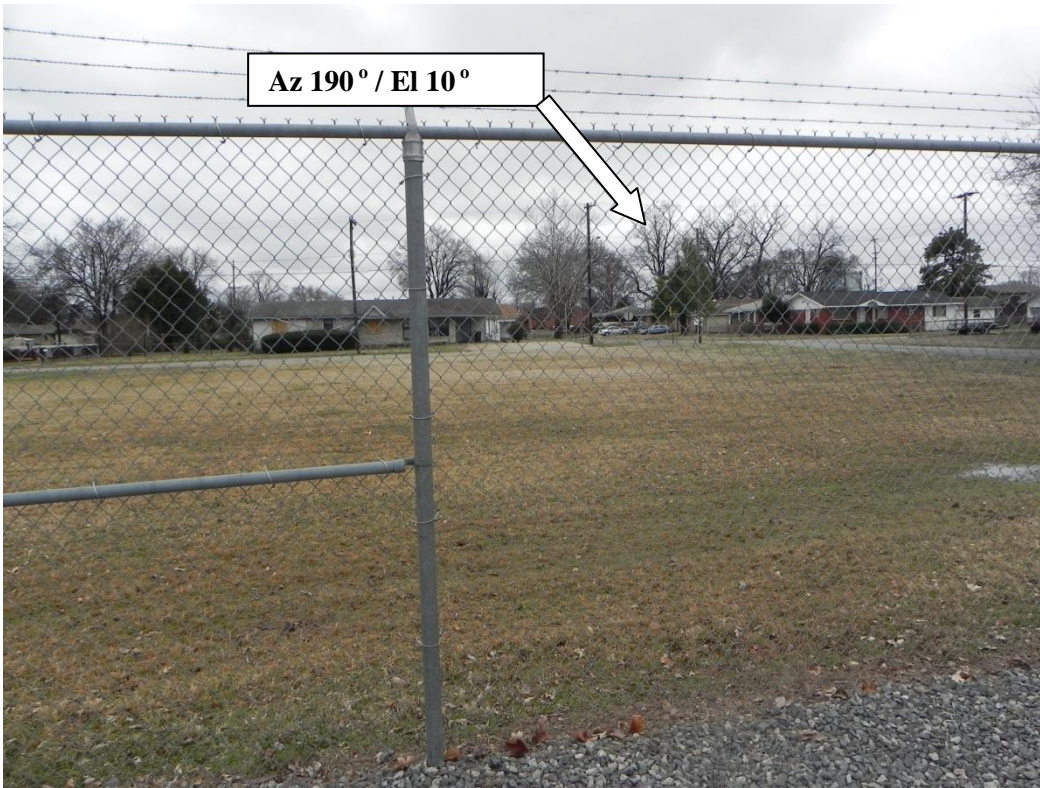
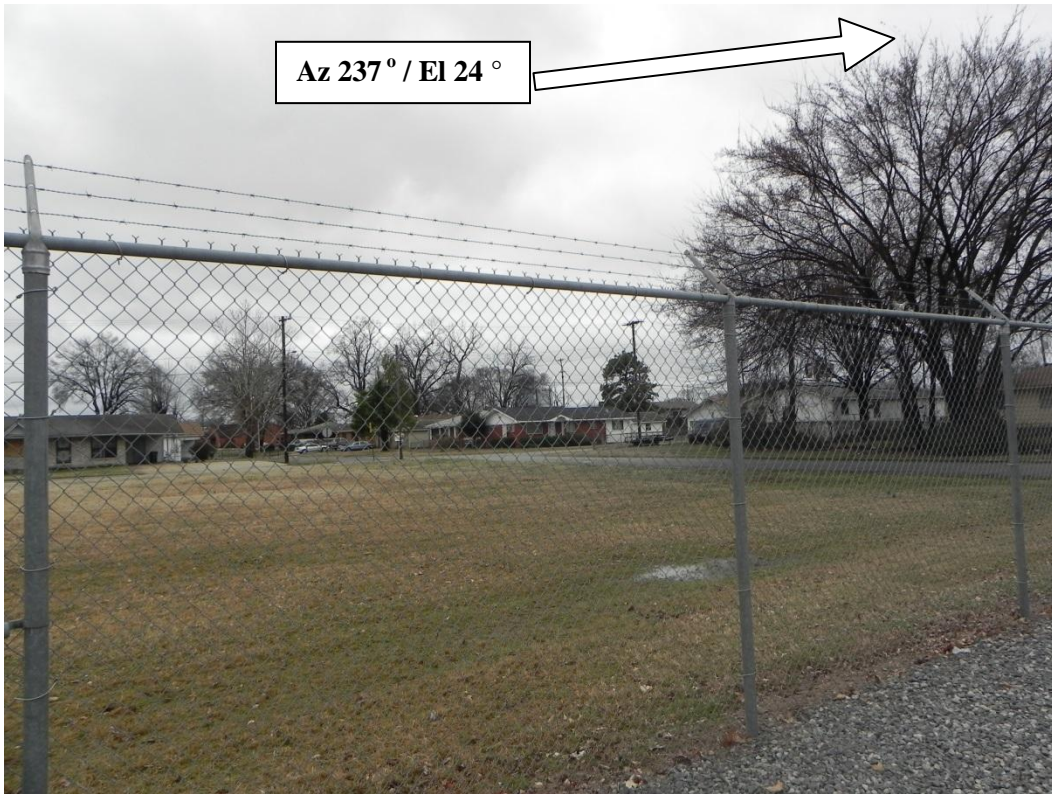
Figure 3.1-2 Horizon Photographs of Earth Station Site

| 8. GEOSTATIONARY ARC VISIBILITY: | Satellite arc has no blockage at this time |

There is no potential satellite arc blockage at this site. Final arc clearance will depend on antenna placement.

The satellite arc has no potential blockage from 55W through 115W.
