MICROWAVE PATH SURVEY REPORT

RADIO FREQUENCY INTERFERENCE (RFI) MEASUREMENT REPORT

ViaSat

Kansas City (Centerview), Missouri

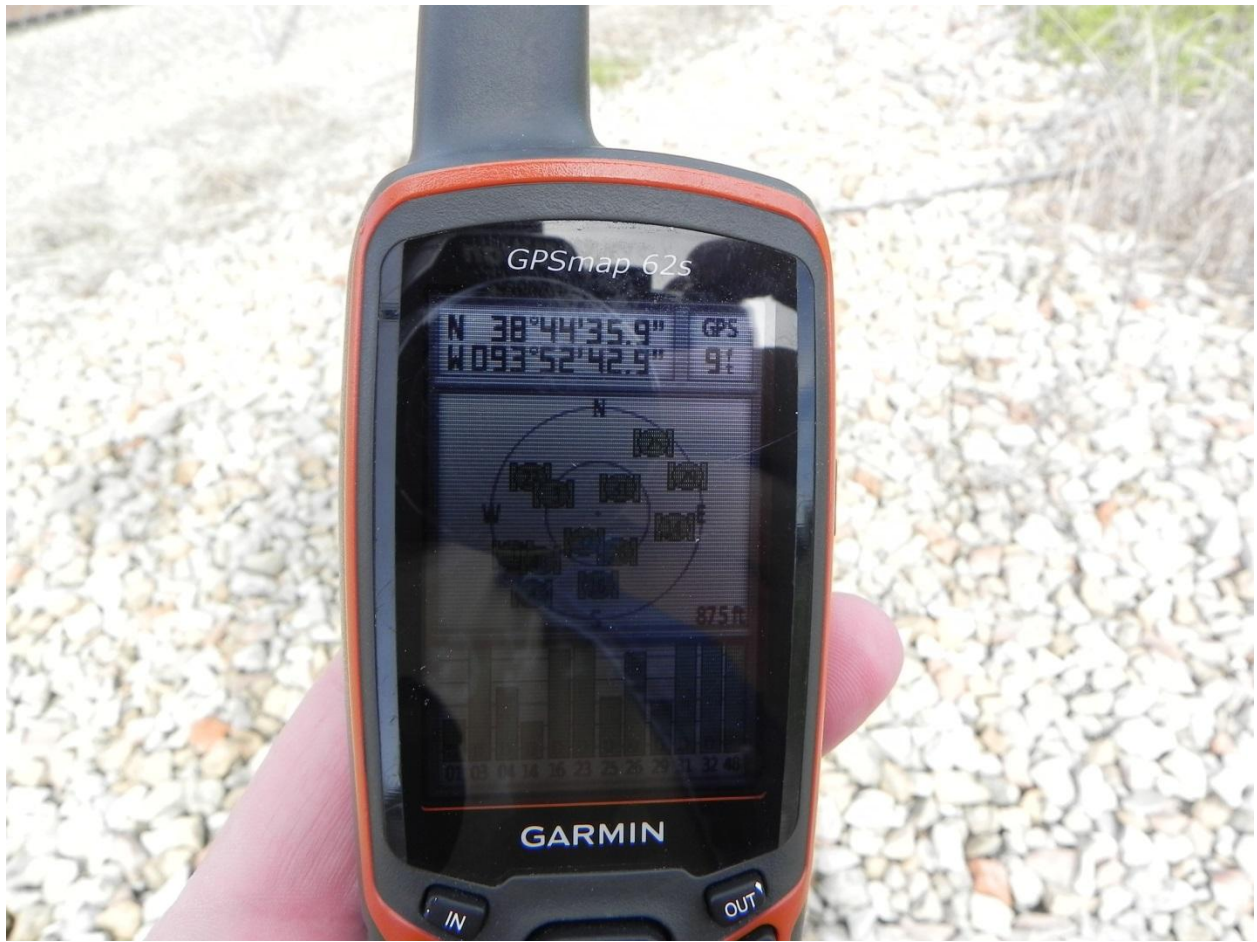
Figure 1.2-3 – GPS Photograph

The measured site is identified on a portion of a topographic map shown in Figure 1.2-1. An aerial photo of the site location is shown in Figure 1.2-2. A photo of the measurement using a GPS is shown in Figure 1.2-3.

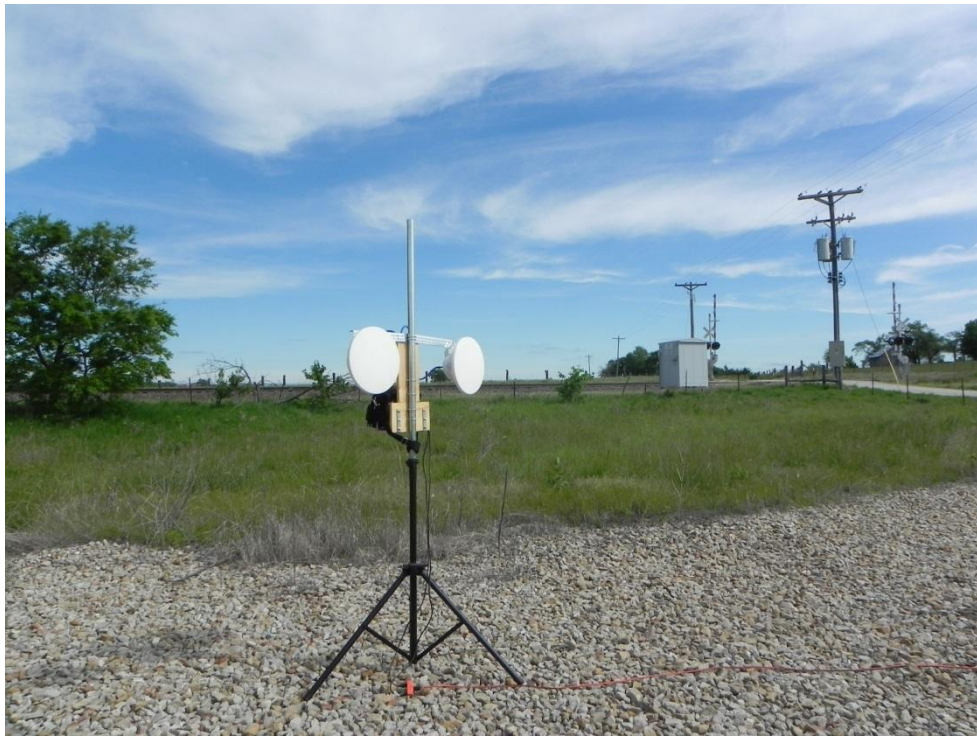
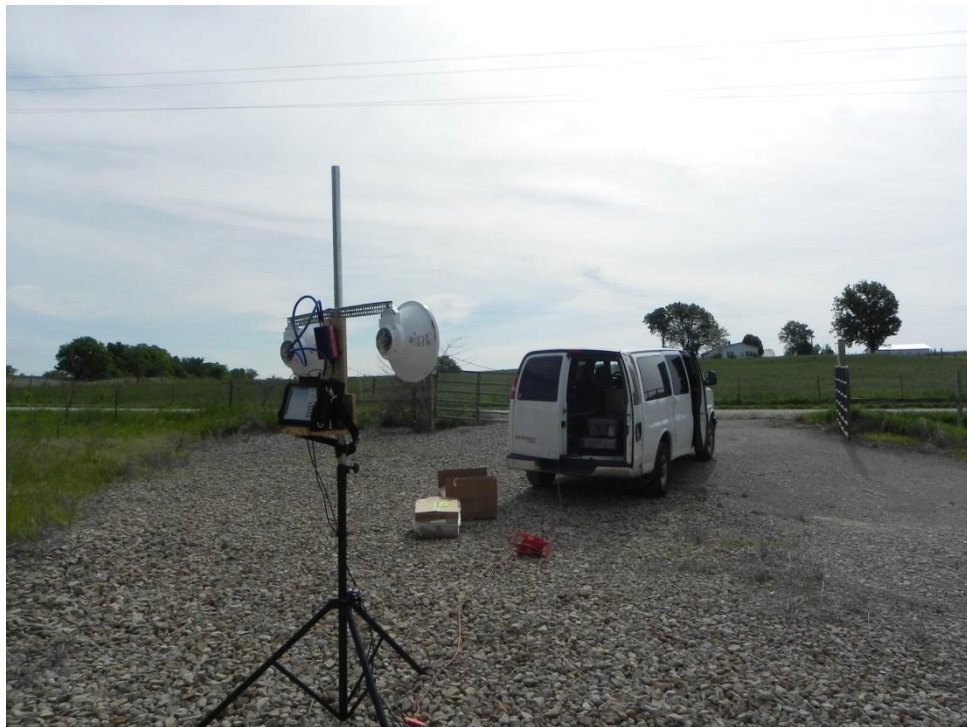
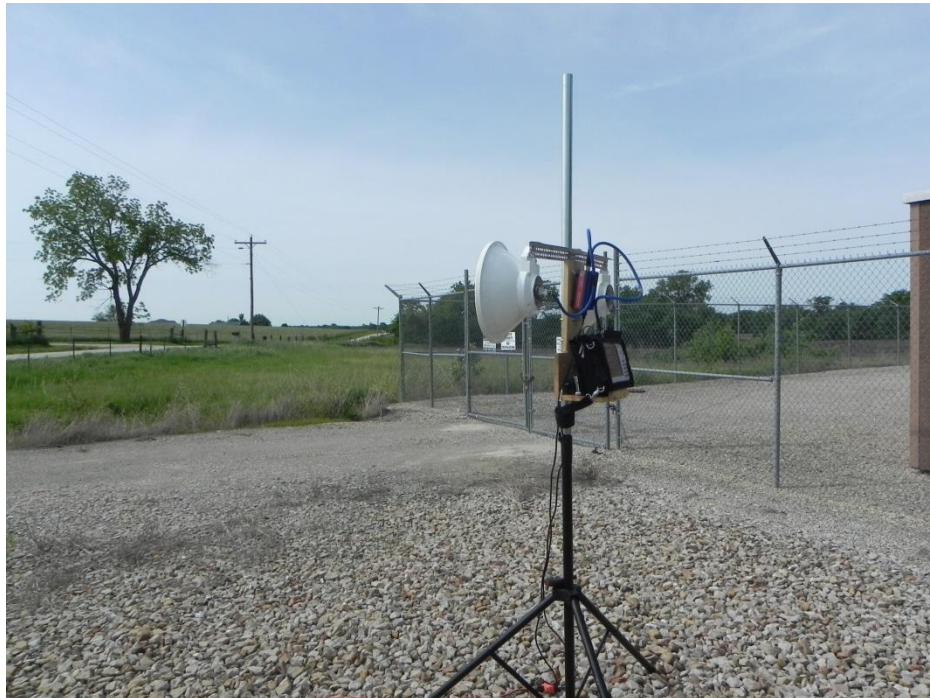
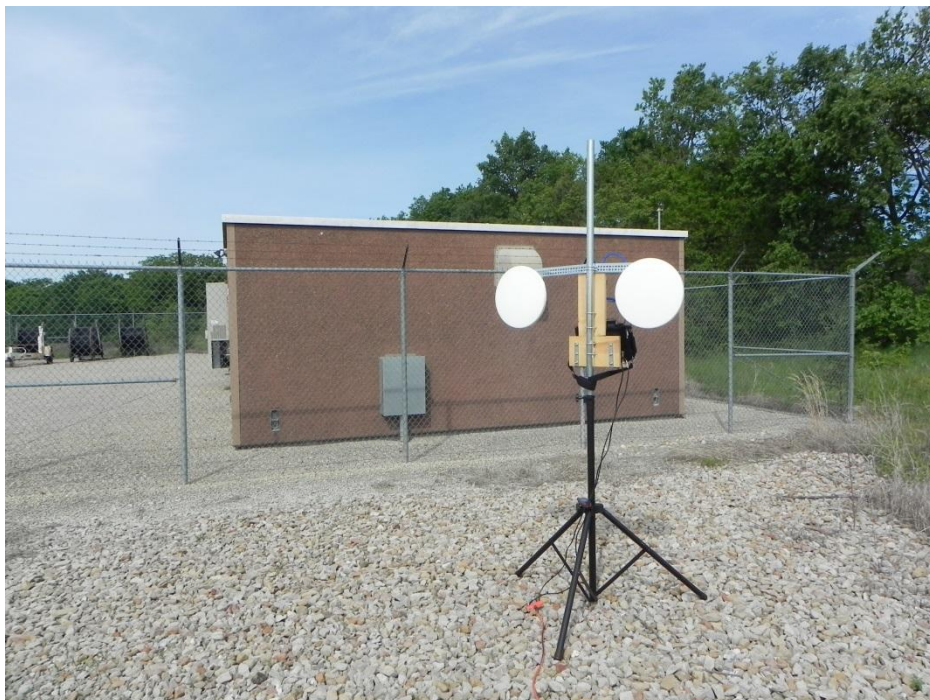
Figure 3.1-1 Earth Station Site Photographs

- Table 3.1-1 presents a site data sheet including all pertinent site information.
- Figures 3.1-1 and 3.1-2 are the photographs depicting the existing earth station site and satellite arc.
- Figures 3.1-3 through 3.1-10 are the RF spectrum photographs depicting the interference environment at the test site.

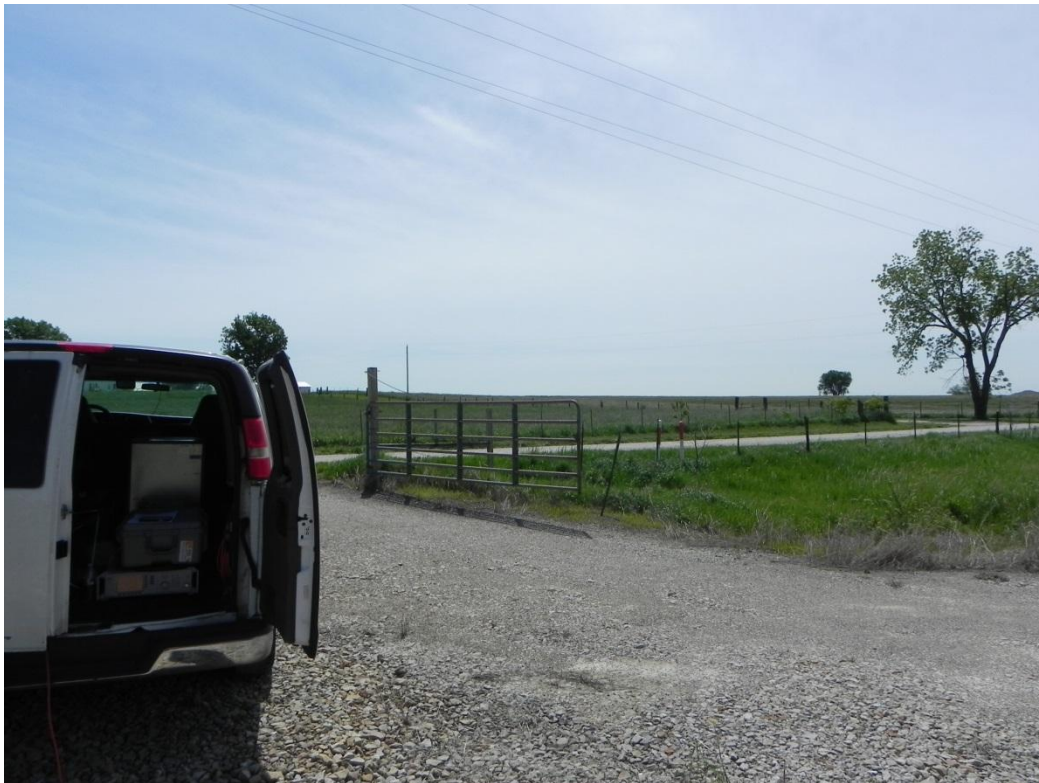
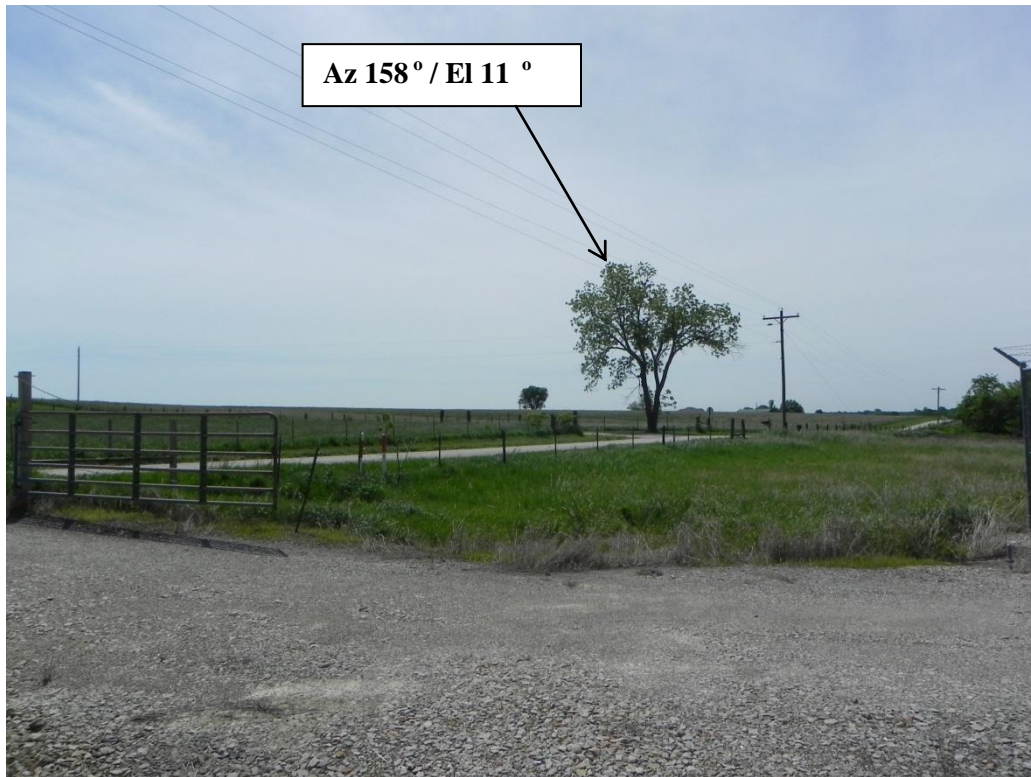
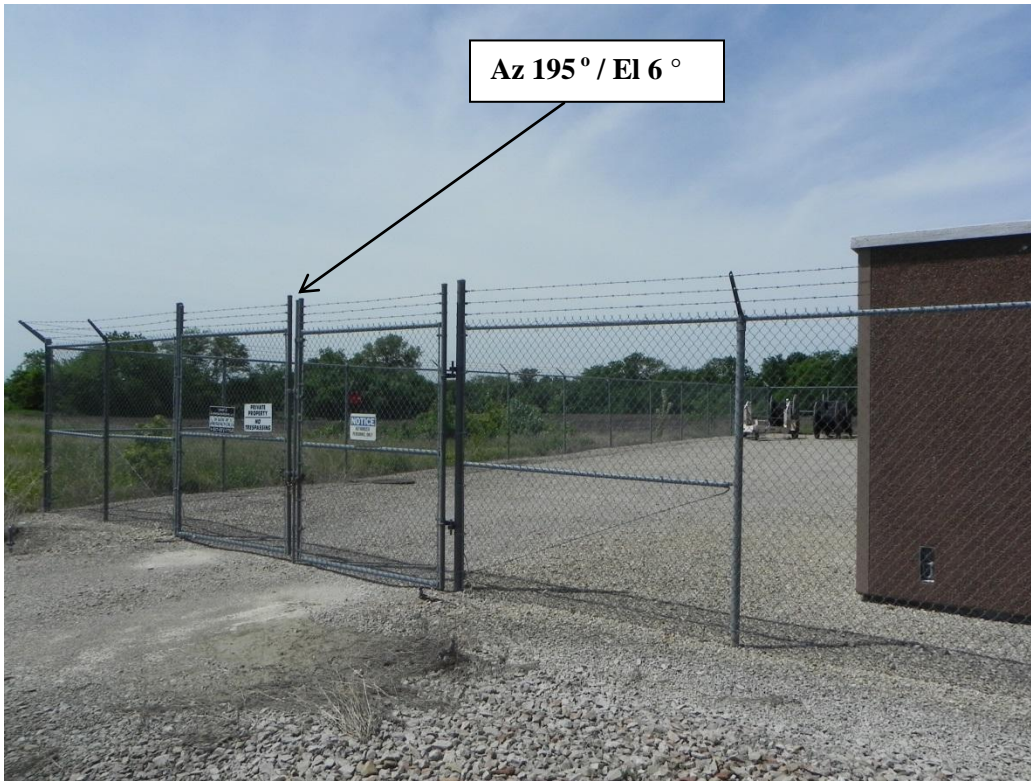
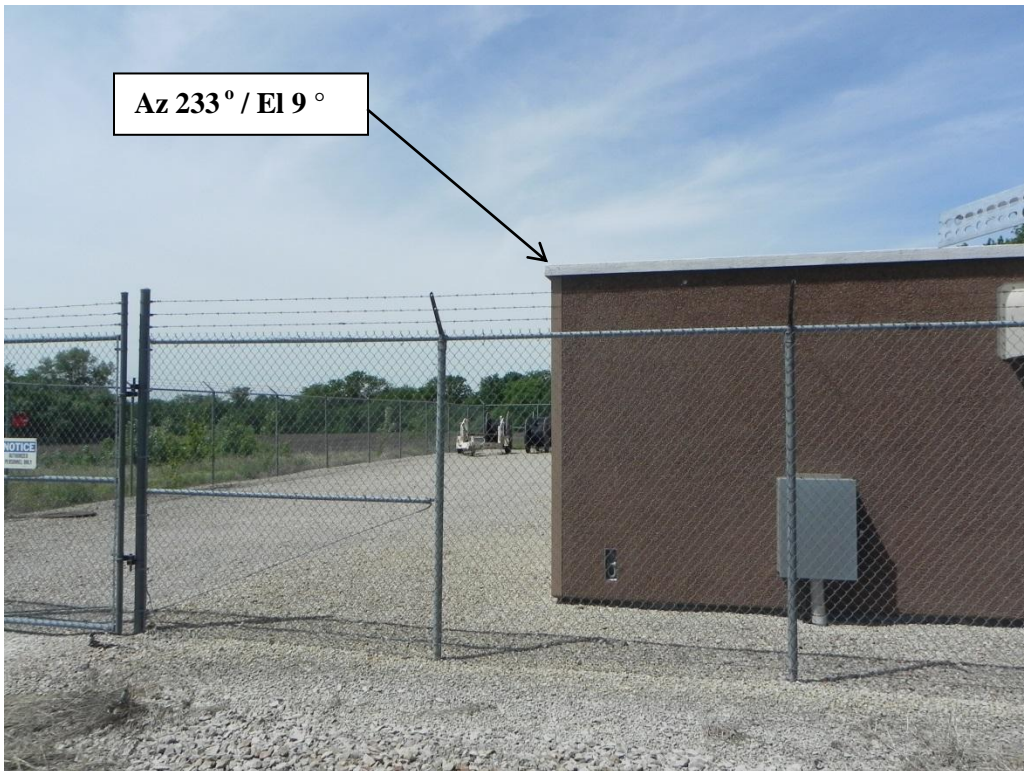
Figure 3.1-2 Horizon Photographs of Earth Station Site

There is no potential satellite arc blockage at this site. Final arc clearance will depend on antenna placement.

The satellite arc has no potential blockage from 55W through 115W.
