MICROWAVE PATH SURVEY REPORT

RADIO FREQUENCY INTERFERENCE (RFI) MEASUREMENT REPORT

ViaSat

Transmit and Receive Earth Station
17-21 GHz and 27-31 GHz

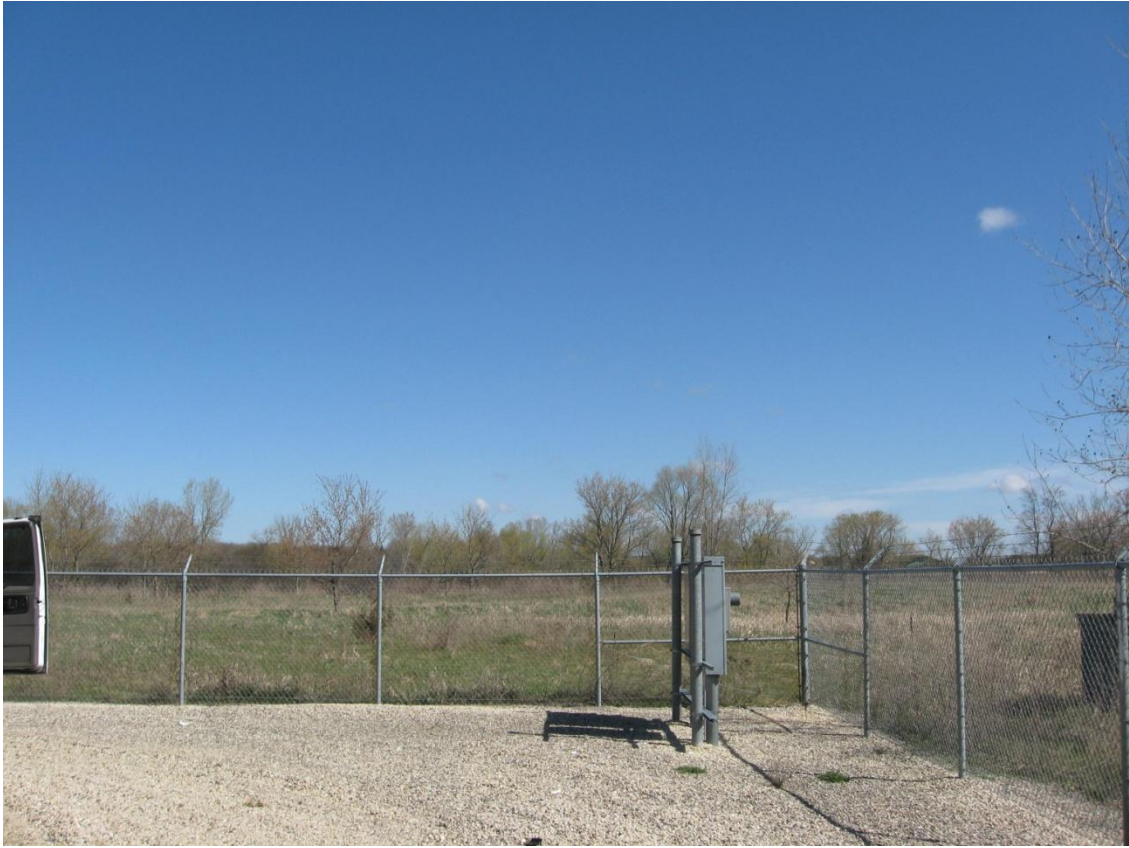
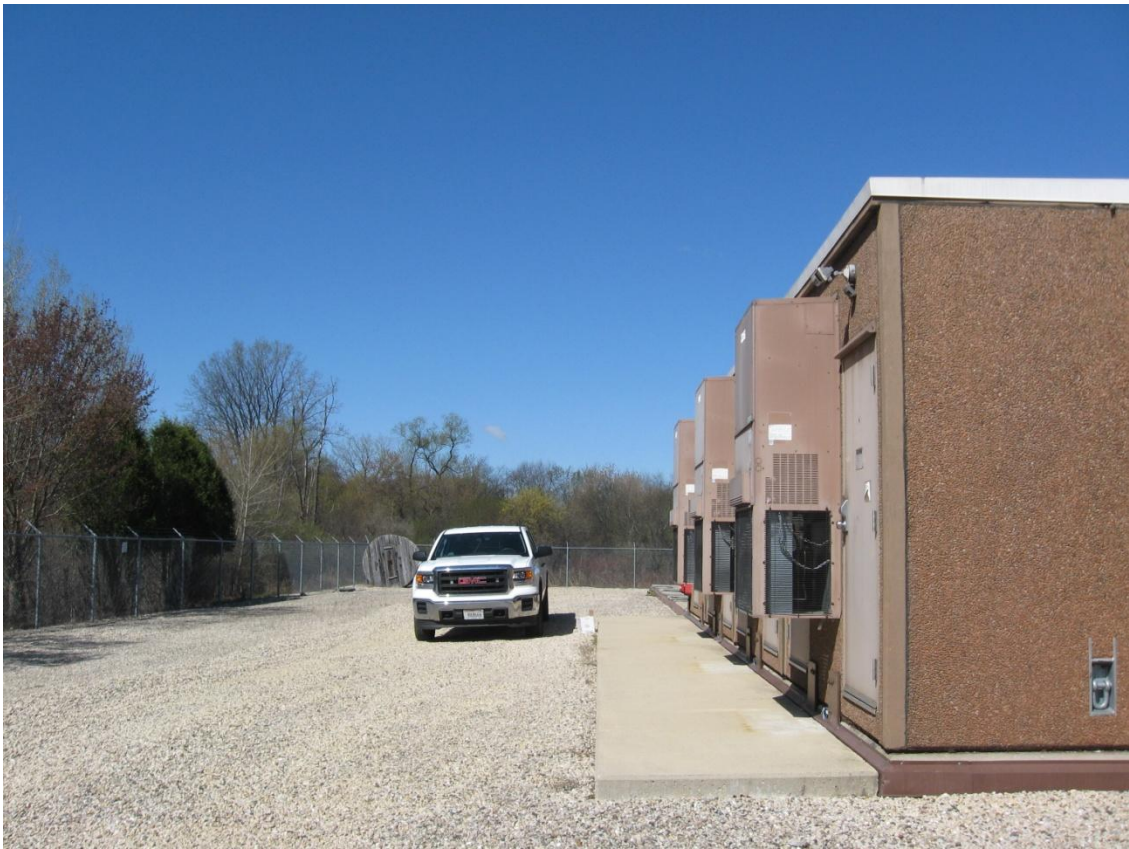
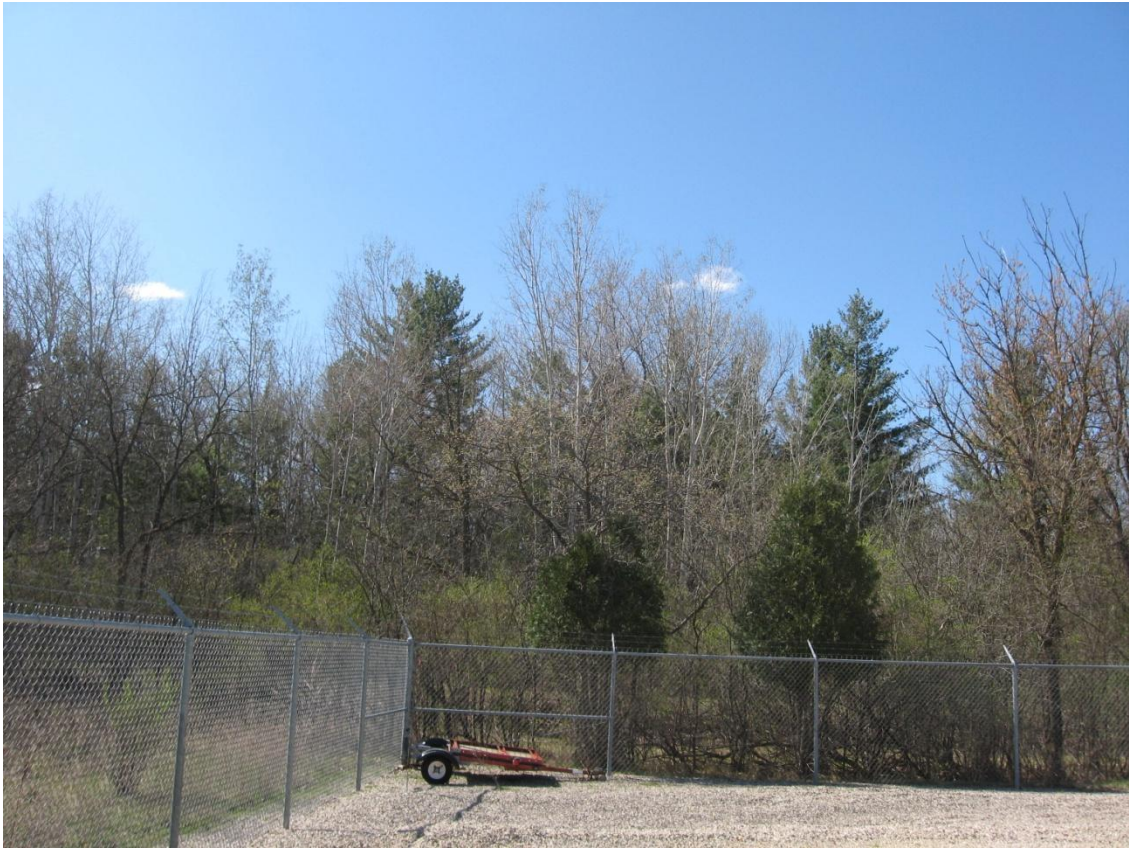
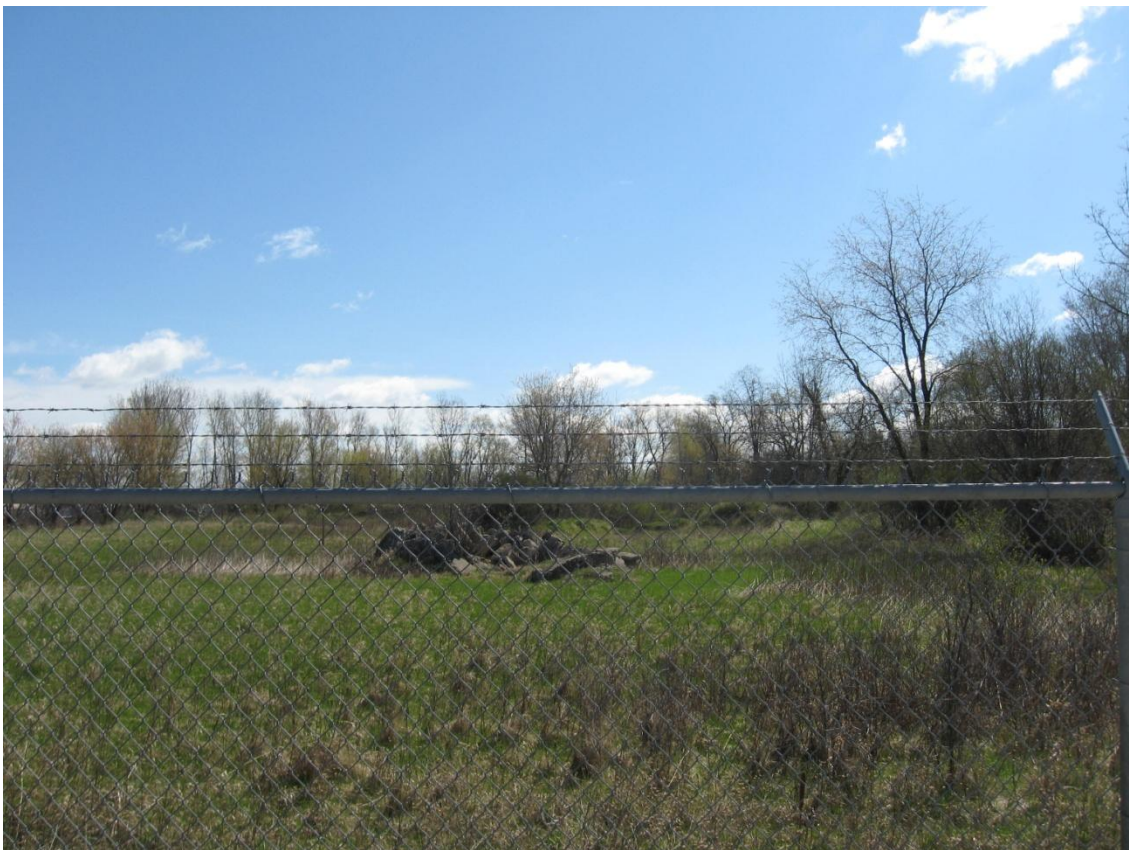
Figure 3.1-1 Earth Station Site Photographs

- Table 3.1-1 presents a site data sheet including all pertinent site information.
- Figures 3.1-1 and 3.1-2 are the photographs depicting the existing earth station site and satellite arc.
- Figures 3.1-3 through 3.1-10 are the RF spectrum photographs depicting the interference environment at the test site.

| 8. GEOSTATIONARY ARC VISIBILITY: | Satellite arc has no blockage at this time |

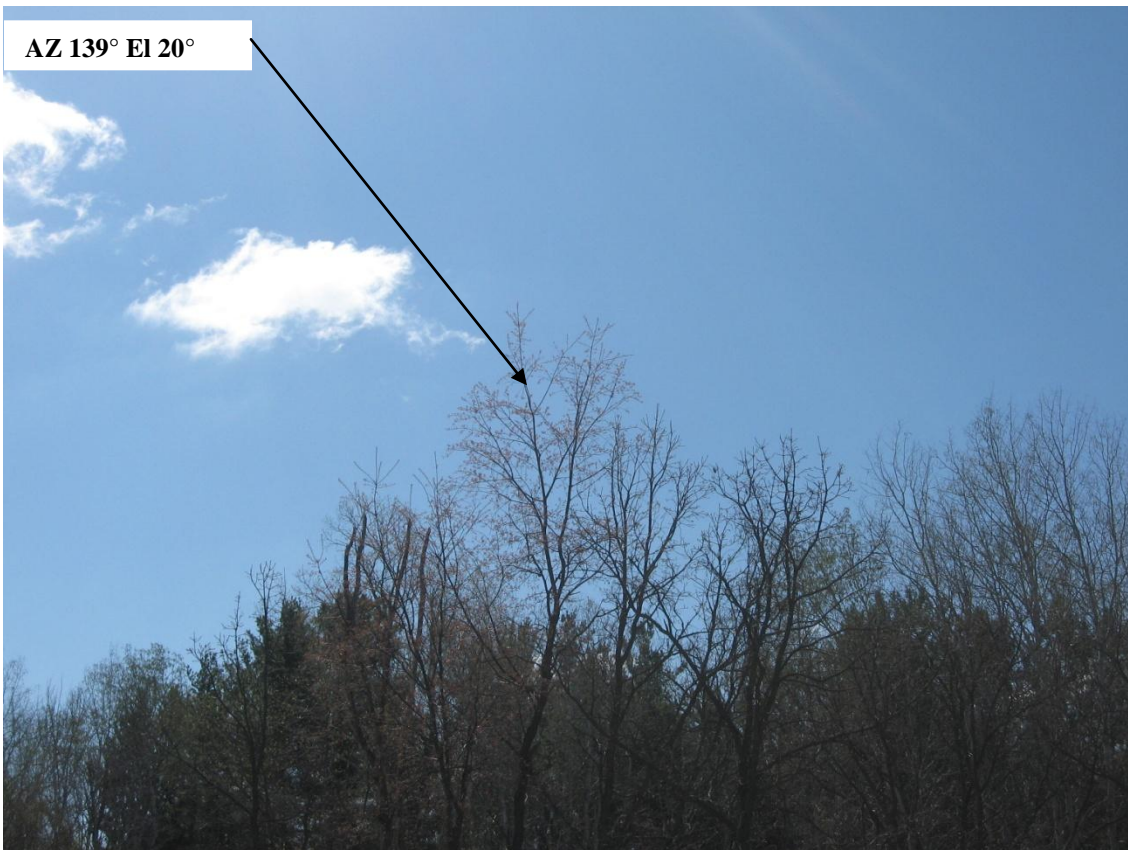
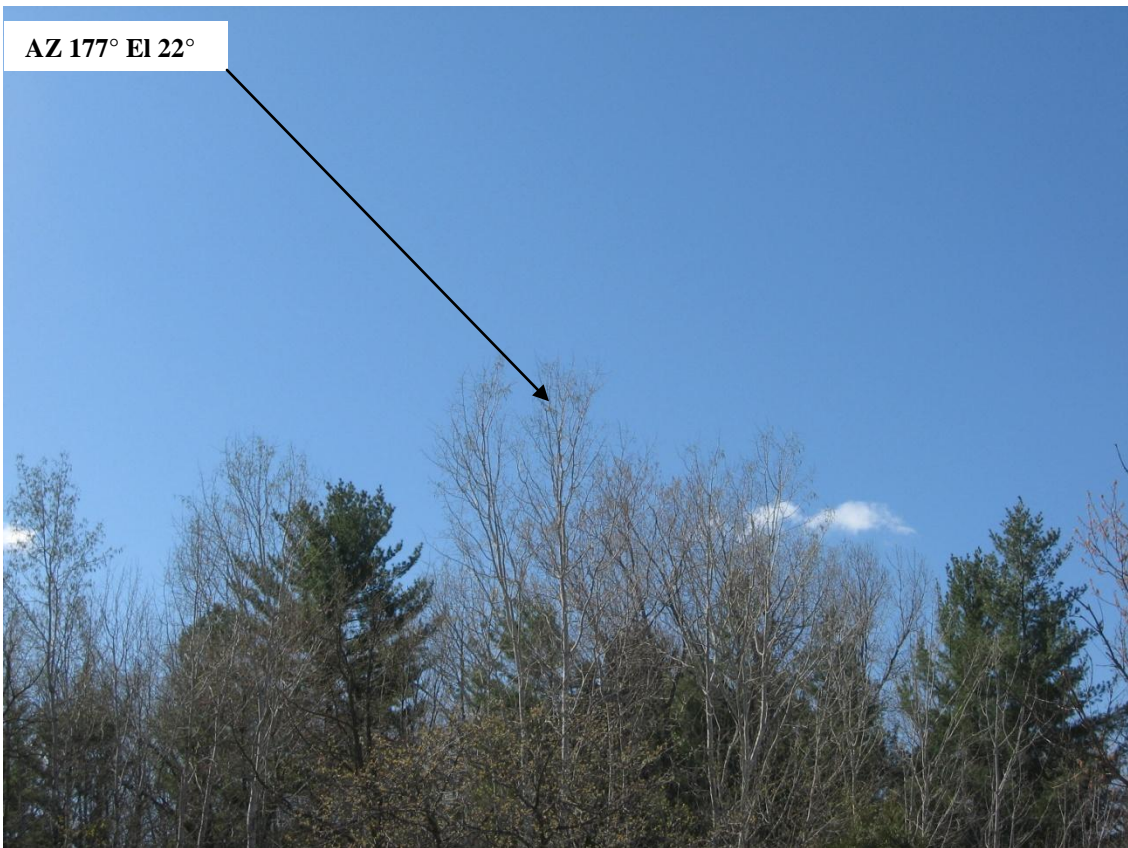
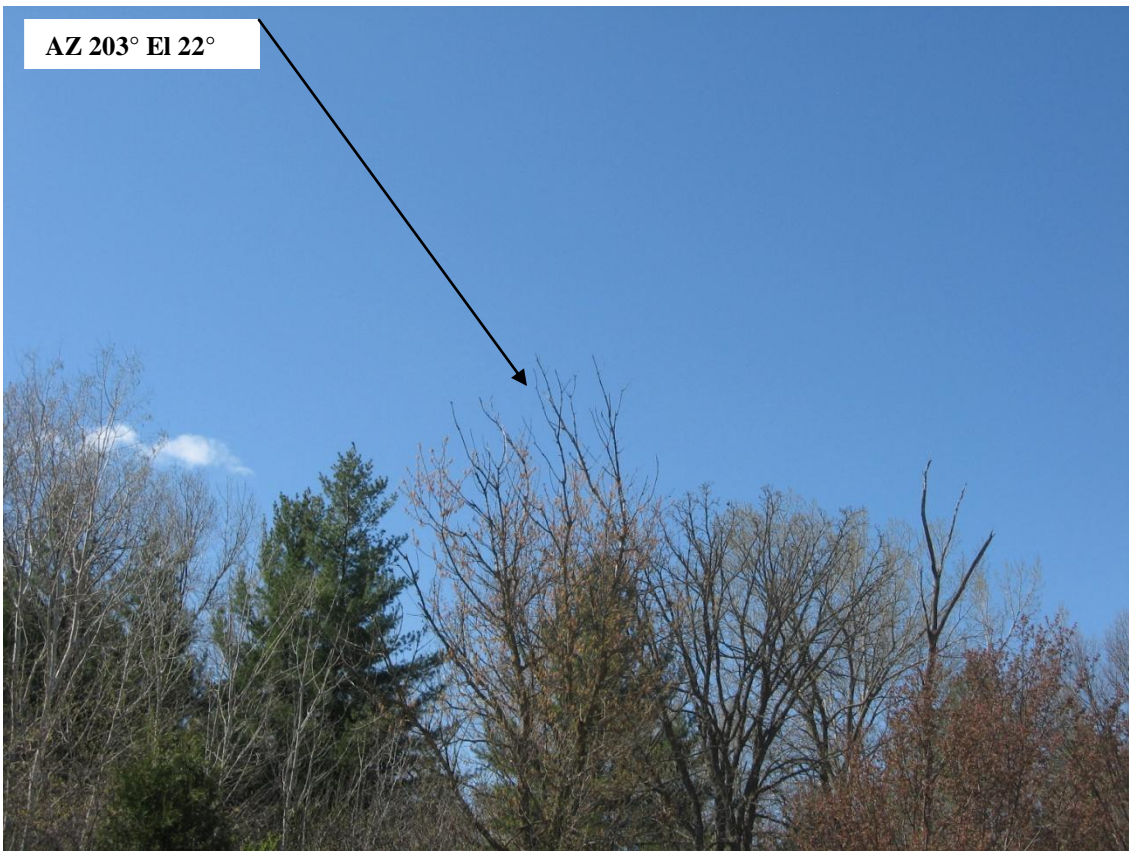
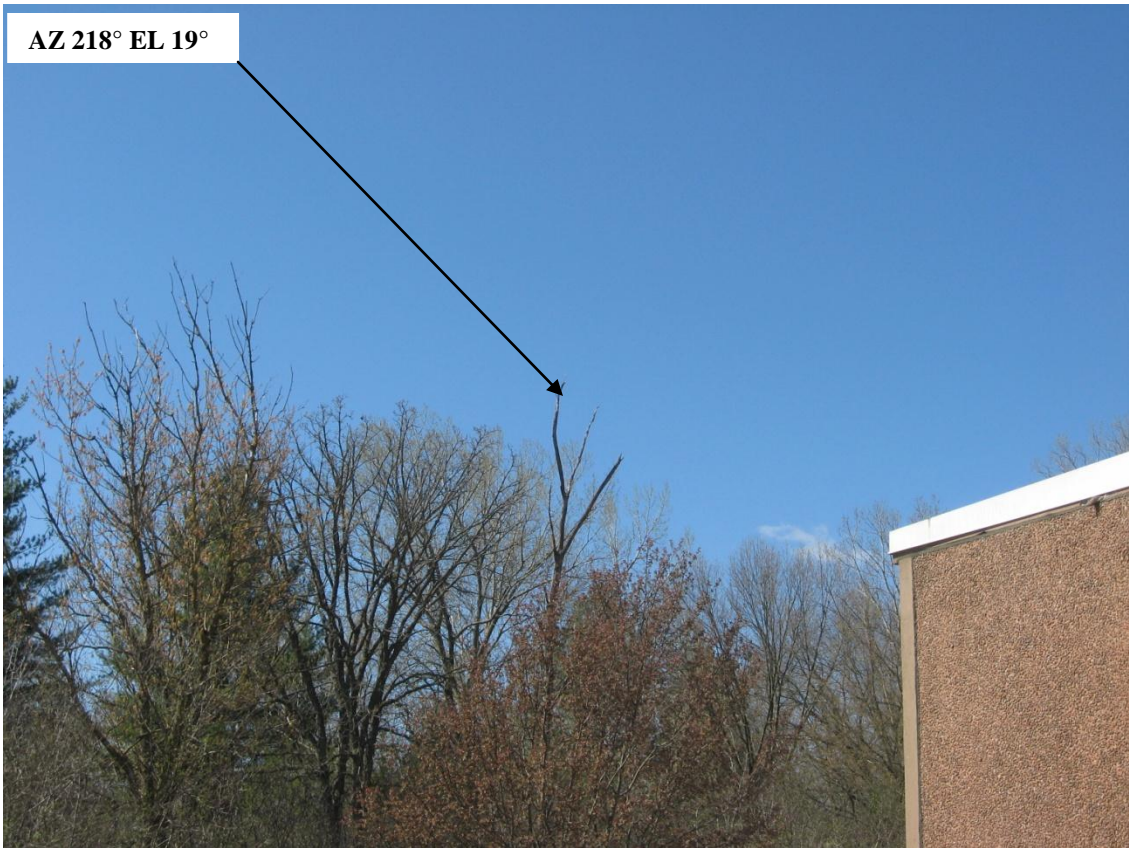
Figure 3.1-2 Horizon Photographs of Earth Station Site

There is no potential satellite arc blockage at this site. Final arc clearance will depend on antenna placement.

The satellite arc has no potential blockage from 55W through 115W.
