MICROWAVE PATH SURVEY REPORT

RADIO FREQUENCY INTERFERENCE (RFI) MEASUREMENT REPORT

ViaSat

Transmit and Receive Earth Station
17-21 GHz and 27-31 GHz

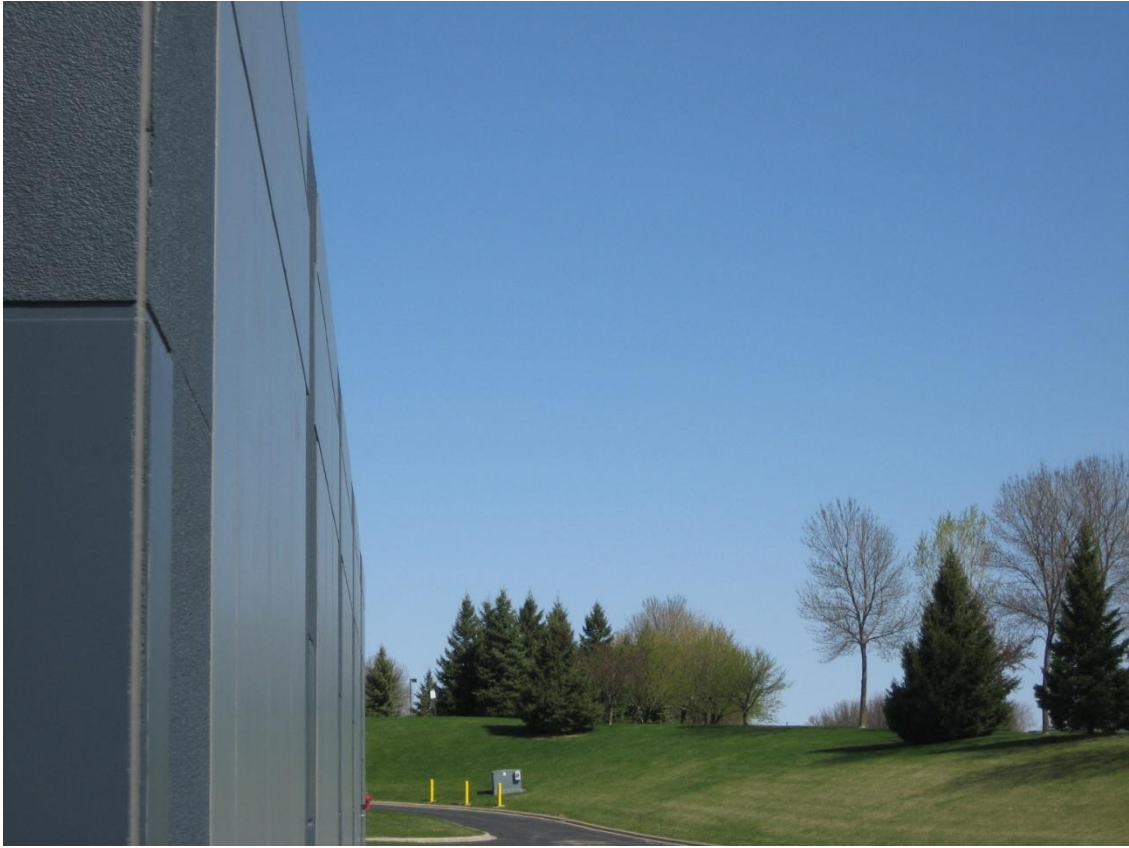
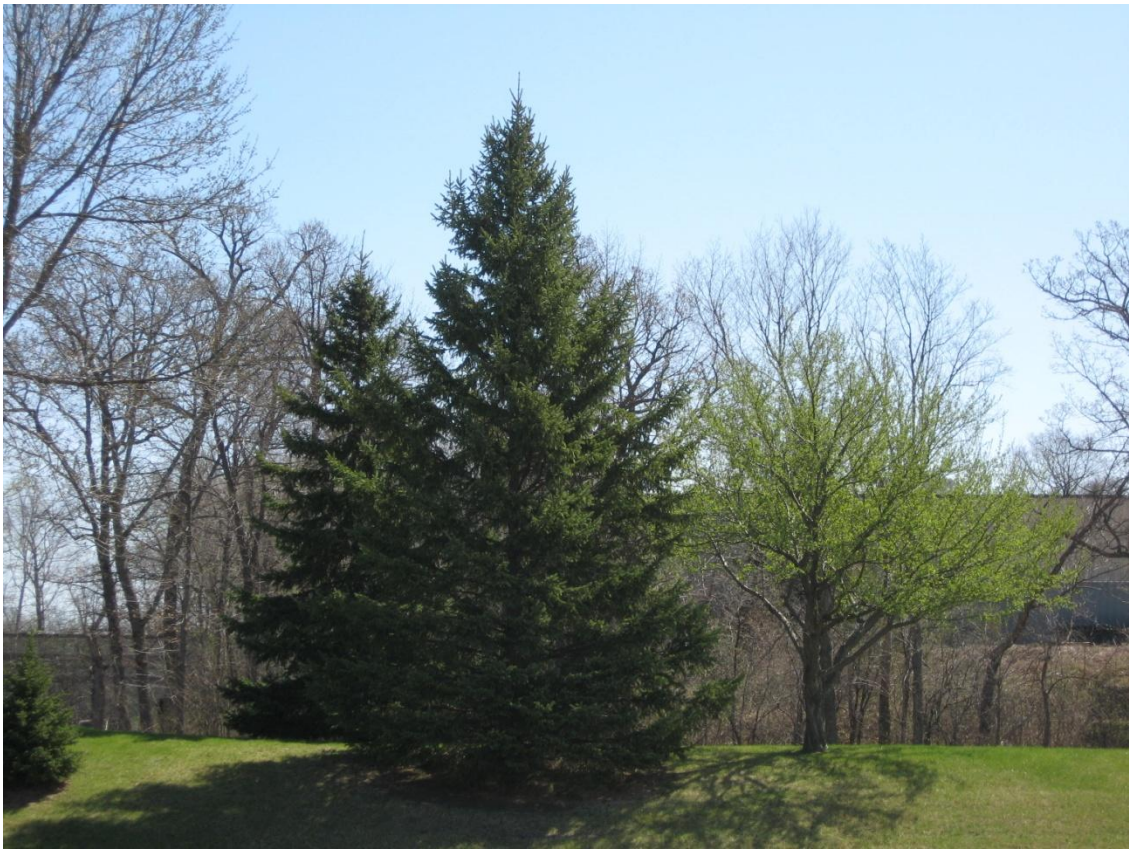
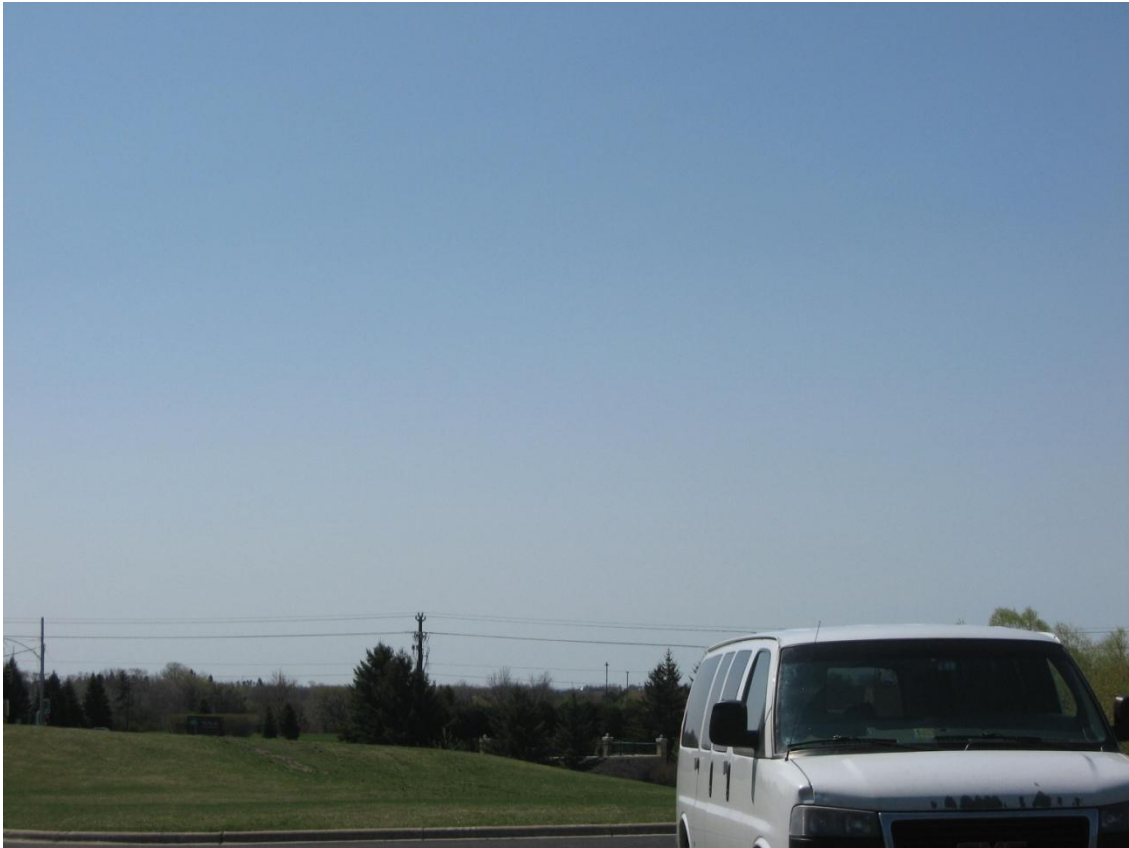
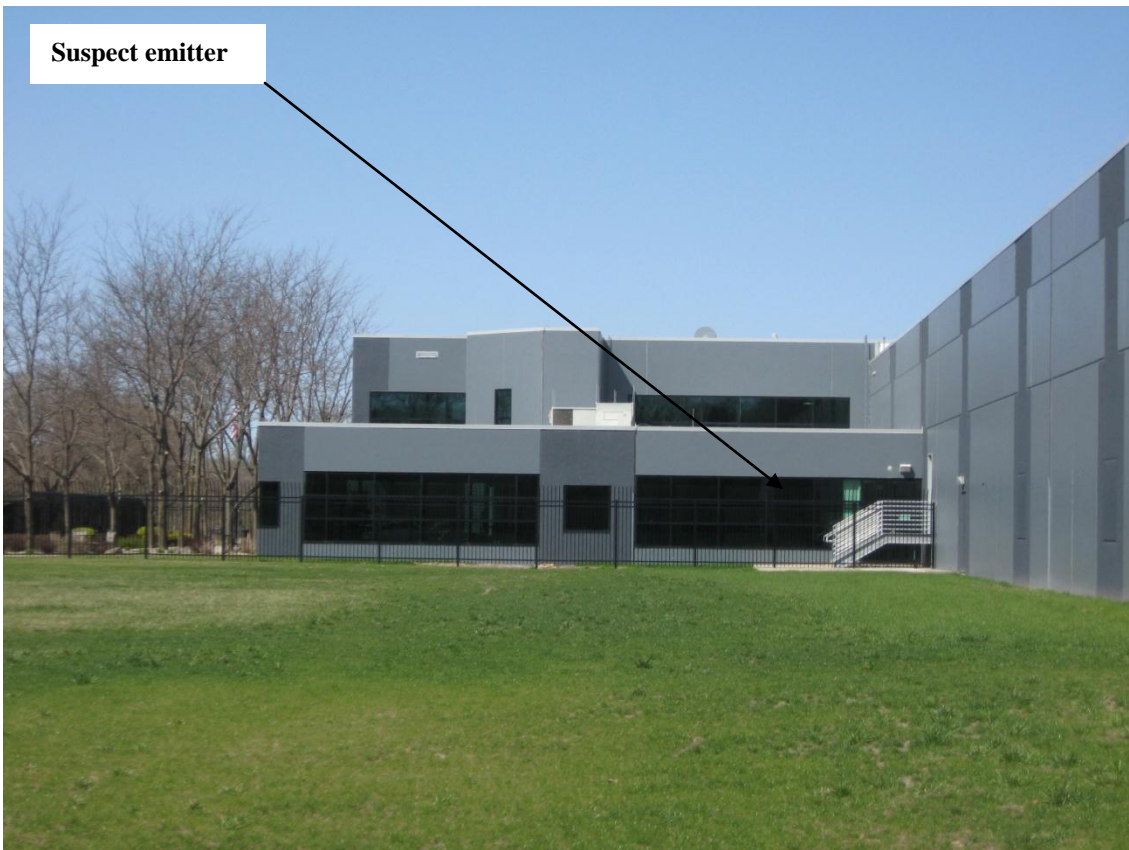
Figure 3.1-1 Earth Station Site Photographs

- Table 3.1-1 presents a site data sheet including all pertinent site information.
- Figures 3.1-1 and 3.1-2 are the photographs depicting the existing earth station site and satellite arc.
- Figures 3.1-3 through 3.1-10 are the RF spectrum photographs depicting the interference environment at the test site.

| 8. GEOSTATIONARY ARC VISIBILITY: | Satellite arc has no blockage at this time |

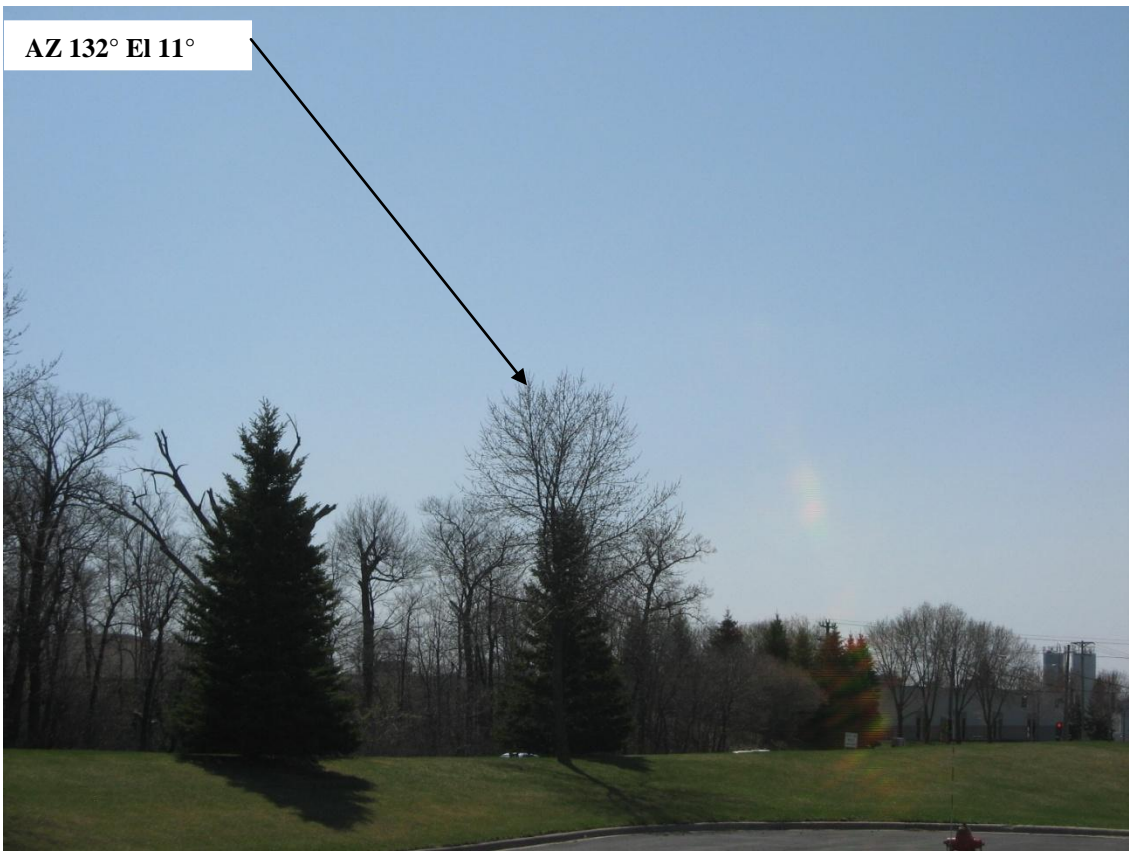
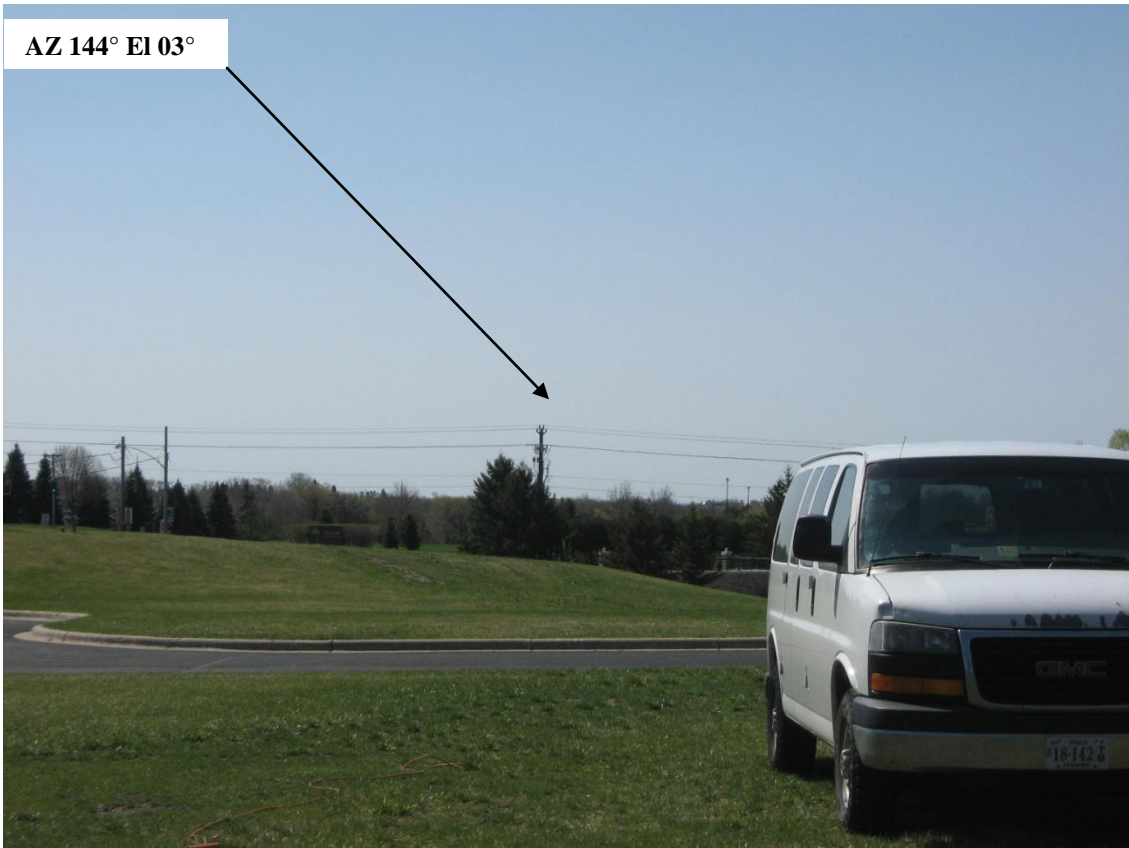
Figure 3.1-2 Horizon Photographs of Earth Station Site

There is no potential satellite arc blockage at this site. Final arc clearance will depend on antenna placement.
