MICROWAVE PATH SURVEY REPORT

**RADIO FREQUENCY INTERFERENCE
(RFI)
MEASUREMENT REPORT**

ViaSat

Transmit and Receive Earth Station
17-21 GHz and 27-31 GHz

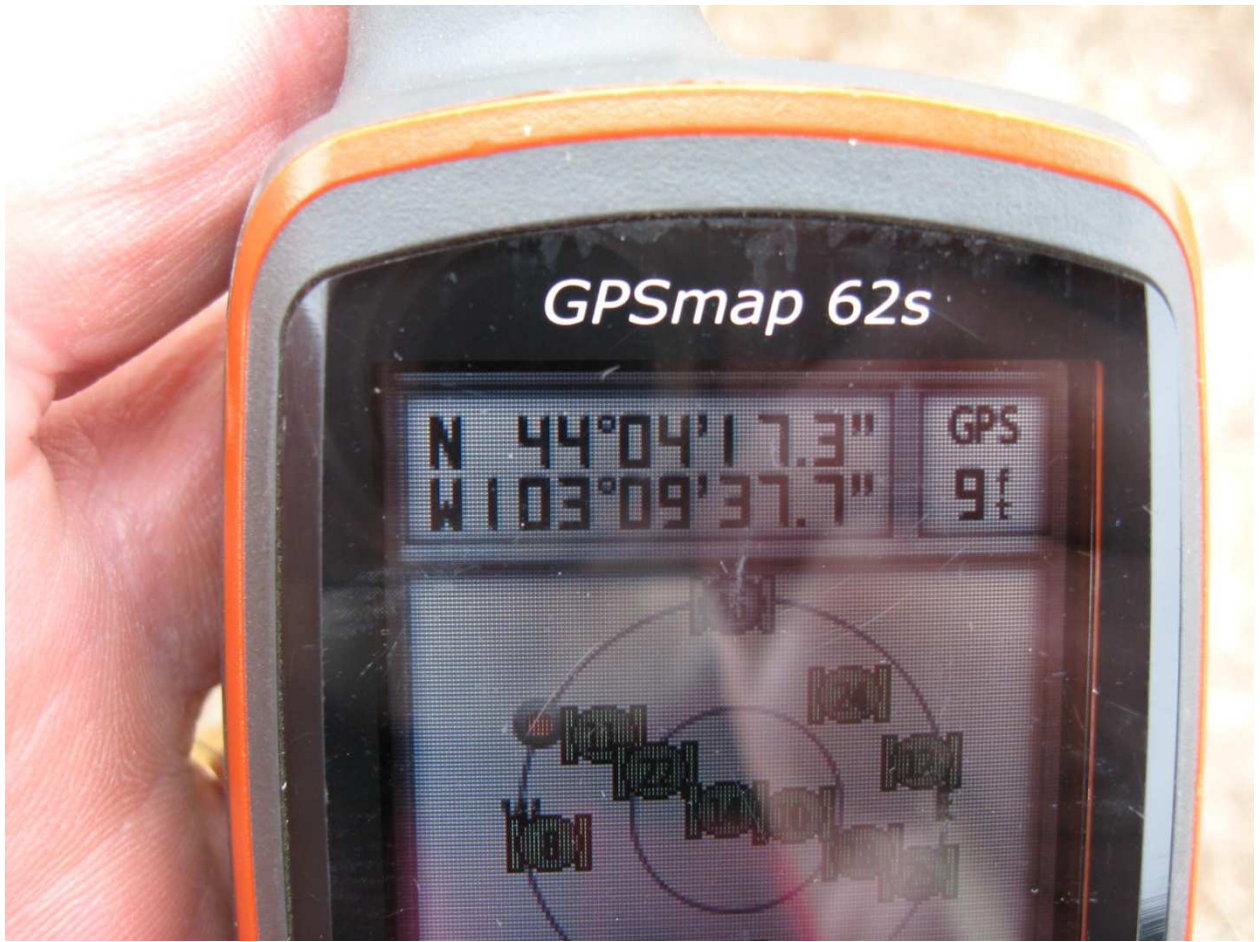
Figure 1.2-3 – GPS Photograph

The measured site is identified on a portion of a topographic map shown in Figure 1.2-1. An aerial photo of the site location is shown in Figure 1.2-2. A photo of the measurement using a GPS is shown in Figure 1.2-3.

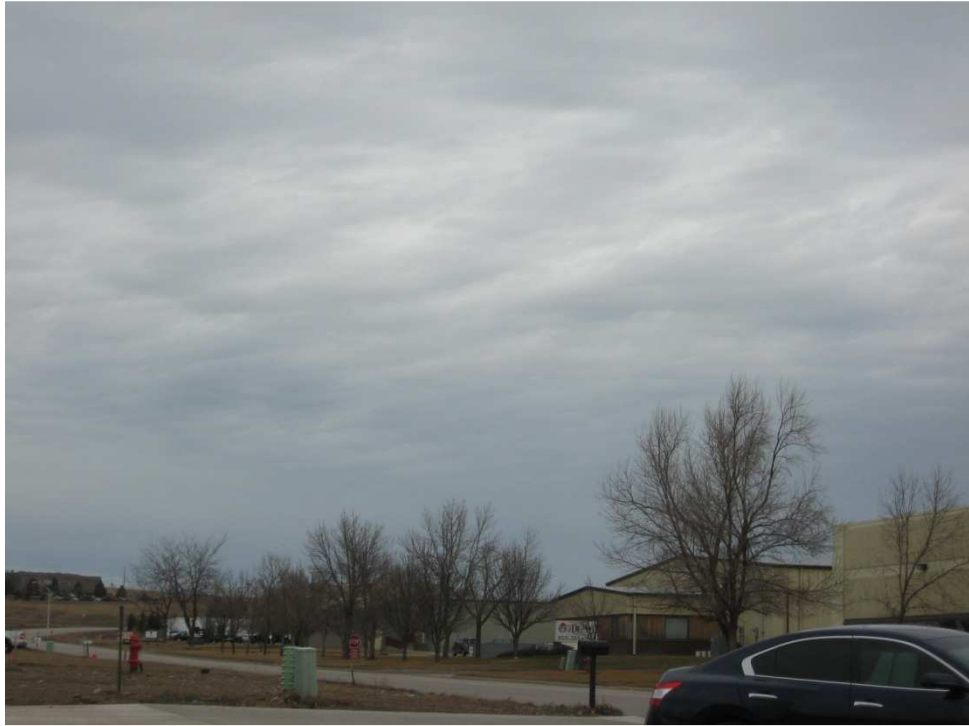
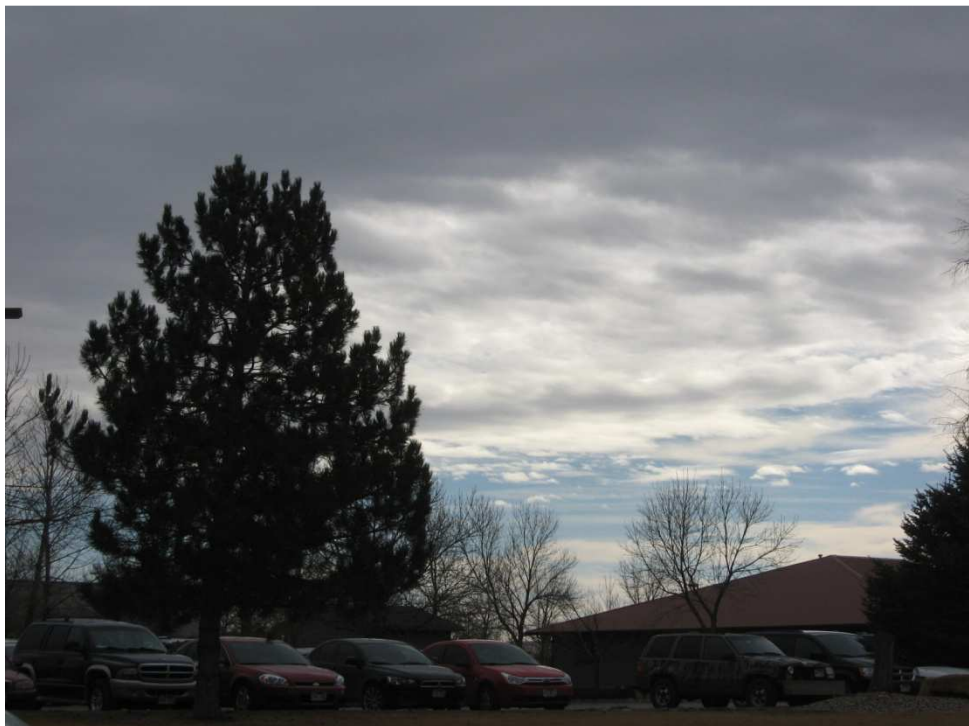
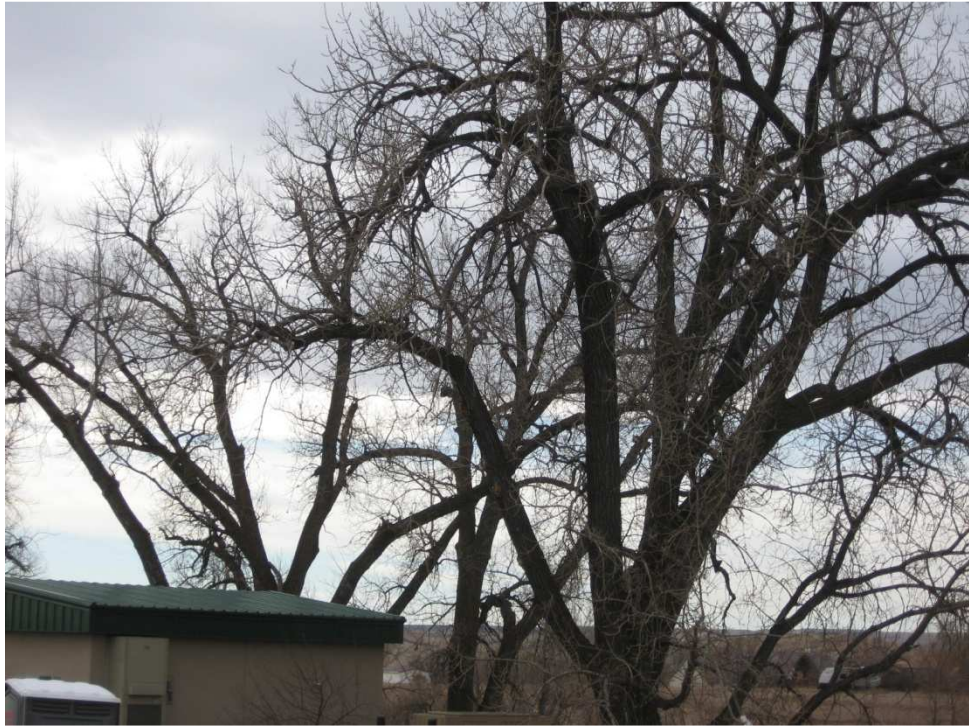
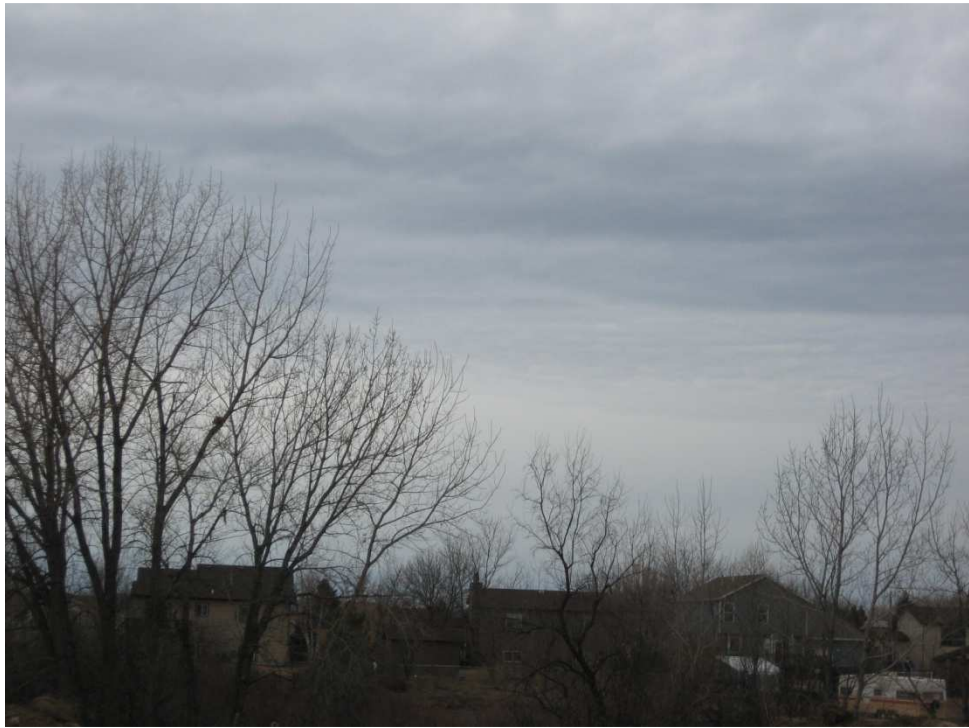
Figure 3.1-1 Earth Station Site Photographs

- Table 3.1-1 presents a site data sheet including all pertinent site information.
- Figures 3.1-1 and 3.1-2 are the photographs depicting the existing earth station site and satellite arc.
- Figures 3.1-3 through 3.1-10 are the RF spectrum photographs depicting the interference environment at the test site.

| 8. GEOSTATIONARY ARC VISIBILITY: | The arc is clear |

There is no potential satellite arc blockage at this site. Final arc clearance will depend on antenna placement.
