MICROWAVE PATH SURVEY REPORT

RADIO FREQUENCY INTERFERENCE (RFI) MEASUREMENT REPORT

ViaSat

Transmit and Receive Earth Station
17-21 GHz and 27-31 GHz

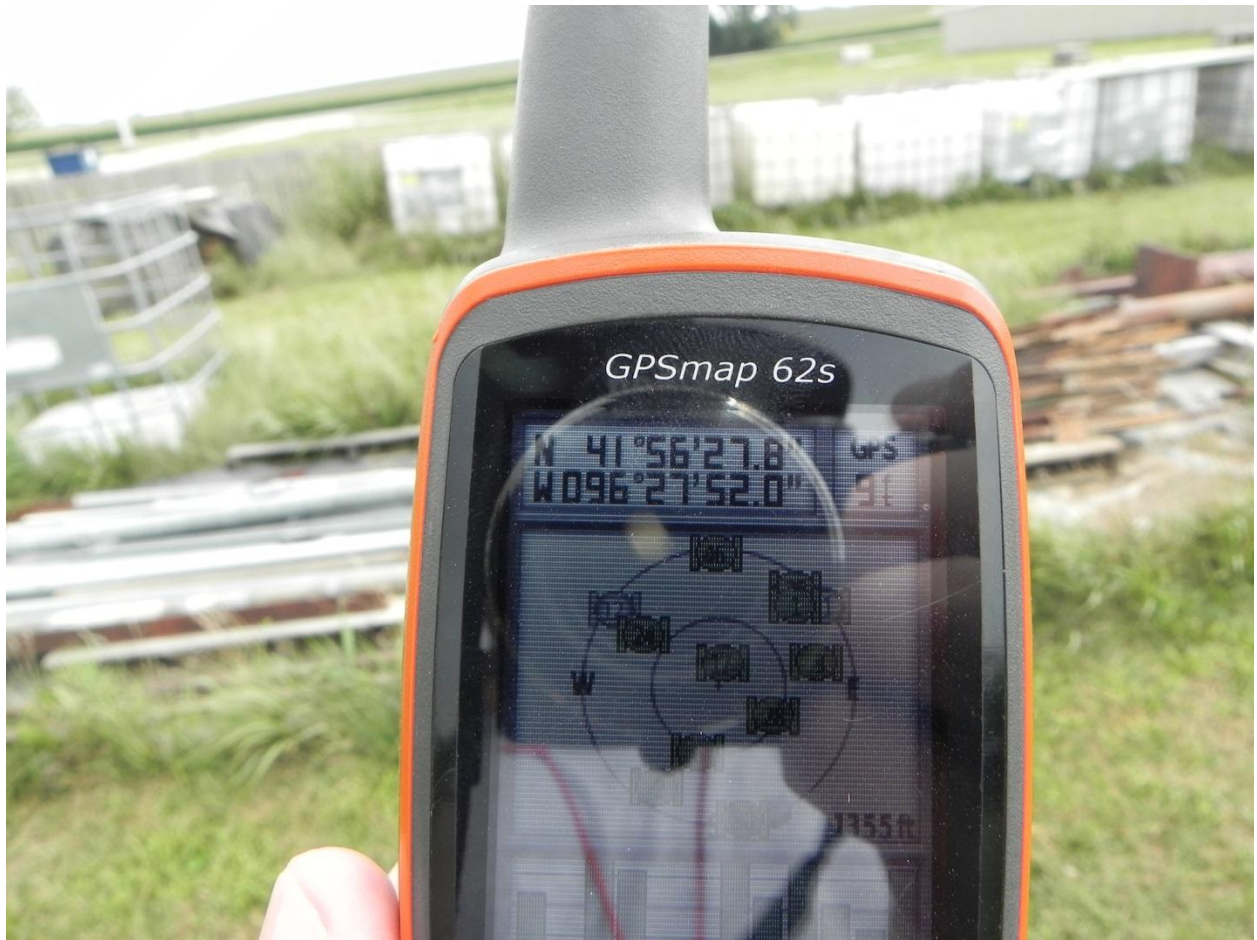
The measured site is identified on a portion of a topographic map shown in Figure 1.2-1. An aerial photo of the site location is shown in Figure 1.2-2. A photo of the measurement using a GPS is shown in Figure 1.2-3.

Figure 1.2-3 – GPS Photograph

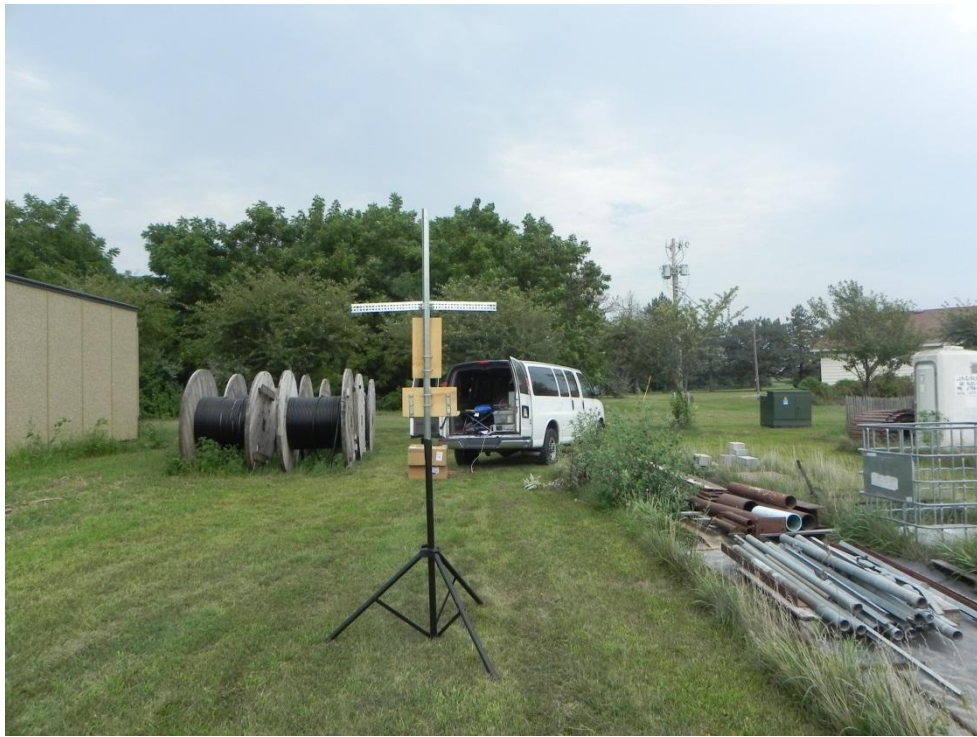
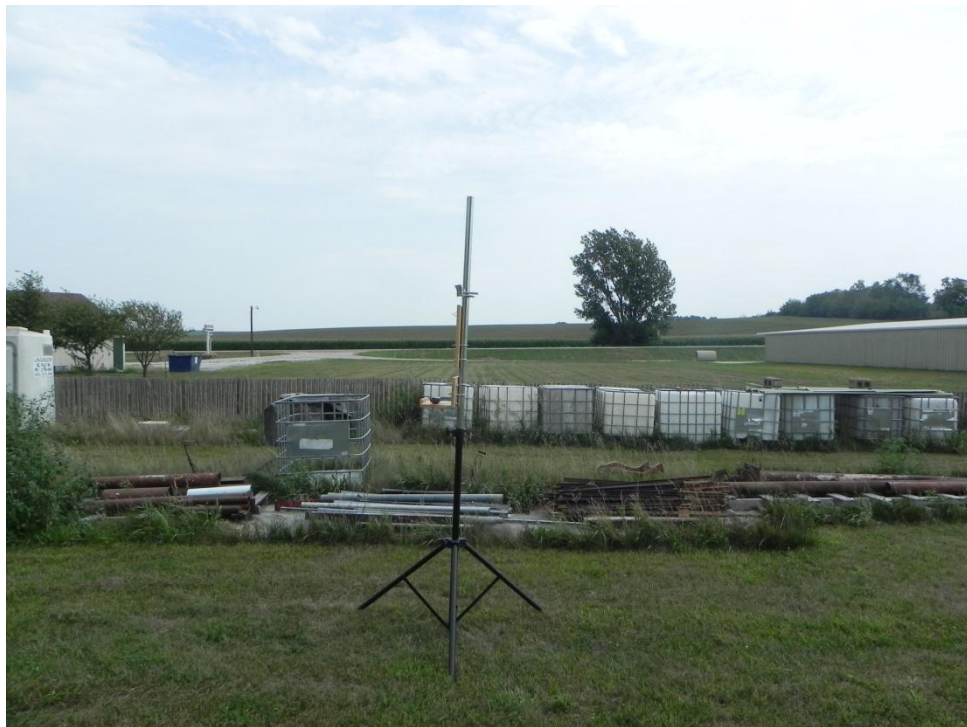
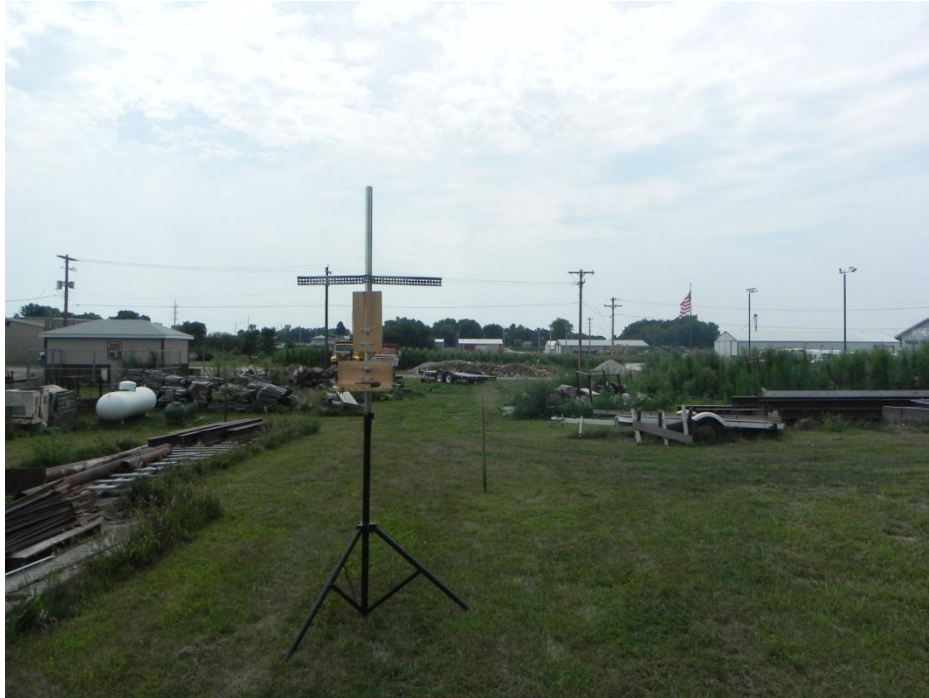
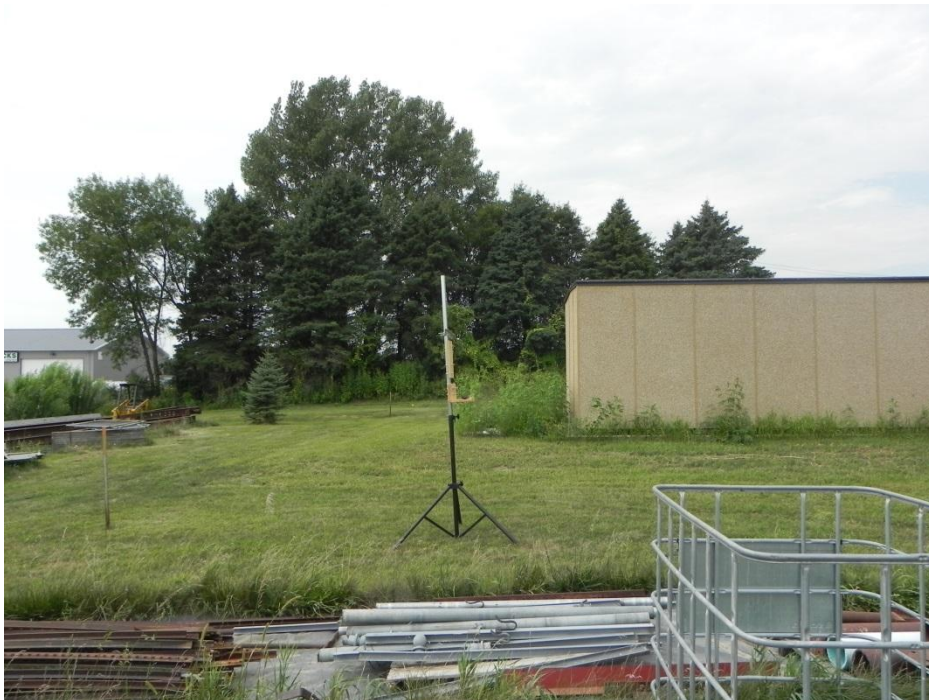
- Table 3.1-1 presents a site data sheet including all pertinent site information.
- Figures 3.1-1 and 3.1-2 are the photographs depicting the existing earth station site and satellite arc.
- Figures 3.1-3 through 3.1-10 are the RF spectrum photographs depicting the interference environment at the test site.

Figure 3.1-1 Earth Station Site Photographs

Figure 3.1-1 (cont.) Earth Station Site Photographs

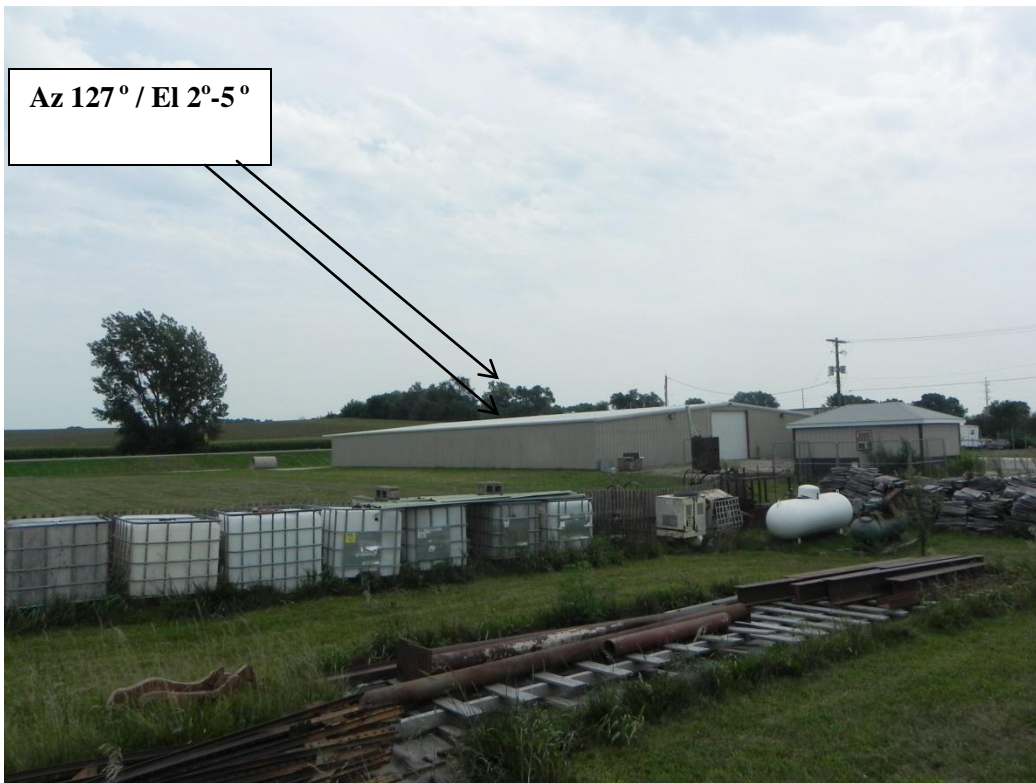
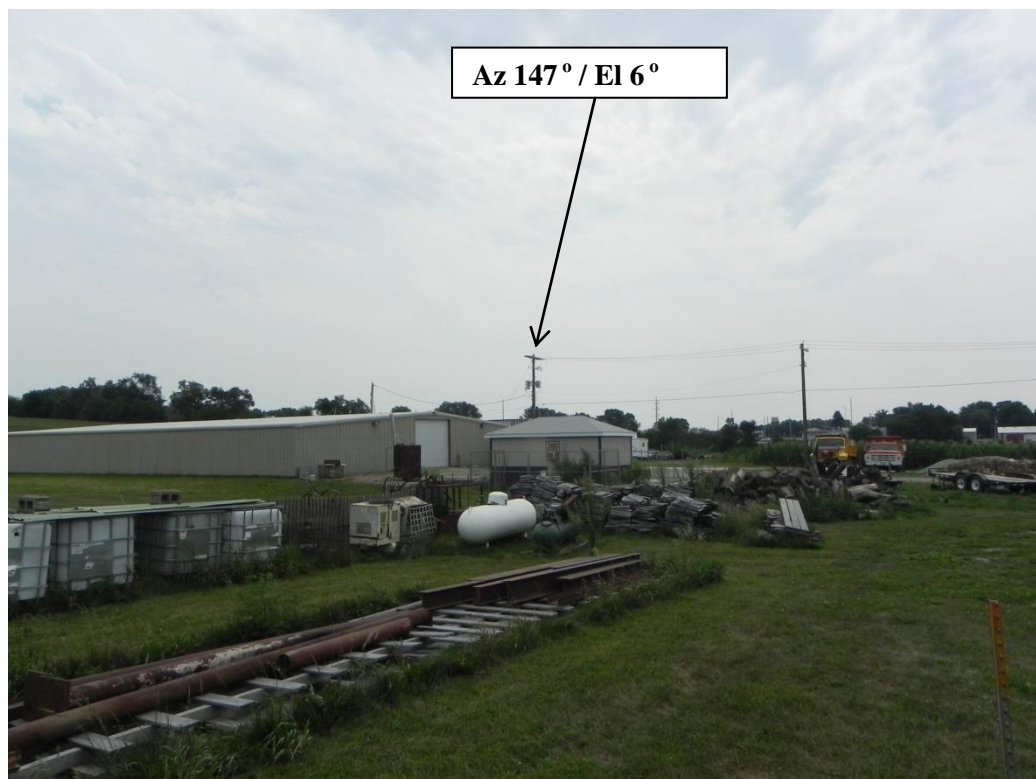
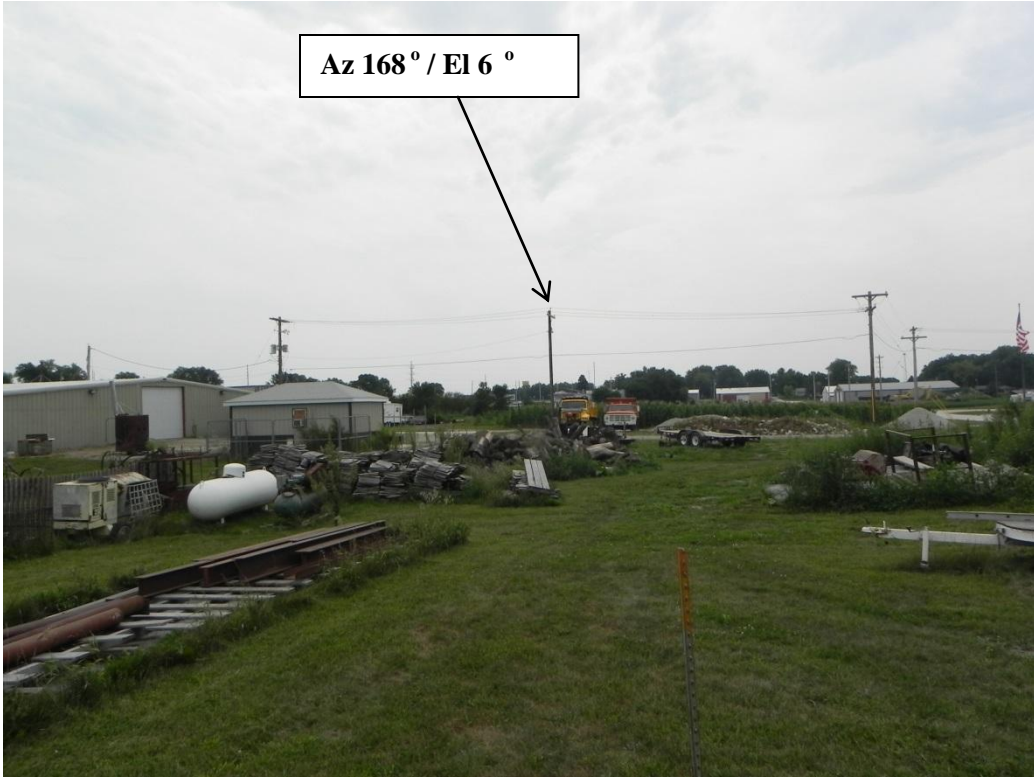
Figure 3.1-2 Horizon Photographs of Earth Station Site

Figure 3.1-2 (cont.) Horizon Photographs of Earth Station Site

There is no potential satellite arc blockage at this site. Final arc clearance will depend on antenna placement.

The satellite arc has no potential blockage from 55W through 115W.
