MICROWAVE PATH SURVEY REPORT

RADIO FREQUENCY INTERFERENCE (RFI) MEASUREMENT REPORT

ViaSat

Transmit and Receive Earth Station
17-21 GHz and 27-31 GHz

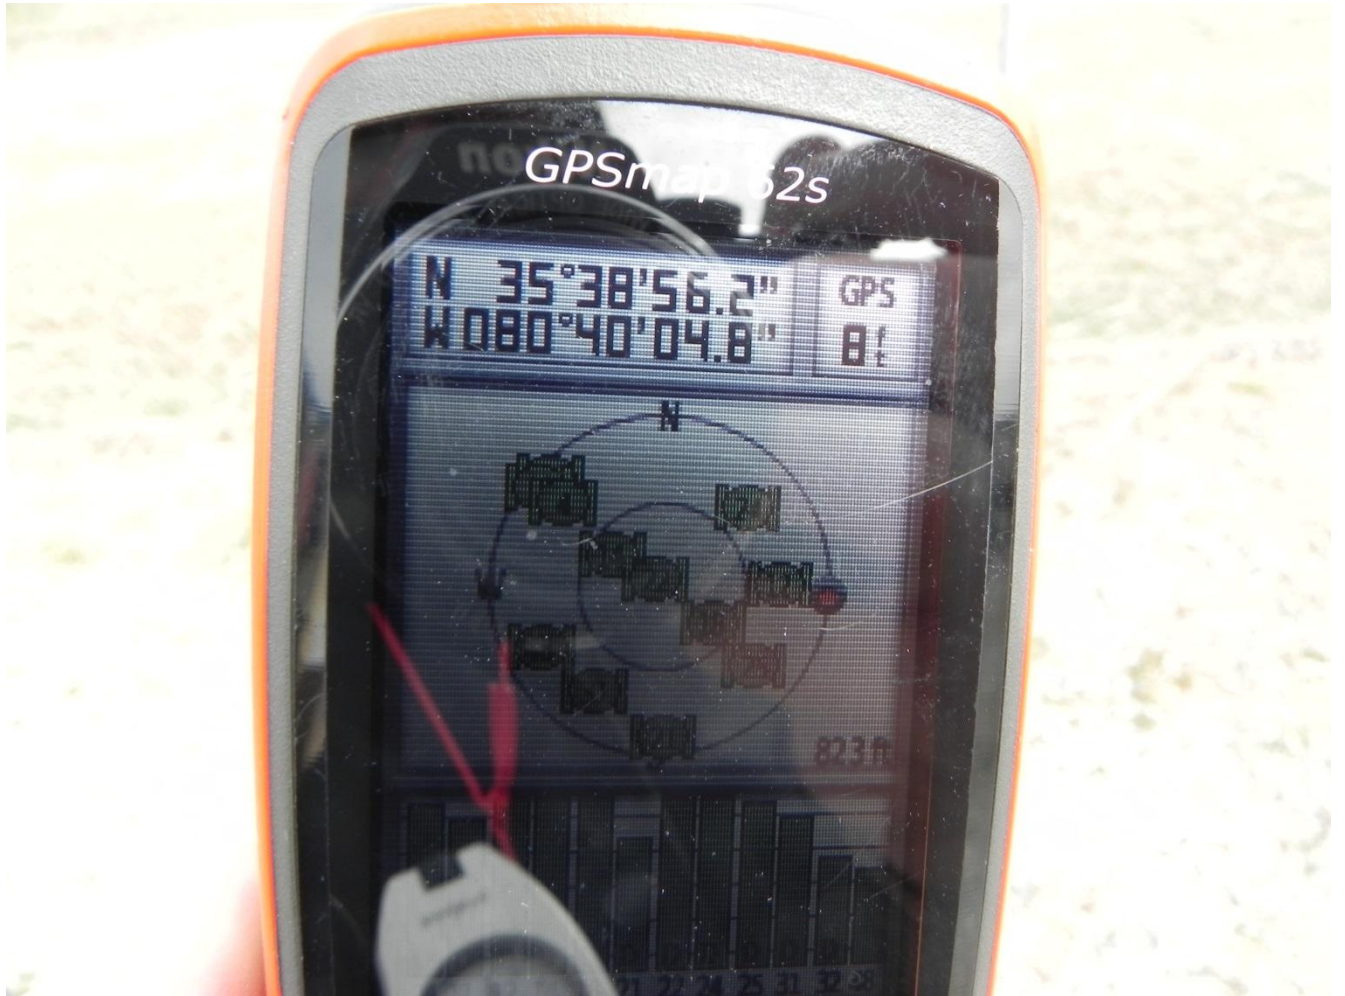
Figure 1.2-3 – GPS Photograph

The measured site is identified on a portion of a topographic map shown in Figure 1.2-1. An aerial photo of the site location is shown in Figure 1.2-2. A photo of the measurement using a GPS is shown in Figure 1.2-3.

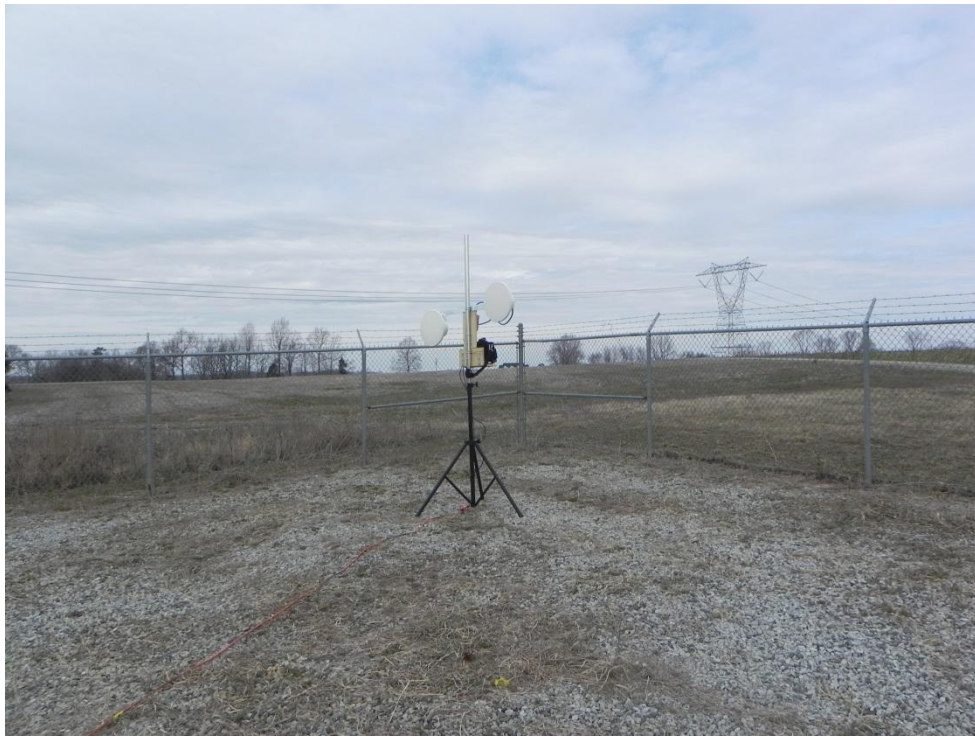
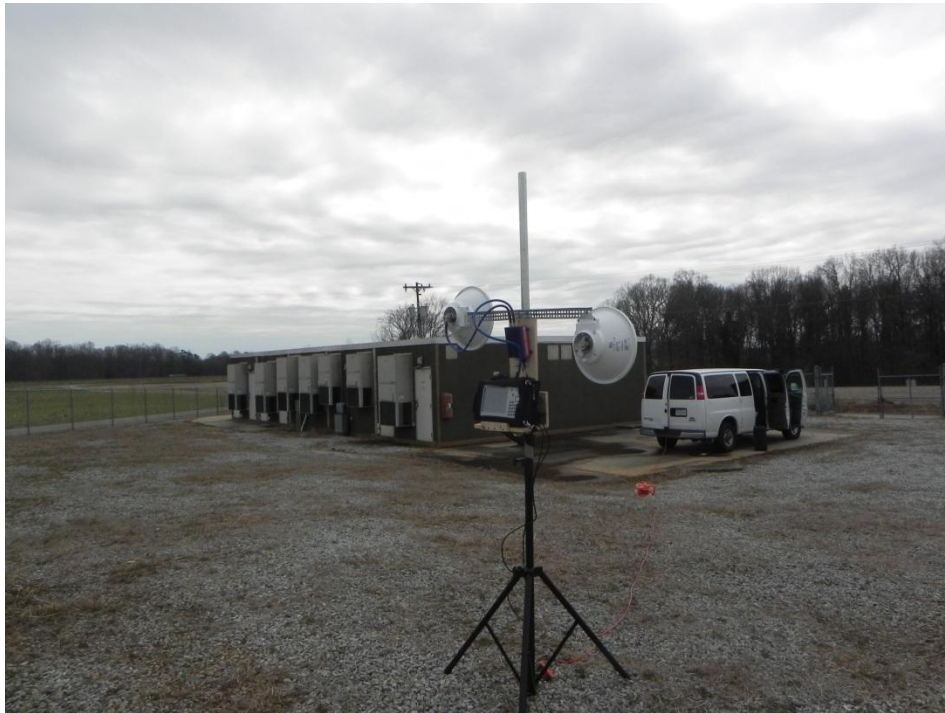
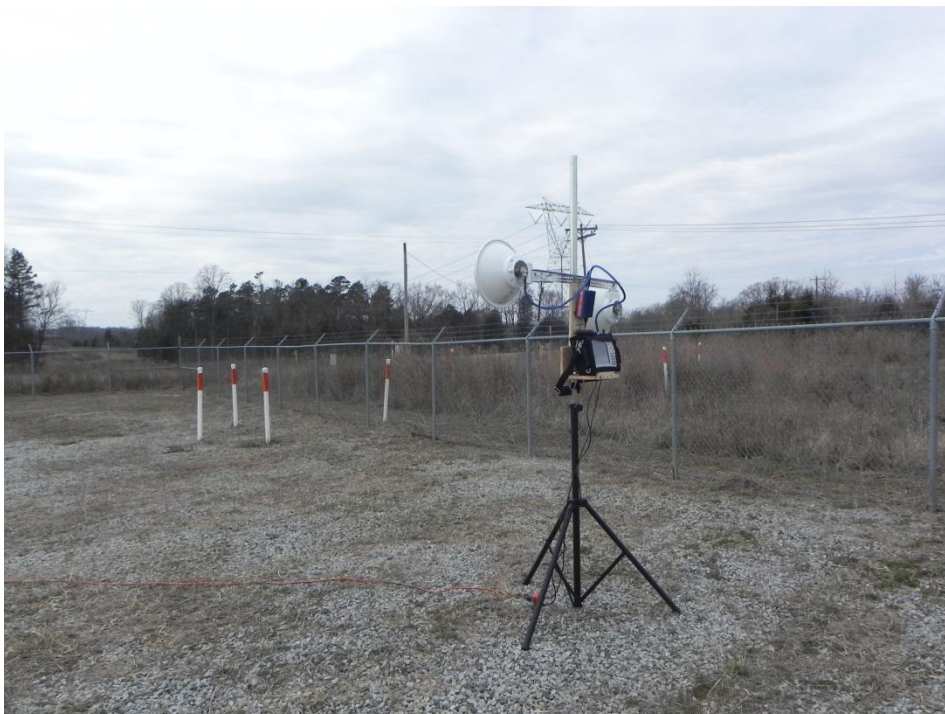
Figure 3.1-1 Earth Station Site Photographs

- Table 3.1-1 presents a site data sheet including all pertinent site information.
- Figures 3.1-1 and 3.1-2 are the photographs depicting the existing earth station site and satellite arc.
- Figures 3.1-3 through 3.1-10 are the RF spectrum photographs depicting the interference environment at the test site.

| 8. GEOSTATIONARY ARC VISIBILITY: | Satellite arc has no blockage at this time |

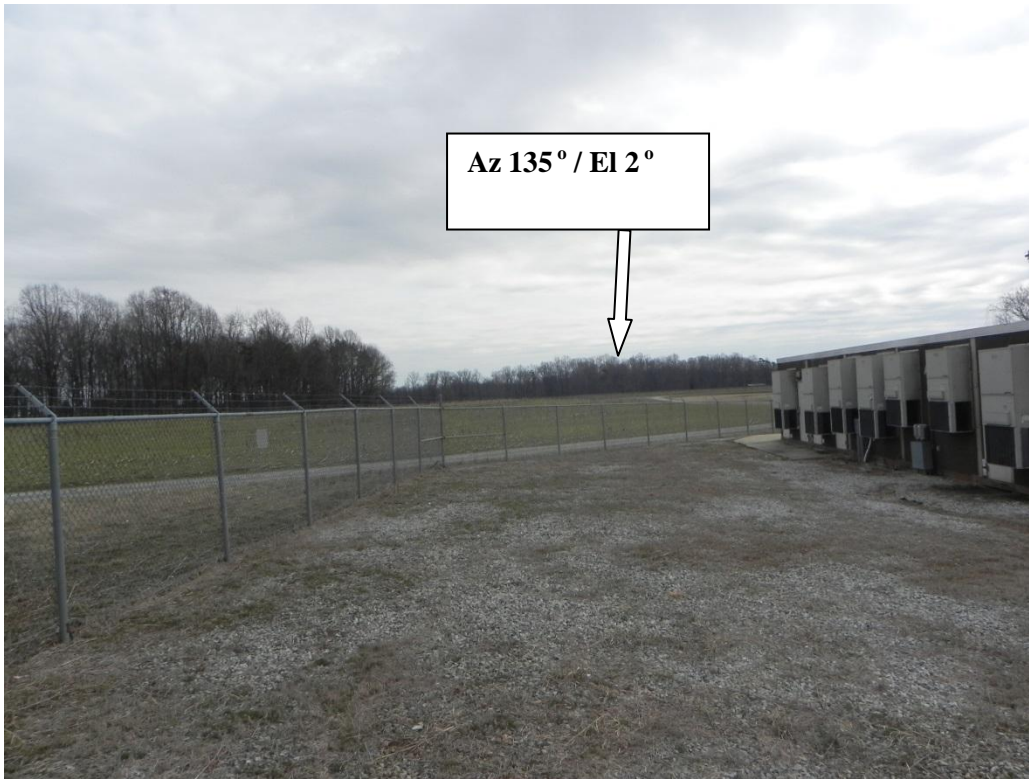
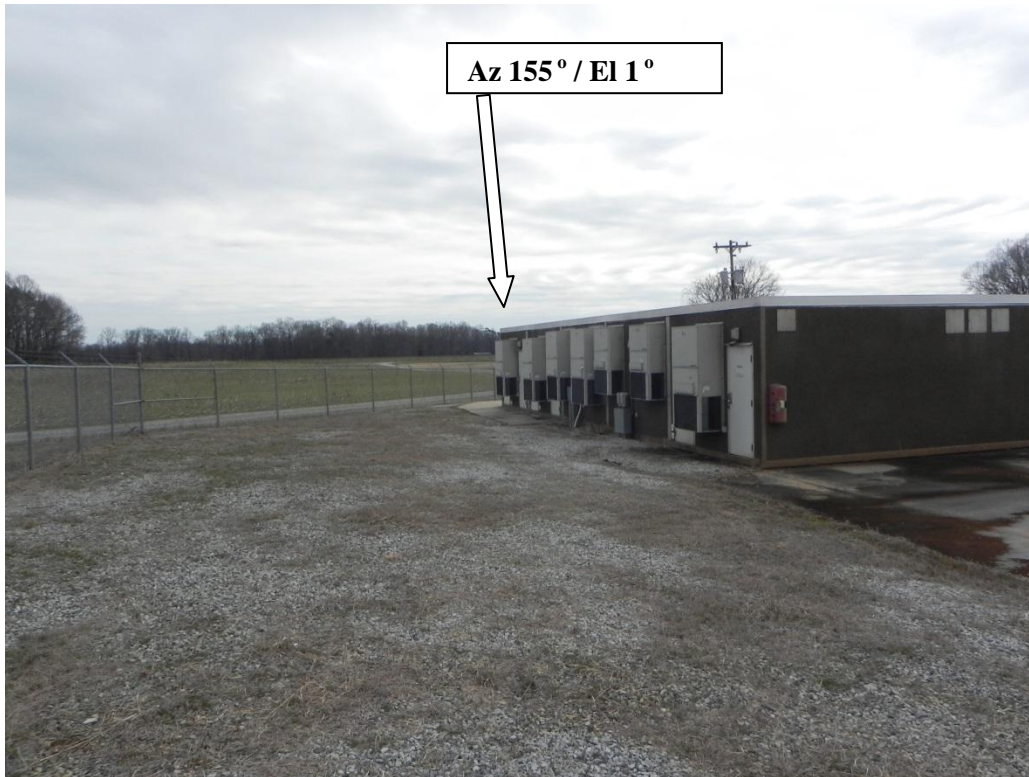
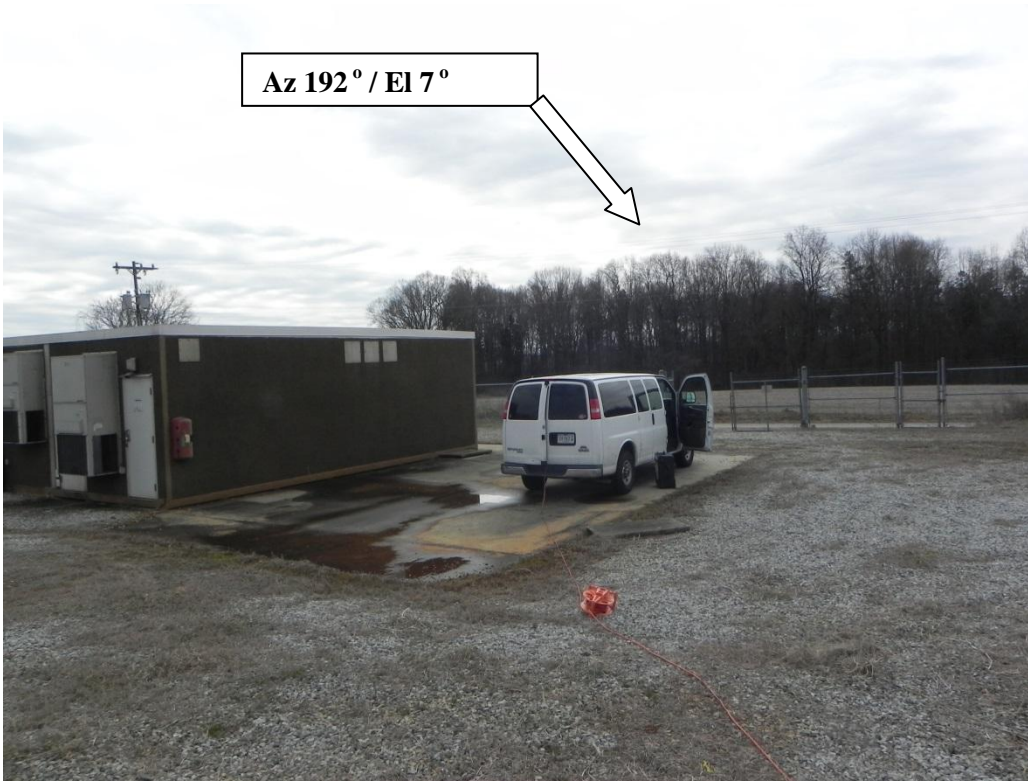
Figure 3.1-2 Horizon Photographs of Earth Station Site

There is no potential satellite arc blockage at this site. Final arc clearance will depend on antenna placement.

The satellite arc has no potential blockage from 55W through 115W.
