MICROWAVE PATH SURVEY REPORT

RADIO FREQUENCY INTERFERENCE (RFI) MEASUREMENT REPORT

ViaSat

Tucson, AZ

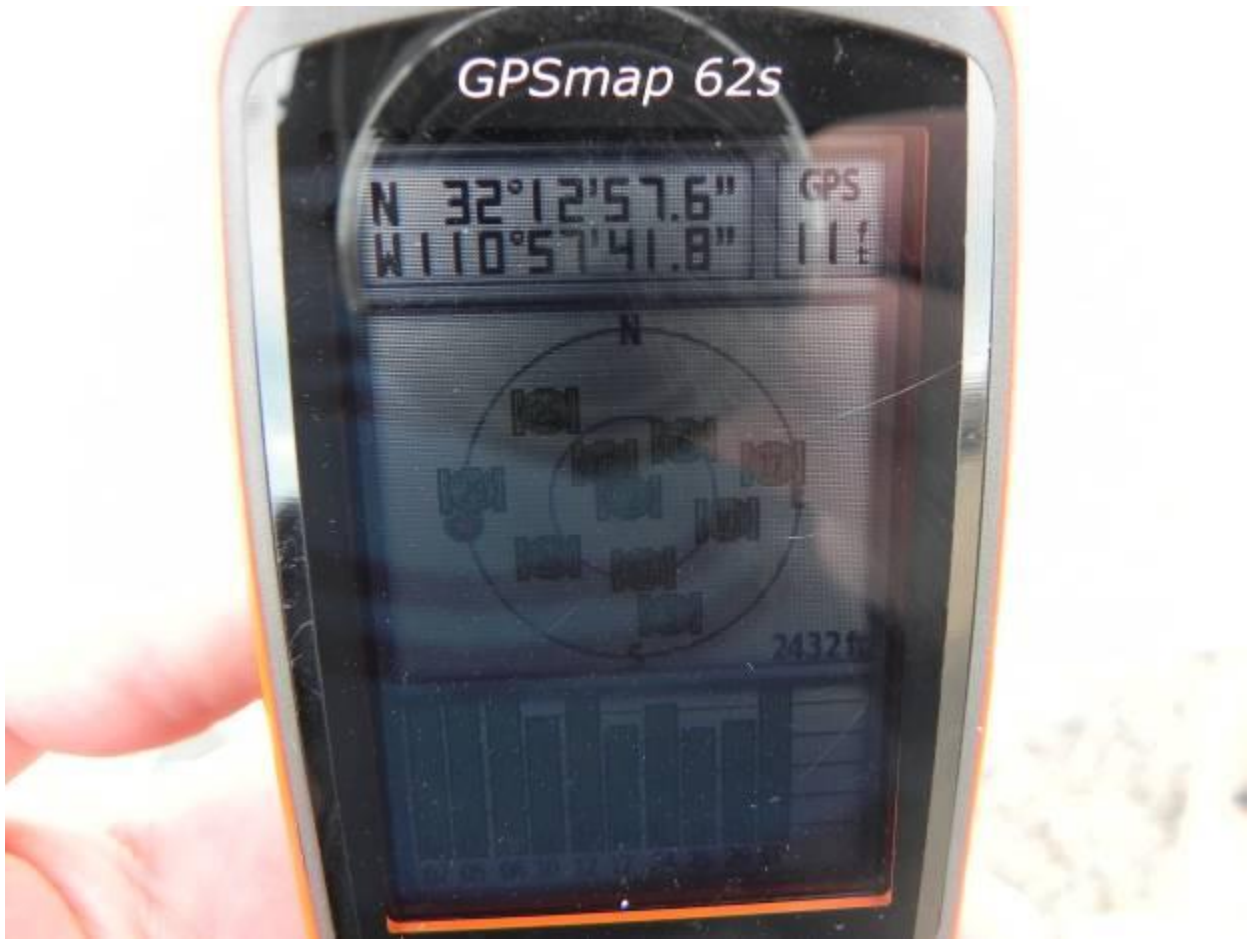
Figure 1.2-3 – GPS Photograph

The measured site is identified on a portion of a topographic map shown in Figure 1.2-1. An aerial photo of the site location is shown in Figure 1.2-2. A photo of the measurement using a GPS is shown in Figure 1.2-3.

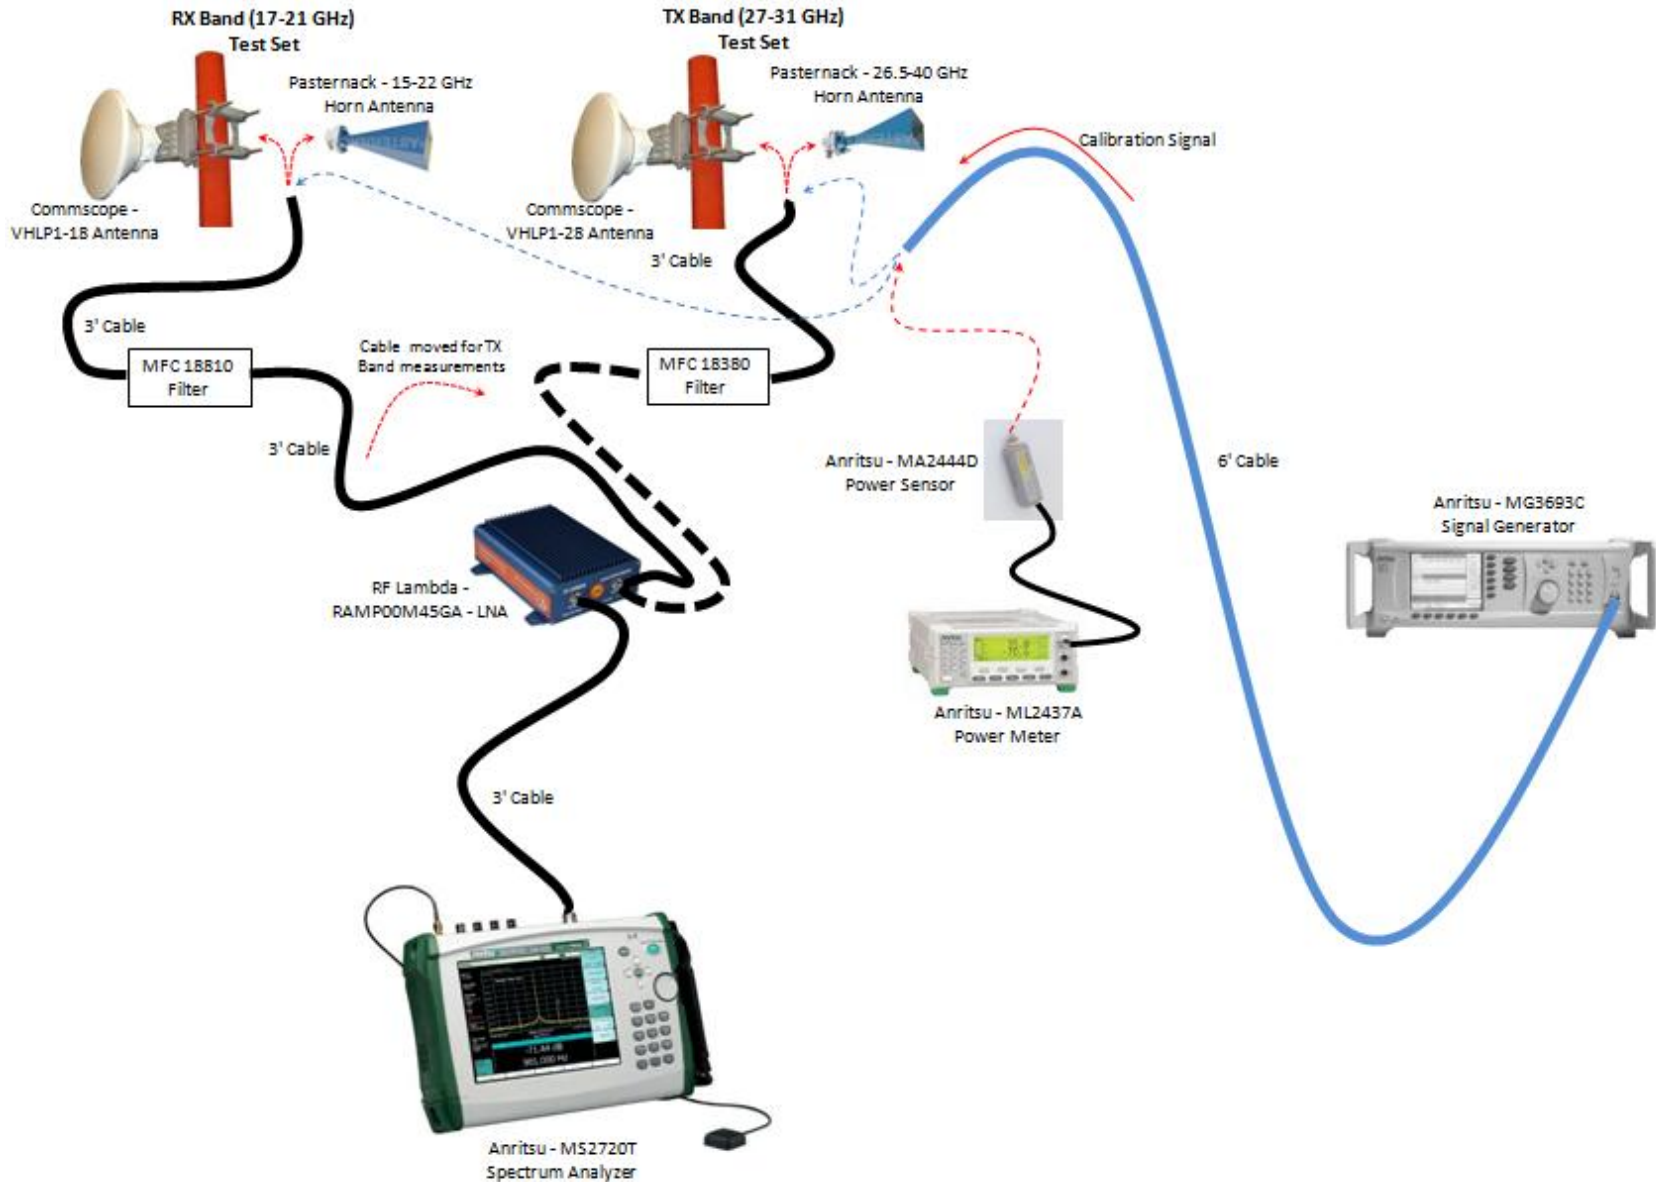
Figure 2.1-1 Receive Test Equipment Block

Figure 2.1-1 is the block diagram of the test set for all bands to be tested. All test equipment used was allowed a proper warm-up period prior to calibration. The test set was calibrated by the signal substitution method, as recommended by NSMA, utilizing a synthesized signal generator. The reference signal from the signal generator was adjusted for the center frequency of each band to be tested and measured with a thermal power meter for calibrated reference test level (-60 dBm). This calibrated reference signal from the signal generator was then injected into the end of the coaxial cable of the test set at the point, which normally connects to the test antenna. A spectrum analyzer then measured the reference test signal level after passing through the test set. At this point, the spectrum analyzer was calibrated such that the top graticule of the spectrum analyzer display (-60 dBm) corresponded to the injected reference signal (-60 dBm) by utilizing the reference level offset function of the Anritsu – MS2720T spectrum analyzer. Upon completion of the calibration process, a known reference level was obtained for the measurements that correspond to a given set of spectrum analyzer display readings.

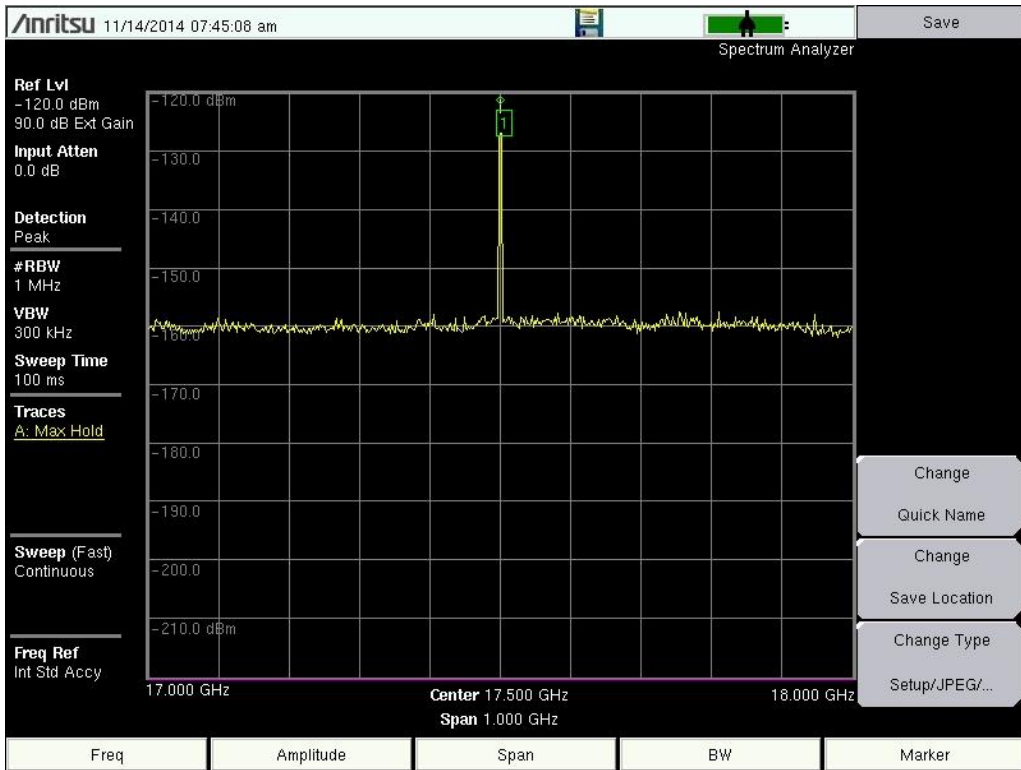
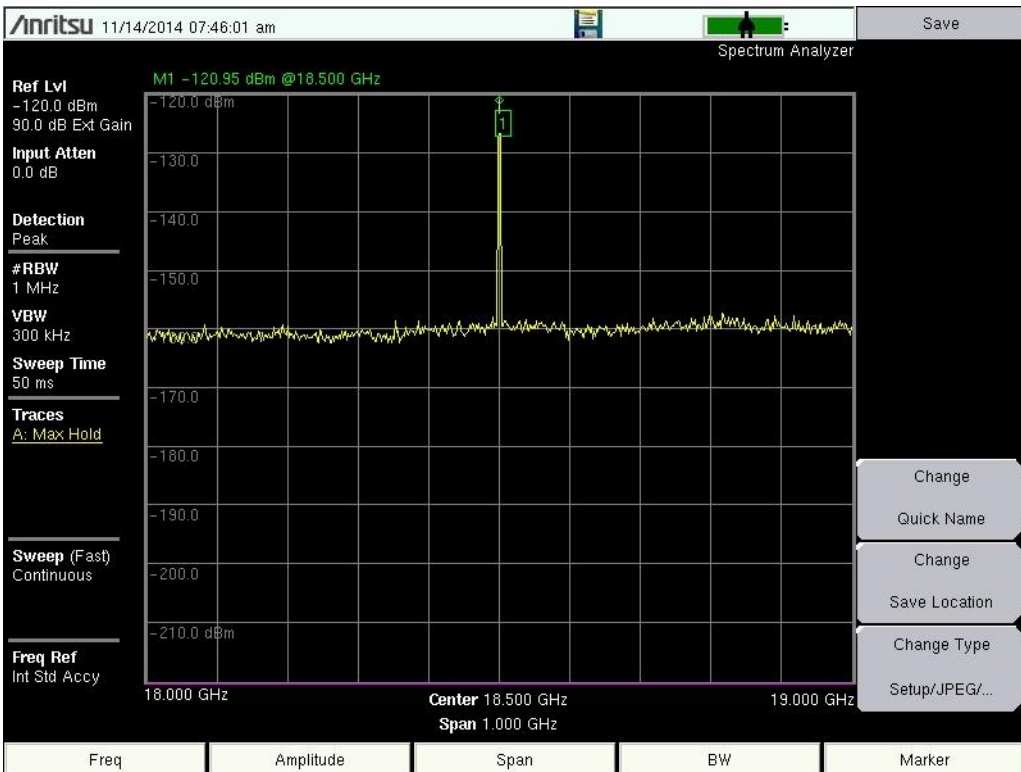
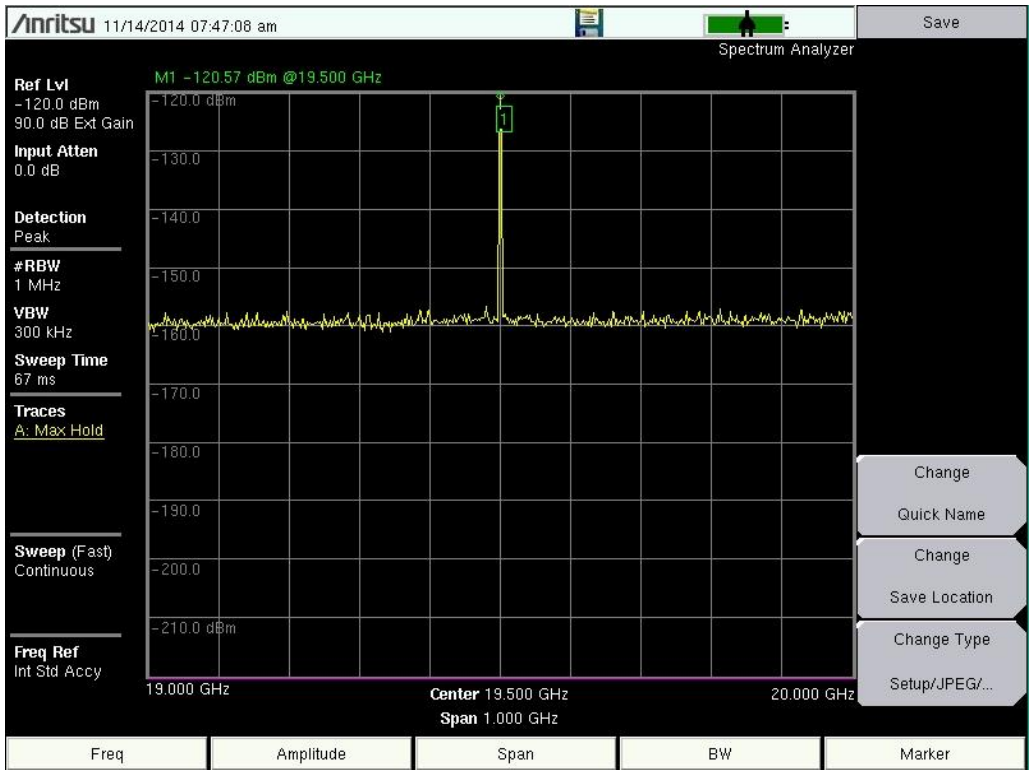
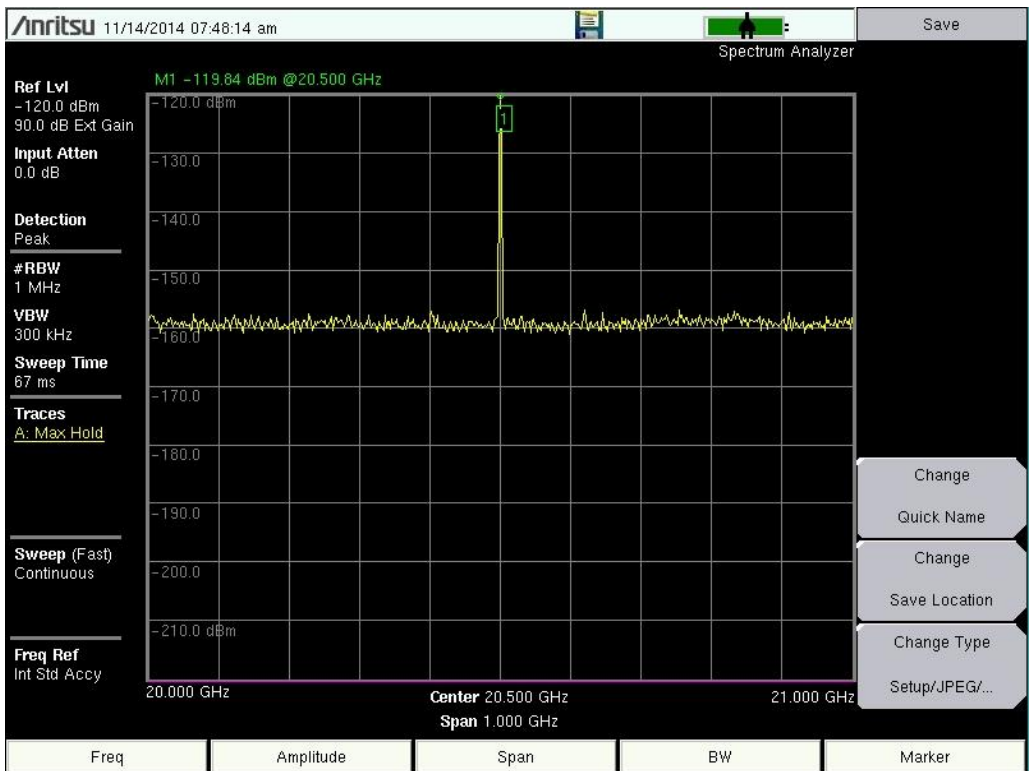
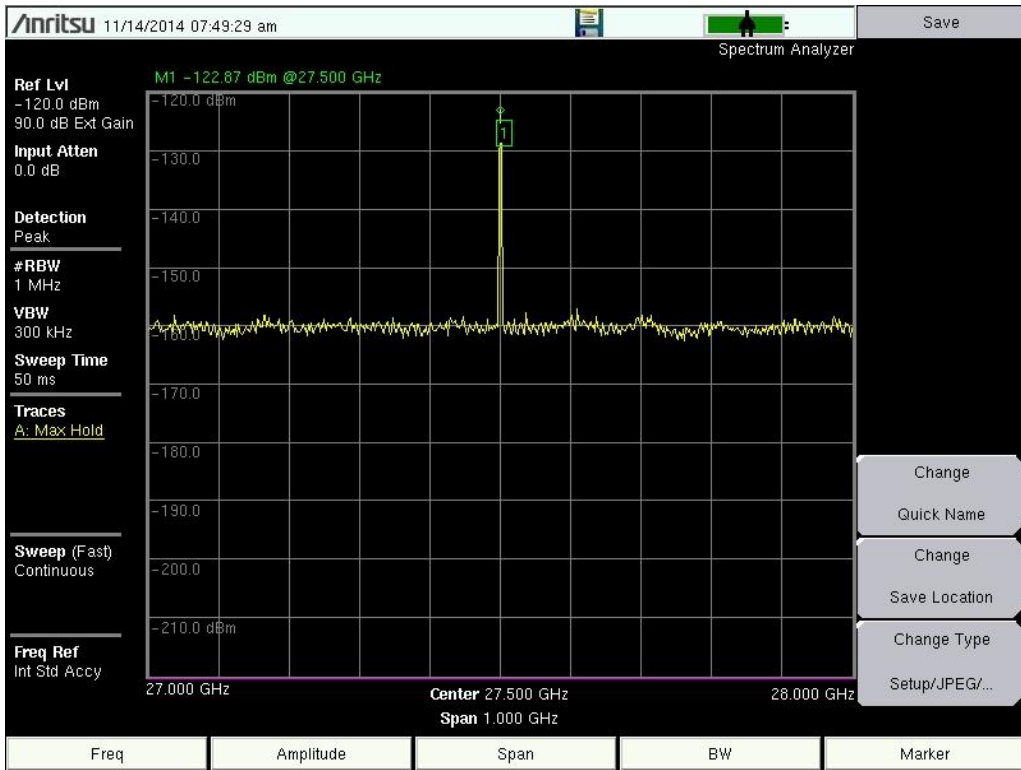
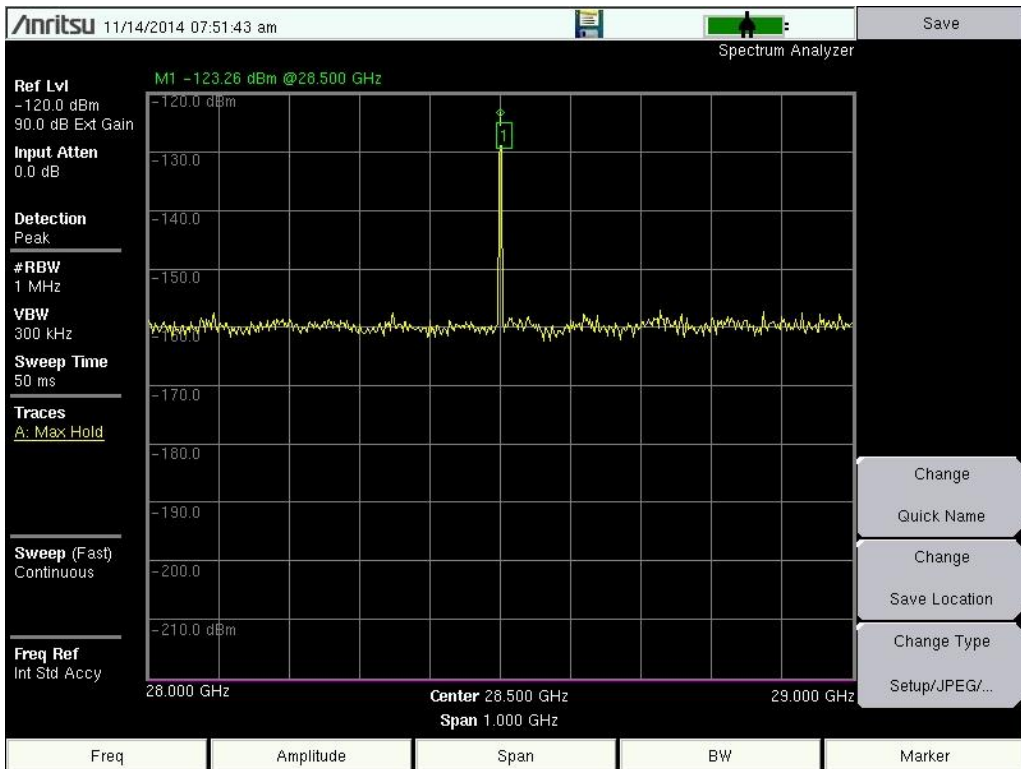
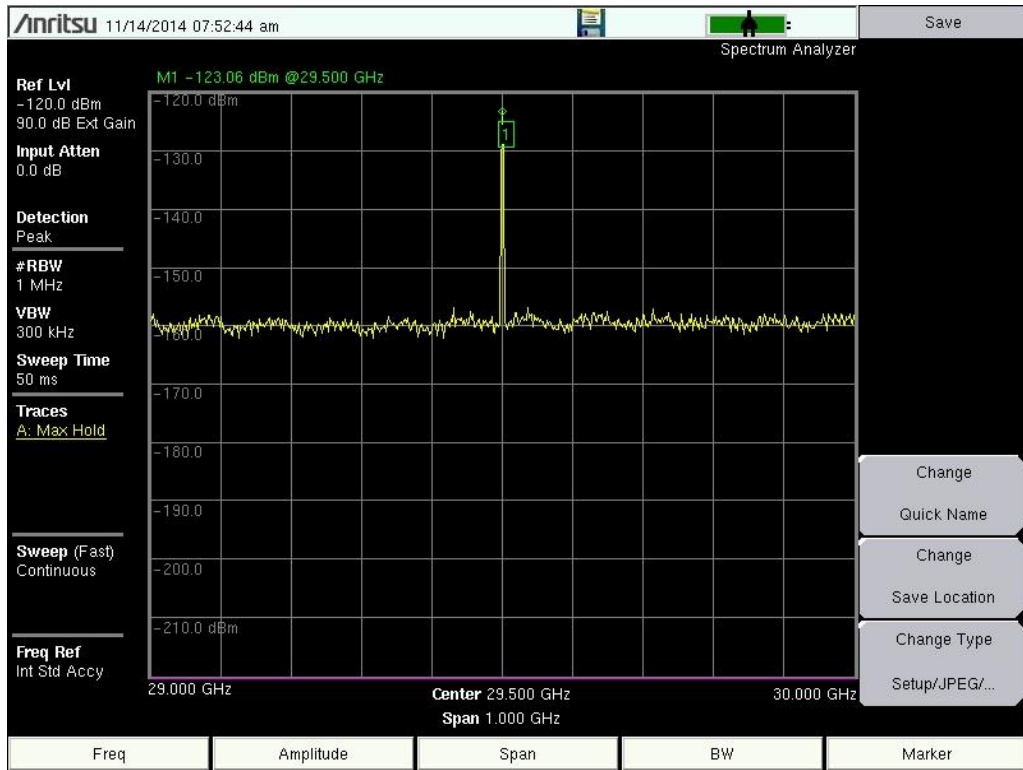
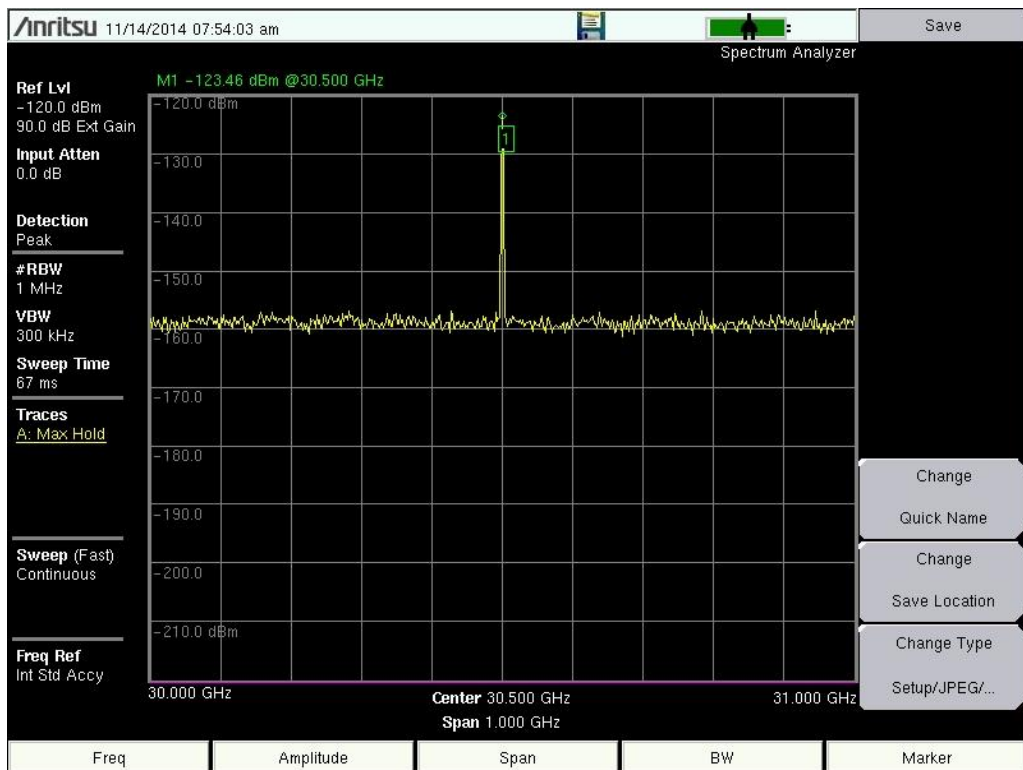
Figures 2.1-2(A-H) displays the spectrum photographs of the described calibration procedure employed during these measurements.

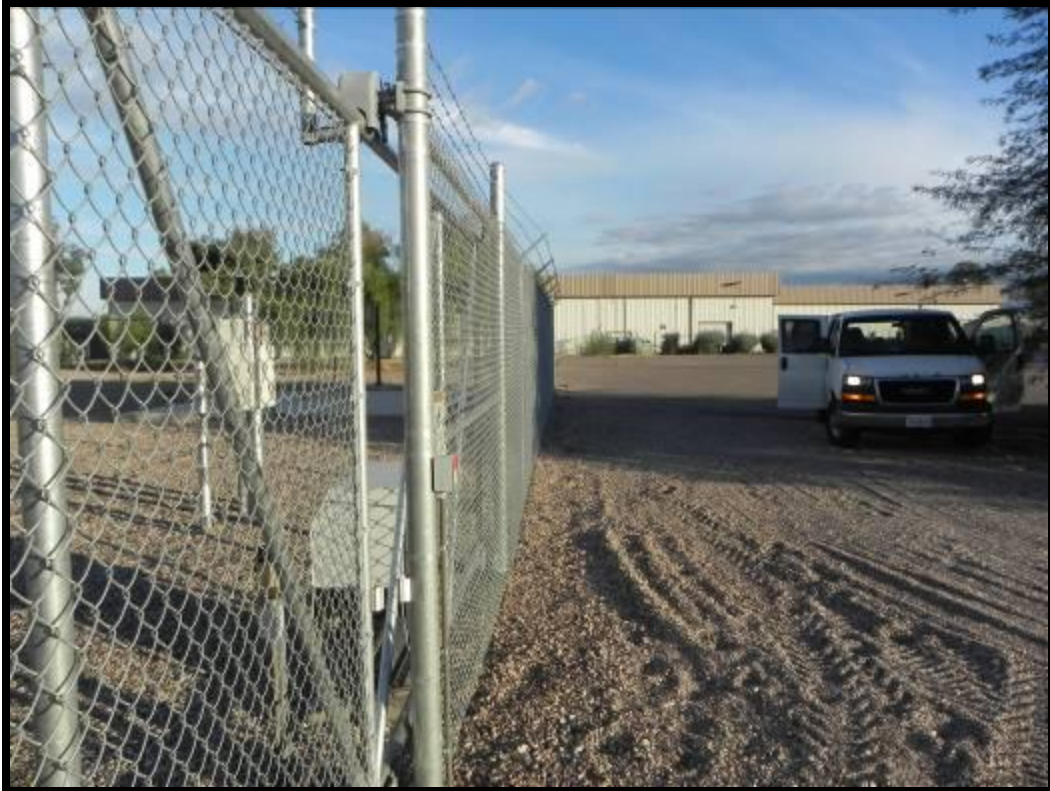
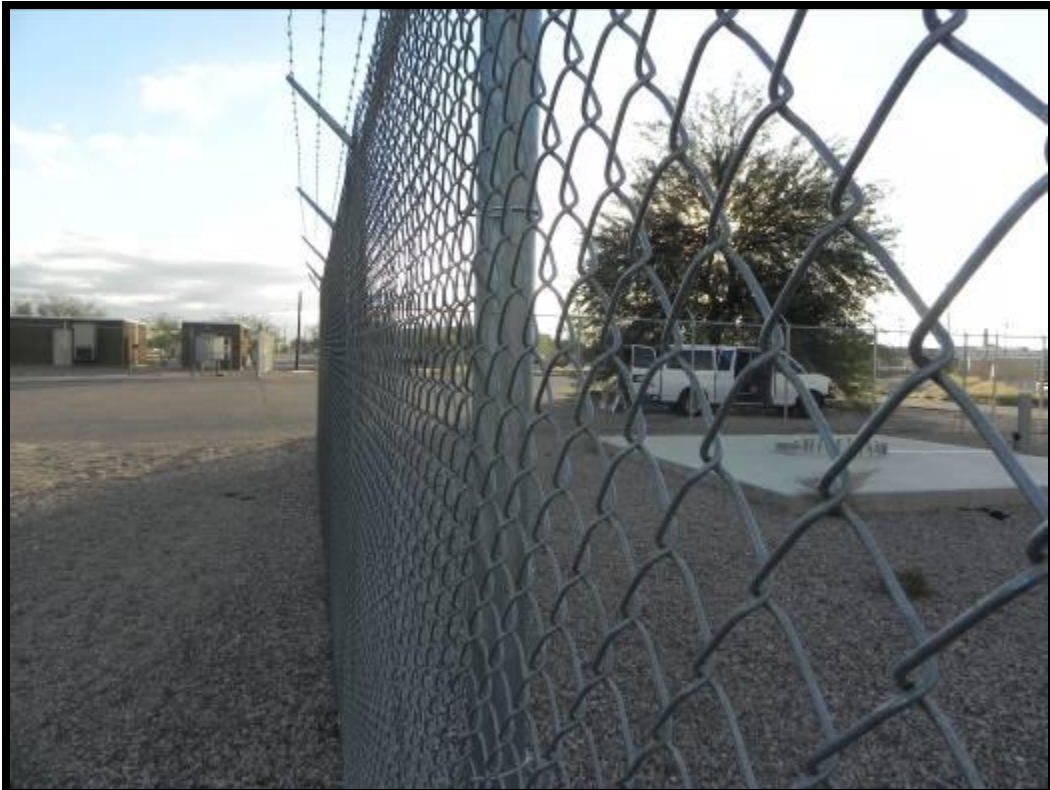
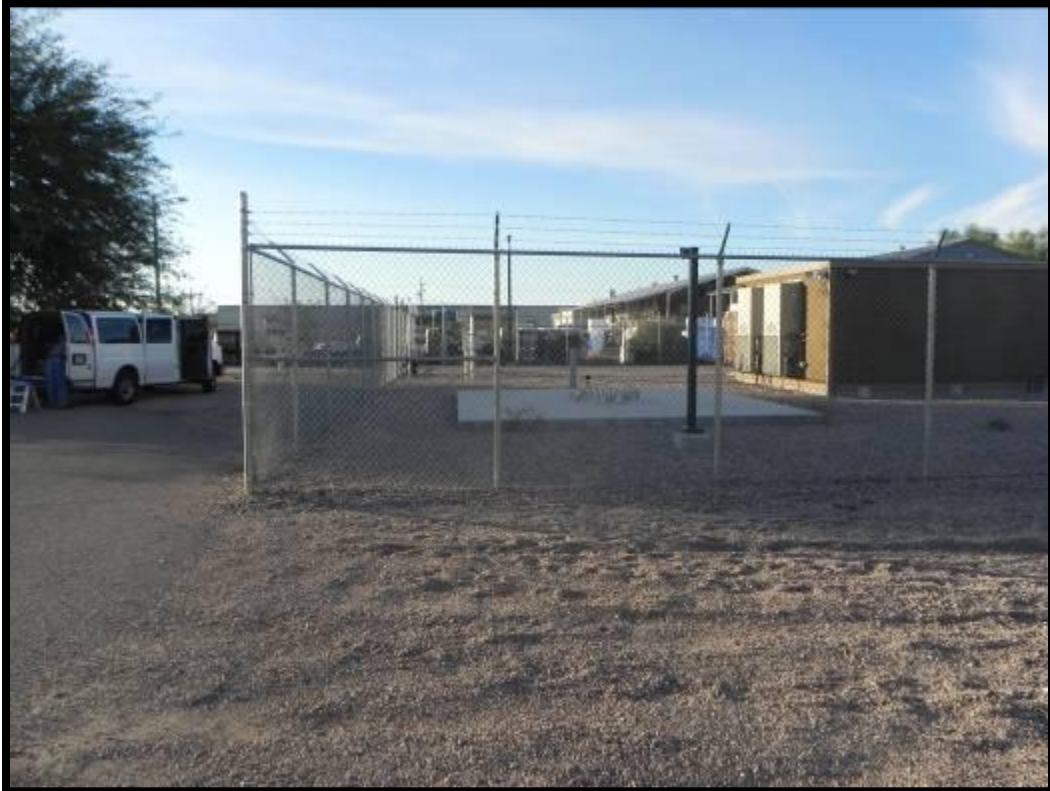
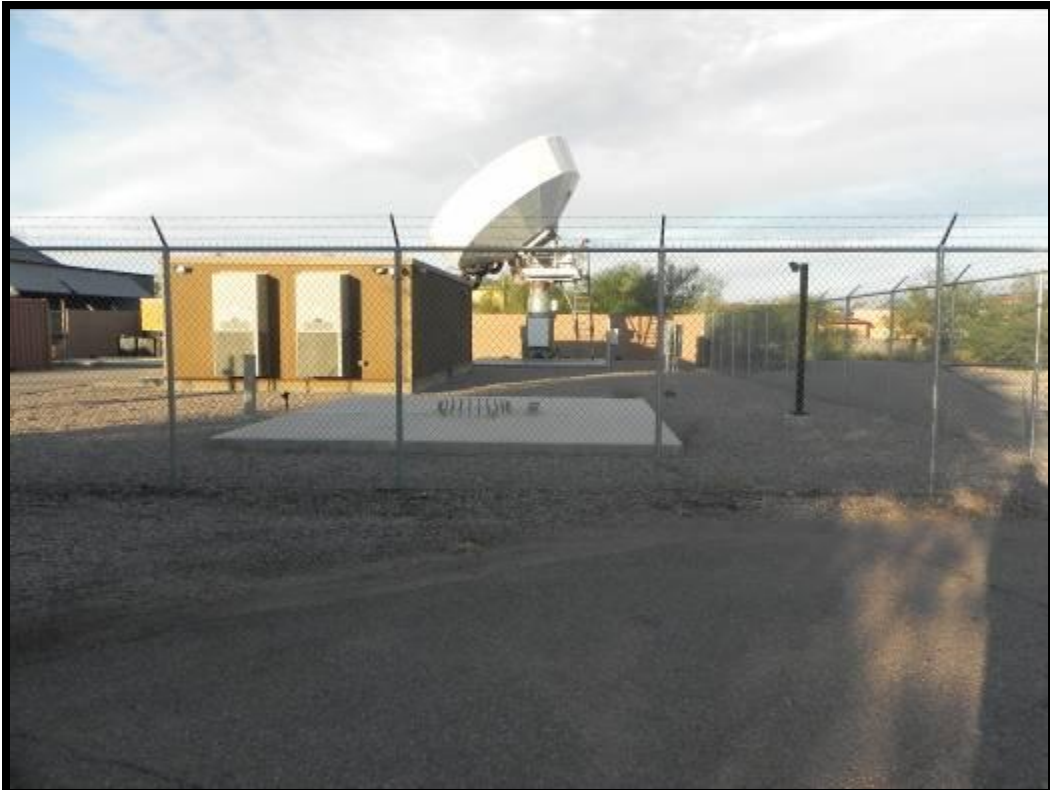
Figure 3.1-1 Earth Station Site Photographs

| 8. GEOSTATIONARY ARC VISIBILITY: | Satellite arc has blockage at this time and may possibly require removal of one tree depending on the satellite accessed. |

There is potential satellite arc blockage at this site. Final arc clearance will depend on antenna placement. One tree will require removal

The satellite arc has potential blockage from 55W through 115W.

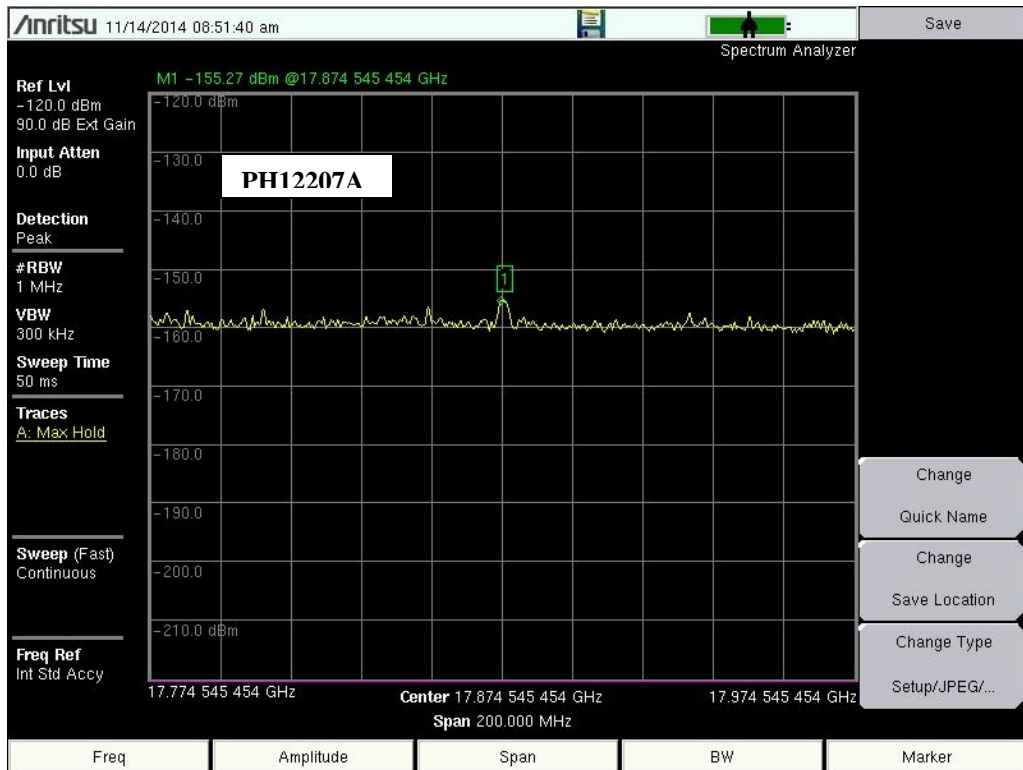
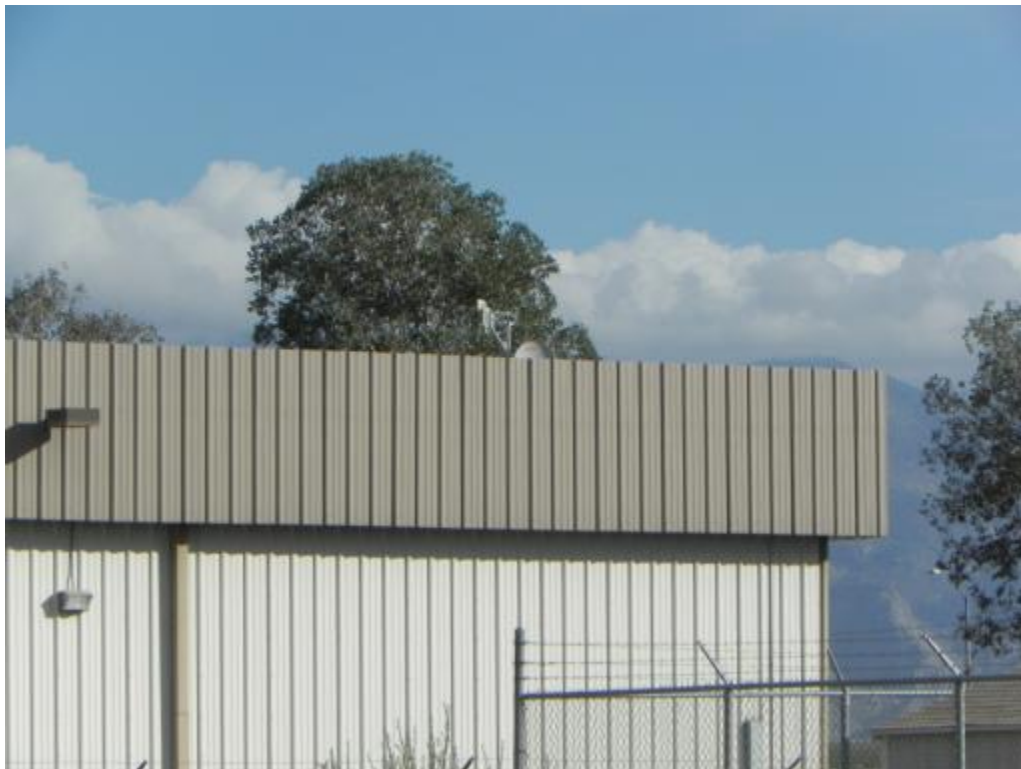
There was one radio frequency interference case measured at this site t above the -156 dBW/ 1 MHz interference objective for digital reception at this site. (See Addendum 1)

Based on actual On-Site measurements at the Tucson ViaSat location of the 15 possible interference cases there was one signal detected of known licensed broadcast in the Receive band. This Addendum contains the spectral photo of the received carrier as well as the direction (030°) and possible transmit site. Photos are shown below in Figures A1.2.1- A1.2.2.

ViaSat, Inc should review the system parameters for this down-link in order to verify the viability of this objective. It is recommended that frequency coordination of this site be initiated to protect this location at the more stringent digital receive interference objective.
