MICROWAVE PATH SURVEY REPORT

RADIO FREQUENCY INTERFERENCE (RFI) MEASUREMENT REPORT

ViaSat

Transmit and Receive Earth Station
17-21 GHz and 27-31 GHz

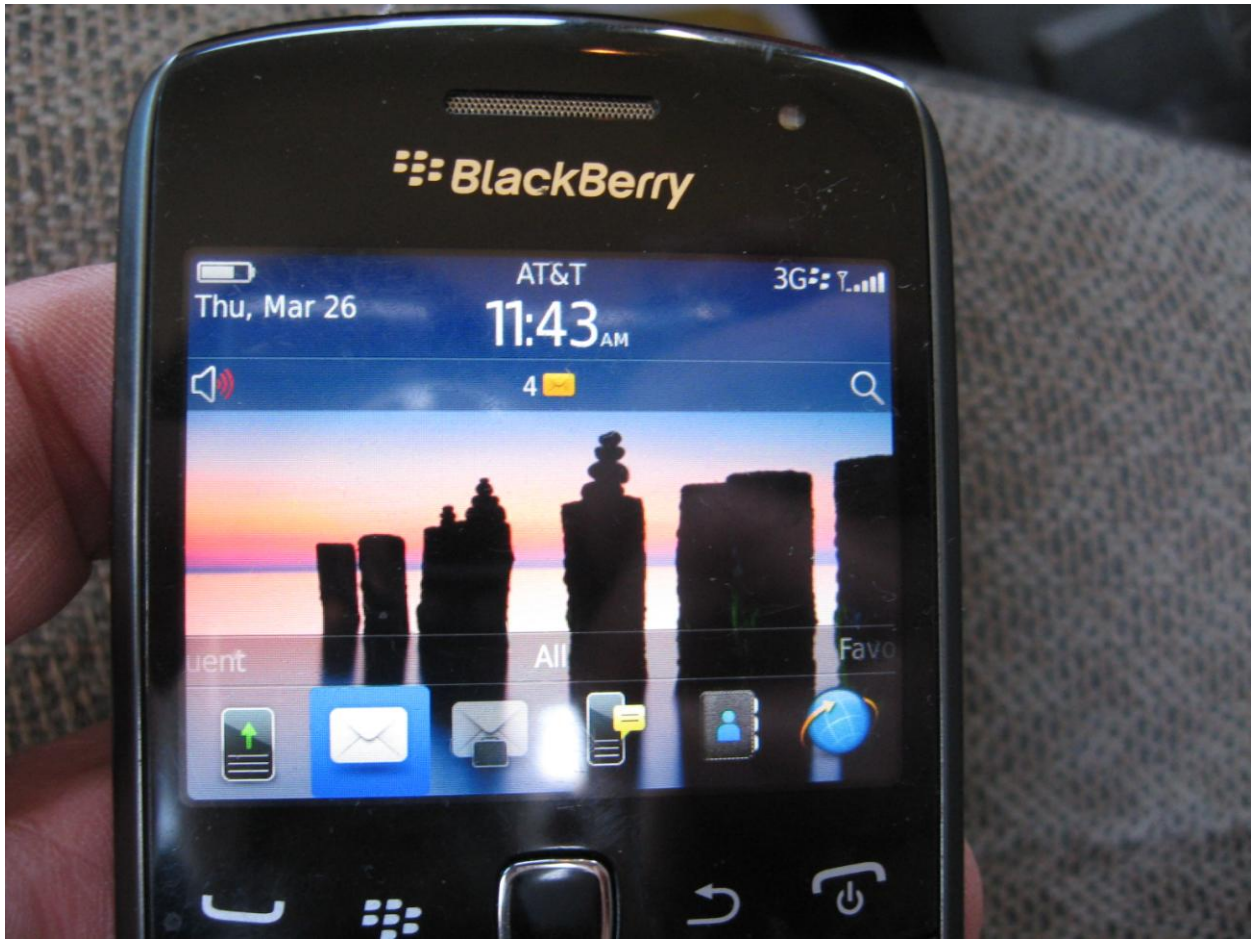
Figure 1.2-4 – Cellular/PCS Coverage

The measured site is identified on a portion of a topographic map shown in Figure 1.2-1. An aerial photo of the site location is shown in Figure 1.2-2. A photo of the measurement using a GPS is shown in Figure 1.2-3. A photo of the surrounding cellular/PCS coverage is shown in Figure 1.2-4.

There were no signals measured above the -156 dBW/ 1 MHz interference objective for digital reception at this site. One concern does exist. There is a cell site on location at the site

It is recommended that frequency coordination of this site be initiated to protect this location at the more stringent digital receive interference objective.

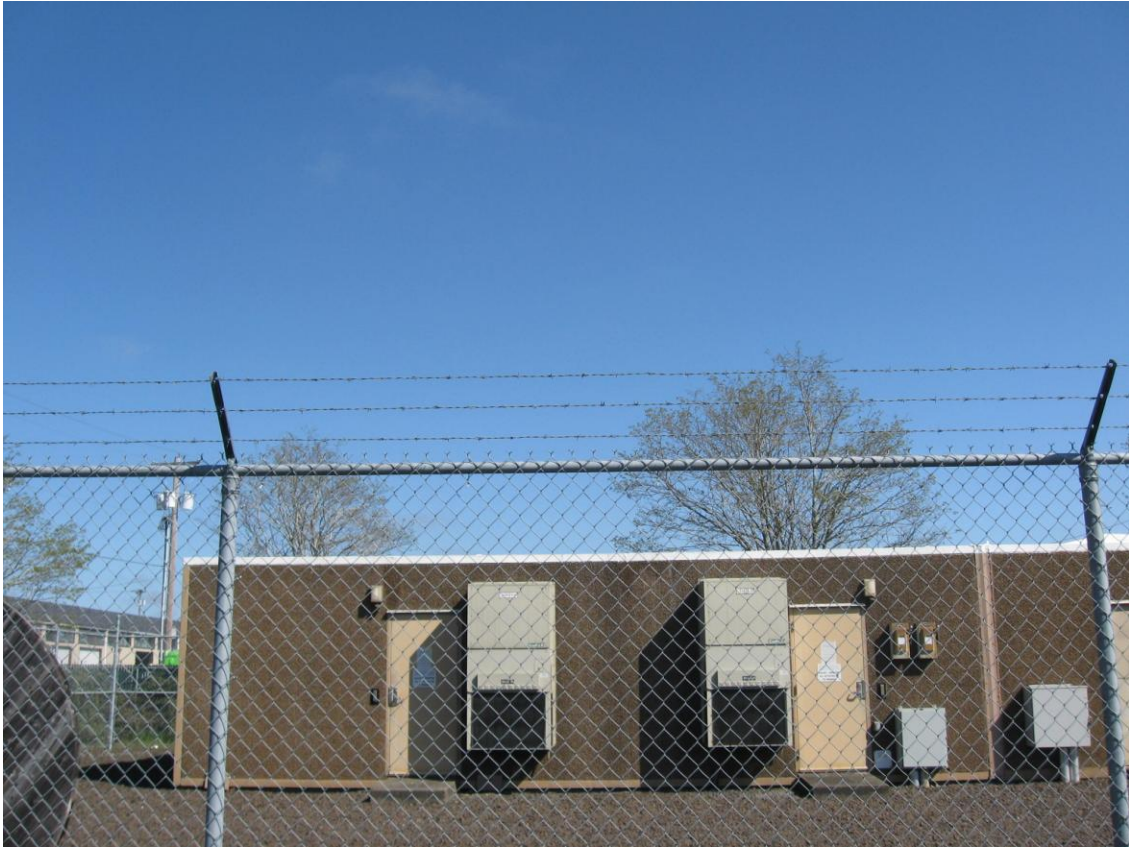
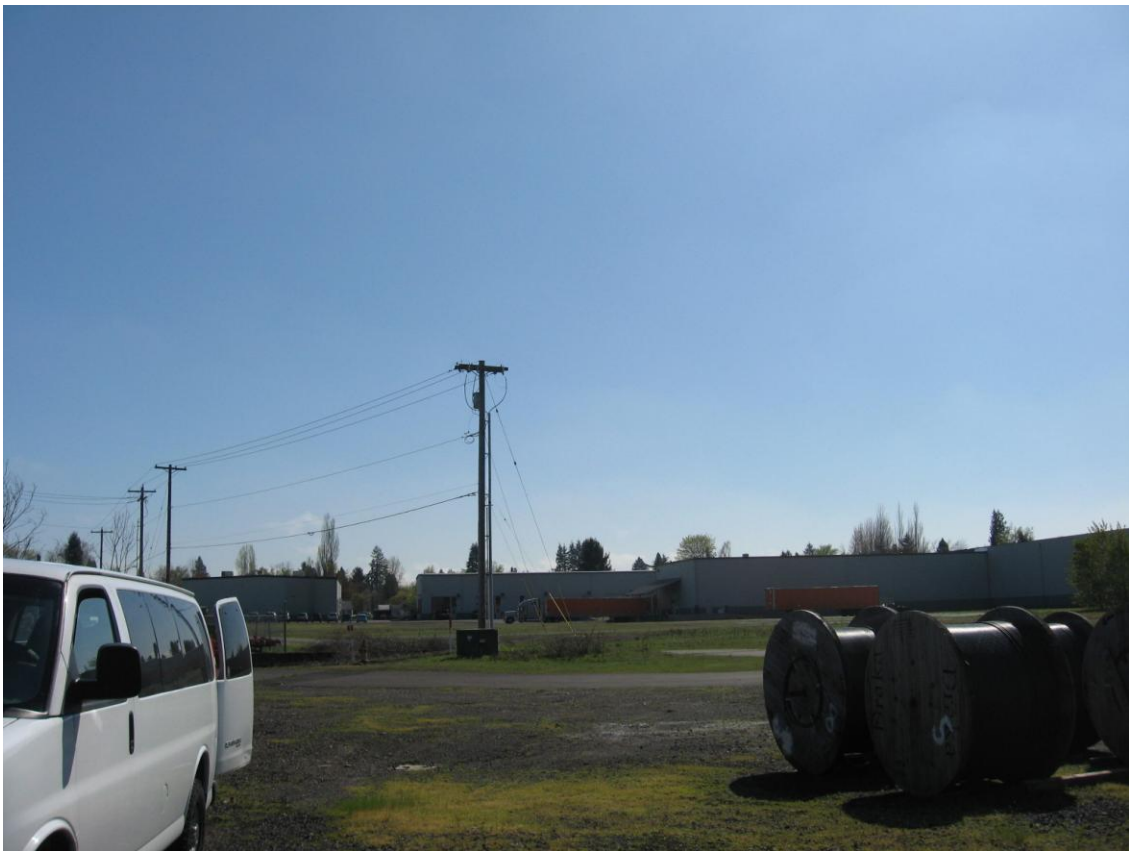
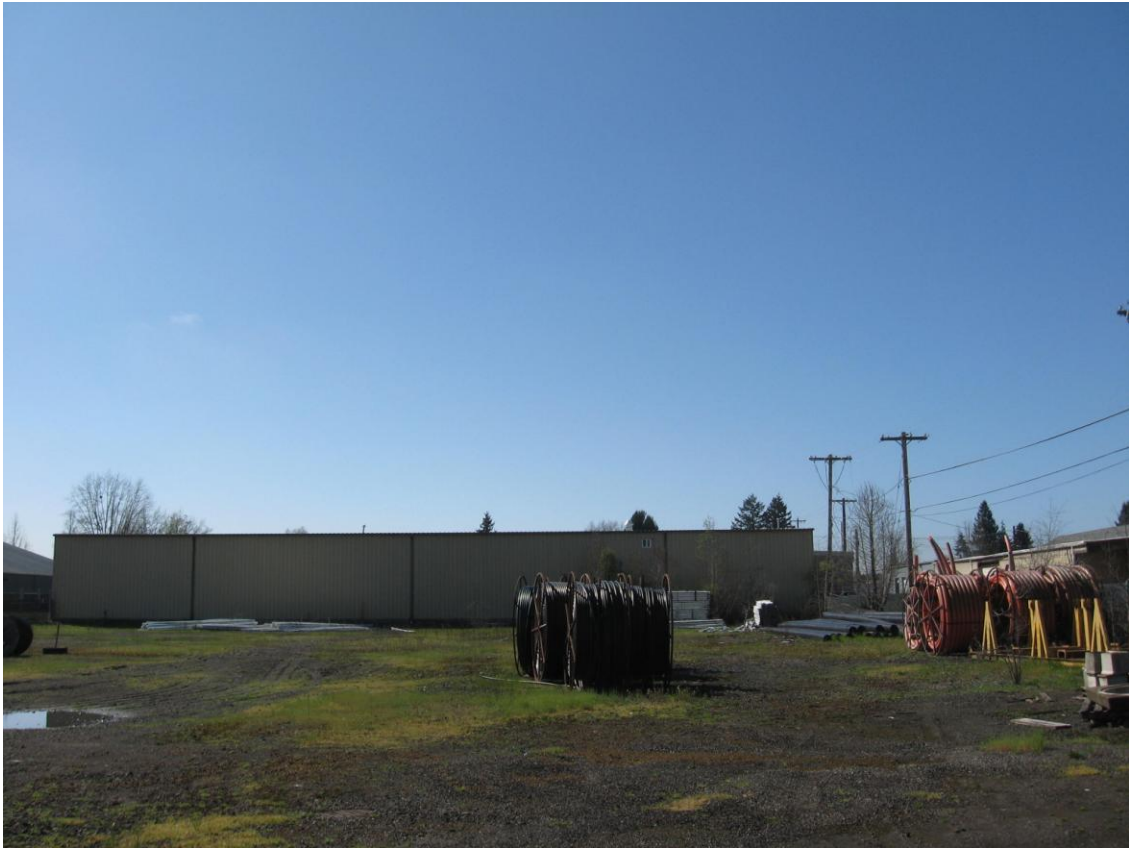
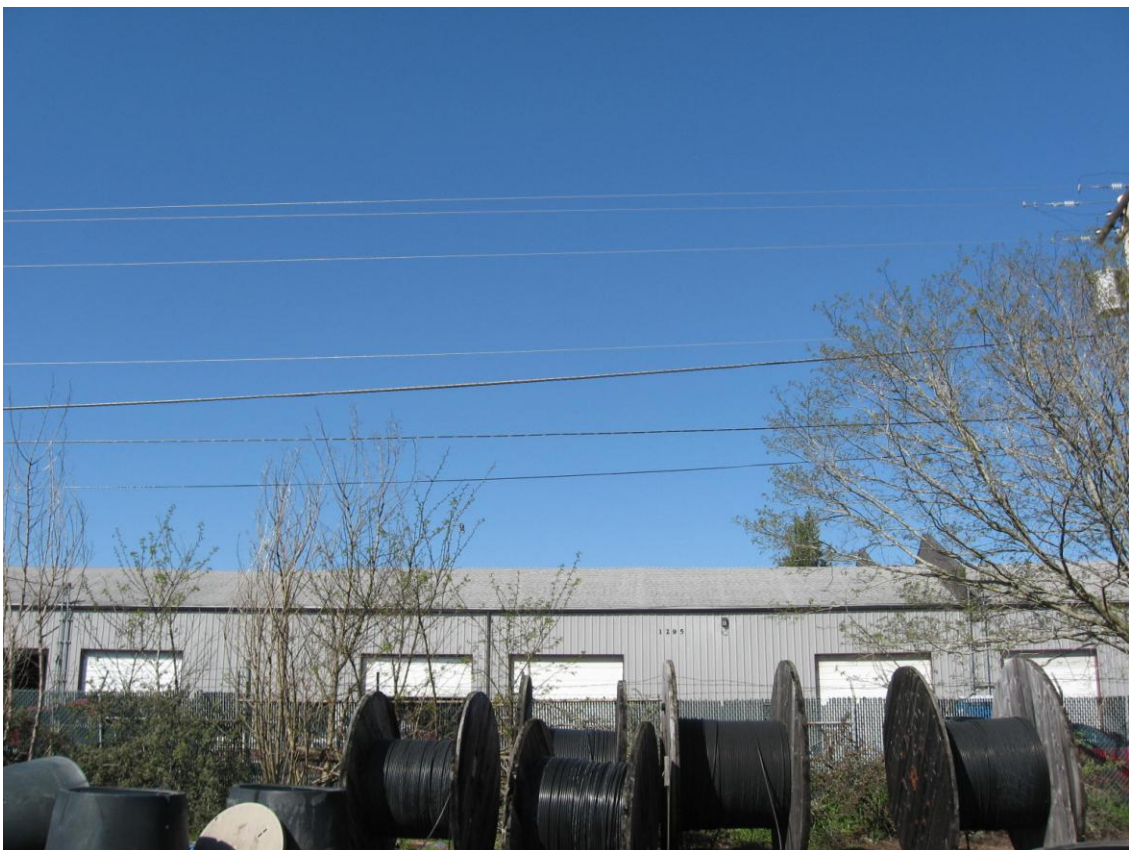
Figure 3.1-1 Earth Station Site Photographs

- Table 3.1-1 presents a site data sheet including all pertinent site information.
- Figures 3.1-1 and 3.1-2 are the photographs depicting the existing earth station site and satellite arc.
- Figures 3.1-3 through 3.1-10 are the RF spectrum photographs depicting the interference environment at the test site.

| 8. GEOSTATIONARY ARC VISIBILITY: | Satellite arc has no blockage at this time |

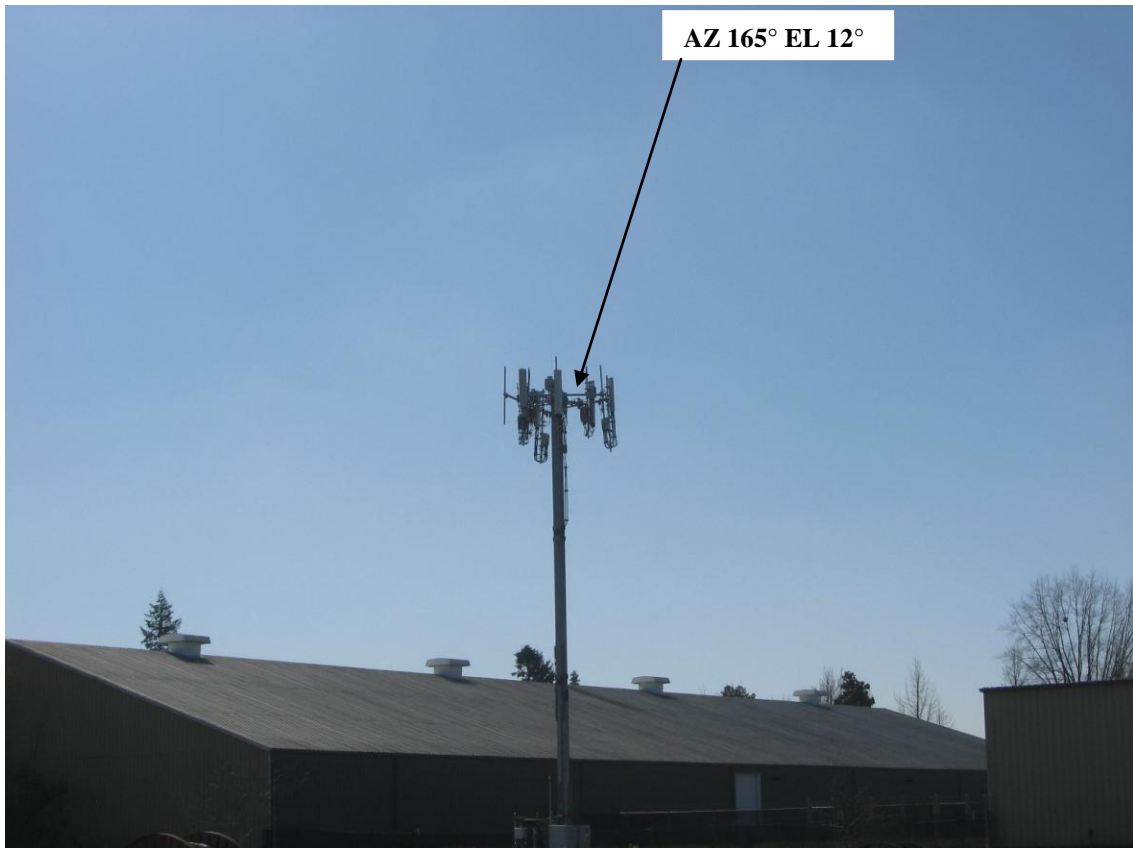
Figure 3.1-2 Horizon Photographs of Earth Station Site

There is no potential satellite arc blockage at this site. Final arc clearance will depend on antenna placement.

The satellite arc has no potential blockage from 55W through 115W.
