MICROWAVE PATH SURVEY REPORT

RADIO FREQUENCY INTERFERENCE (RFI) MEASUREMENT REPORT

ViaSat

Tornillo, TX

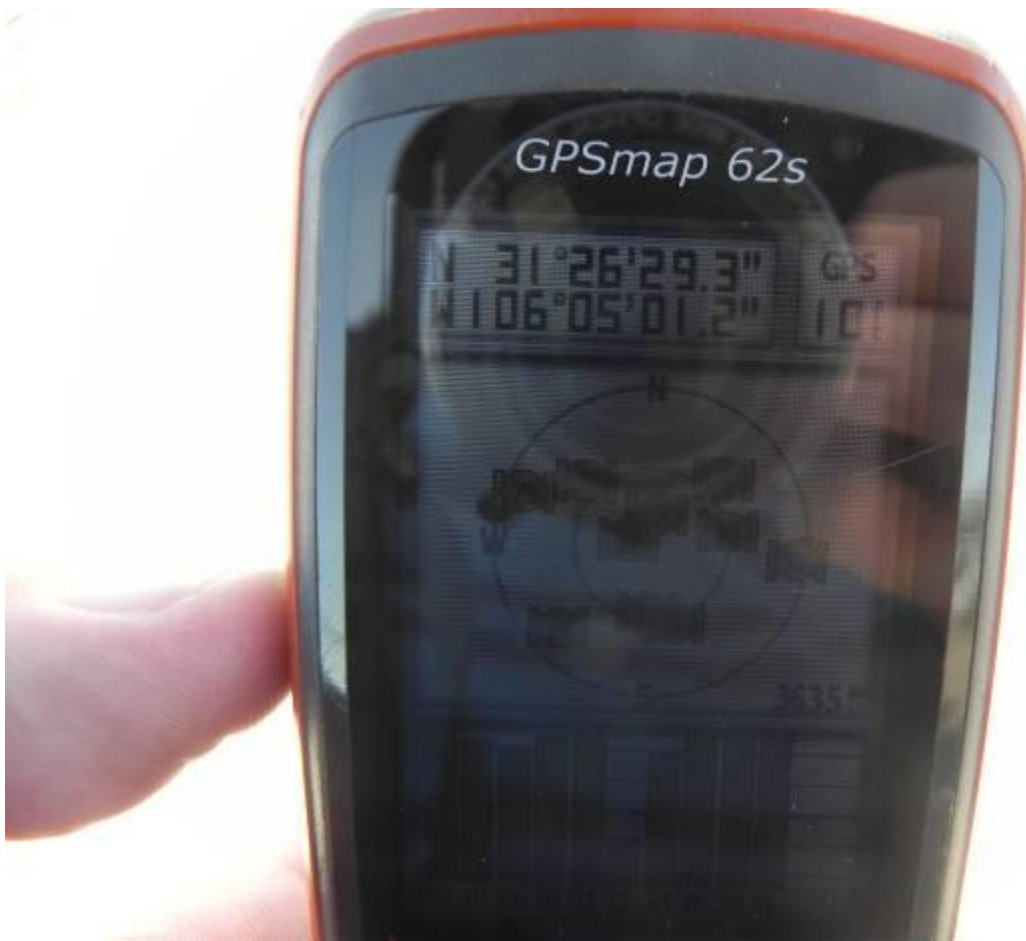
Figure 1.2-3 – GPS Photograph

The measured site is identified on a portion of a topographic map shown in Figure 1.2-1. An aerial photo of the site location is shown in Figure 1.2-2. A photo of the measurement using a GPS is shown in Figure 1.2-3.

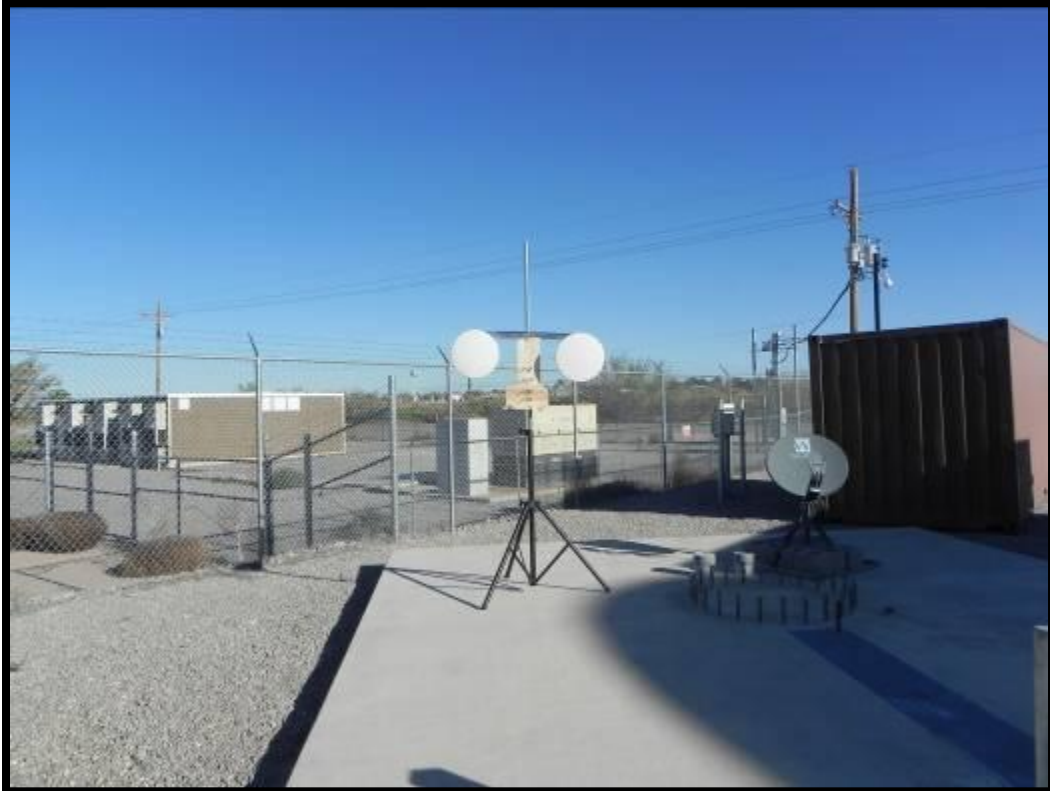
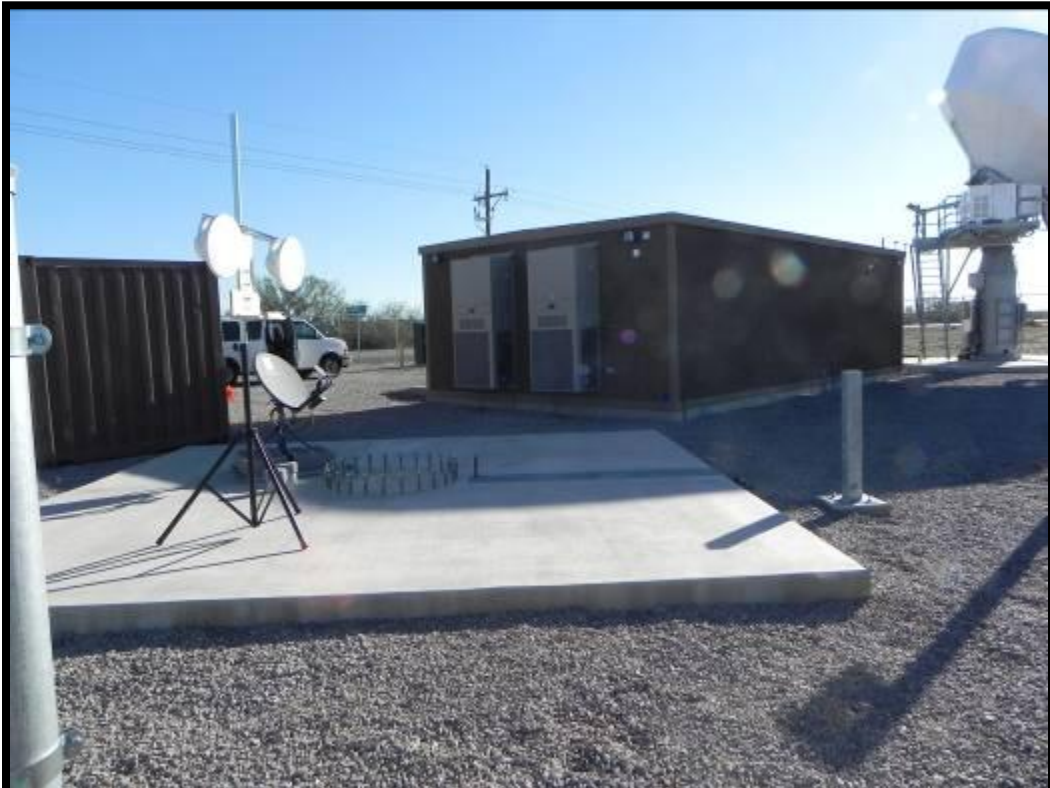
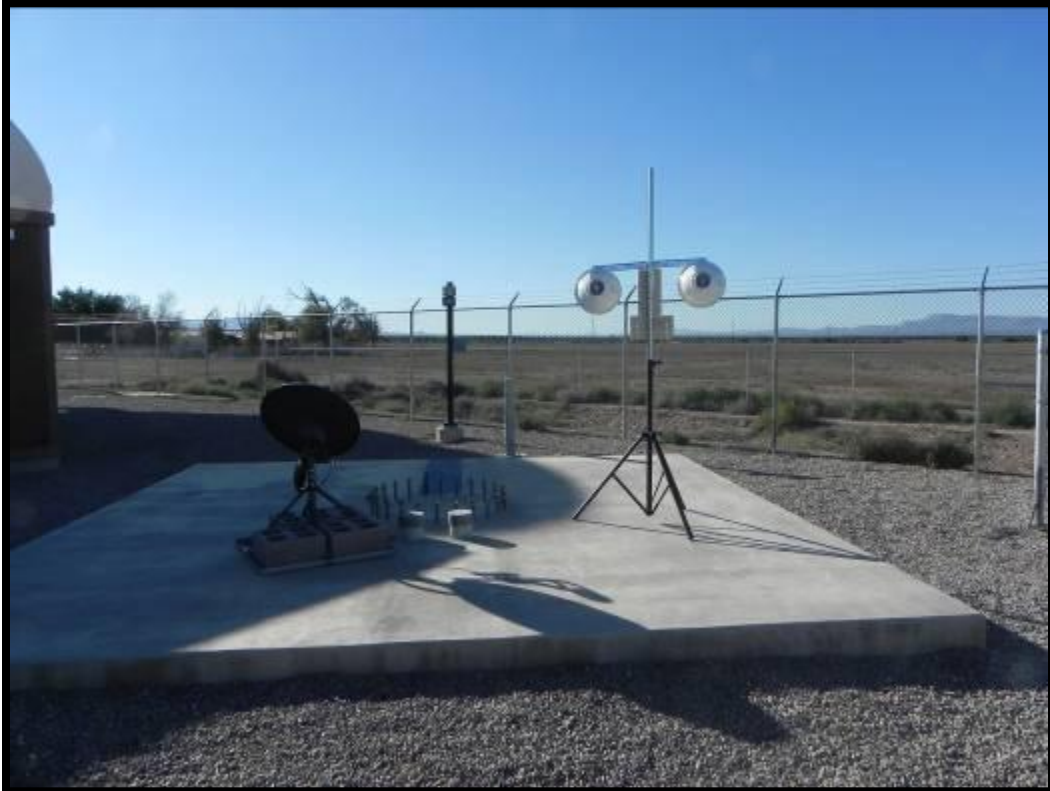
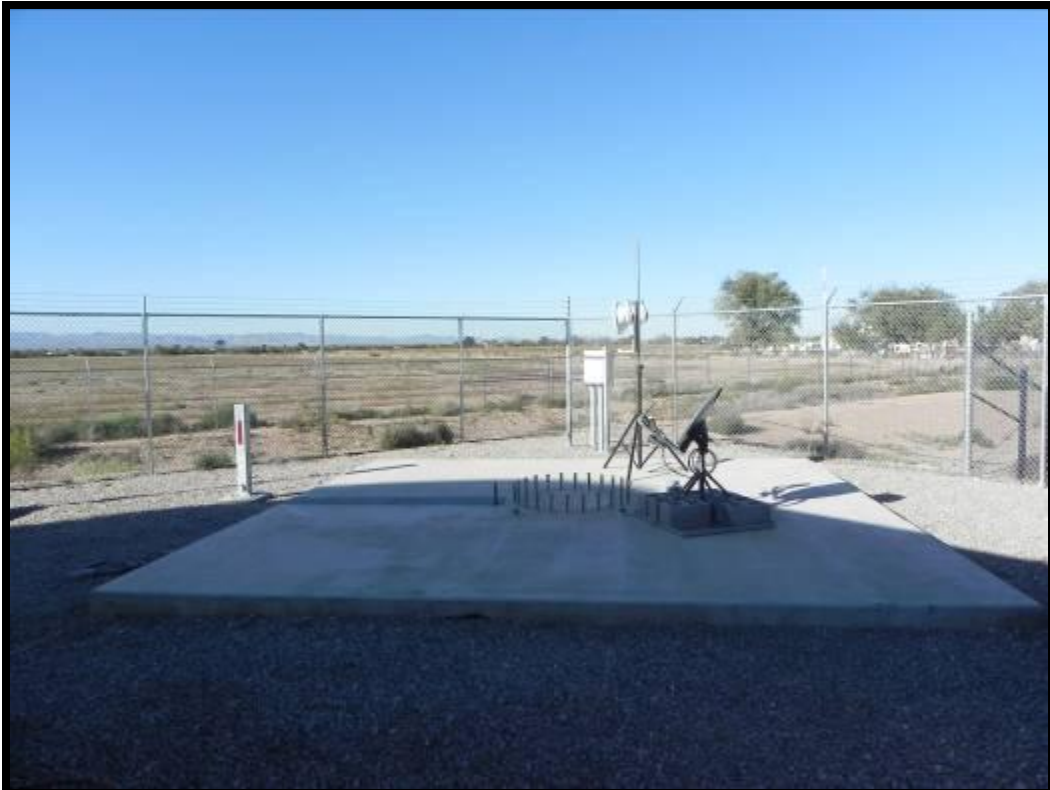
Figure 3.1-1 Earth Station Site Photographs

- Table 3.1-1 presents a site data sheet including all pertinent site information.
- Figures 3.1-1 and 3.1-2 are the photographs depicting the existing earth station site and satellite arc.
- Figures 3.1-3 through 3.1-10 are the RF spectrum photographs depicting the interference environment at the test site.

| 8. GEOSTATIONARY ARC VISIBILITY: | Satellite arc has no blockage at this time |

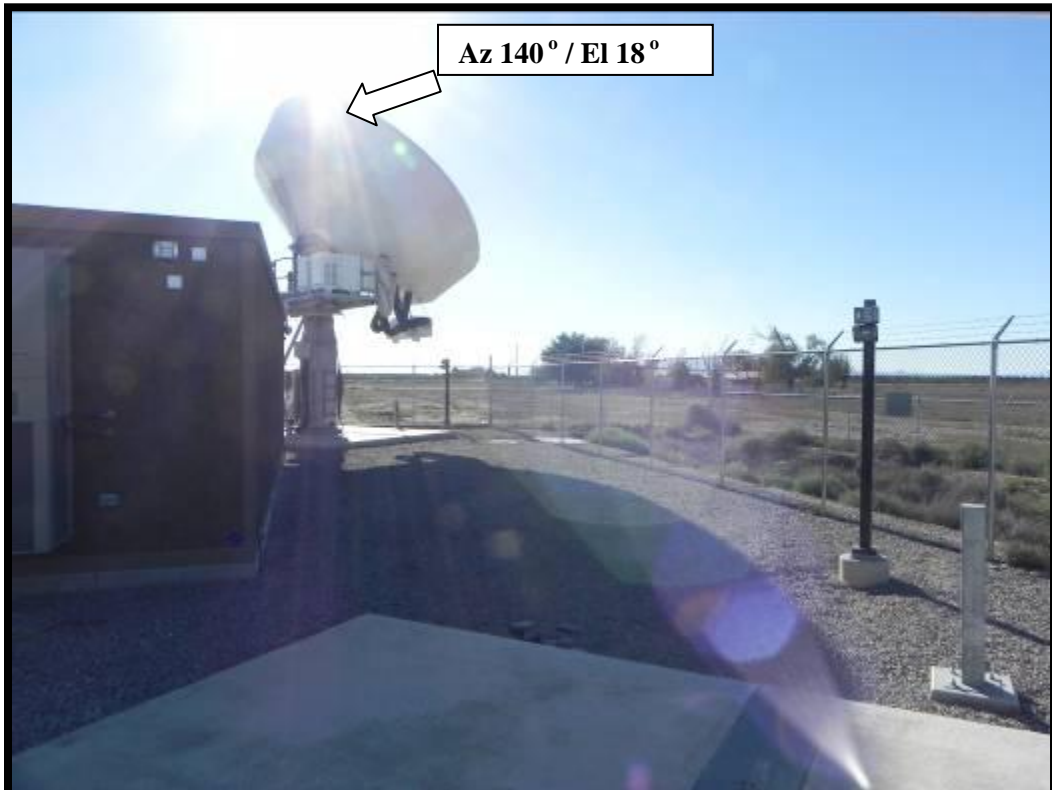
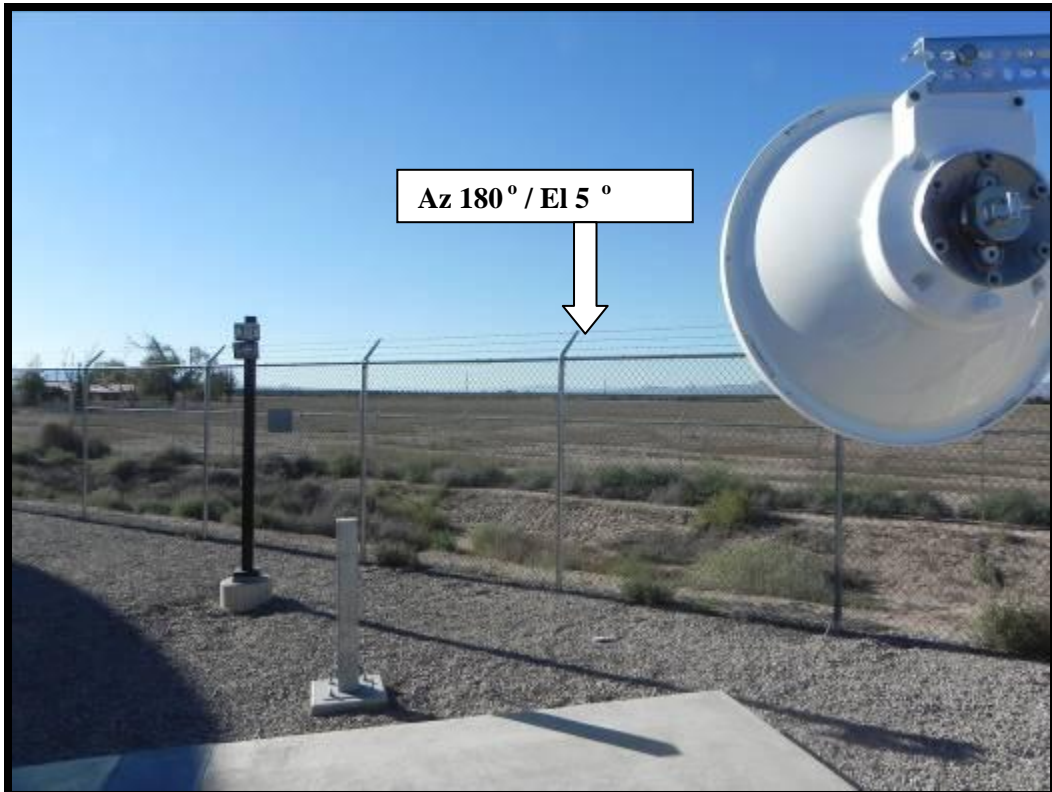
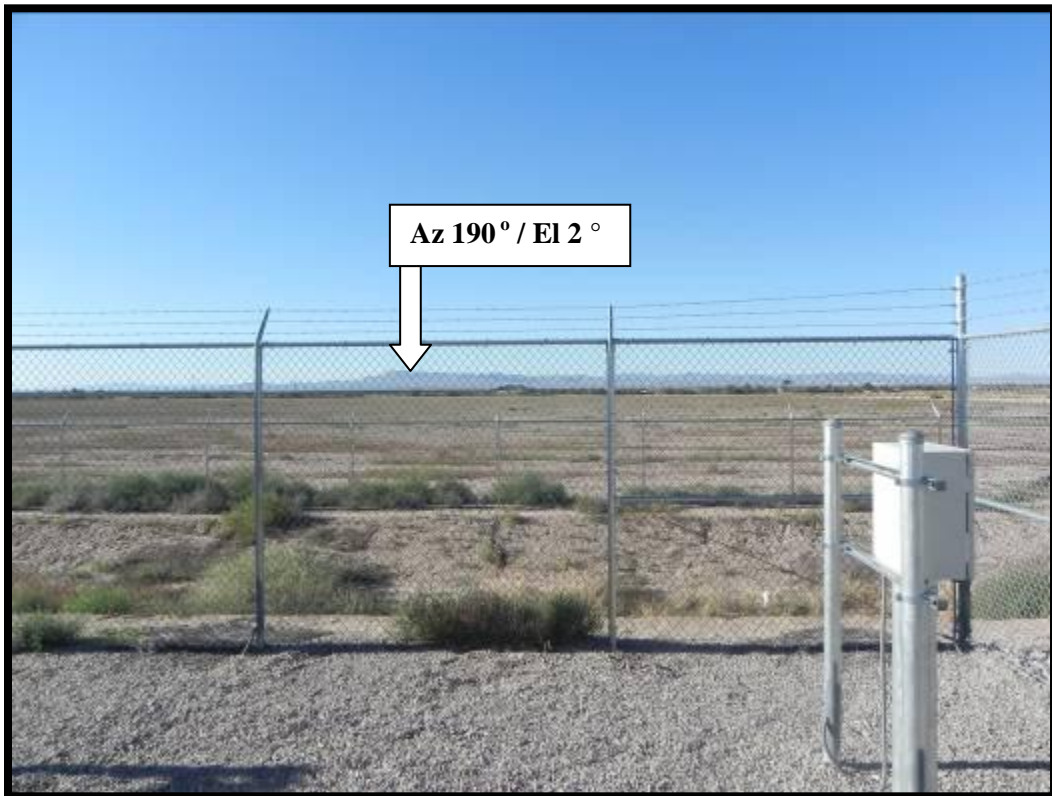
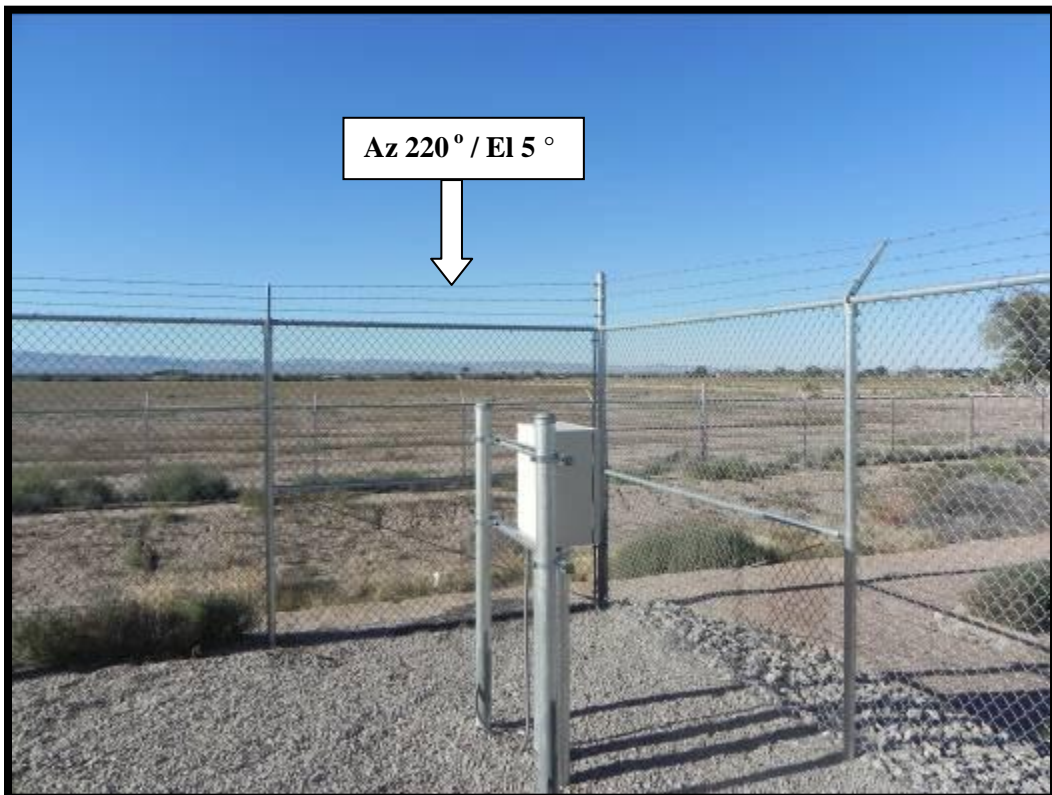
Figure 3.1-2 Horizon Photographs of Earth Station Site

There is no potential satellite arc blockage at this site. Final arc clearance will depend on antenna placement.

The satellite arc has no potential blockage from 55W through 115W.
