MICROWAVE PATH SURVEY REPORT

RADIO FREQUENCY INTERFERENCE (RFI) MEASUREMENT REPORT

ViaSat

Chiefland, Florida

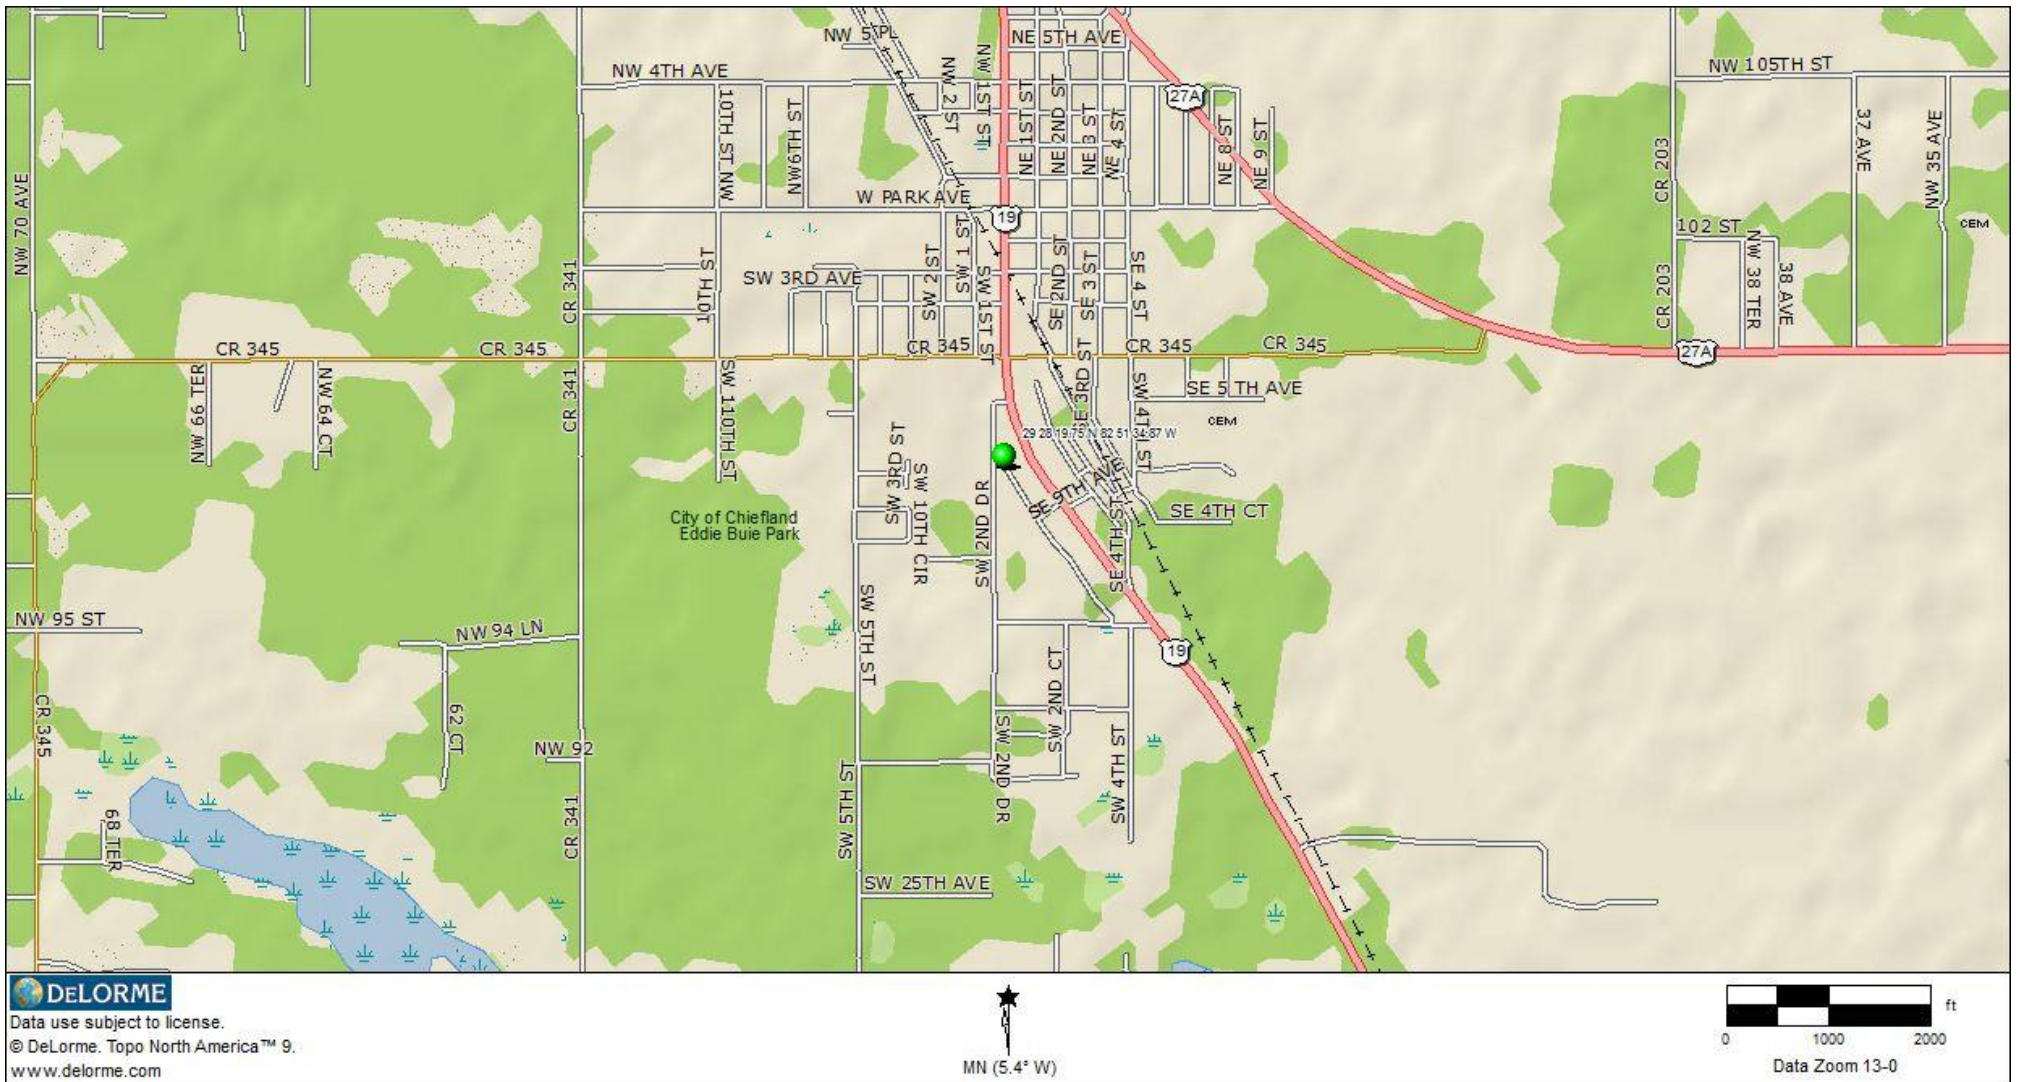
Figure 1.2-1 – Topographic Map

The measured site is identified on a portion of a topographic map shown in Figure 1.2-1. An aerial photo of the site location is shown in Figure 1.2-2. A photo of the measurement using a GPS is shown in Figure 1.2-3.

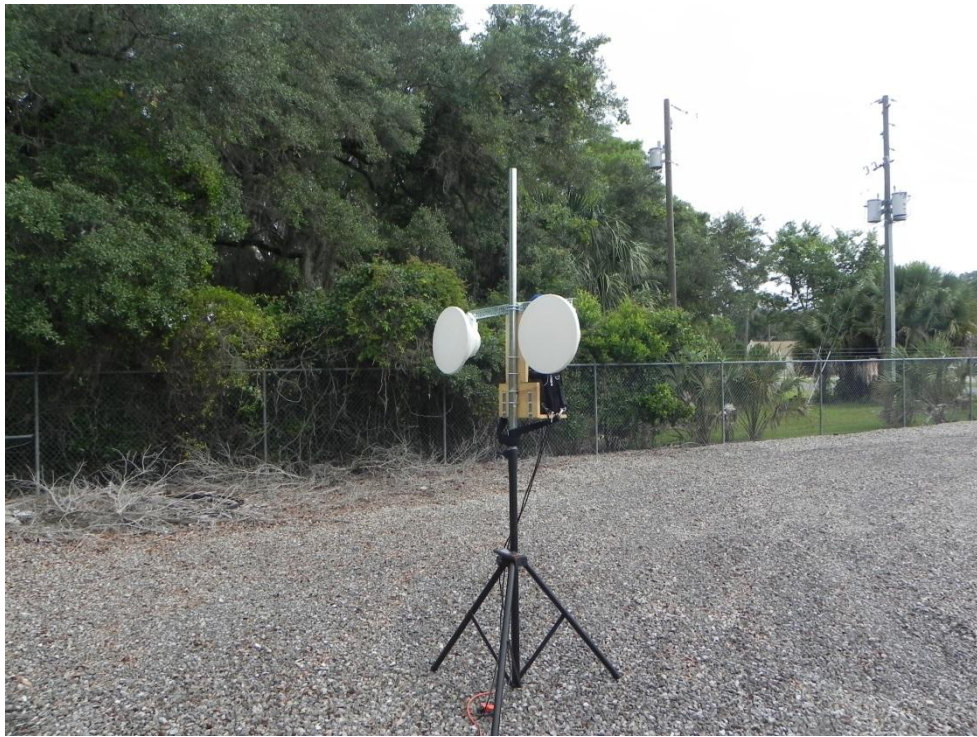
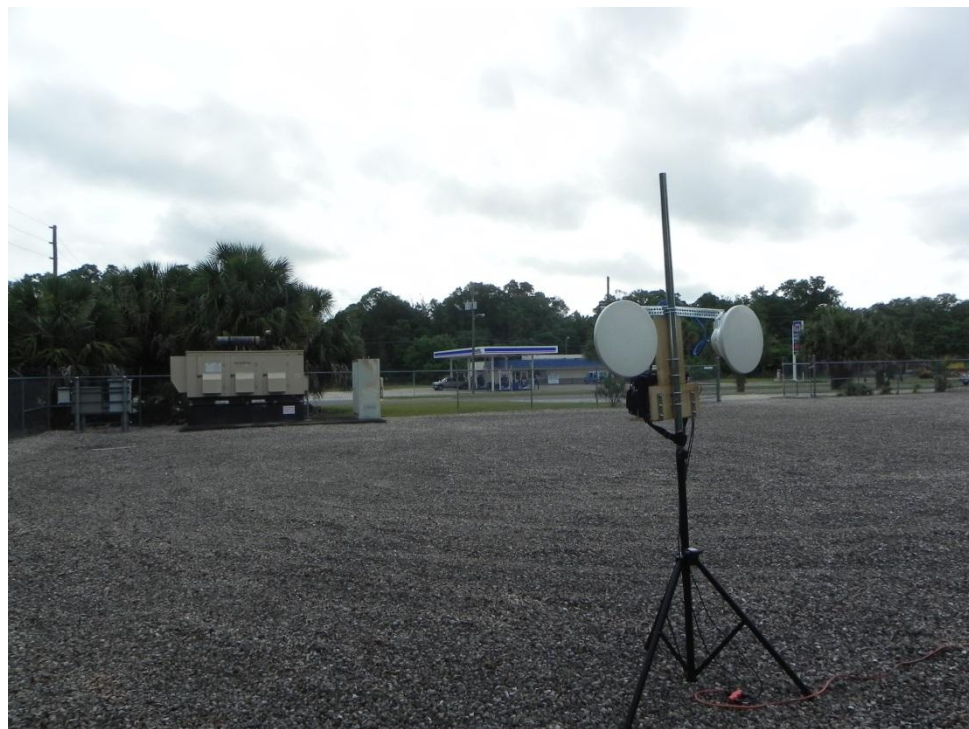
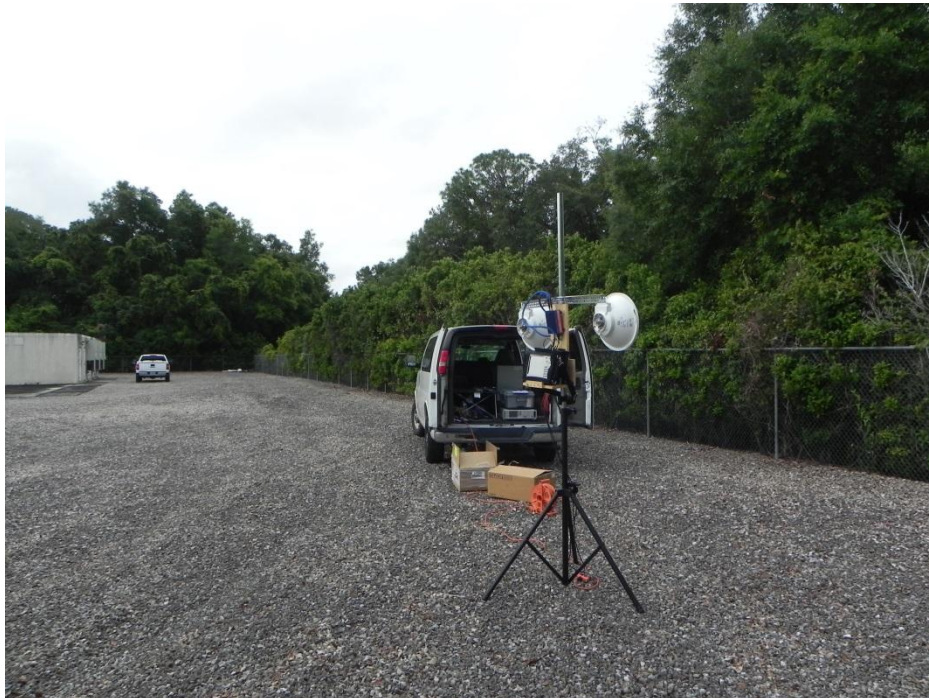
Figure 3.1-1 Earth Station Site Photographs

- Table 3.1-1 presents a site data sheet including all pertinent site information.
- Figures 3.1-1 and 3.1-2 are the photographs depicting the existing earth station site and satellite arc.
- Figures 3.1-3 through 3.1-10 are the RF spectrum photographs depicting the interference environment at the test site.

There is no potential satellite arc blockage at this site. Final arc clearance will depend on antenna placement.

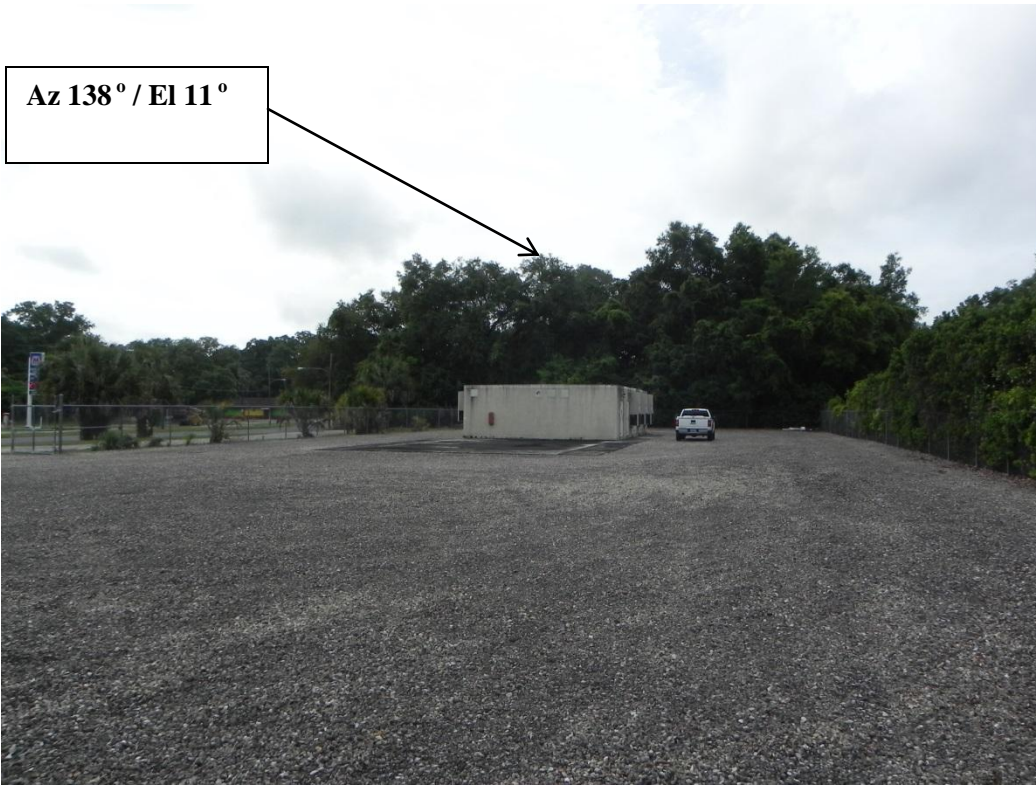
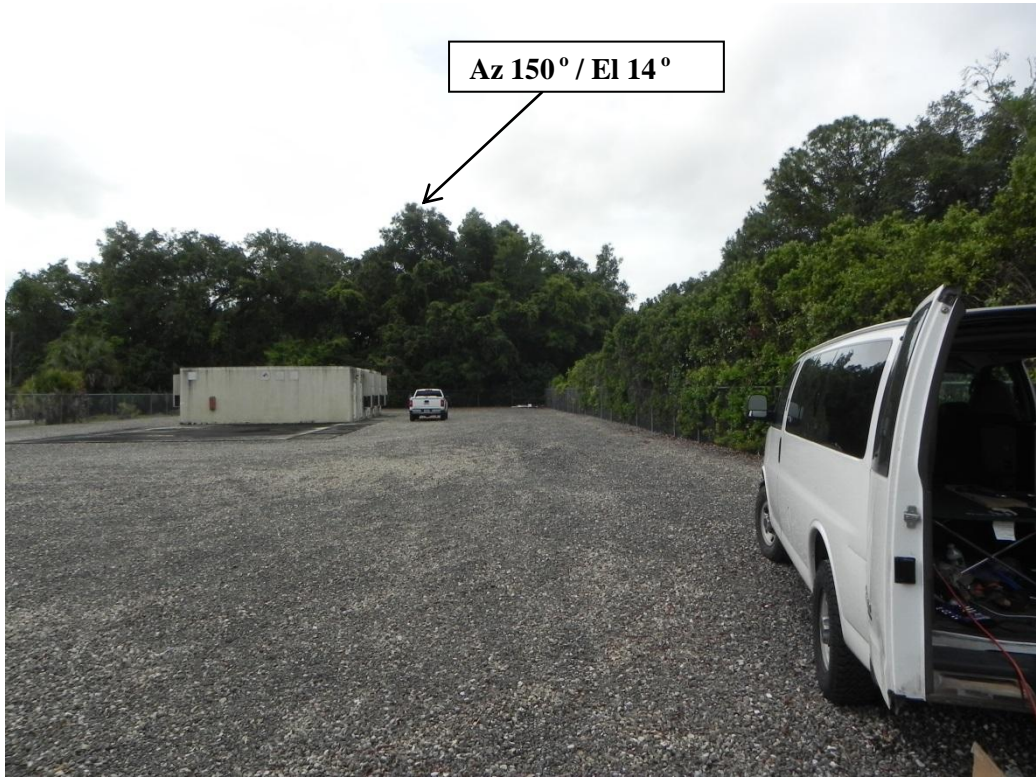
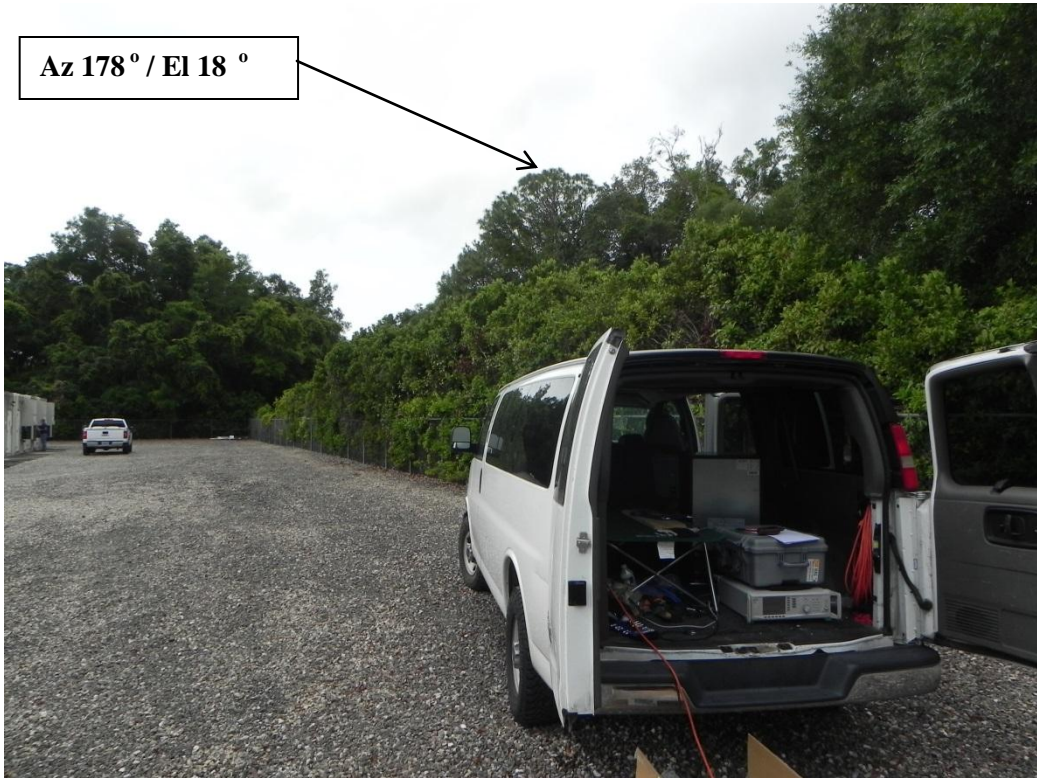
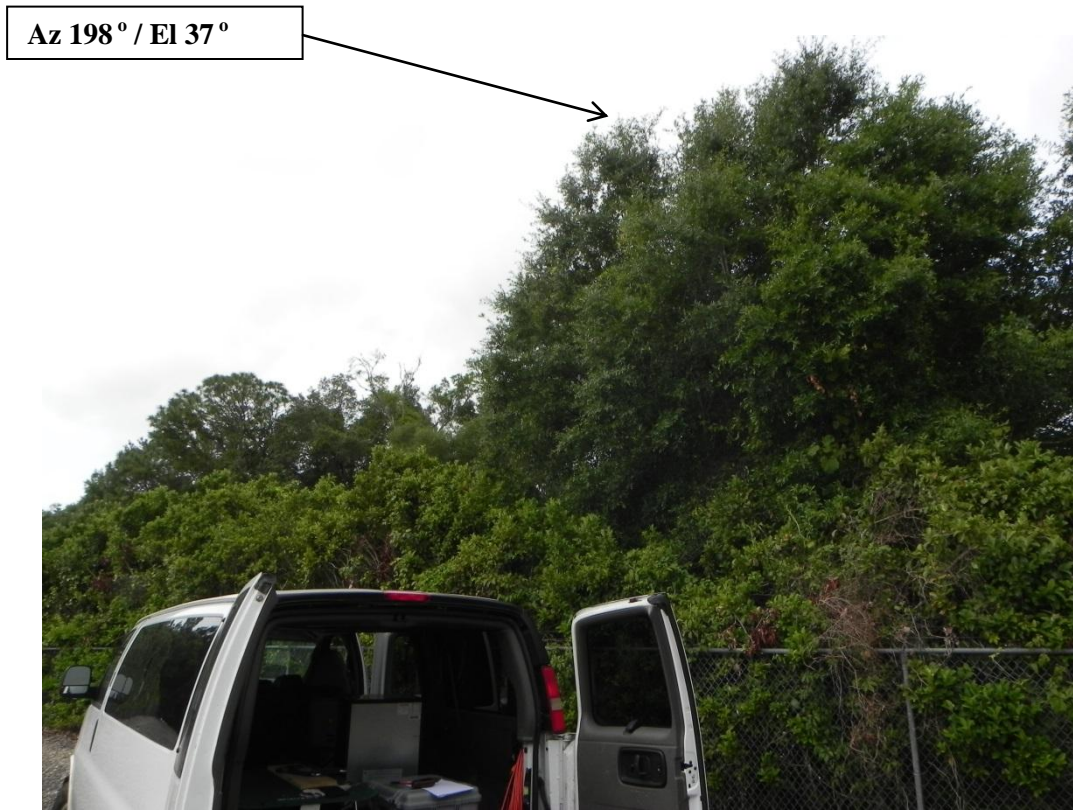
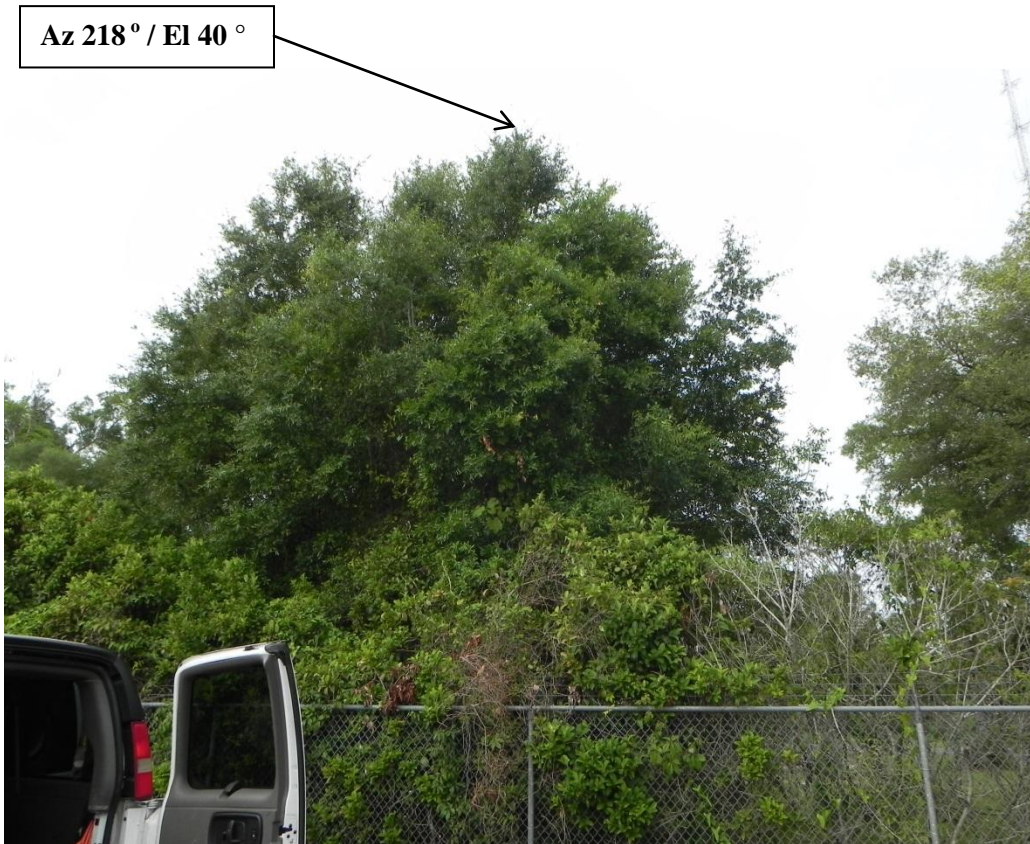
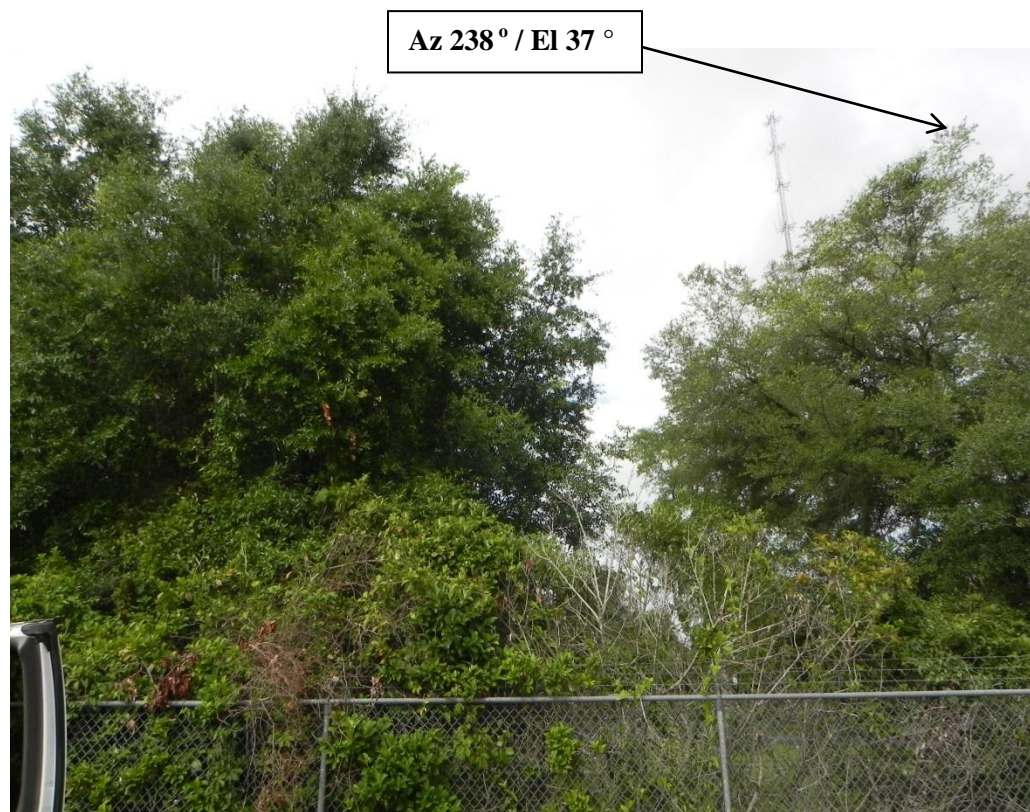
Figure 3.1-2 Horizon Photographs of Earth Station Site

The satellite arc has minimal potential blockage from 55° W through 115° W. The potential blockage is only from azimuths of 198° - 238° in the form of trees that are currently measured at an elevation of 37° - 40° .
