MICROWAVE PATH SURVEY REPORT

RADIO FREQUENCY INTERFERENCE (RFI) MEASUREMENT REPORT

ViaSat

Hammonton, NJ

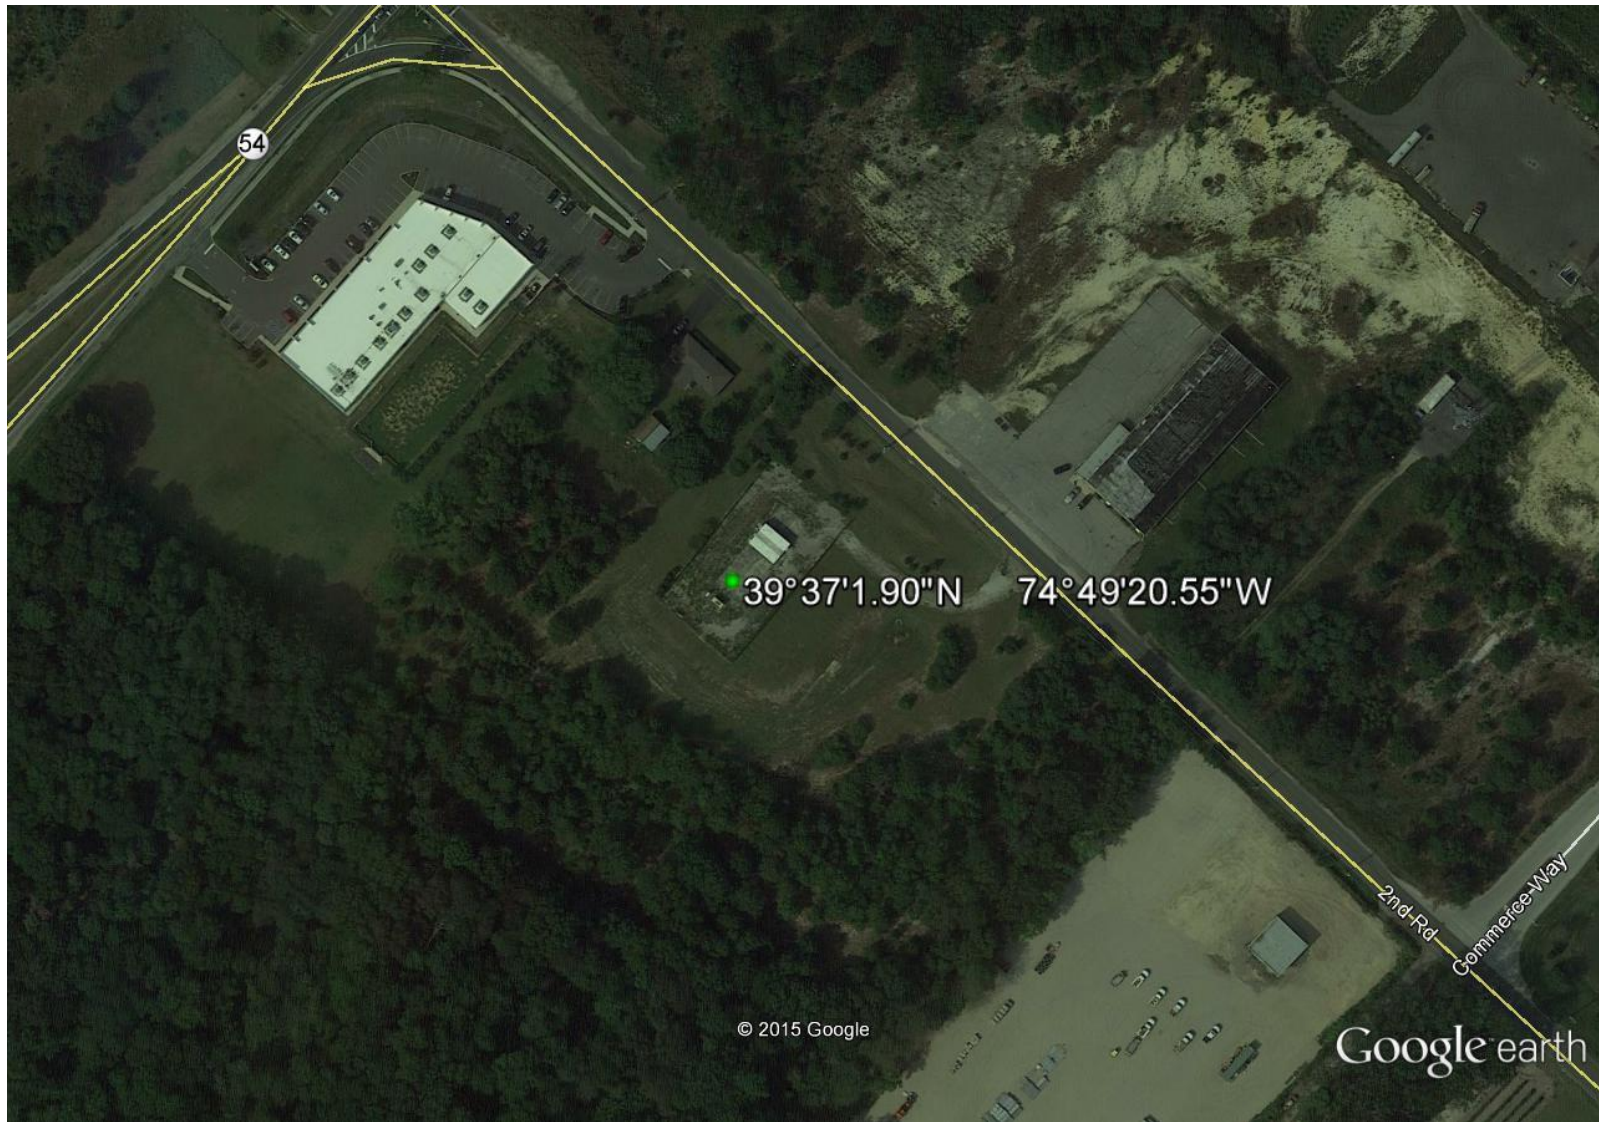
Figure 1.2-2 – Aerial Photograph

The measured site is identified on a portion of a topographic map shown in Figure 1.2-1. An aerial photo of the site location is shown in Figure 1.2-2. A photo of the measurement using a GPS is shown in Figure 1.2-3.

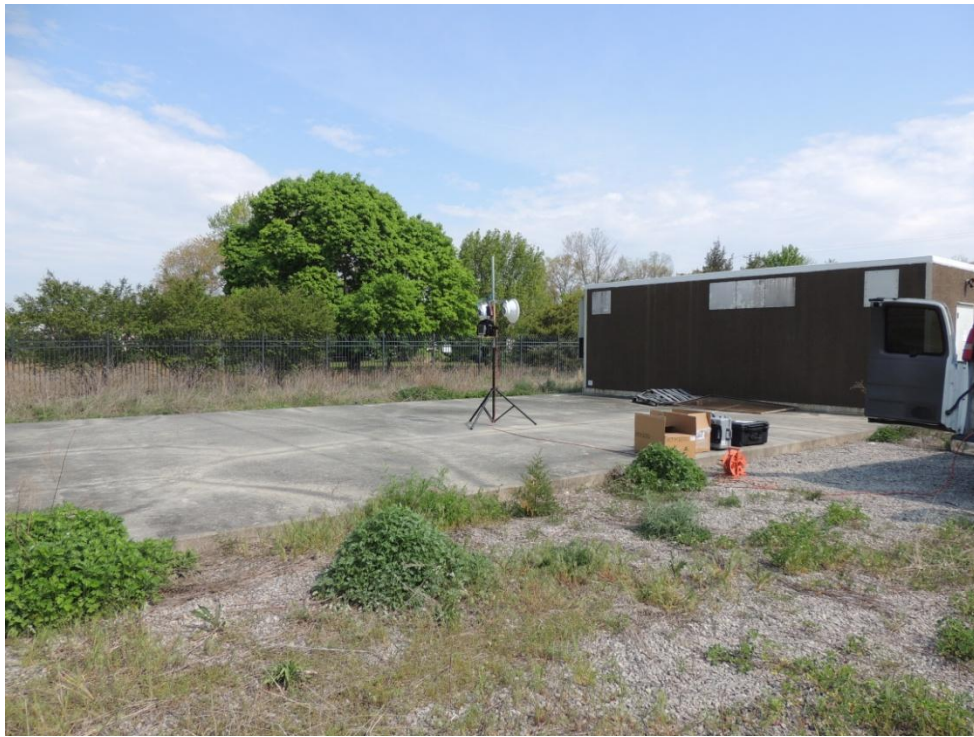
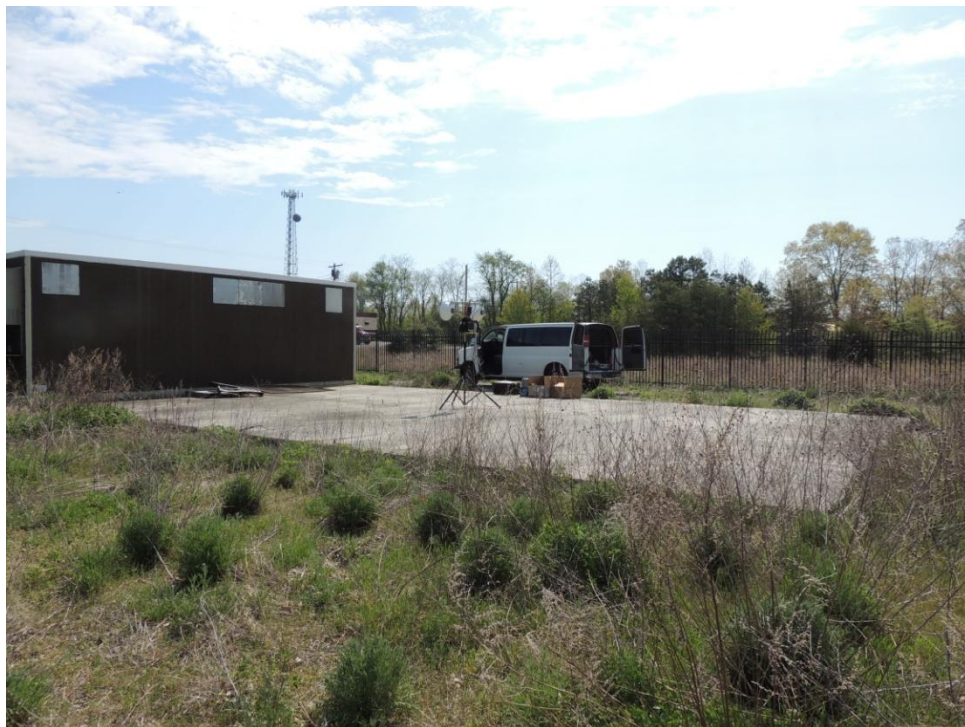
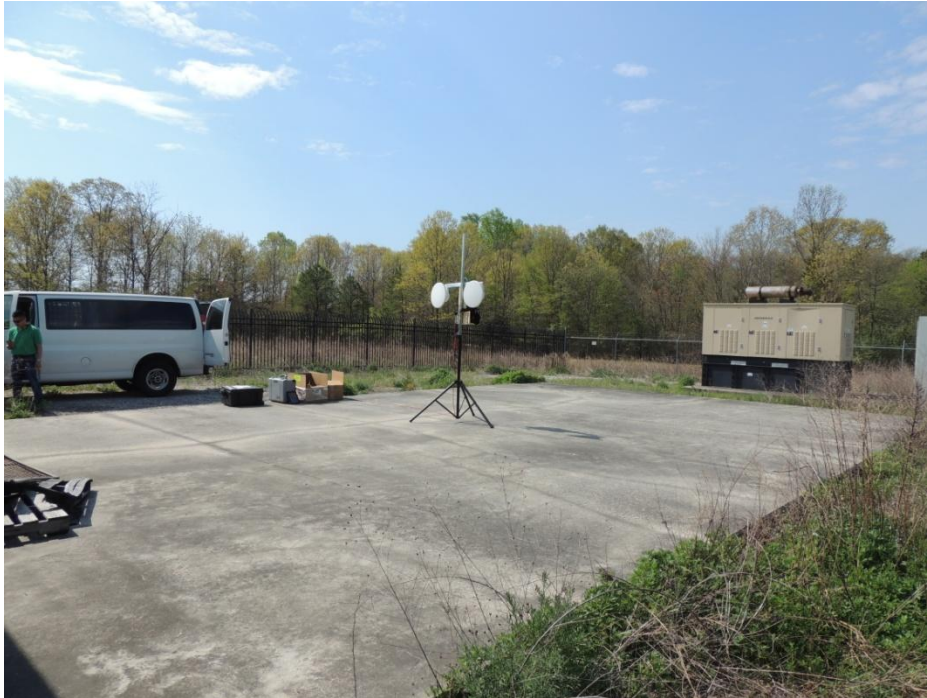
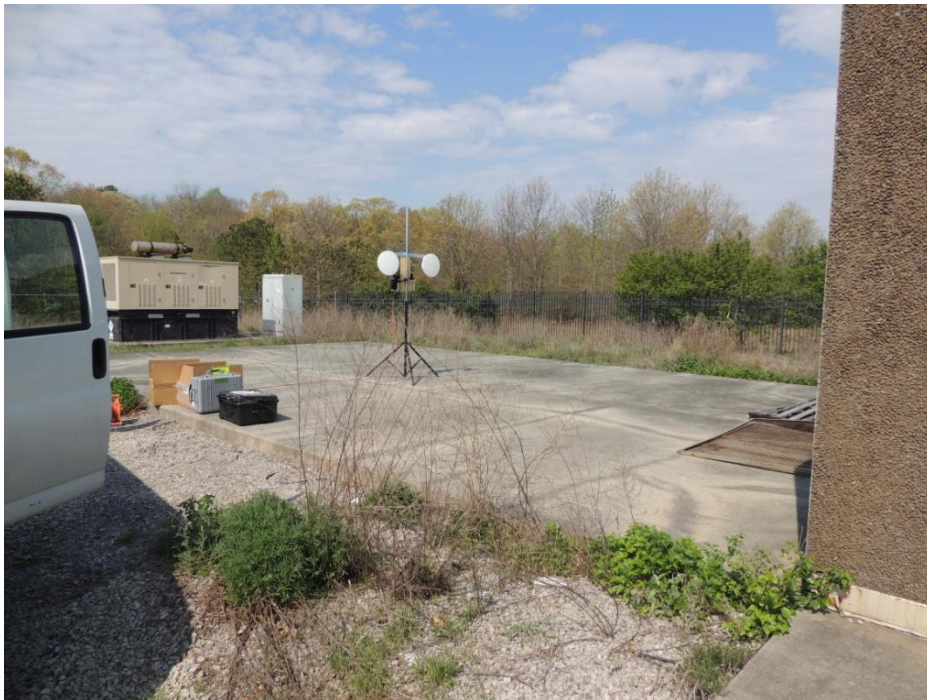
Figure 3.1-1 Earth Station Site Photographs

- Table 3.1-1 presents a site data sheet including all pertinent site information.
- Figures 3.1-1 and 3.1-2 are the photographs depicting the existing earth station site and satellite arc.
- Figures 3.1-3 through 3.1-10 are the RF spectrum photographs depicting the interference environment at the test site.

| 8. GEOSTATIONARY ARC VISIBILITY: | Satellite arc has no blockage at this time |

There is no potential satellite arc blockage at this site. Final arc clearance will depend on antenna placement.

The satellite arc has no potential blockage from 55W through 115W.
