MICROWAVE PATH SURVEY REPORT

RADIO FREQUENCY INTERFERENCE (RFI) MEASUREMENT REPORT

ViaSat

Transmit and Receive Earth Station
17-21 GHz and 27-31 GHz

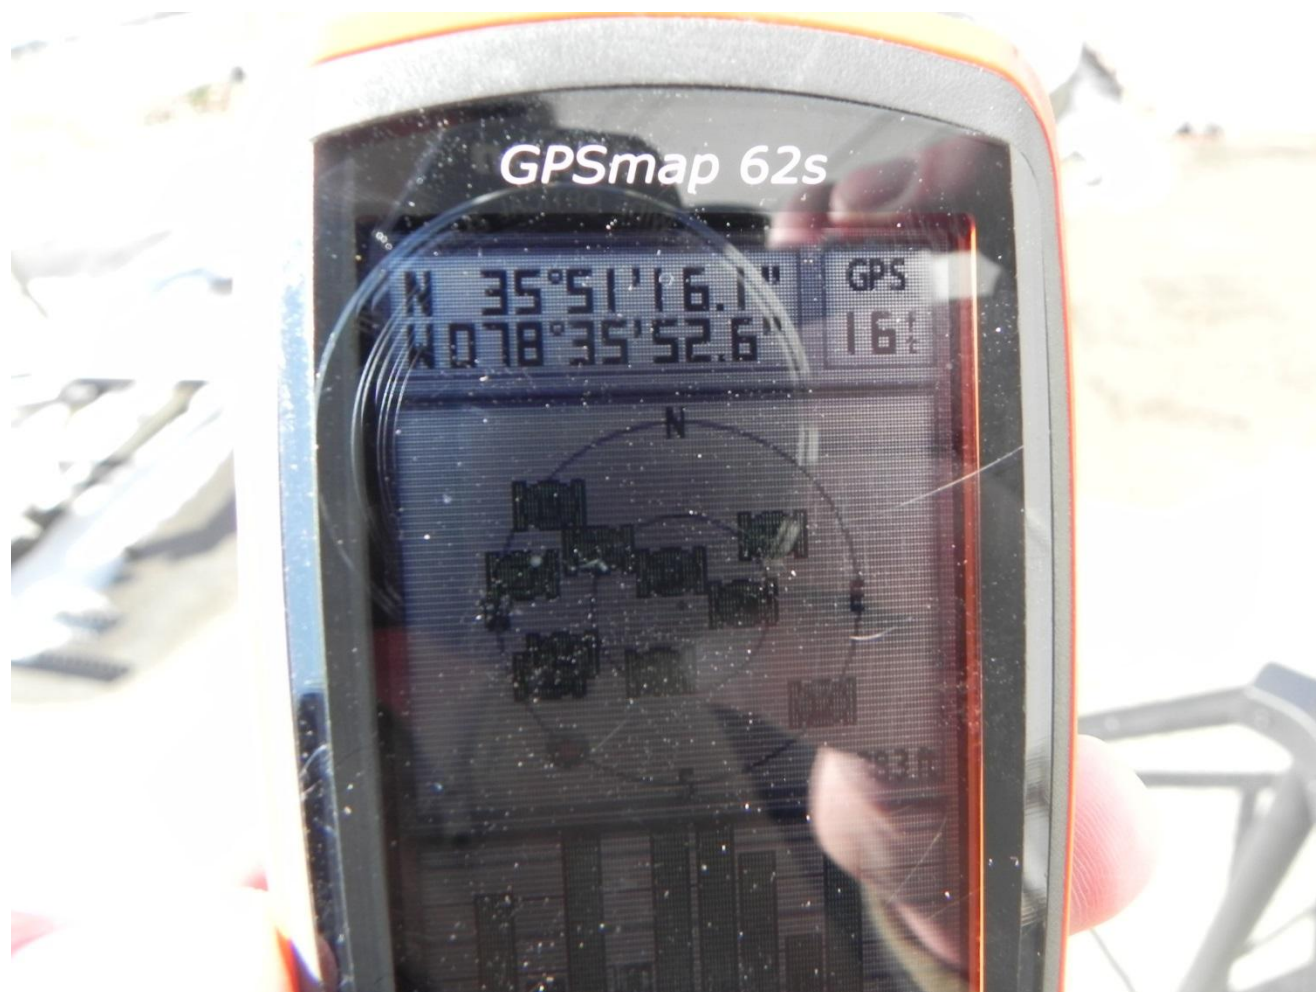
Figure 1.2-3 – GPS Photograph

The measured site is identified on a portion of a topographic map shown in Figure 1.2-1. An aerial photo of the site location is shown in Figure 1.2-2. A photo of the measurement using a GPS is shown in Figure 1.2-3.

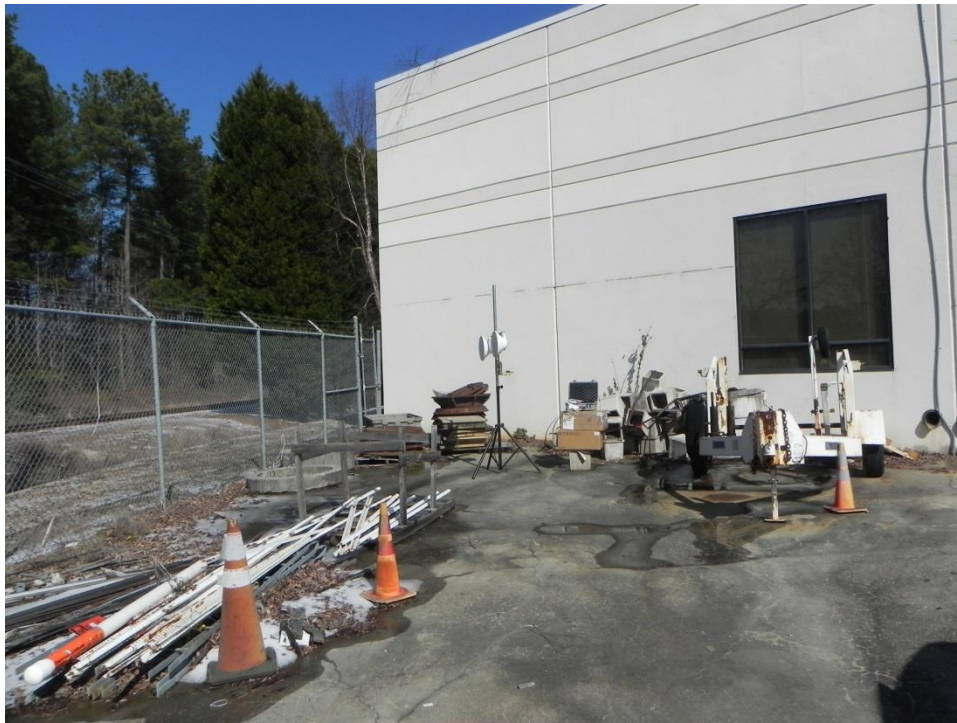
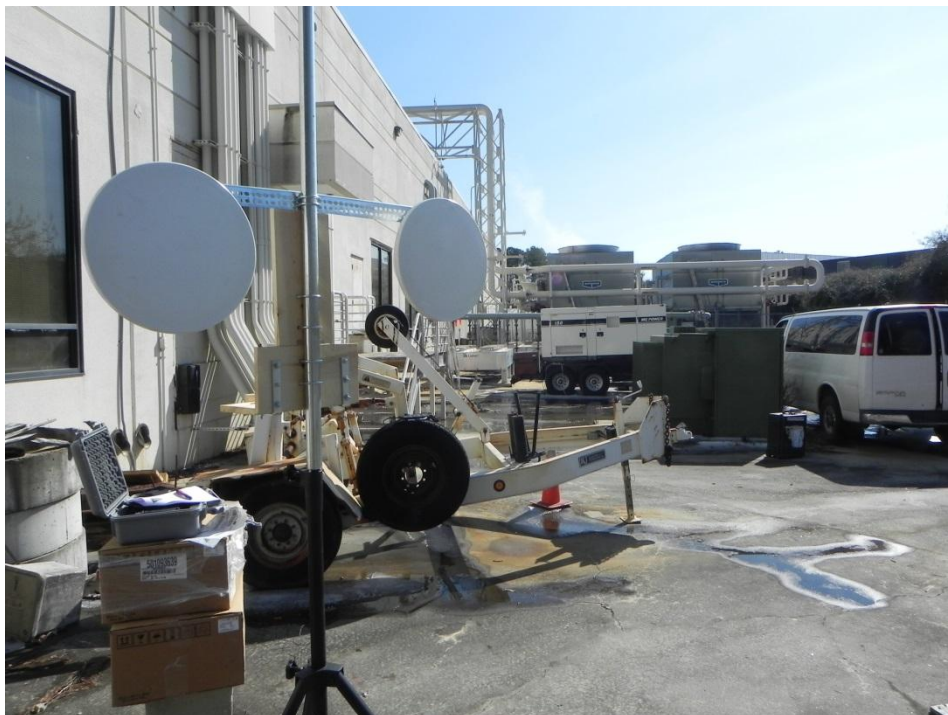
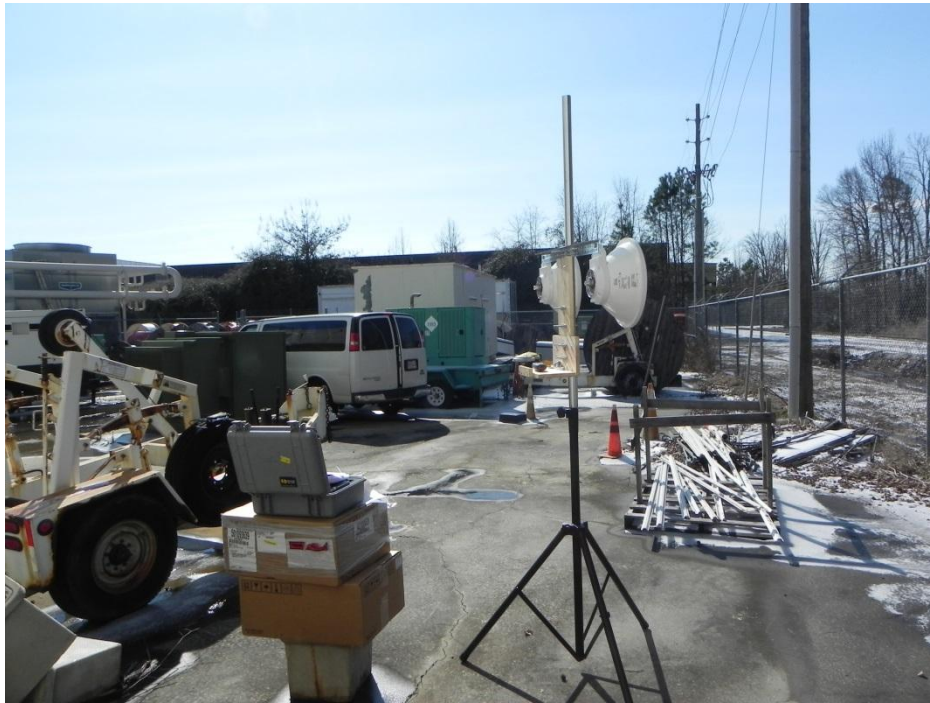
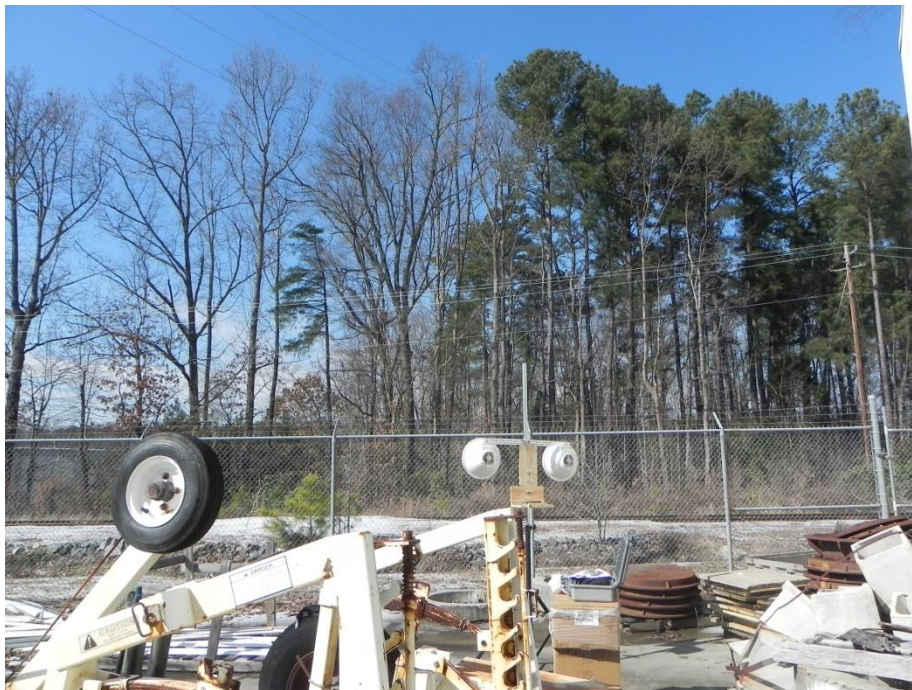
Figure 3.1-1 Earth Station Site Photographs

- Table 3.1-1 presents a site data sheet including all pertinent site information.
- Figures 3.1-1 and 3.1-2 are the photographs depicting the existing earth station site and satellite arc.
- Figures 3.1-3 through 3.1-10 are the RF spectrum photographs depicting the interference environment at the test site.

| 8. GEOSTATIONARY ARC VISIBILITY: | Satellite arc has no blockage at this time |

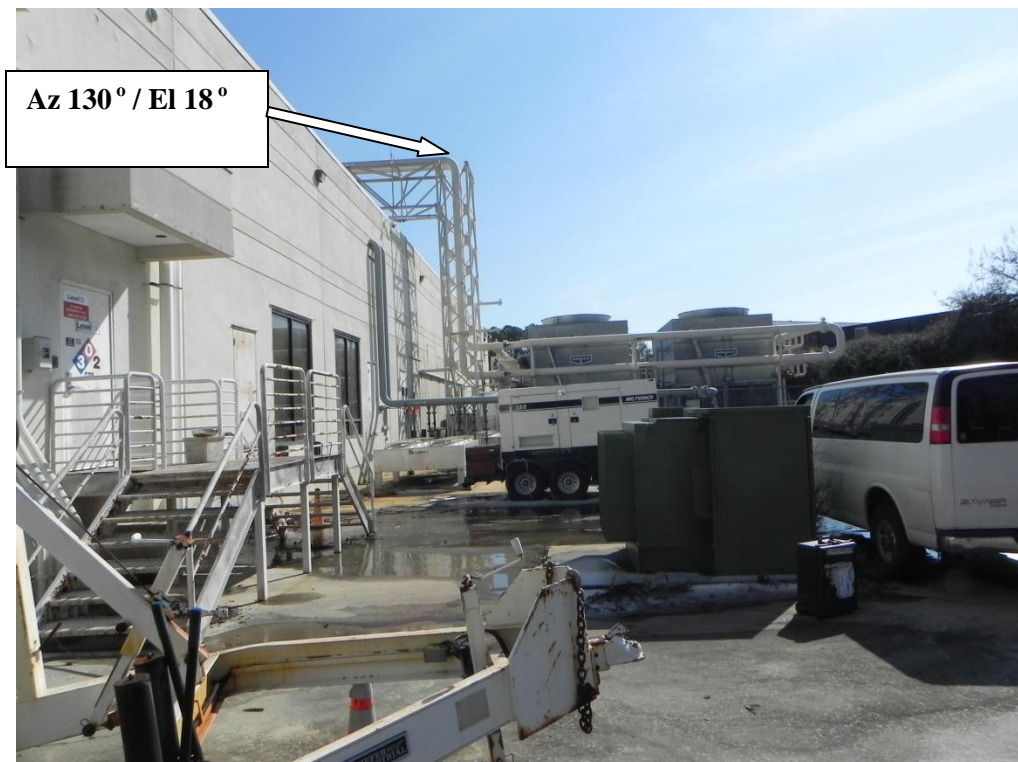
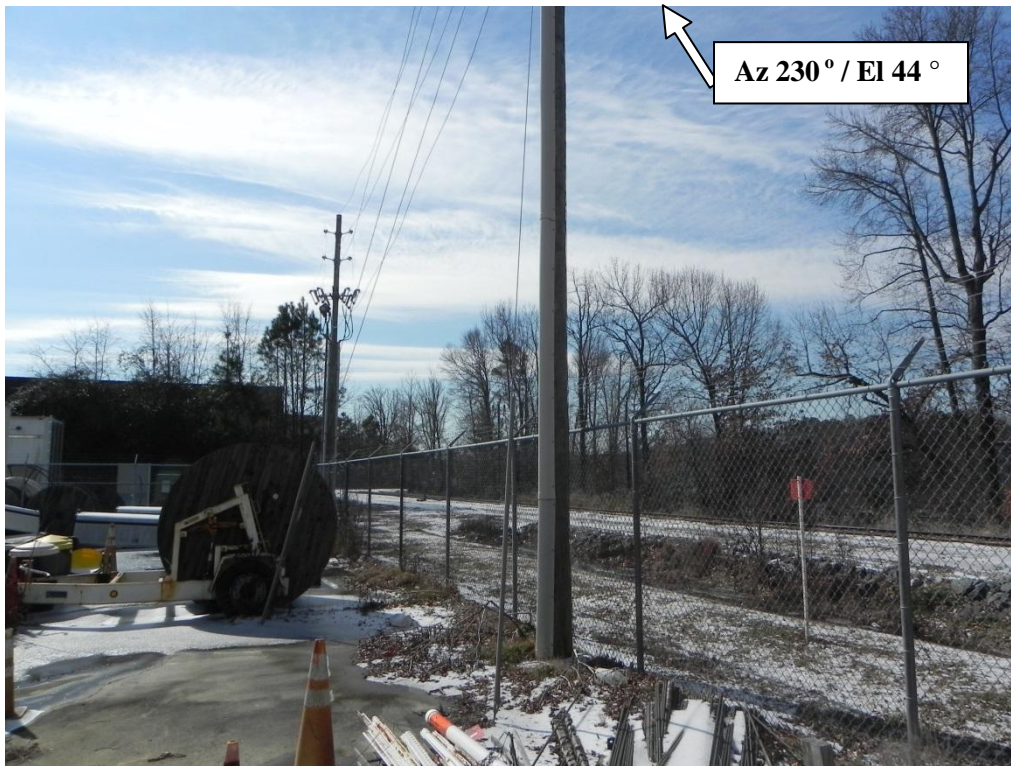
Figure 3.1-2 Horizon Photographs of Earth Station Site

There is no potential satellite arc blockage at this site. Final arc clearance will depend on antenna placement.

The satellite arc has no potential blockage from 55W through 115W.
