MICROWAVE PATH SURVEY REPORT

RADIO FREQUENCY INTERFERENCE (RFI) MEASUREMENT REPORT

ViaSat

Transmit and Receive Earth Station
17-21 GHz and 27-31 GHz

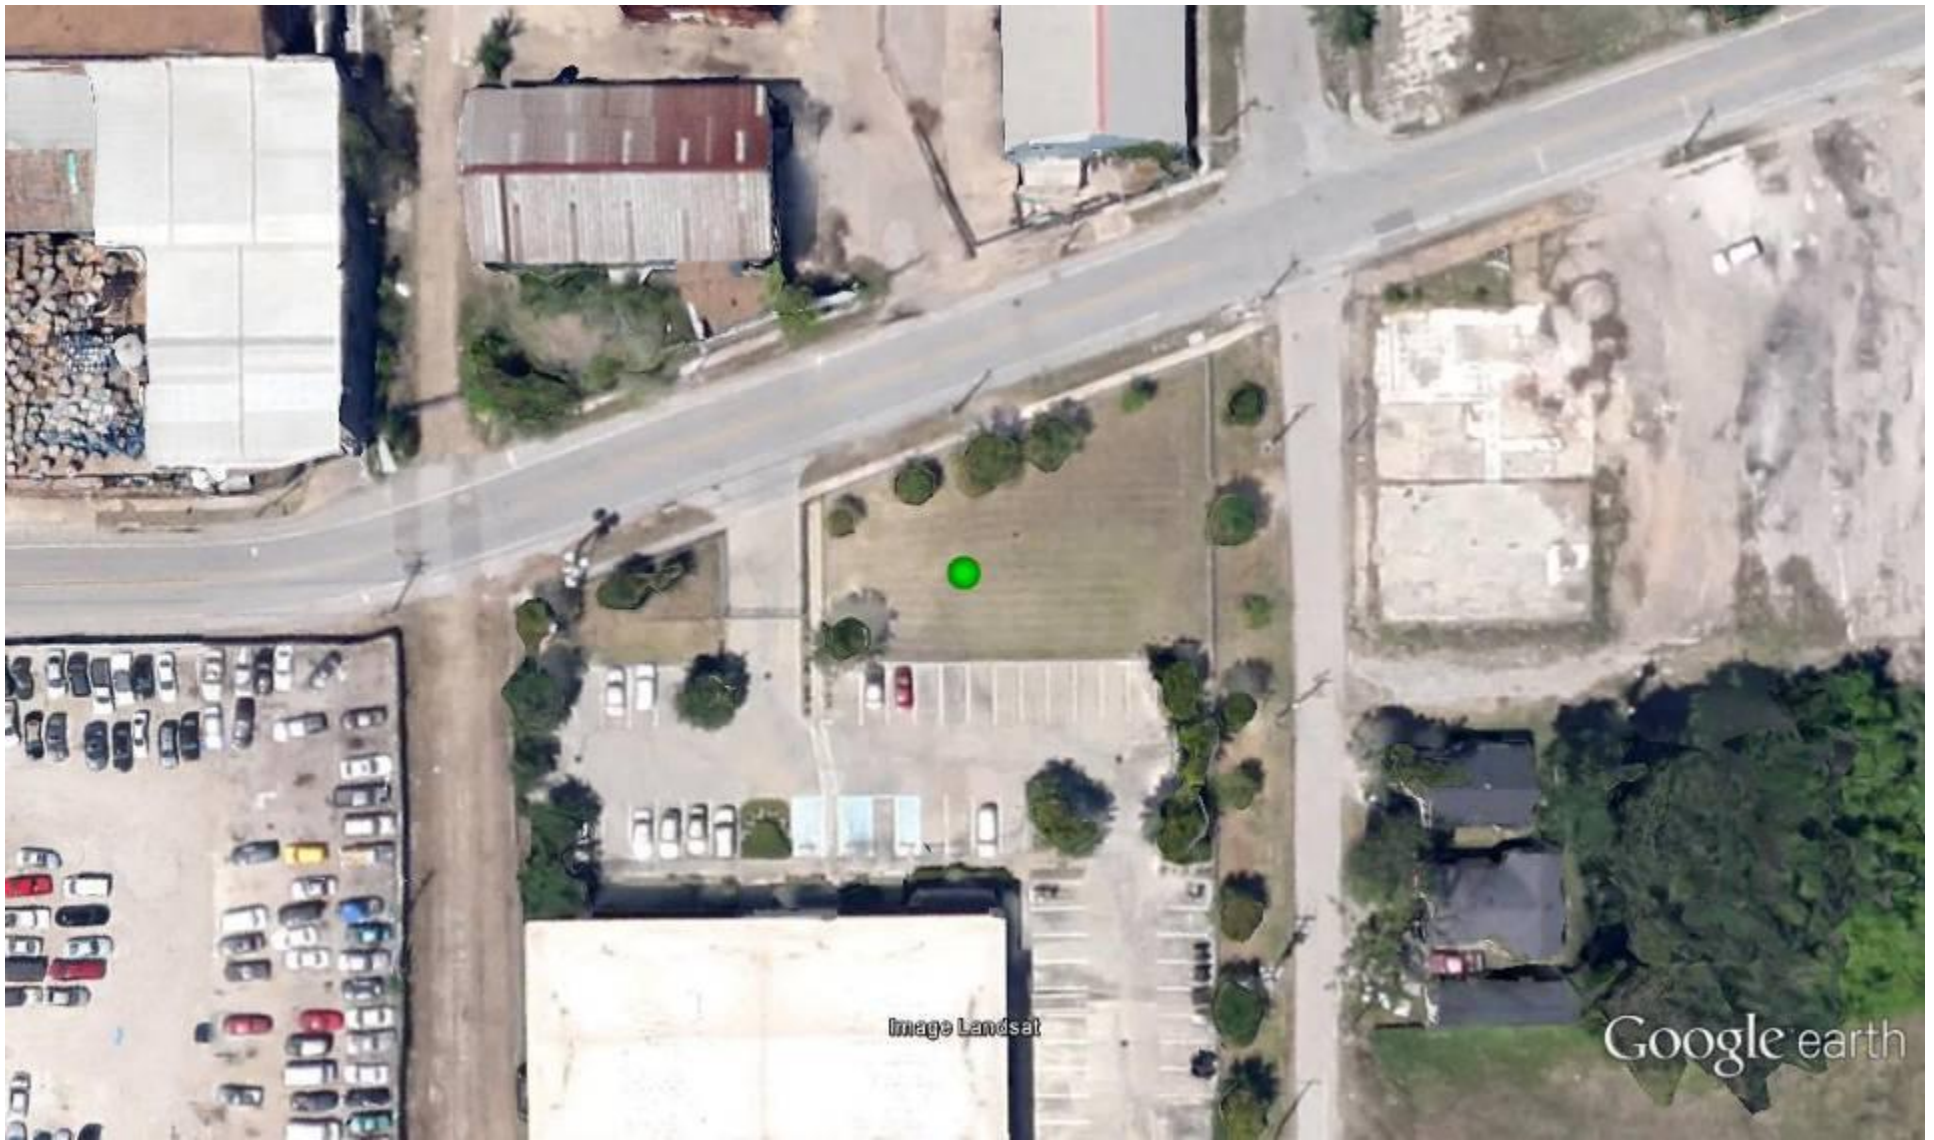
Figure 1.2-2 – Aerial Photograph

The measured site is identified on a portion of a topographic map shown in Figure 1.2-1. An aerial photo of the site location is shown in Figure 1.2-2. A photo of the measurement using a GPS is shown in Figure 1.2-3.

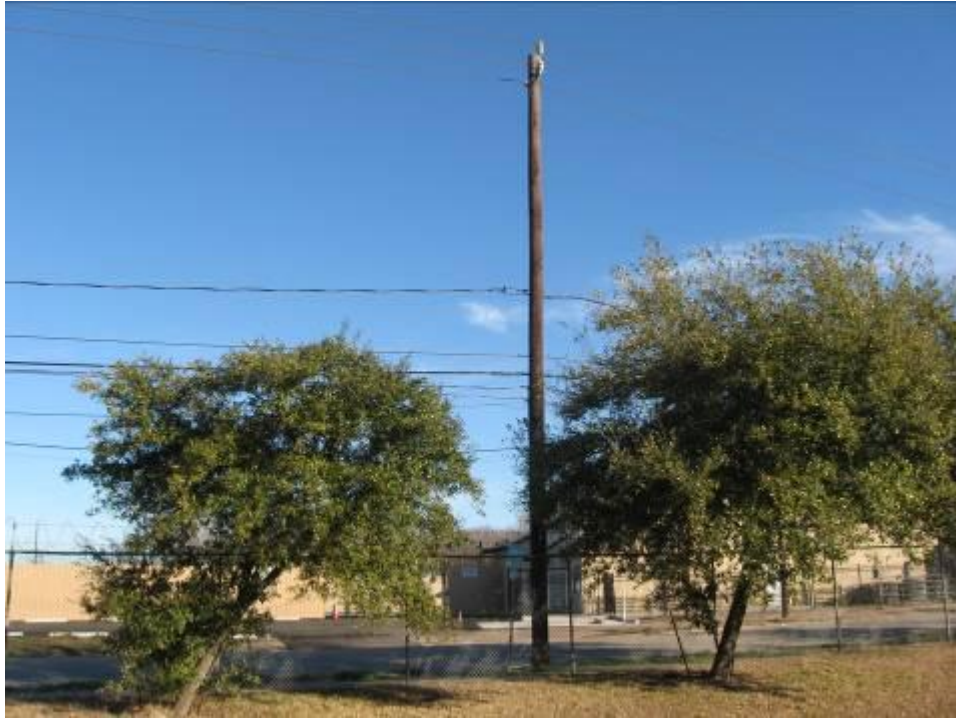
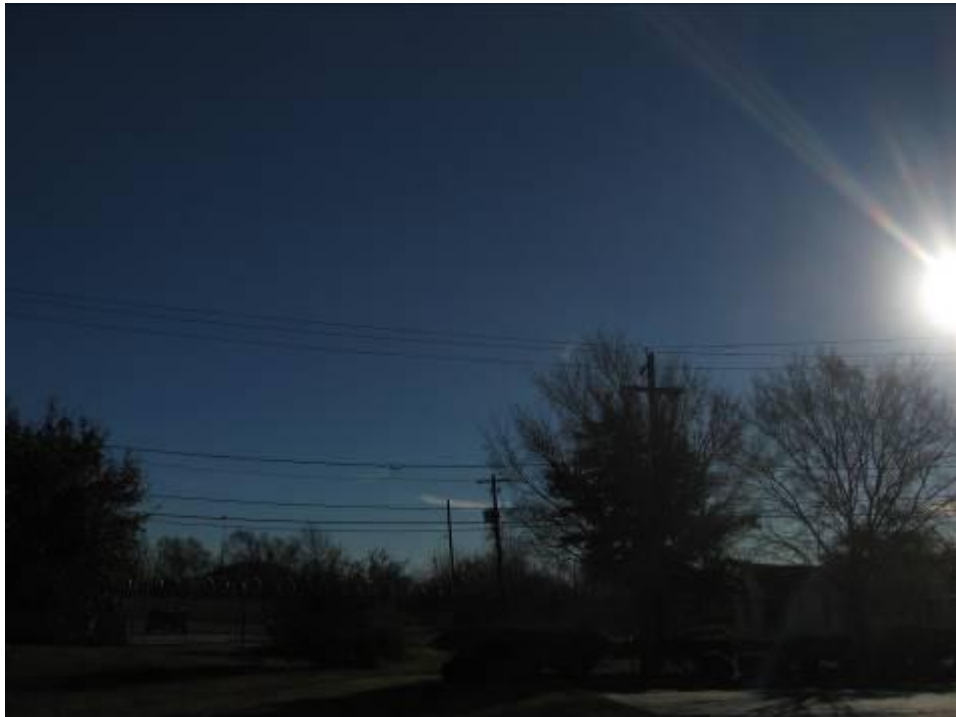
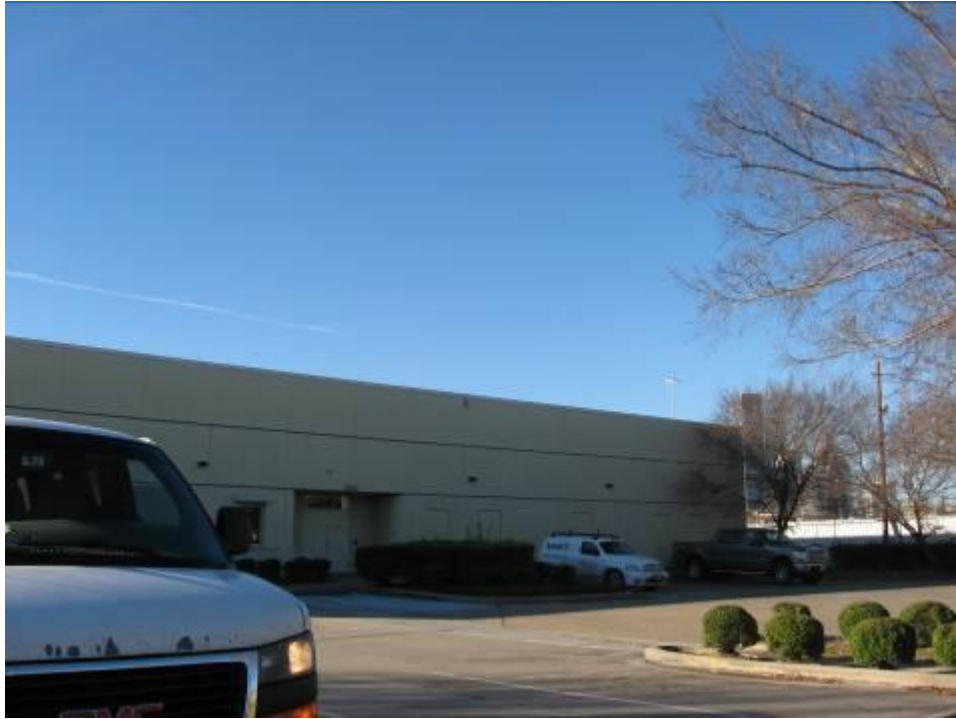
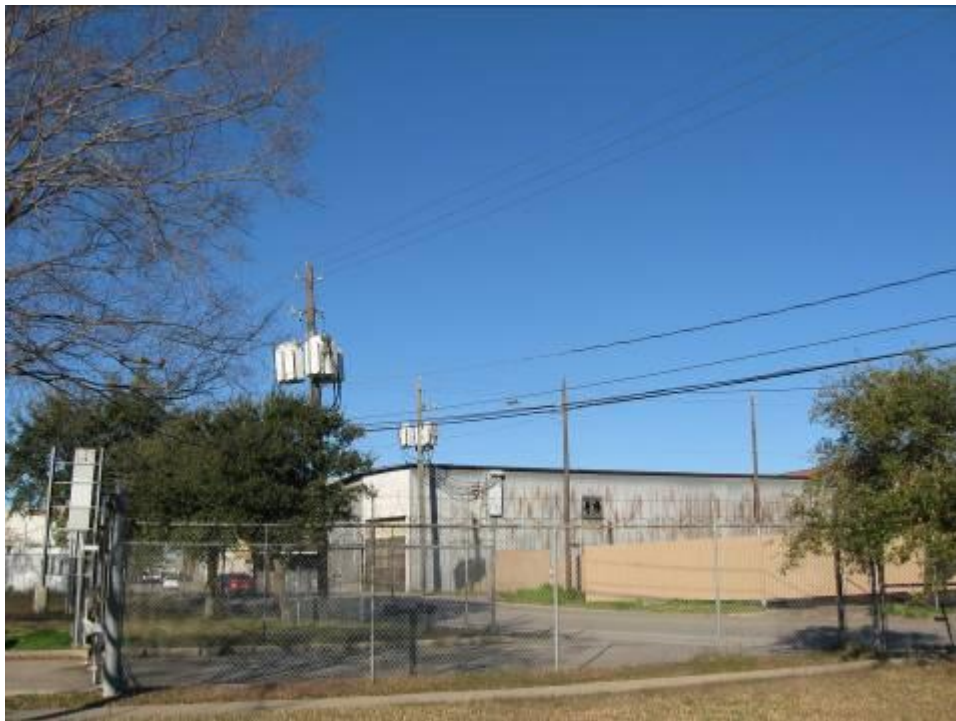
Figure 3.1-1 Earth Station Site Photographs

- Table 3.1-1 presents a site data sheet including all pertinent site information.
- Figures 3.1-1 and 3.1-2 are the photographs depicting the existing earth station site and satellite arc.
- Figures 3.1-3 through 3.1-10 are the RF spectrum photographs depicting the interference environment at the test site.

| 8. GEOSTATIONARY ARC VISIBILITY: | Satellite arc has no blockage at this time |

The satellite arc has no potential blockage from 55W through 115W.

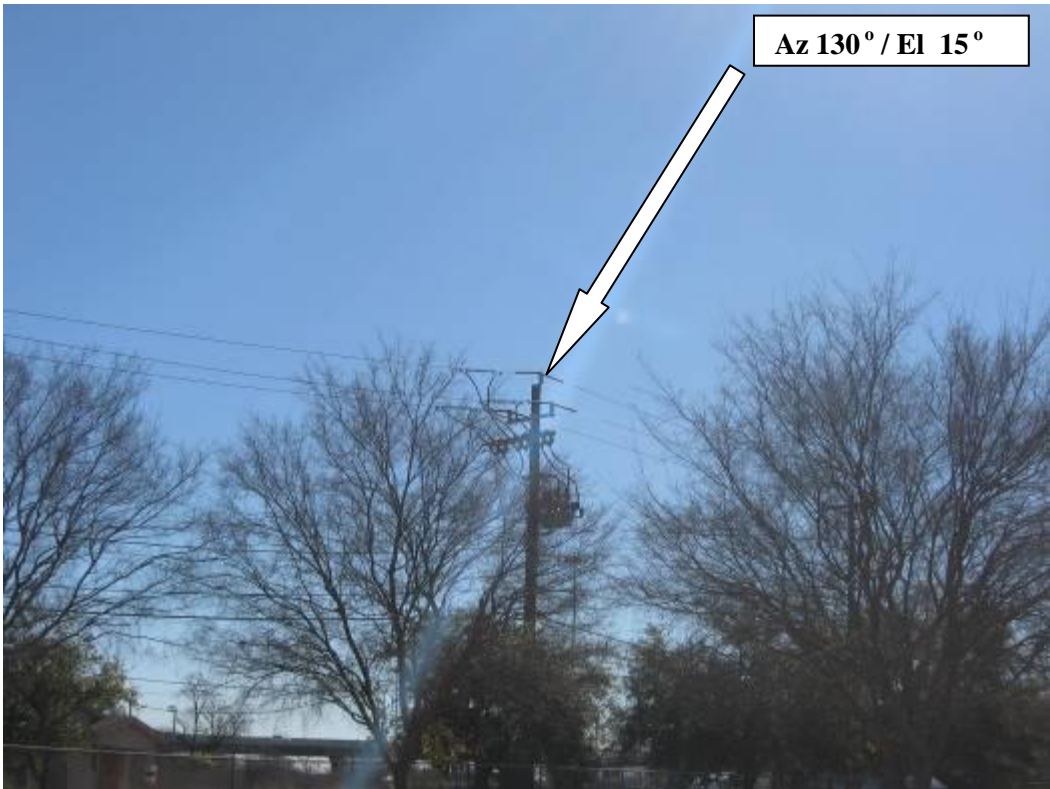
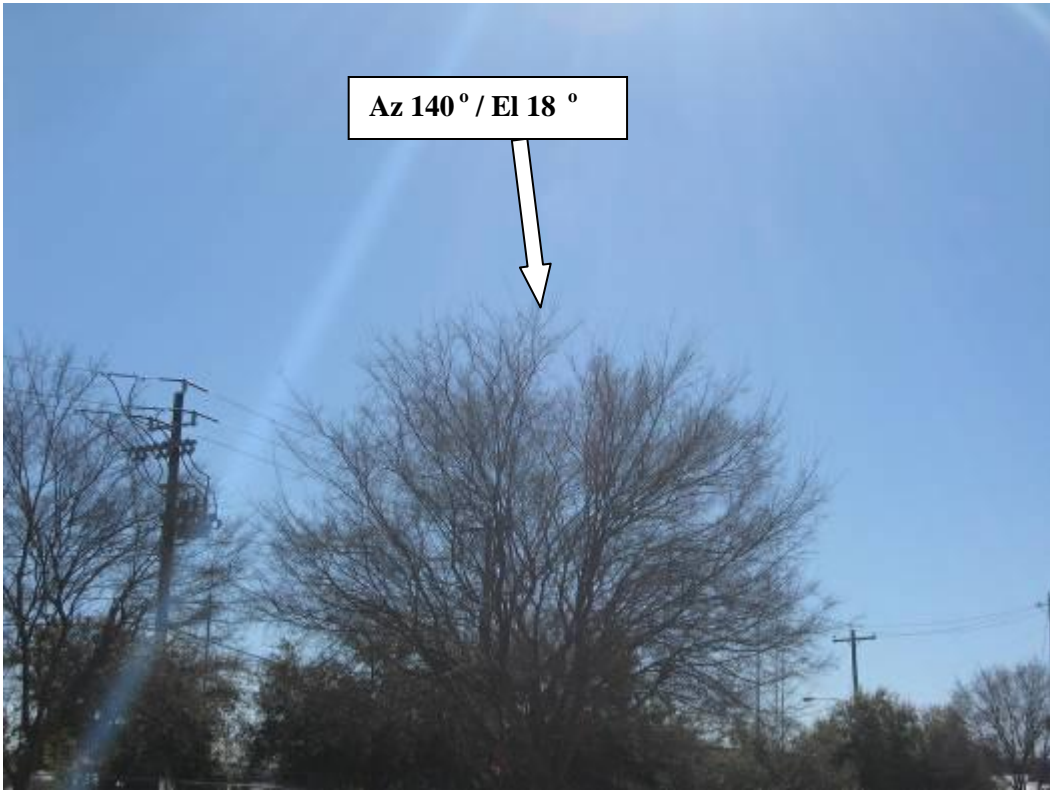
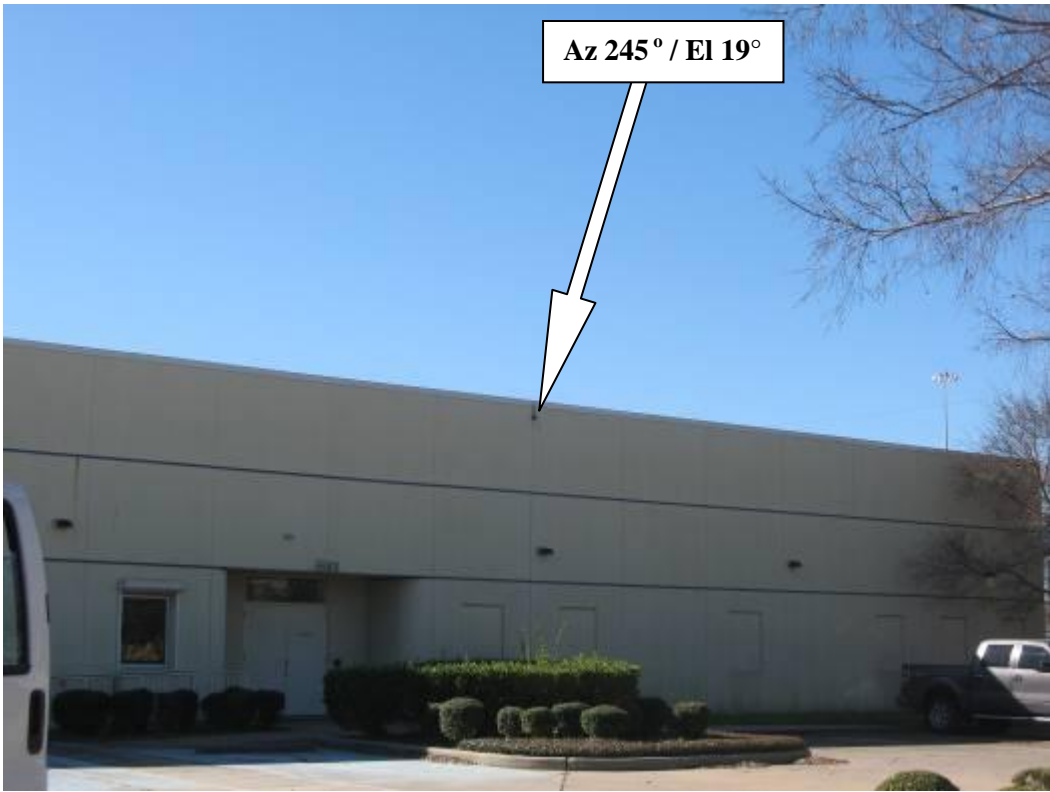
Figure 3.1-2 Horizon Photographs of Earth Station Site

There is no potential satellite arc blockage at this site. Final arc clearance will depend on antenna placement.
