MICROWAVE PATH SURVEY REPORT

RADIO FREQUENCY INTERFERENCE (RFI) MEASUREMENT REPORT

ViaSat

Transmit and Receive Earth Station
17-21 GHz and 27-31 GHz

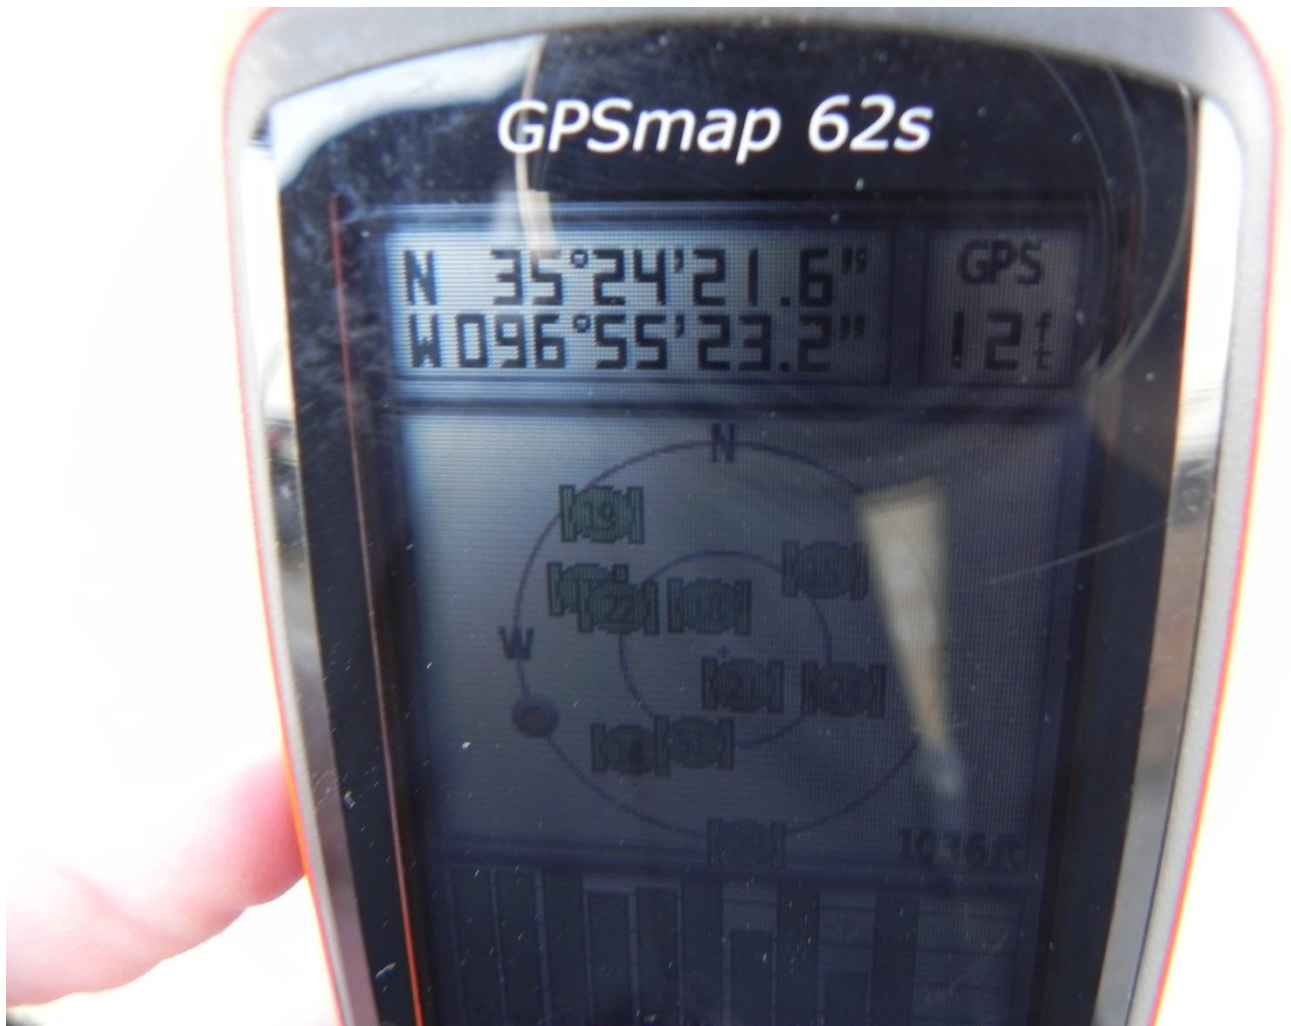
Figure 1.2-3 – GPS Photograph

The measured site is identified on a portion of a topographic map shown in Figure 1.2-1. An aerial photo of the site location is shown in Figure 1.2-2. A photo of the measurement using a GPS is shown in Figure 1.2-3.

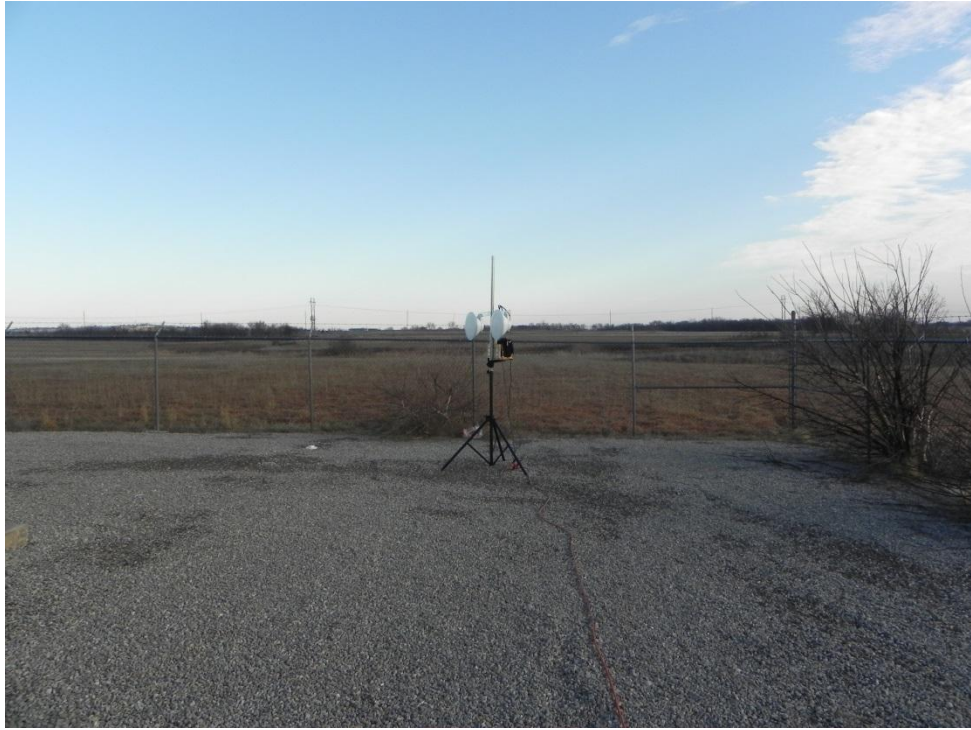
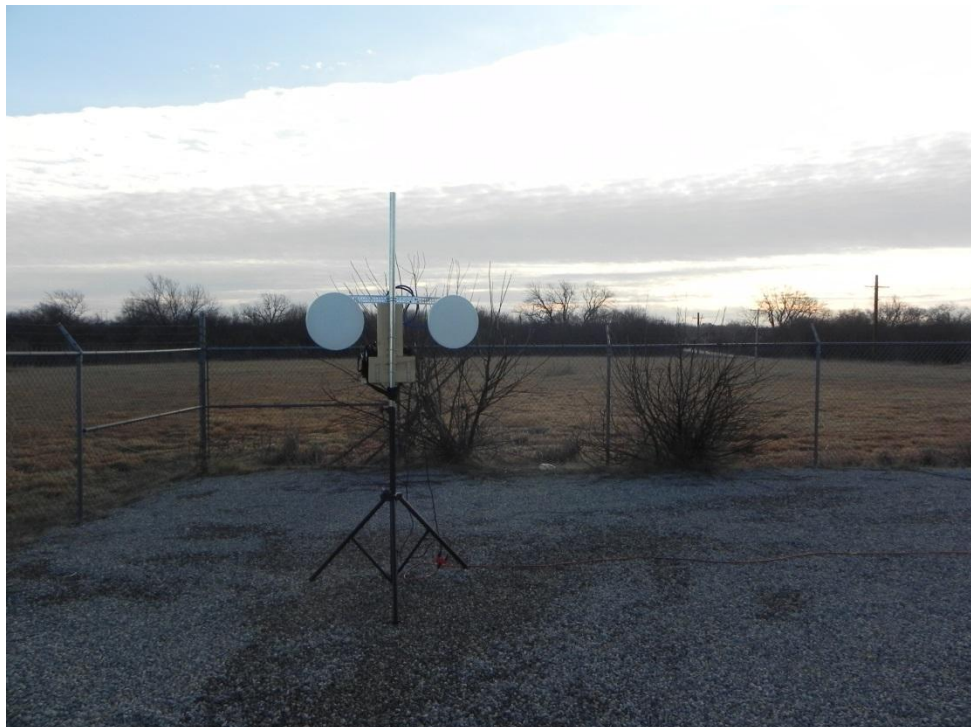
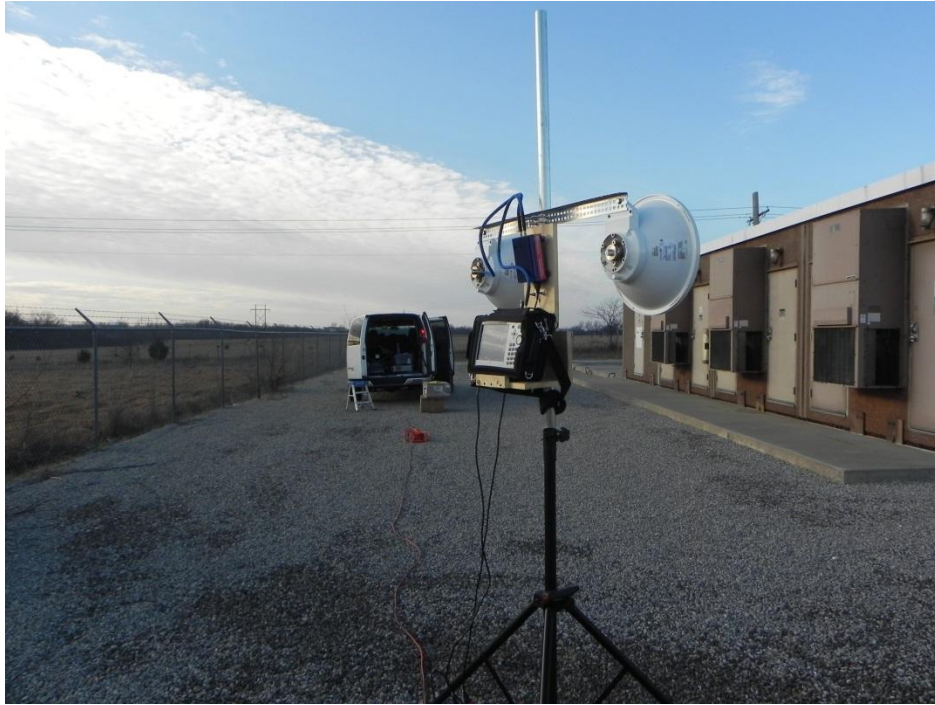
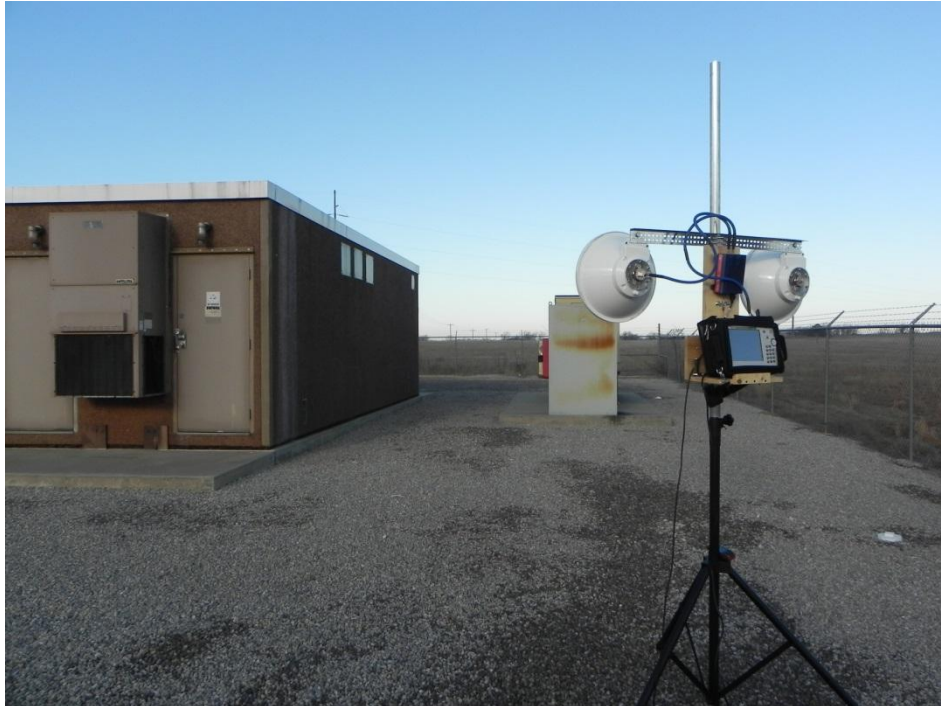
Figure 3.1-1 Earth Station Site Photographs

- Table 3.1-1 presents a site data sheet including all pertinent site information.
- Figures 3.1-1 and 3.1-2 are the photographs depicting the existing earth station site and satellite arc.
- Figures 3.1-3 through 3.1-10 are the RF spectrum photographs depicting the interference environment at the test site.

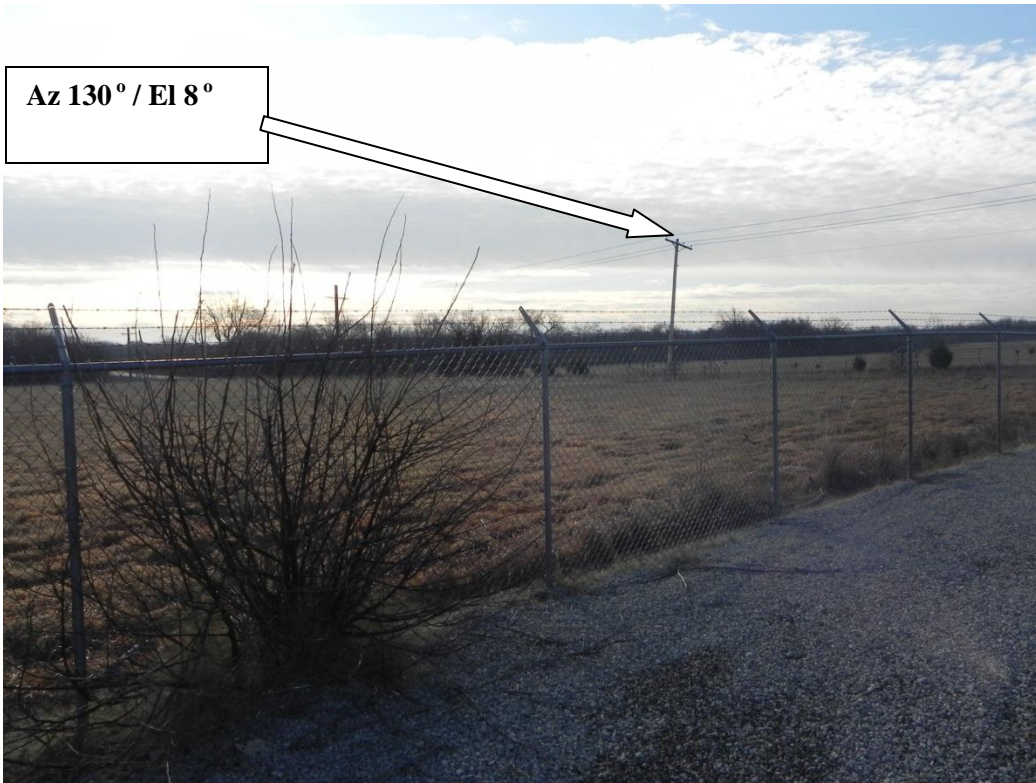
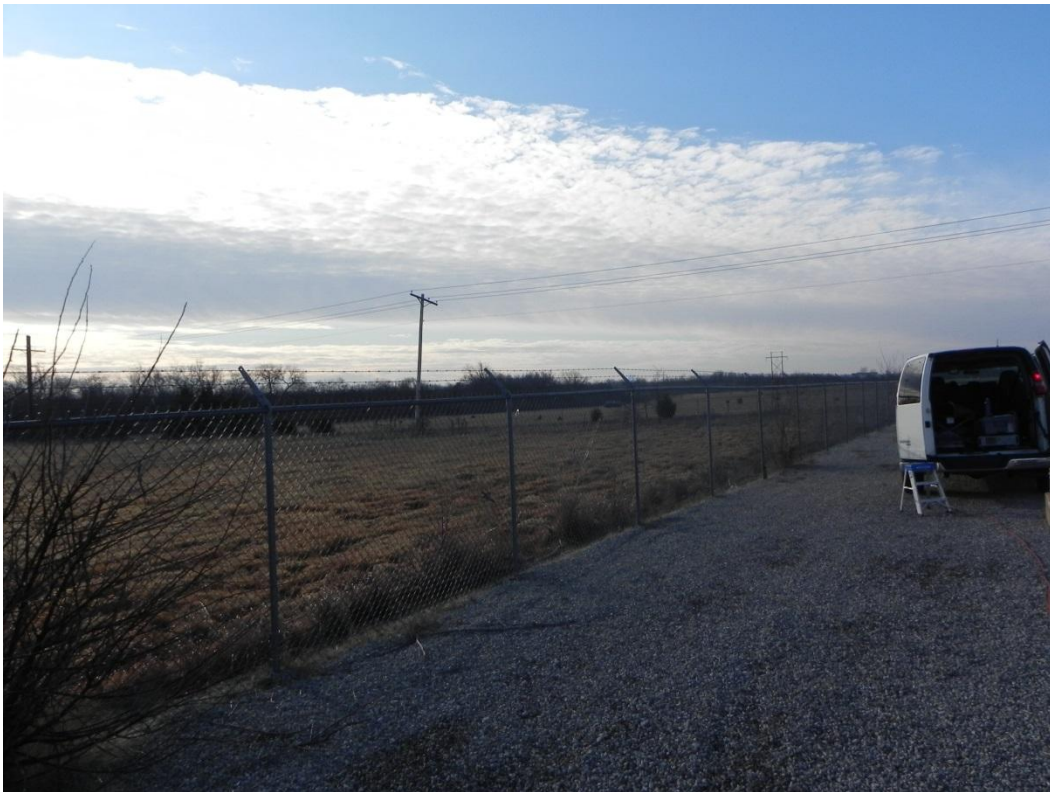
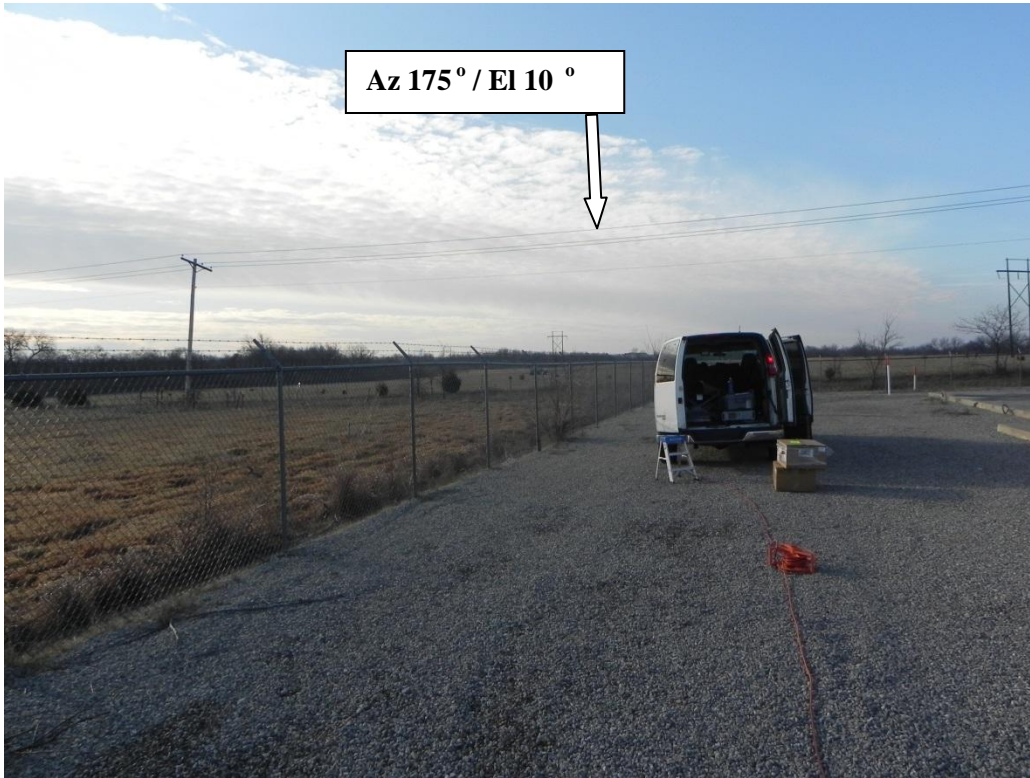
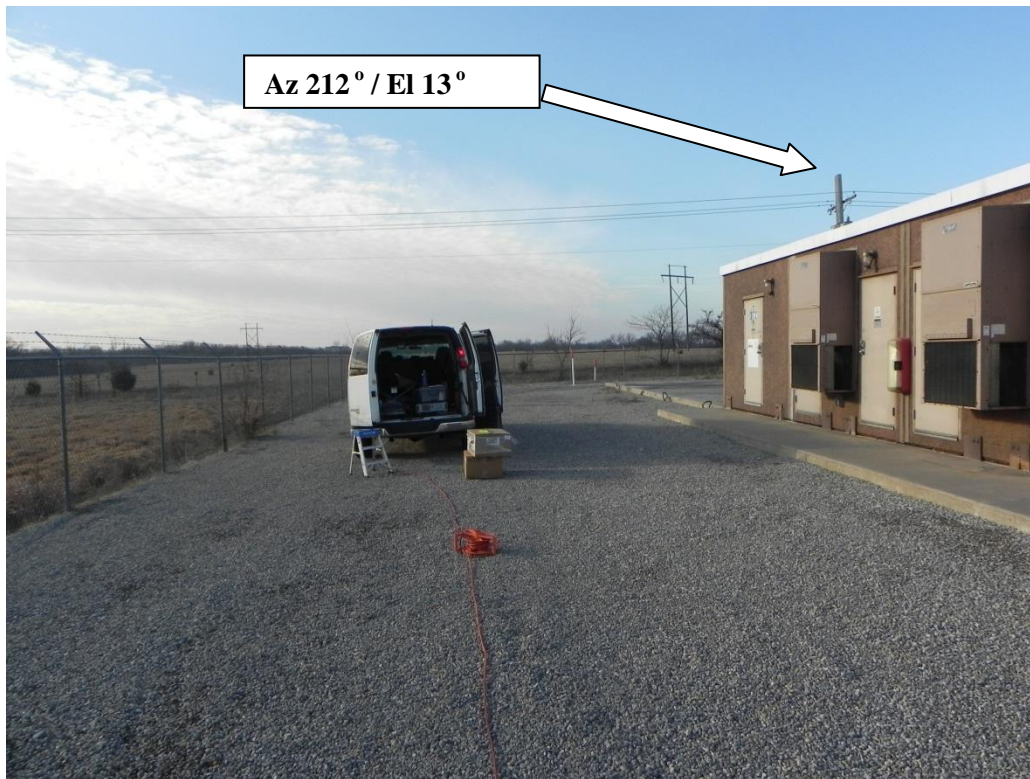
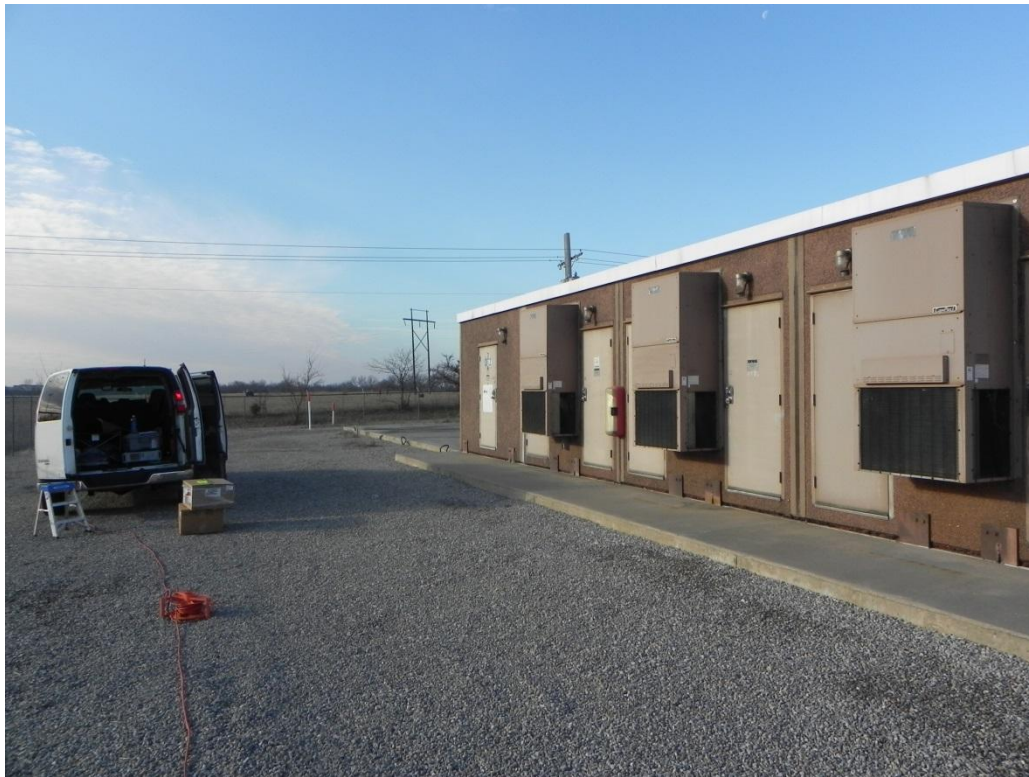
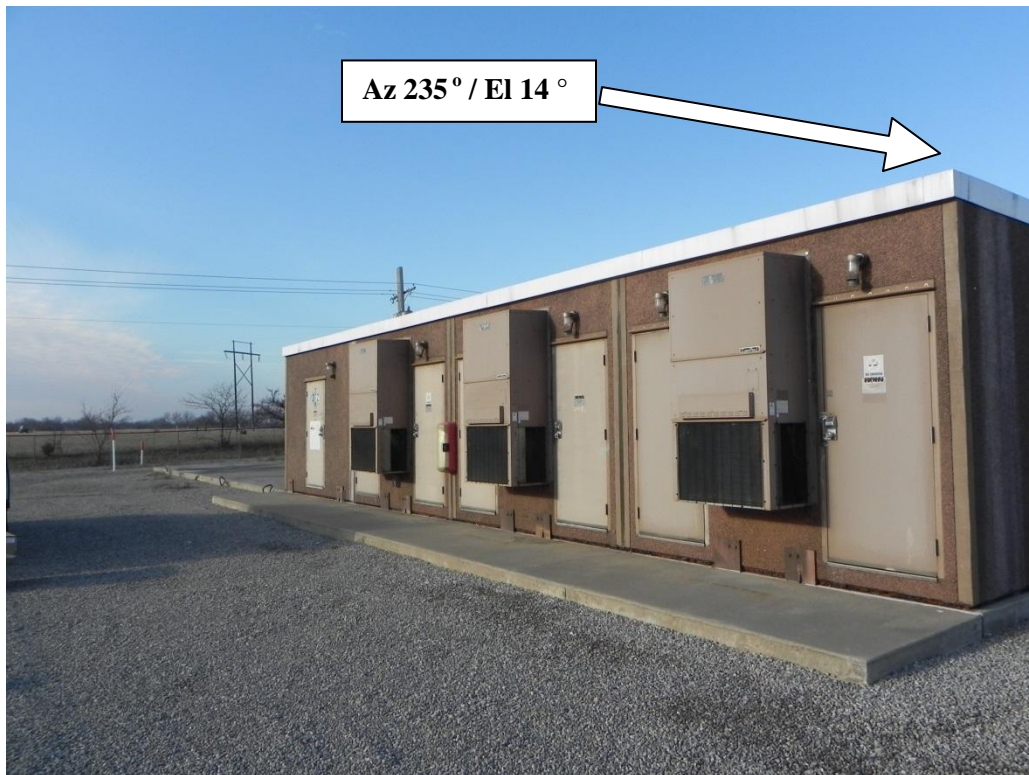
Figure 3.1-2 Horizon Photographs of Earth Station Site

There is no potential satellite arc blockage at this site. Final arc clearance will depend on antenna placement.

The satellite arc has no potential blockage from 55W through 115W.
