MICROWAVE PATH SURVEY REPORT

RADIO FREQUENCY INTERFERENCE (RFI) MEASUREMENT REPORT

ViaSat

McAllen, TX (Weslaco, TX)

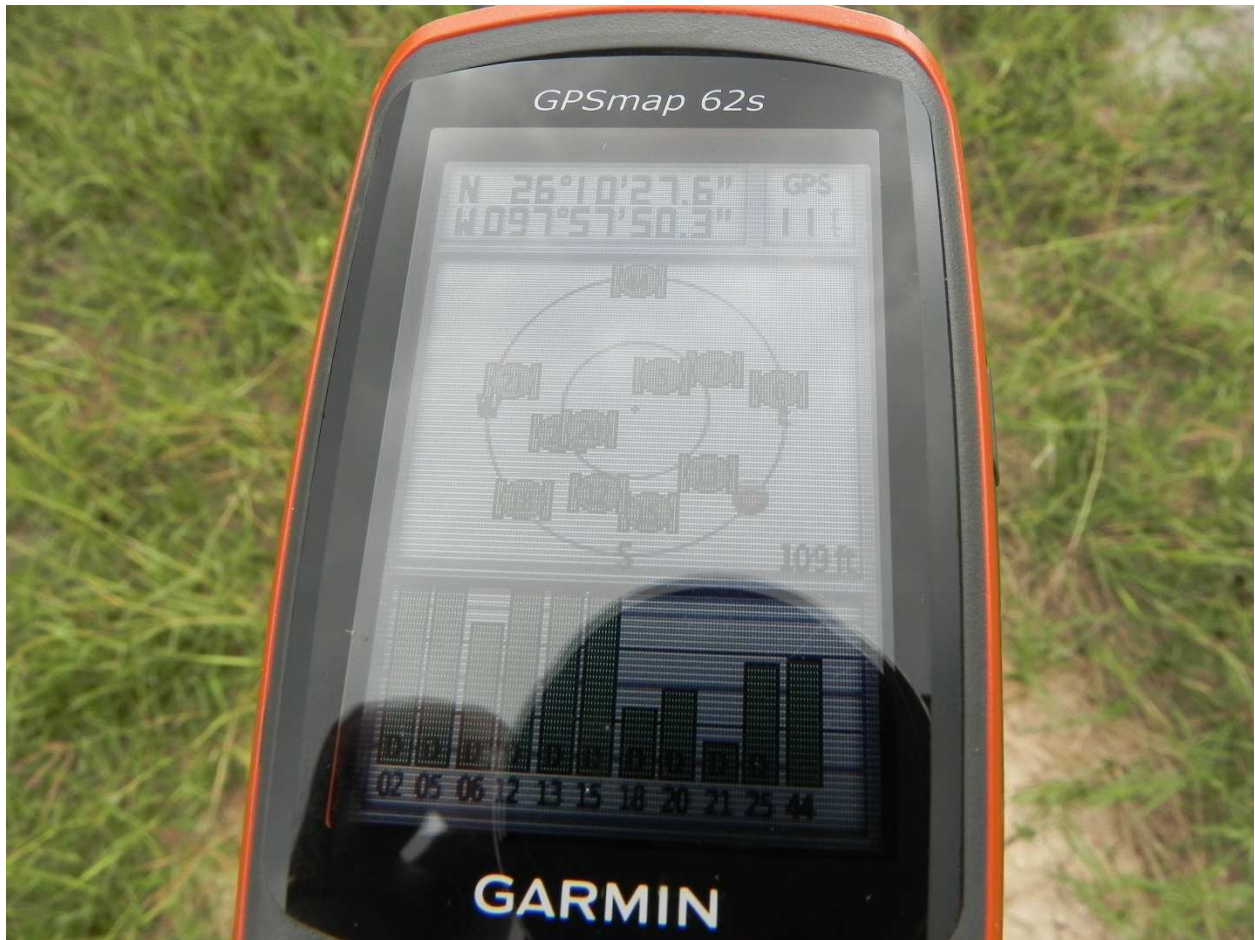
Figure 1.2-3 – GPS Photograph

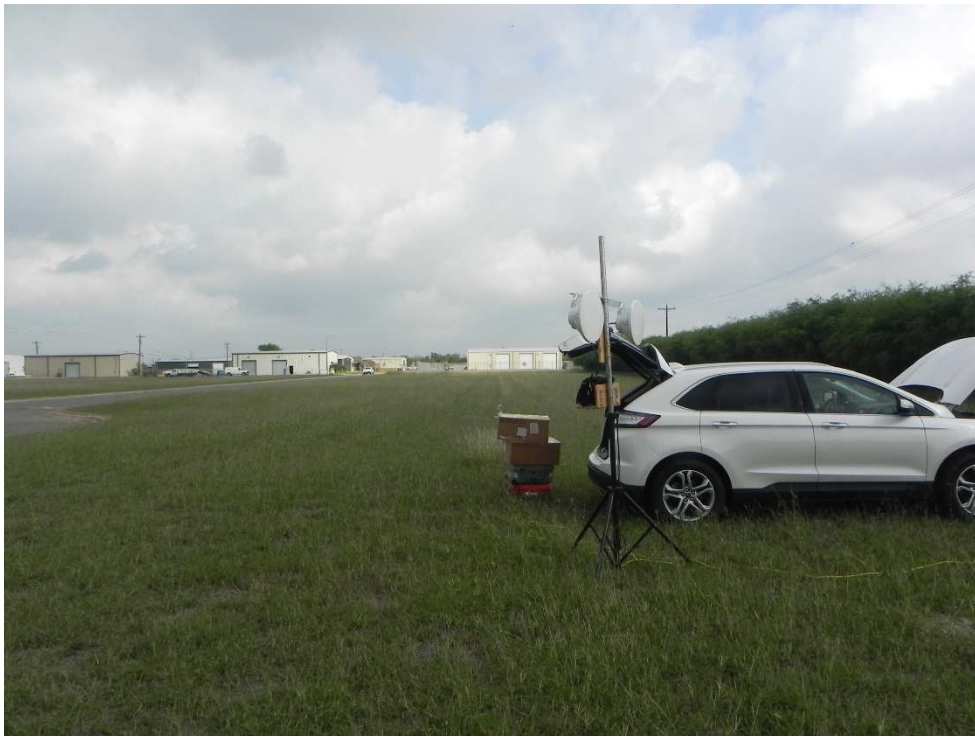
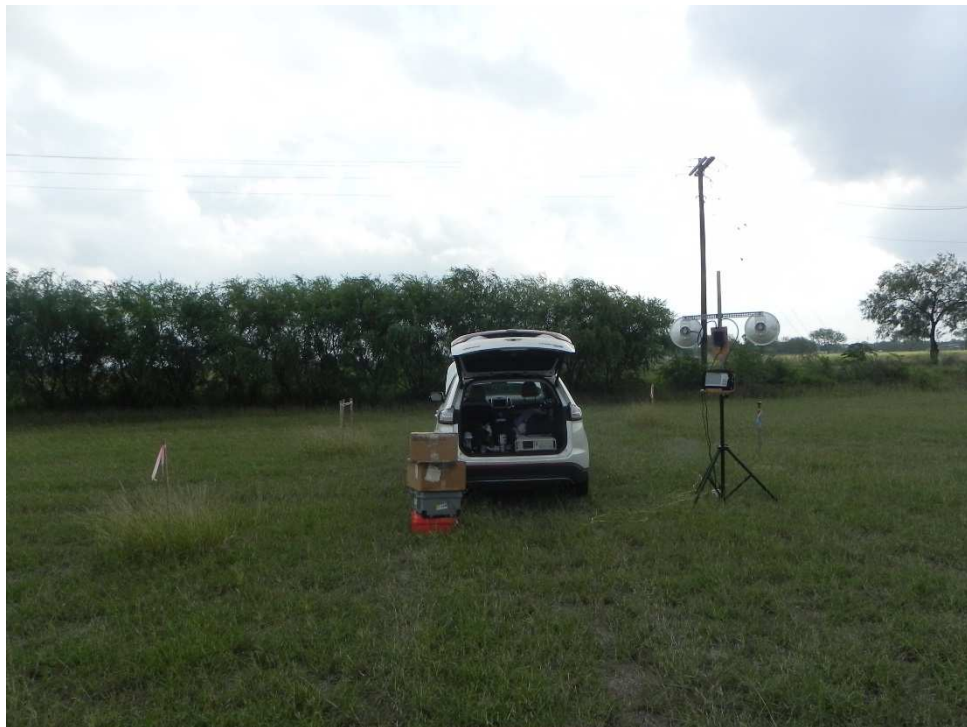
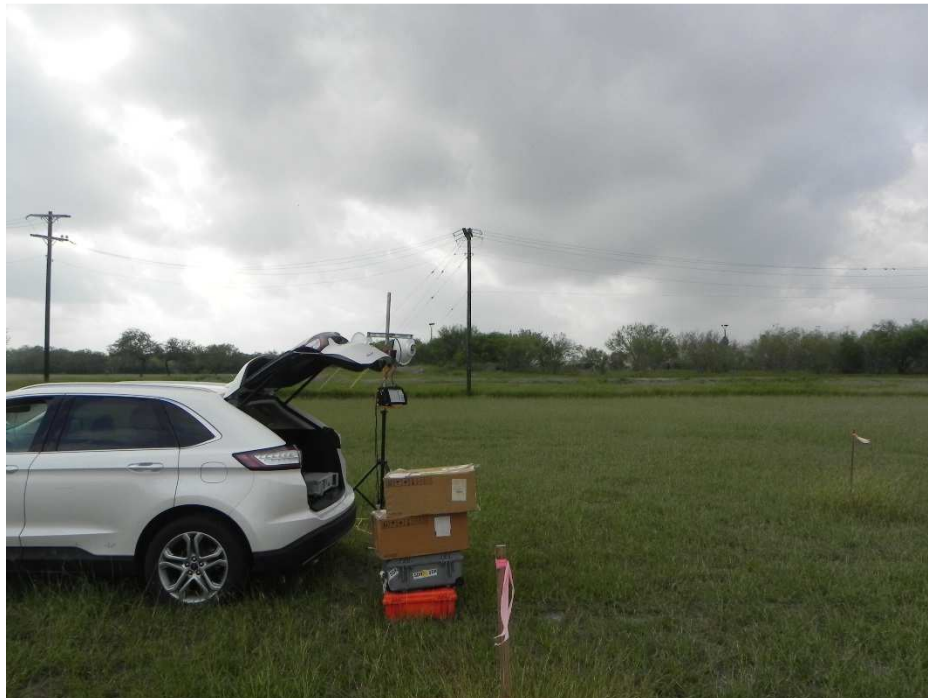
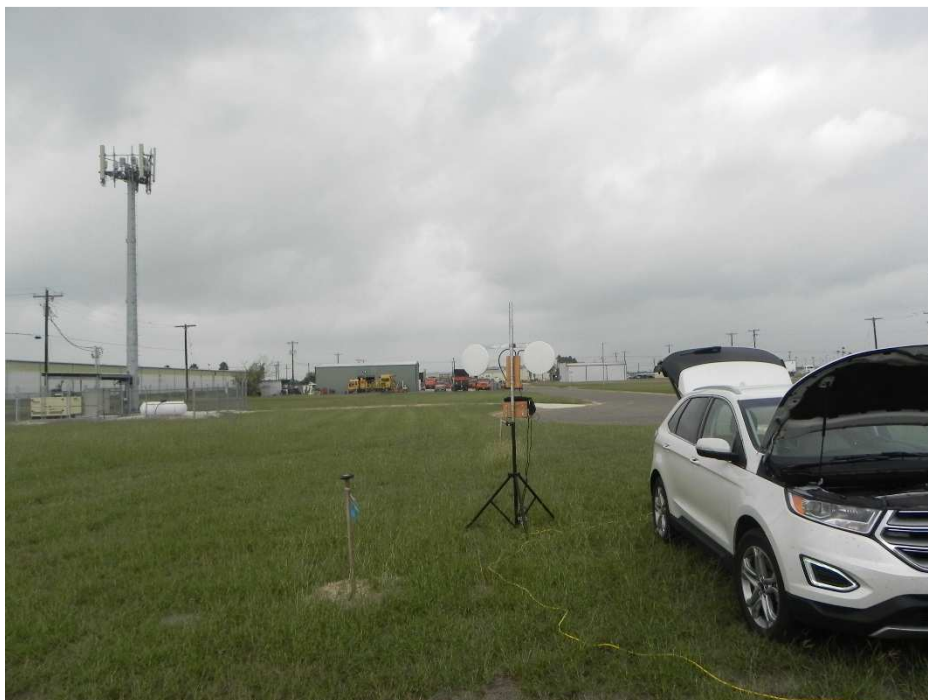
Figure 3.1-1 Earth Station Site Photographs

| 8. GEOSTATIONARY ARC VISIBILITY: | Satellite arc has no blockage at this time. |

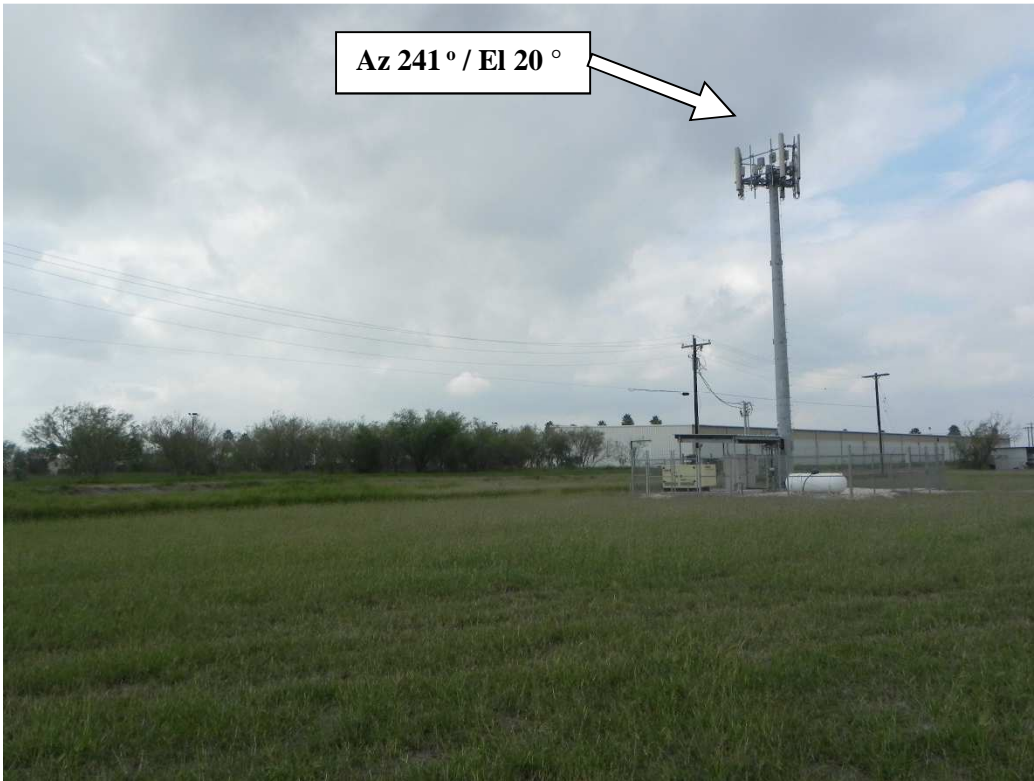
Figure 3.1-2 Horizon Photographs of Earth Station Site

There is no potential satellite arc blockage at this site. Final arc clearance will depend on antenna placement.

The satellite arc has no potential blockage from 55W through 115W.
