# **MICROWAVE PATH SURVEY REPORT**

## **RADIO FREQUENCY INTERFERENCE (RFI) MEASUREMENT REPORT**

ViaSat

**Transmit and Receive Earth Station**  
17-21 GHz and 27-31 GHz

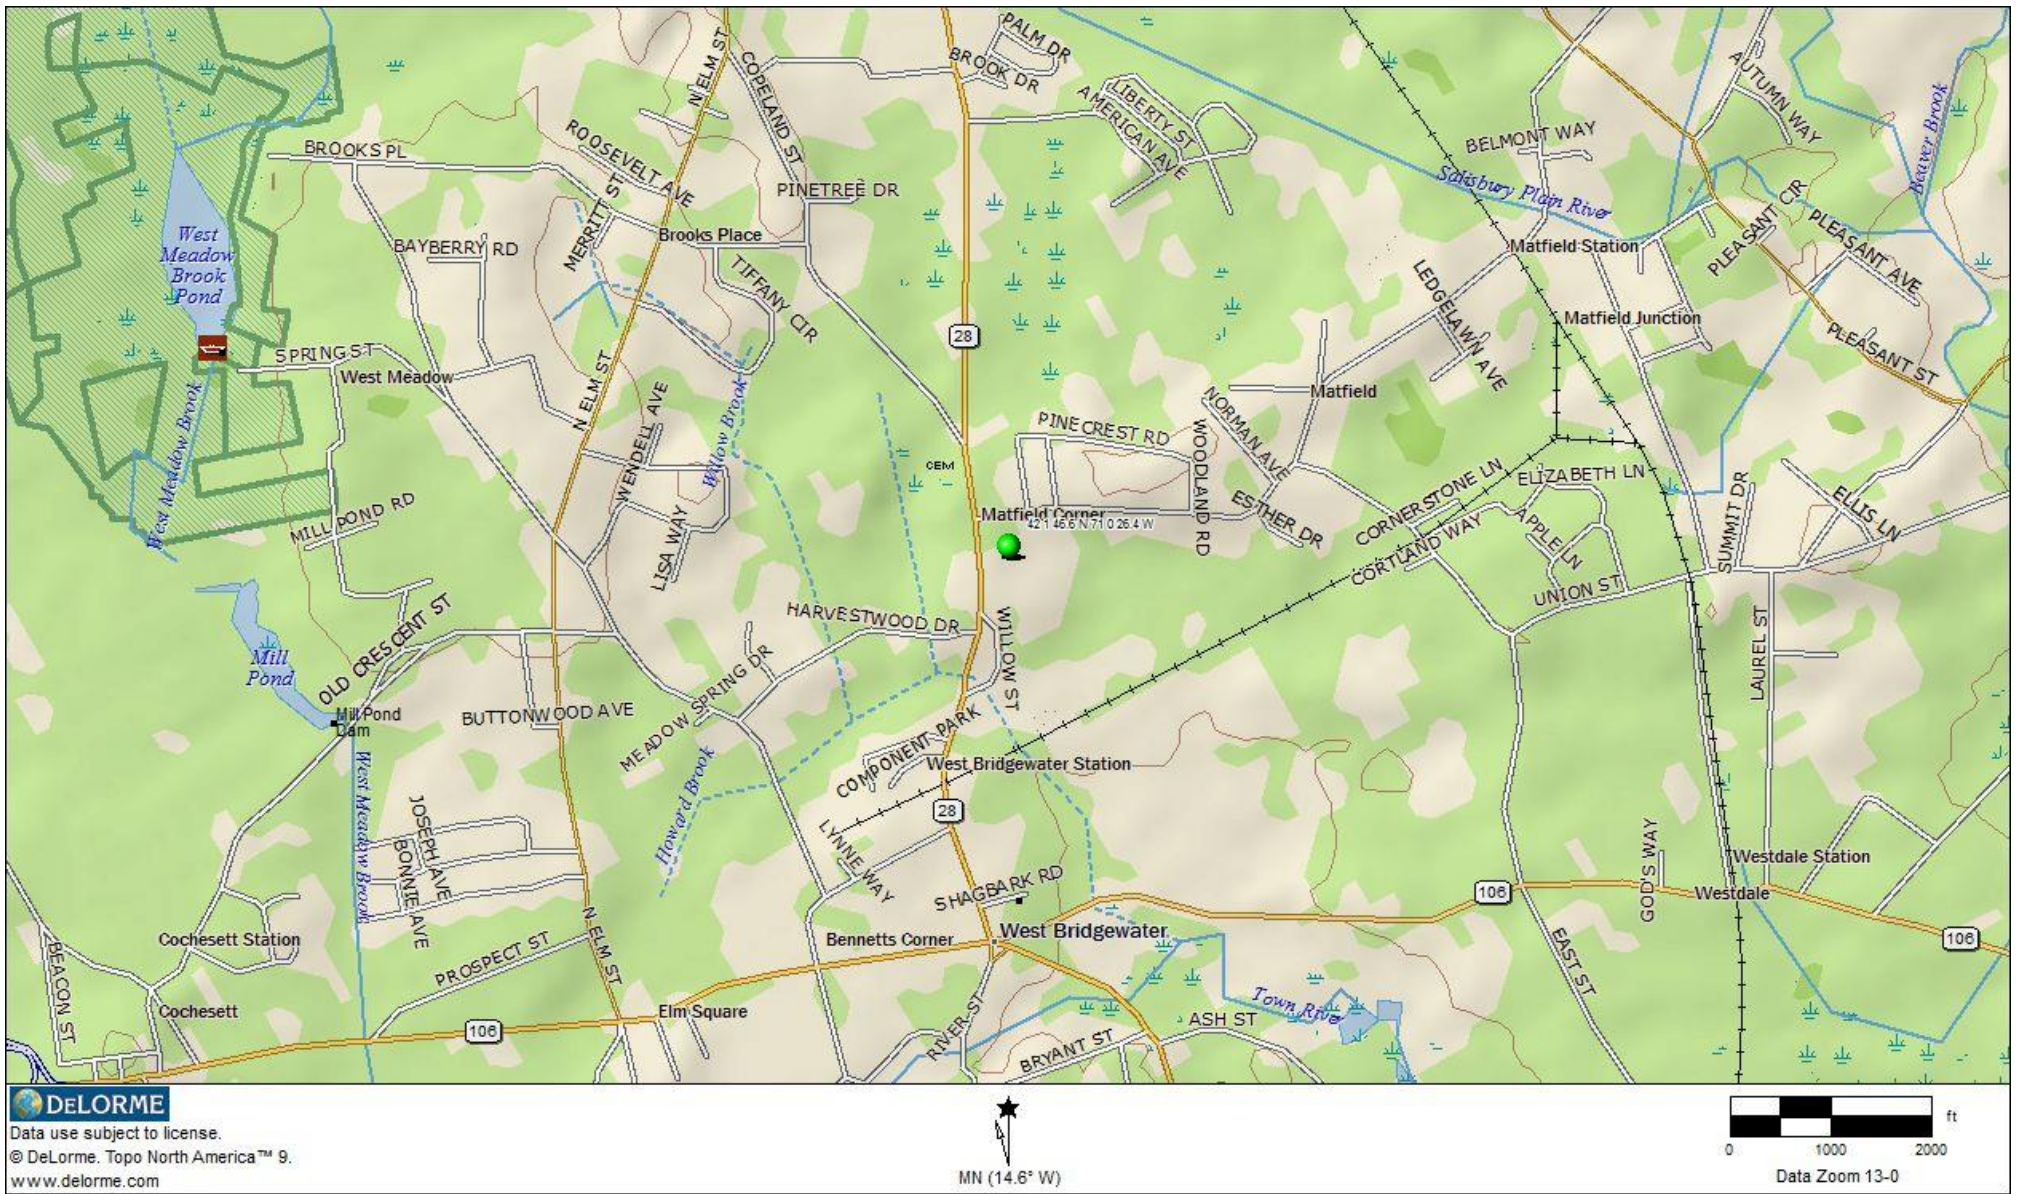
Figure 1.2-1 – Topographic Map

The measured site is identified on a portion of a topographic map shown in Figure 1.2-1. An aerial photo of the site location is shown in Figure 1.2-2. A photo of the measurement using a GPS is shown in Figure 1.2-3.

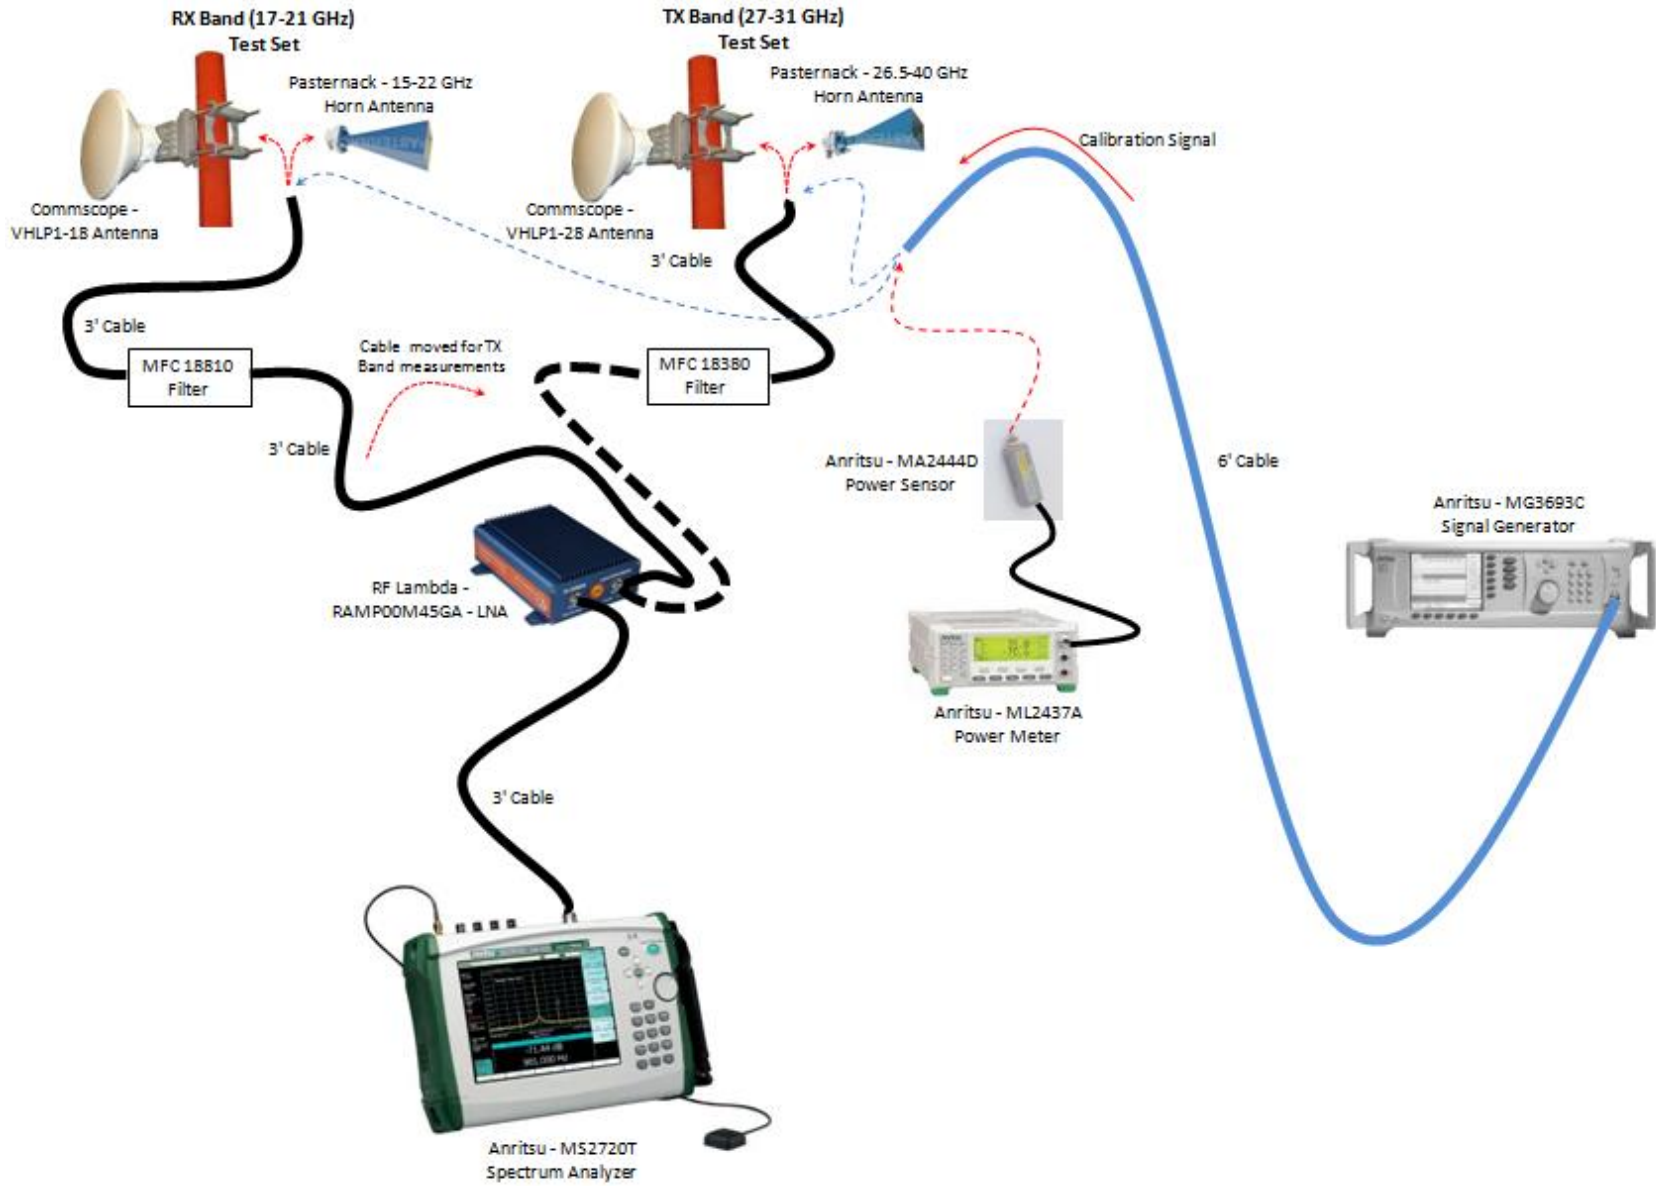
Figure 2.1-1 Receive Test Equipment Block

Figures 2.1-1 is the block diagram of the test set for all bands to be tested. All test equipment used was allowed a proper warm-up period prior to calibration. The test set was calibrated by the signal substitution method, as recommended by NSMA, utilizing a synthesized signal generator. The reference signal from the signal generator was adjusted for the center frequency of each band to be tested and measured with a thermal power meter for calibrated reference test level (-60 dBm). This calibrated reference signal from the signal generator was then injected into the end of the coaxial cable of the test set at the point, which normally connects to the test antenna. A spectrum analyzer then measured the reference test signal level after passing through the test set. At this point, the spectrum analyzer was calibrated such that the top graticule of the spectrum analyzer display (-60 dBm) corresponded to the injected reference signal (-60 dBm) by utilizing the reference level offset function of the Anritsu –M52720T spectrum analyzer. Upon completion of the calibration process, a known reference level was obtained for the measurements that correspond to a given set of spectrum analyzer display readings.

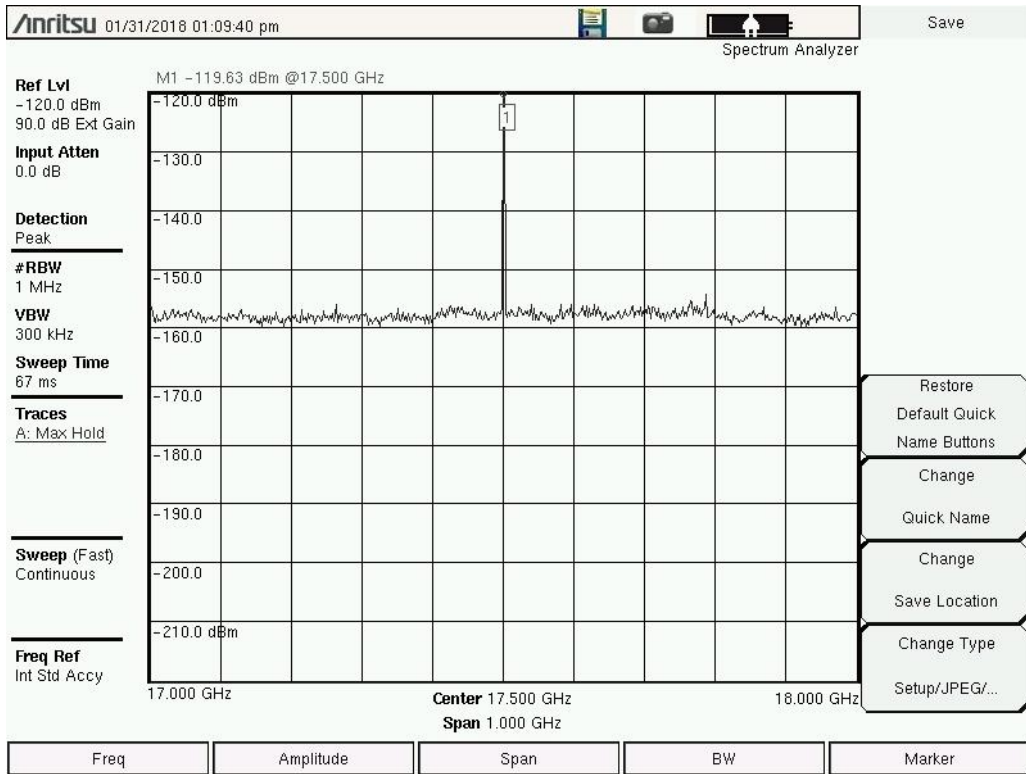
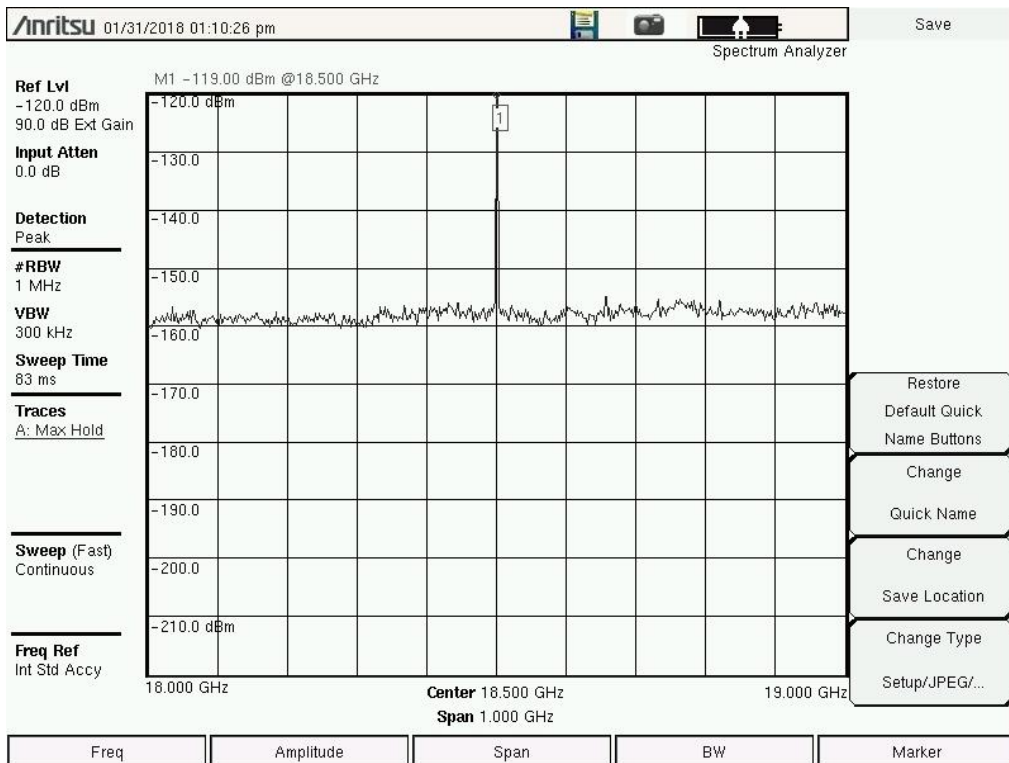
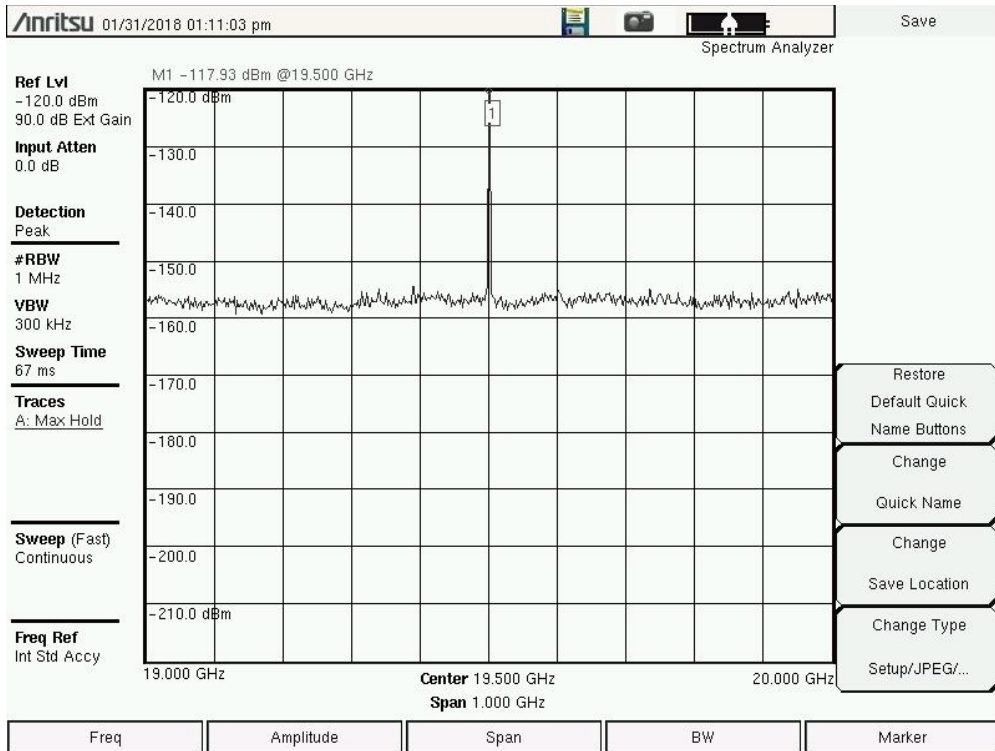
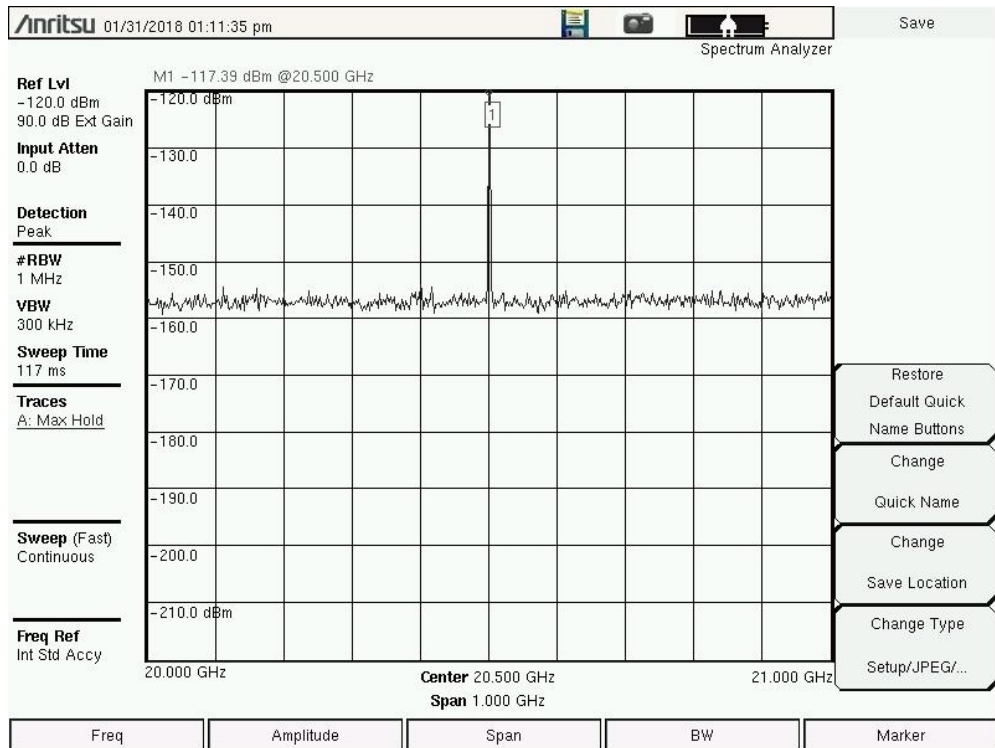
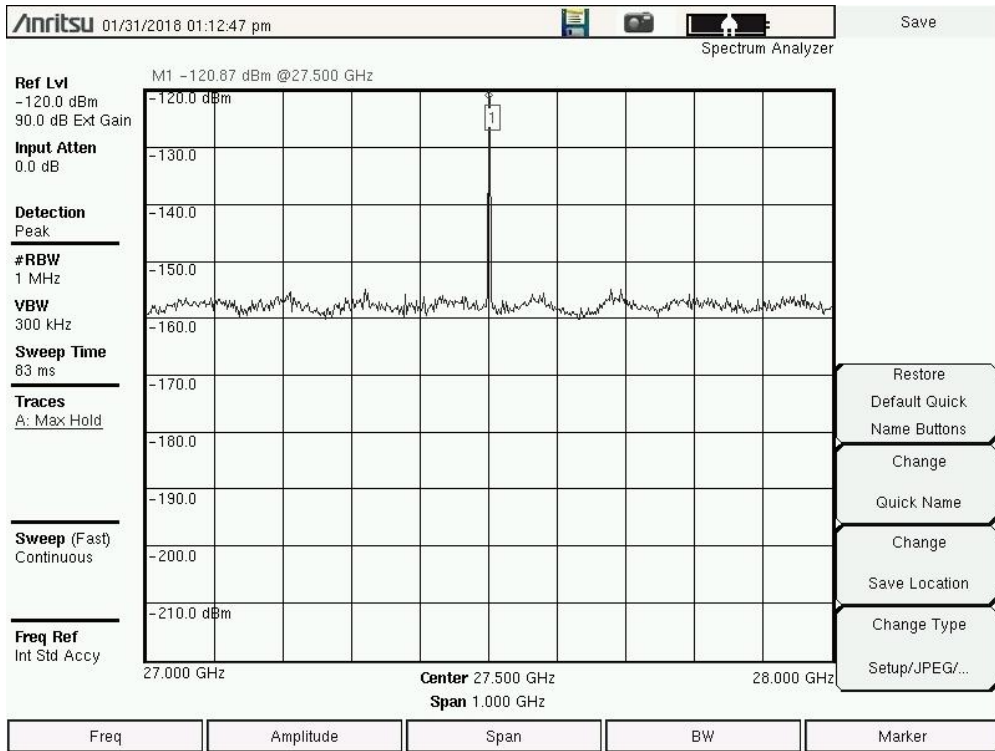
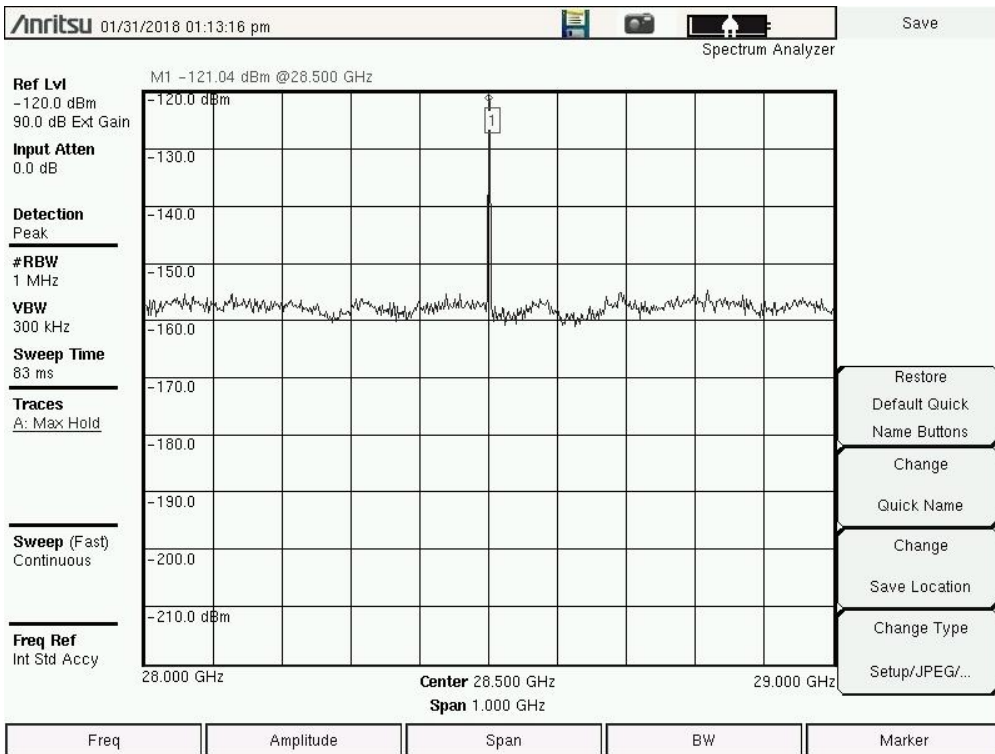
In this instance, the spectrum analyzer displayed measured signal level of –60 dBm equates to an isotropic signal level of –120 dBW<sub>I</sub>.

Figures 2.1-2(A-H) displays the spectrum photographs of the described calibration procedure employed during these measurement.

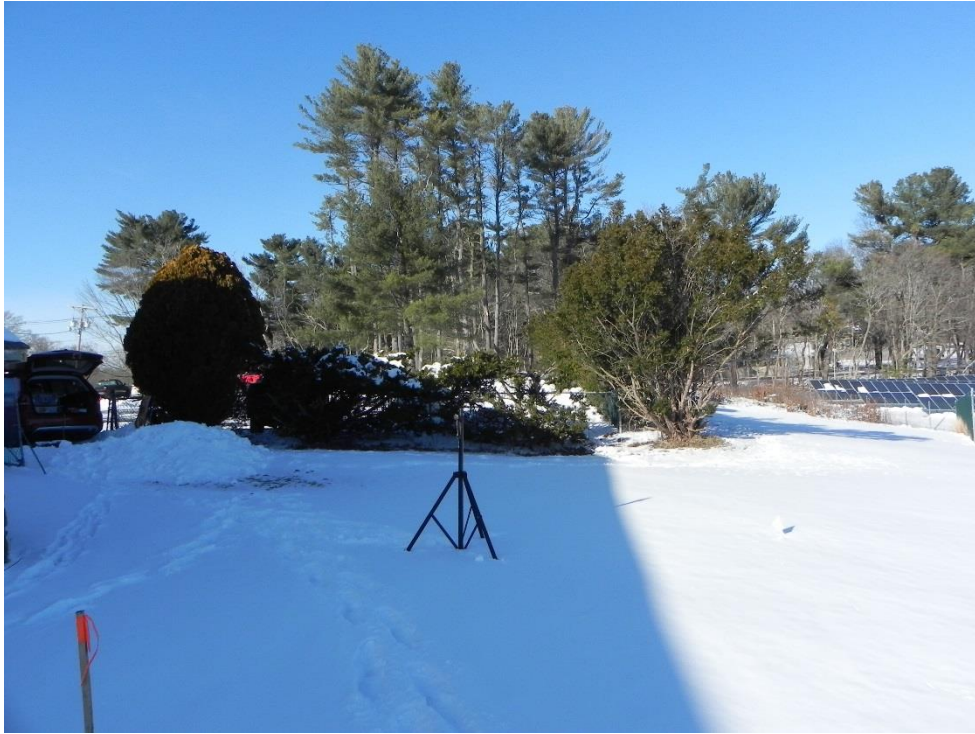
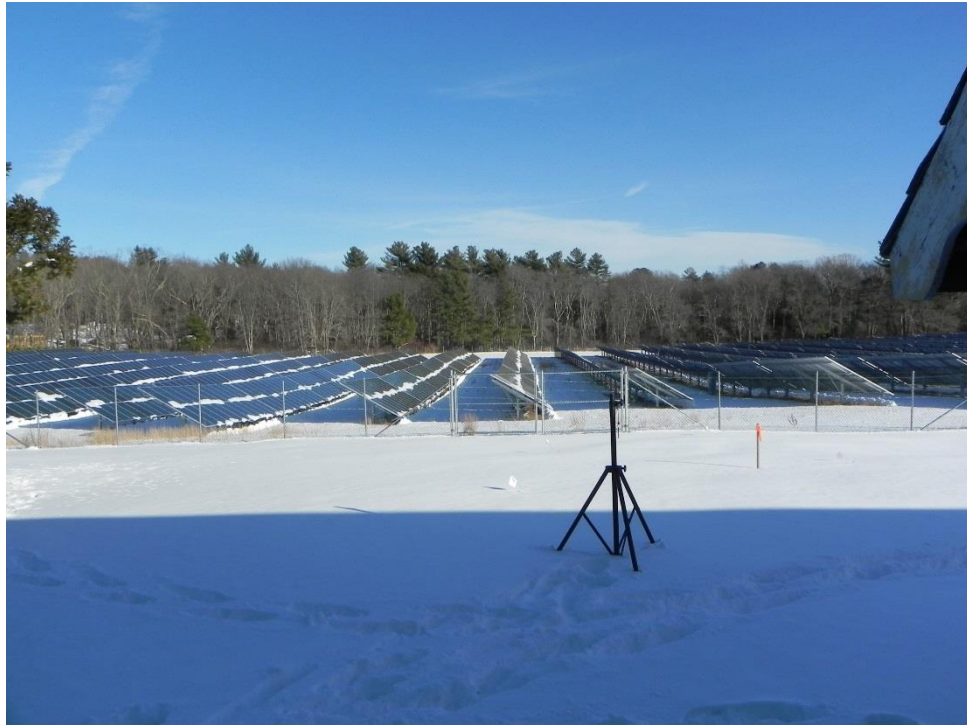
Figure 3.1-1 Earth Station Site Photographs

- Table 3.1-1 presents a site data sheet including all pertinent site information.
- Figures 3.1-1 and 3.1-2 are the photographs depicting the existing earth station site and satellite arc.
- Figures 3.1-3 through 3.1-10 are the RF spectrum photographs depicting the interference environment at the test site.

| 8. GEOSTATIONARY ARC VISIBILITY: | Satellite arc has no permanent blockage at this time. |

There is no potential satellite arc blockage at this site. Final arc clearance will depend on antenna placement.

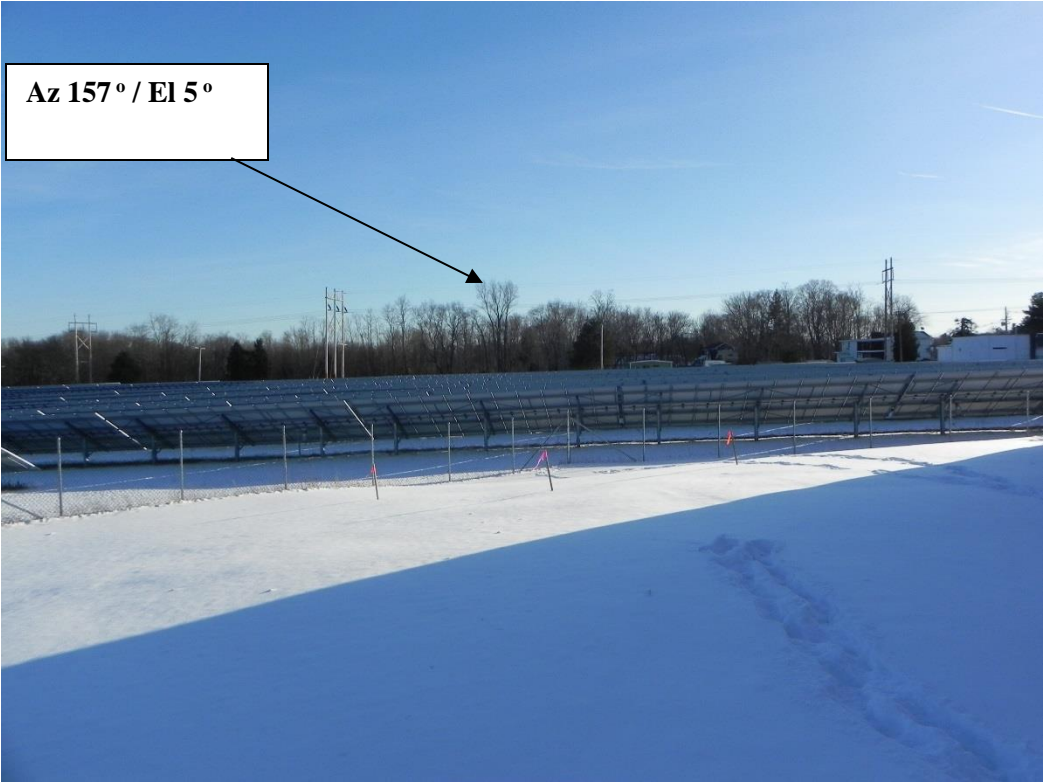
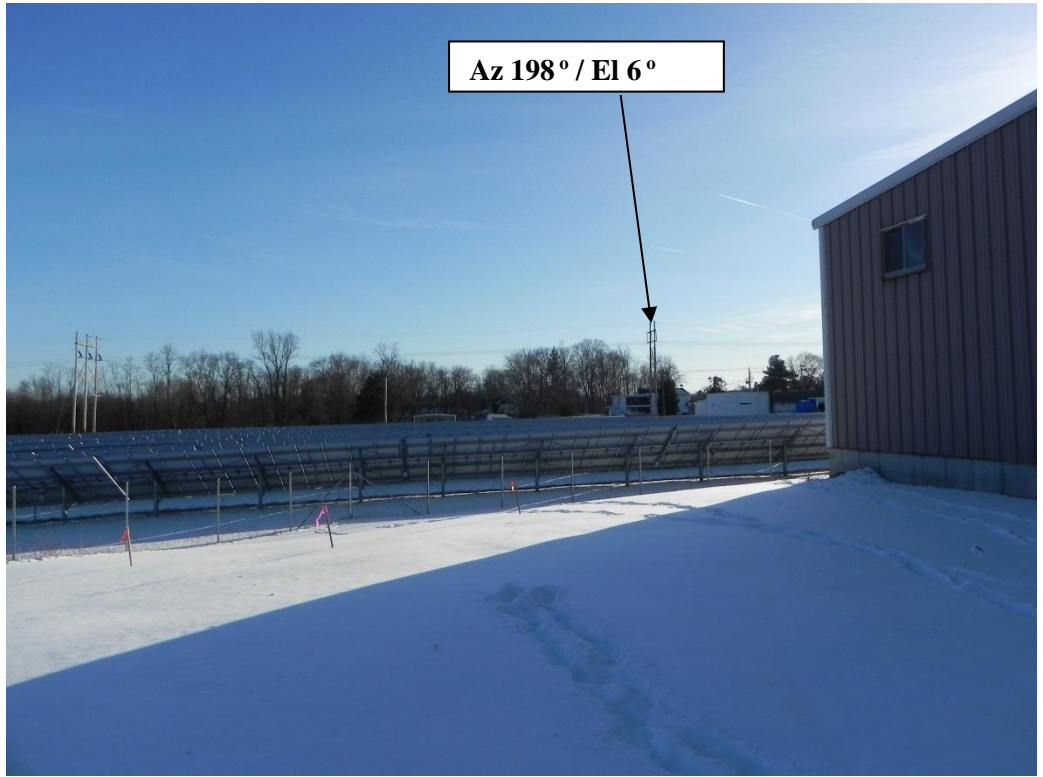
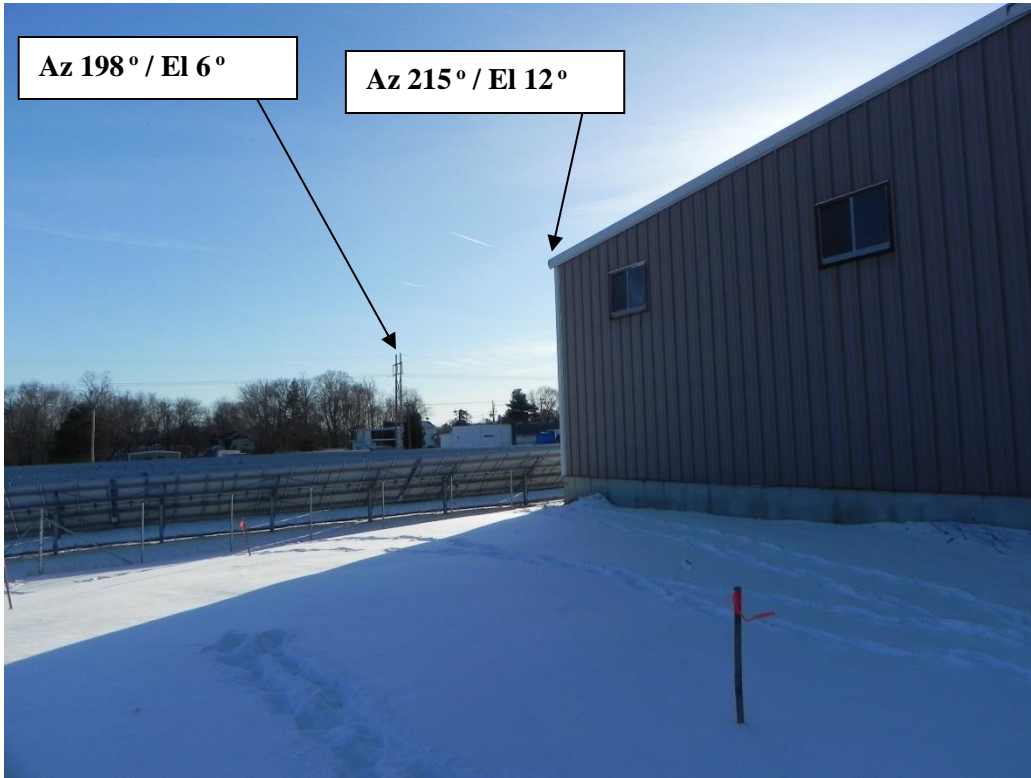
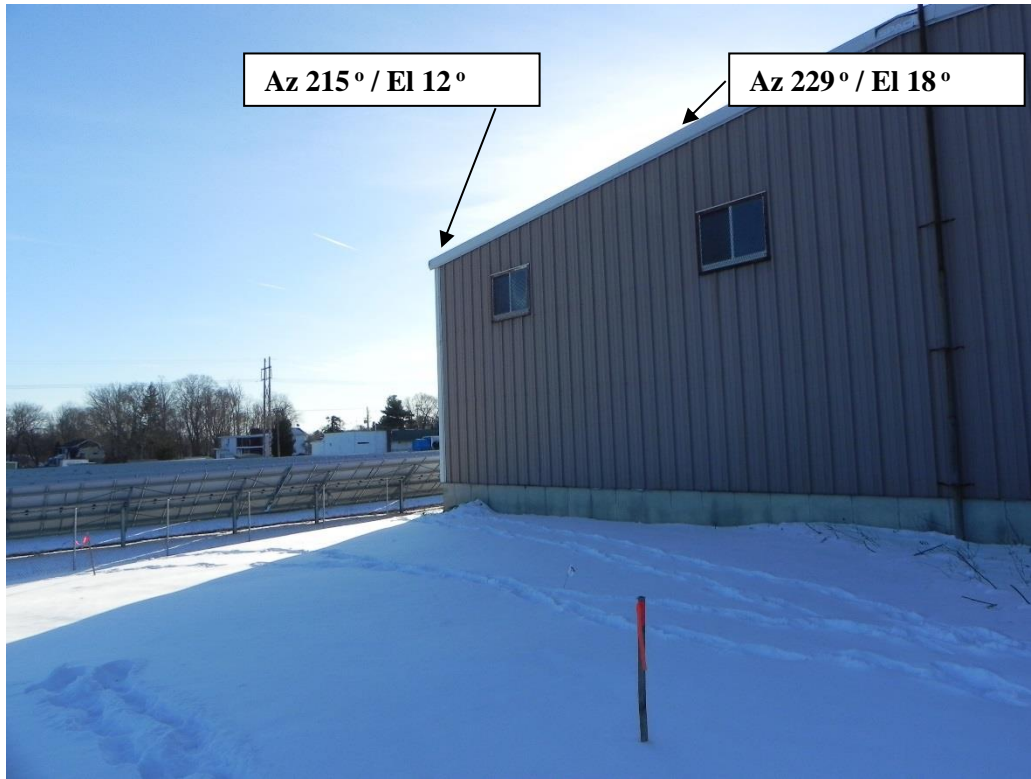
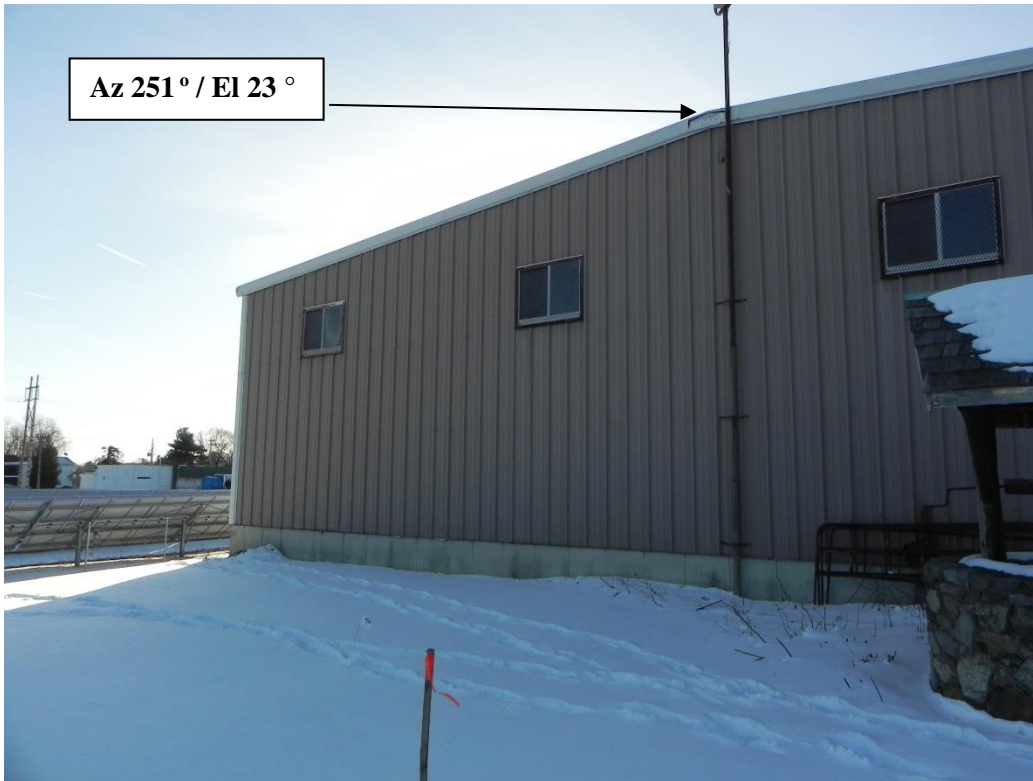
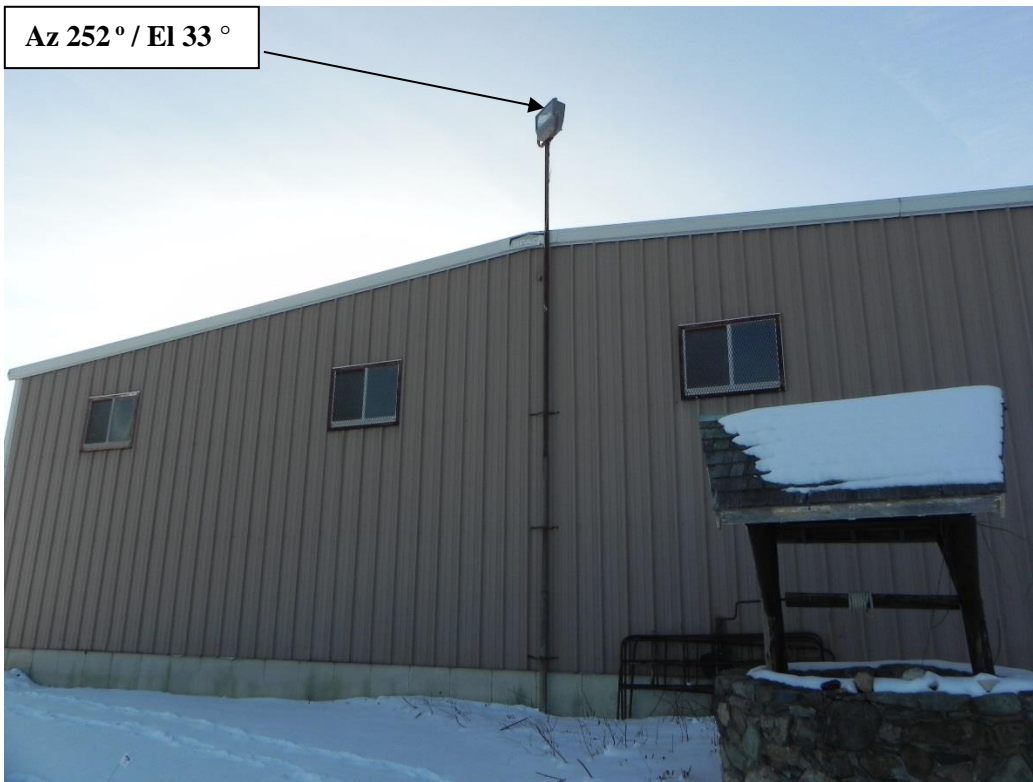
Figure 3.1-2 Horizon Photographs of Earth Station Site

The satellite arc has no potential blockage from 55W through 115W.

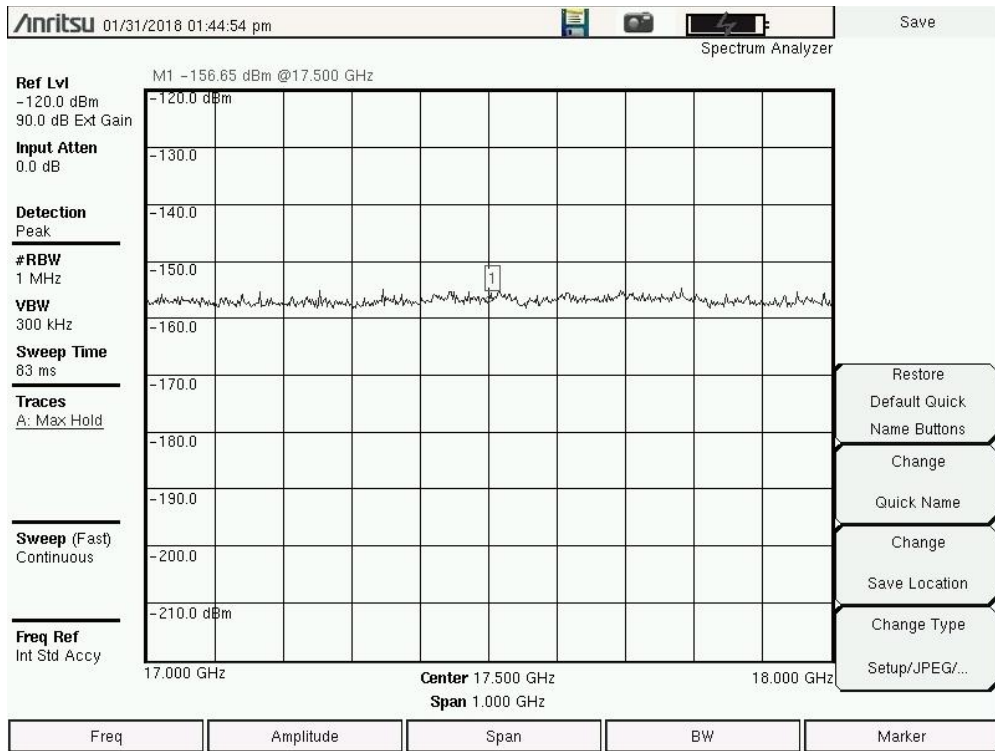
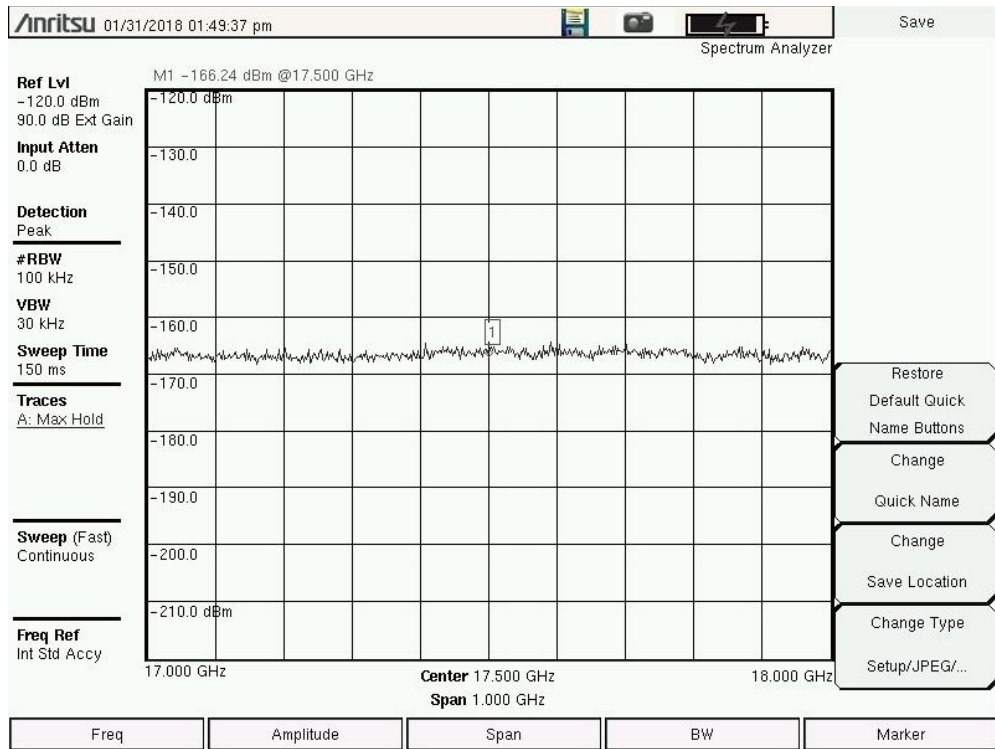
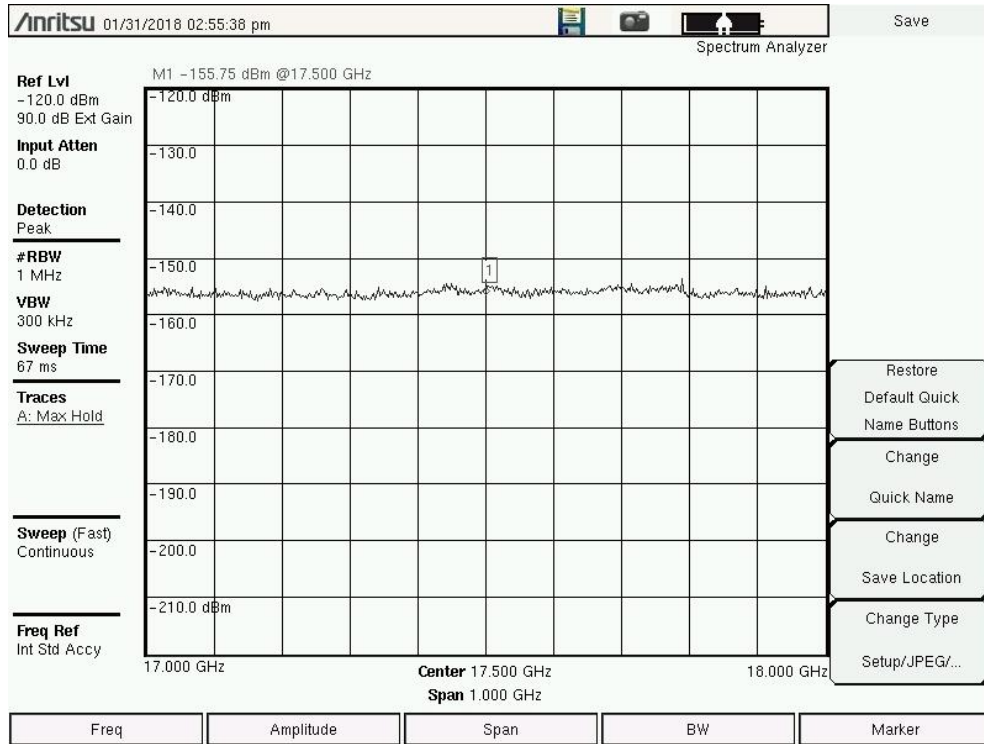
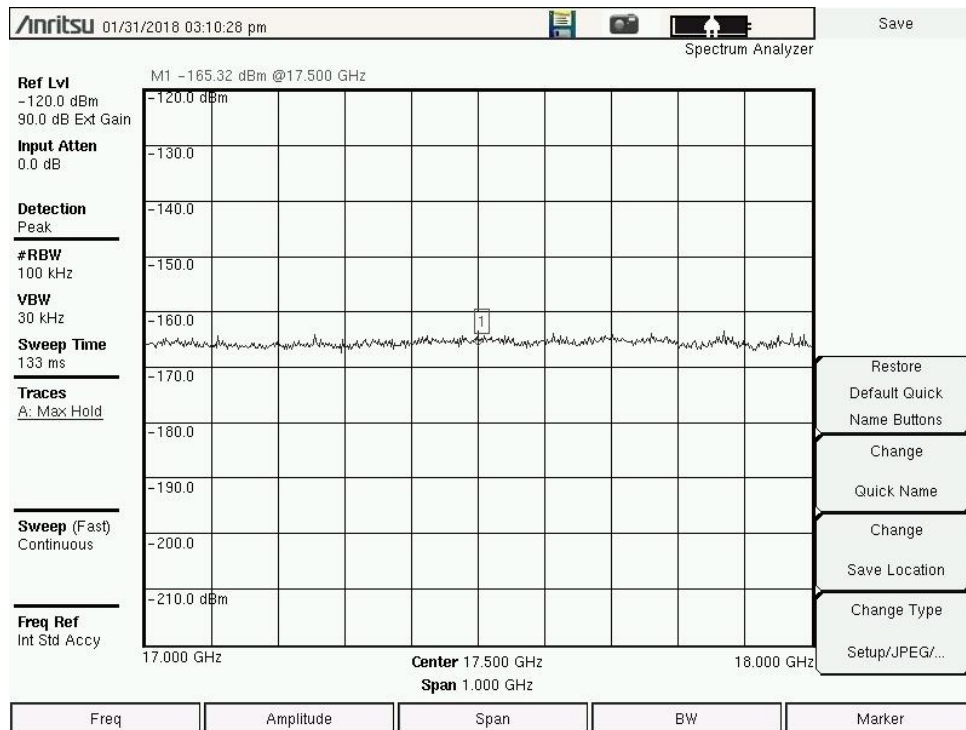
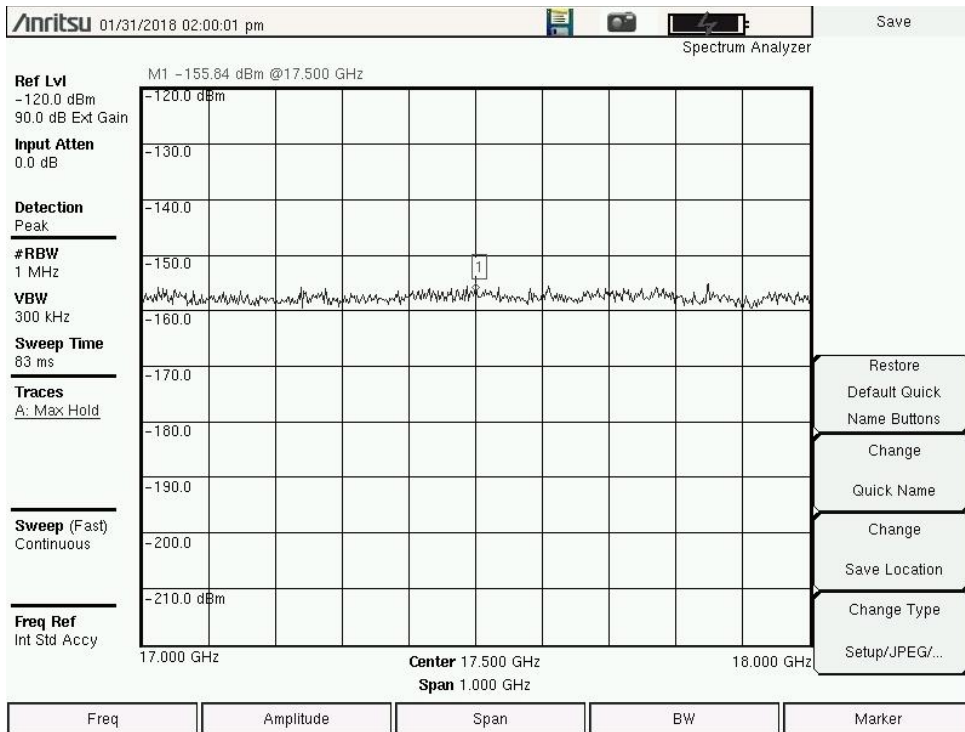
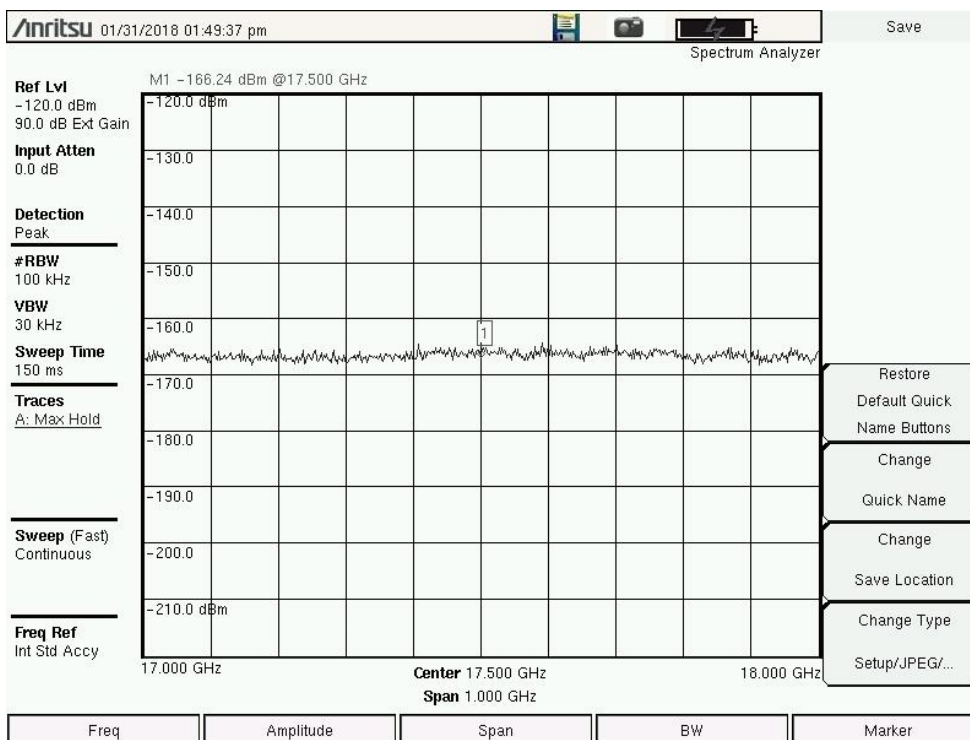
There was no radio frequency interference cases measured at this site above the noise floor of the test equipment.

There were no signals measured above the  $-156$  dBW/ 1 MHz interference objective for digital reception at this site.

It is recommended that frequency coordination of this site be initiated to protect this location at the more stringent digital receive interference objective.

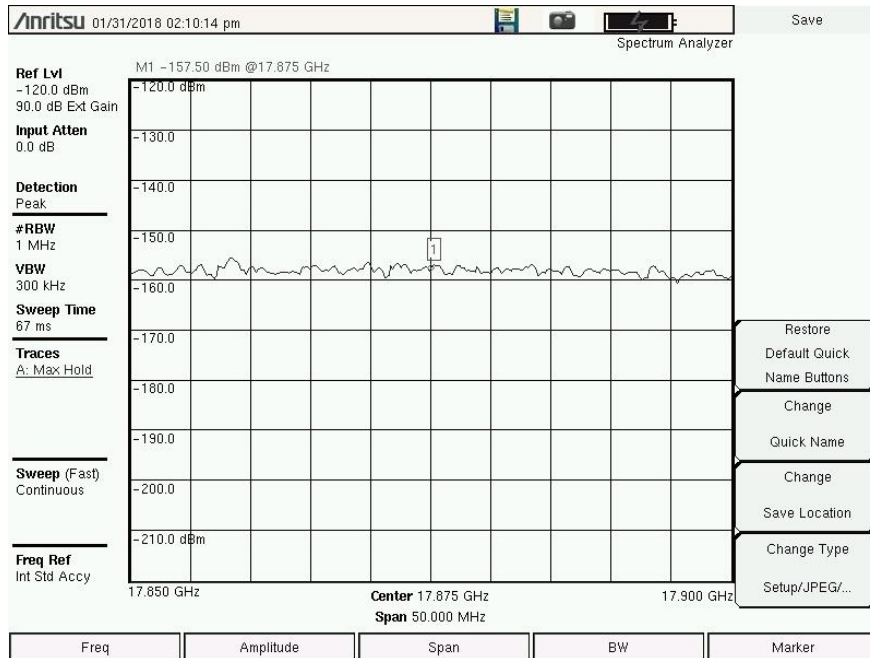
There was one case identified in the paper engineering study that could not be resolved by terrain pathloss calculations. The spectral analysis results as conducted on site are shown in Addendum 1. No interference was detected during the test duration.

Spectrum Photos 17.875 GHz 1 MHz Res BW Vertical Pol 109.8<sup>0</sup>
