MICROWAVE PATH SURVEY REPORT

RADIO FREQUENCY INTERFERENCE (RFI) MEASUREMENT REPORT

ViaSat

Memphis, TN (Olive Branch, MS)

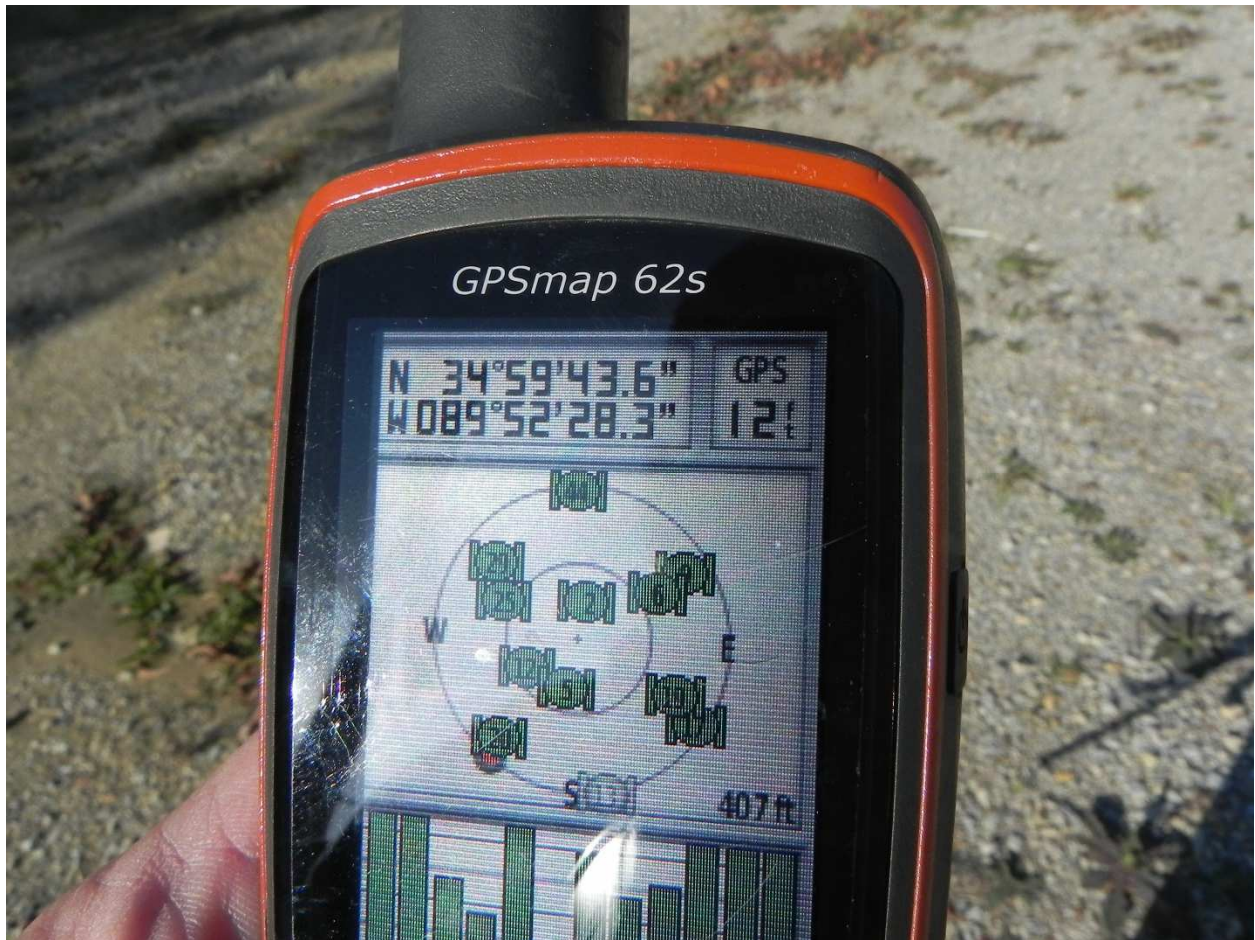
Figure 1.2-3 – GPS Photograph

The measured site is identified on a portion of a topographic map shown in Figure 1.2-1. An aerial photo of the site location is shown in Figure 1.2-2. A photo of the measurement using a GPS is shown in Figure 1.2-3.

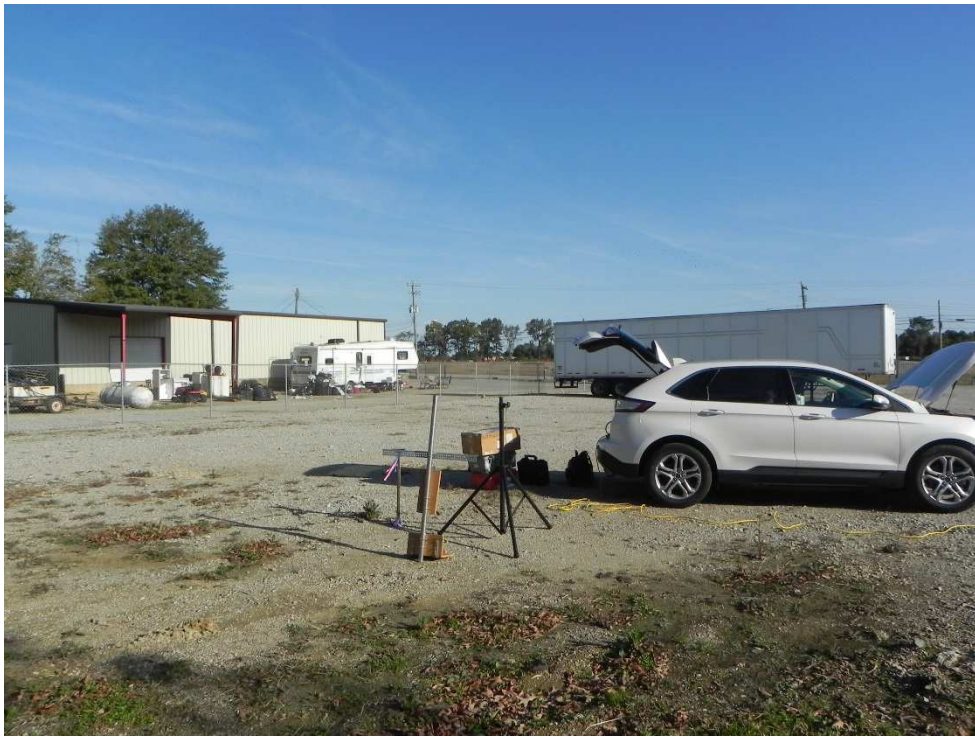
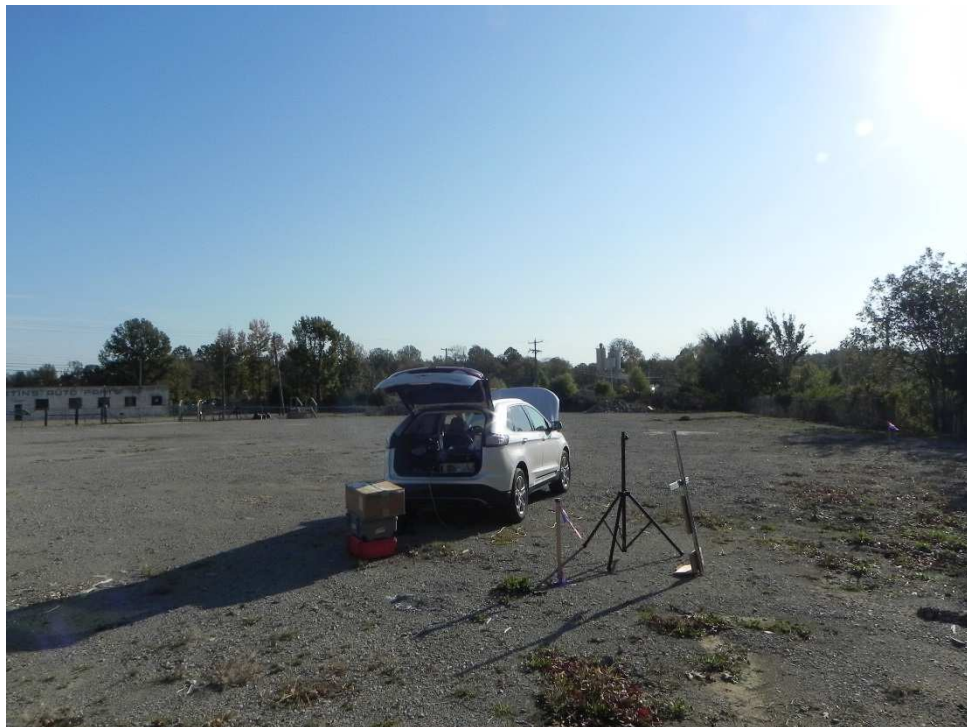
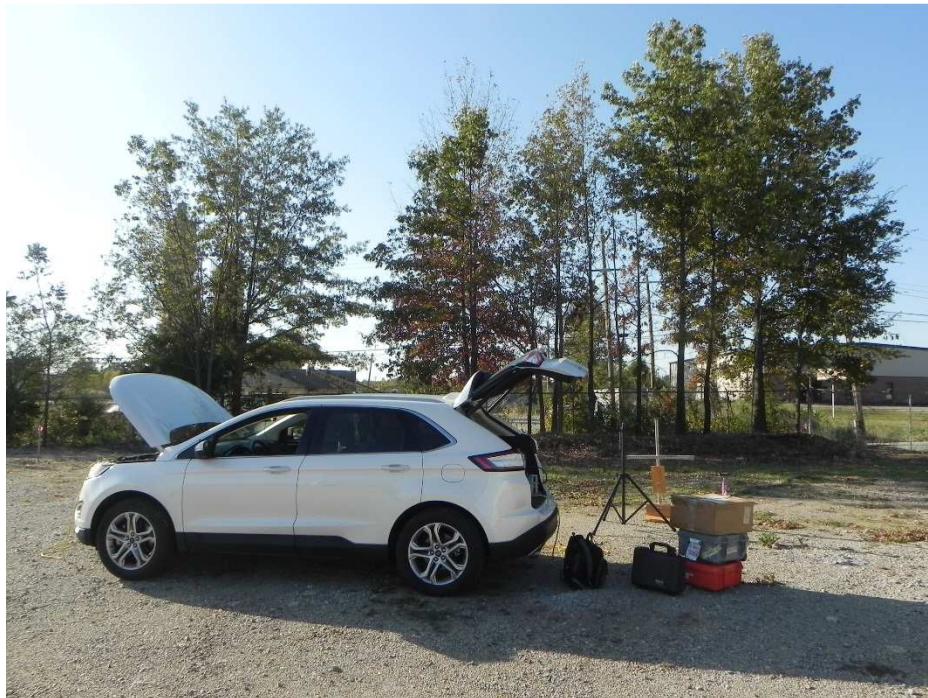
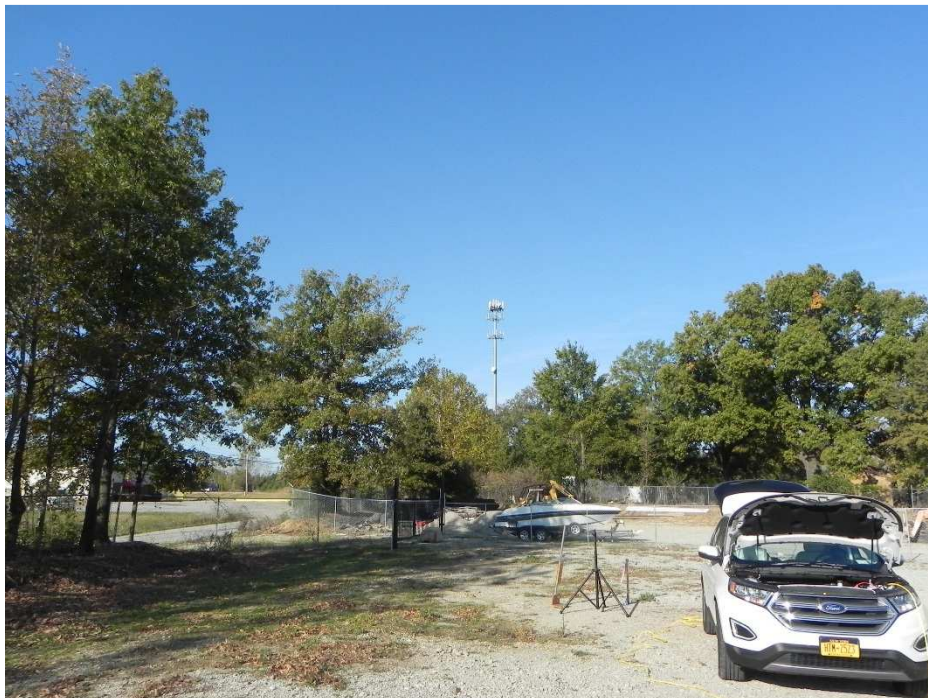
Figure 3.1-1 Earth Station Site Photographs

- Table 3.1-1 presents a site data sheet including all pertinent site information.
- Figures 3.1-1 and 3.1-2 are the photographs depicting the existing earth station site and satellite arc.
- Figures 3.1-3 through 3.1-10 are the RF spectrum photographs depicting the interference environment at the test site.

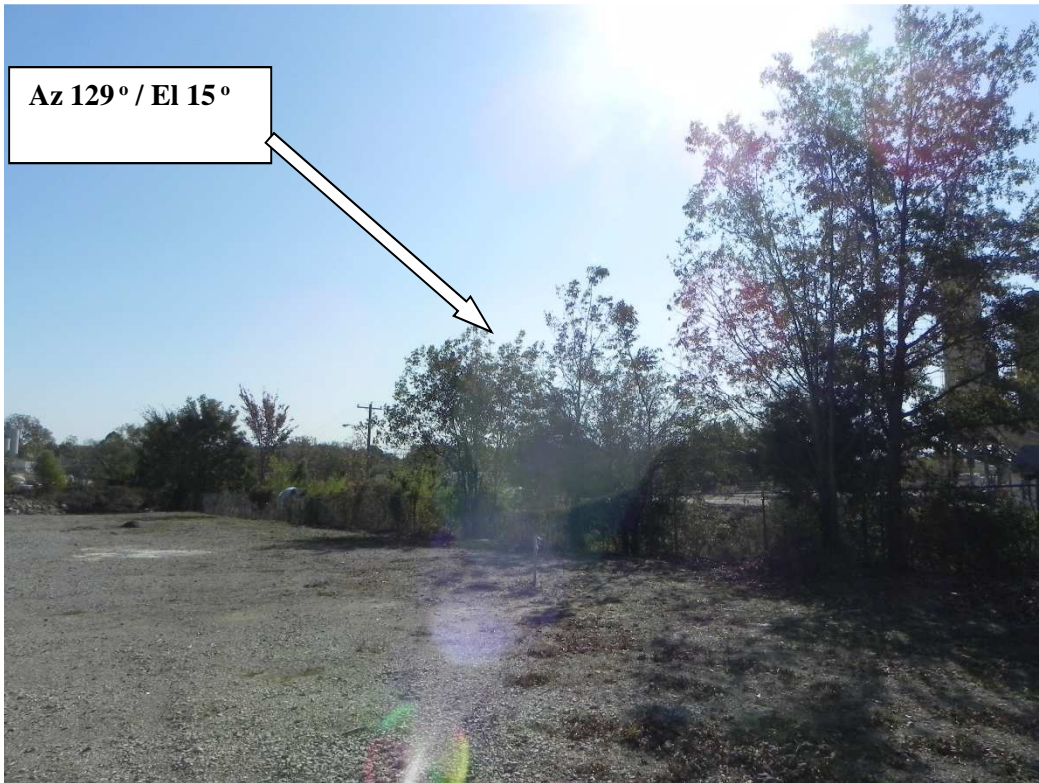
Figure 3.1-2 Horizon Photographs of Earth Station Site

There is minor potential satellite arc blockage at this site at the 189⁰ to 205⁰ range of azimuths. The heights of the trees are at 35⁰ to 40⁰ degrees. Final arc clearance will depend on antenna placement.

The satellite arc has minor potential blockage from 55W through 115W. The trees at the 189⁰ to 205⁰ range of azimuth are right at the limit for blockage and may need to be trimmed depending on satellite selection and final placement of the terminal.
