# **MICROWAVE PATH SURVEY REPORT**

## **RADIO FREQUENCY INTERFERENCE (RFI) MEASUREMENT REPORT**

ViaSat

Augusta, Georgia

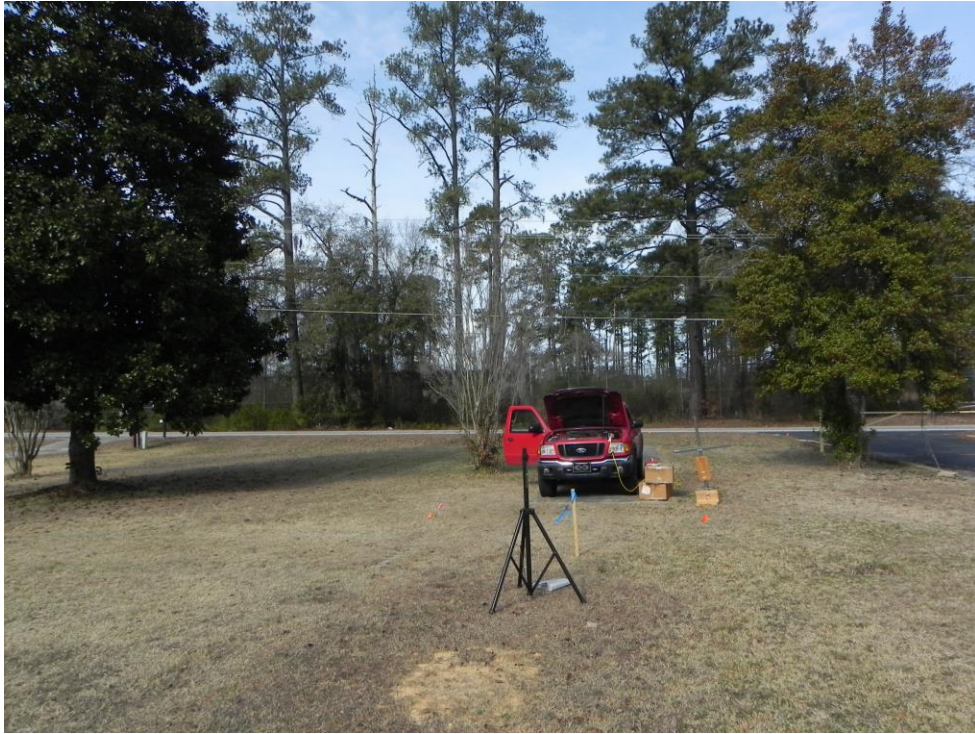
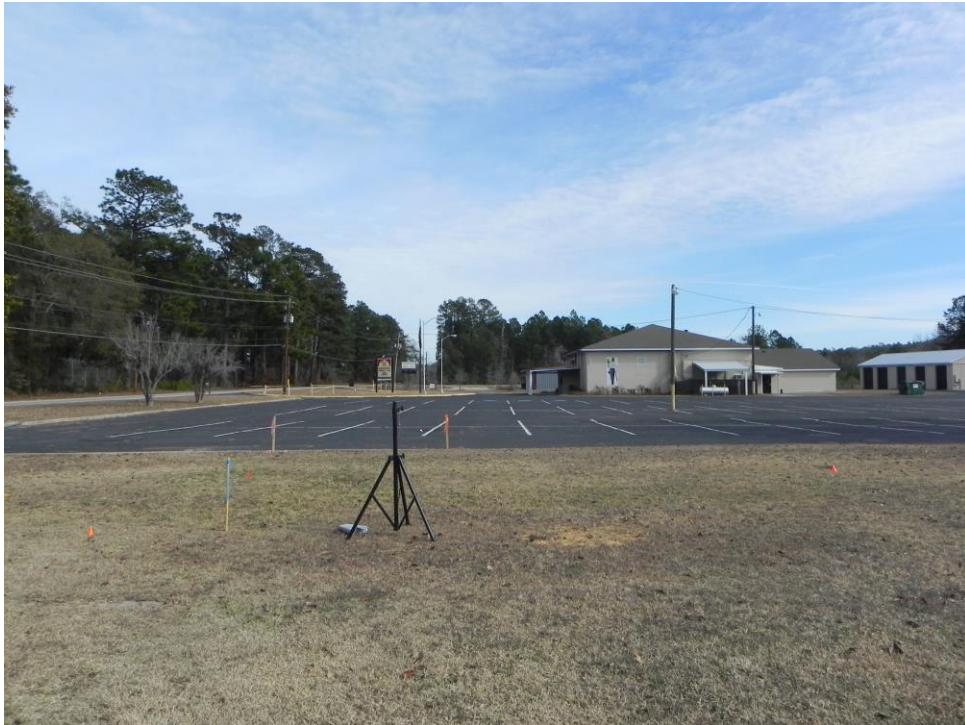
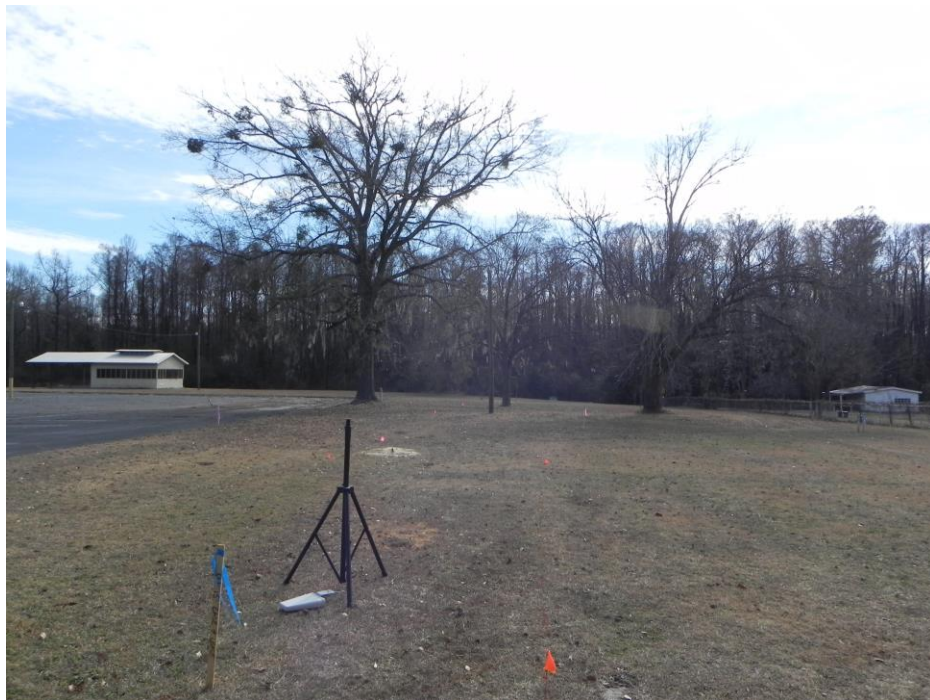
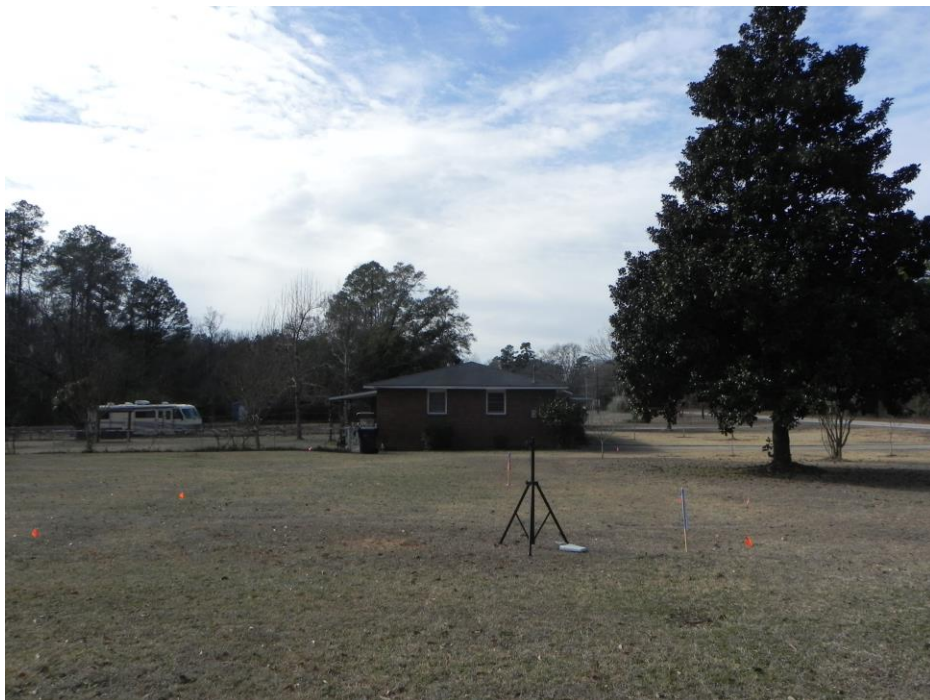
Figure 3.1-1 Earth Station Site Photographs

- Table 3.1-1 presents a site data sheet including all pertinent site information.
- Figures 3.1-1 and 3.1-2 are the photographs depicting the existing earth station site and satellite arc.
- Figures 3.1-3 through 3.1-10 are the RF spectrum photographs depicting the interference environment at the test site.
