Certificate No: CD1880V3-1122_Feb23

CALIBRATION CERTIFICATE

Object: CD1880V3 - SN: 1122

Dipole Impedance Measurement

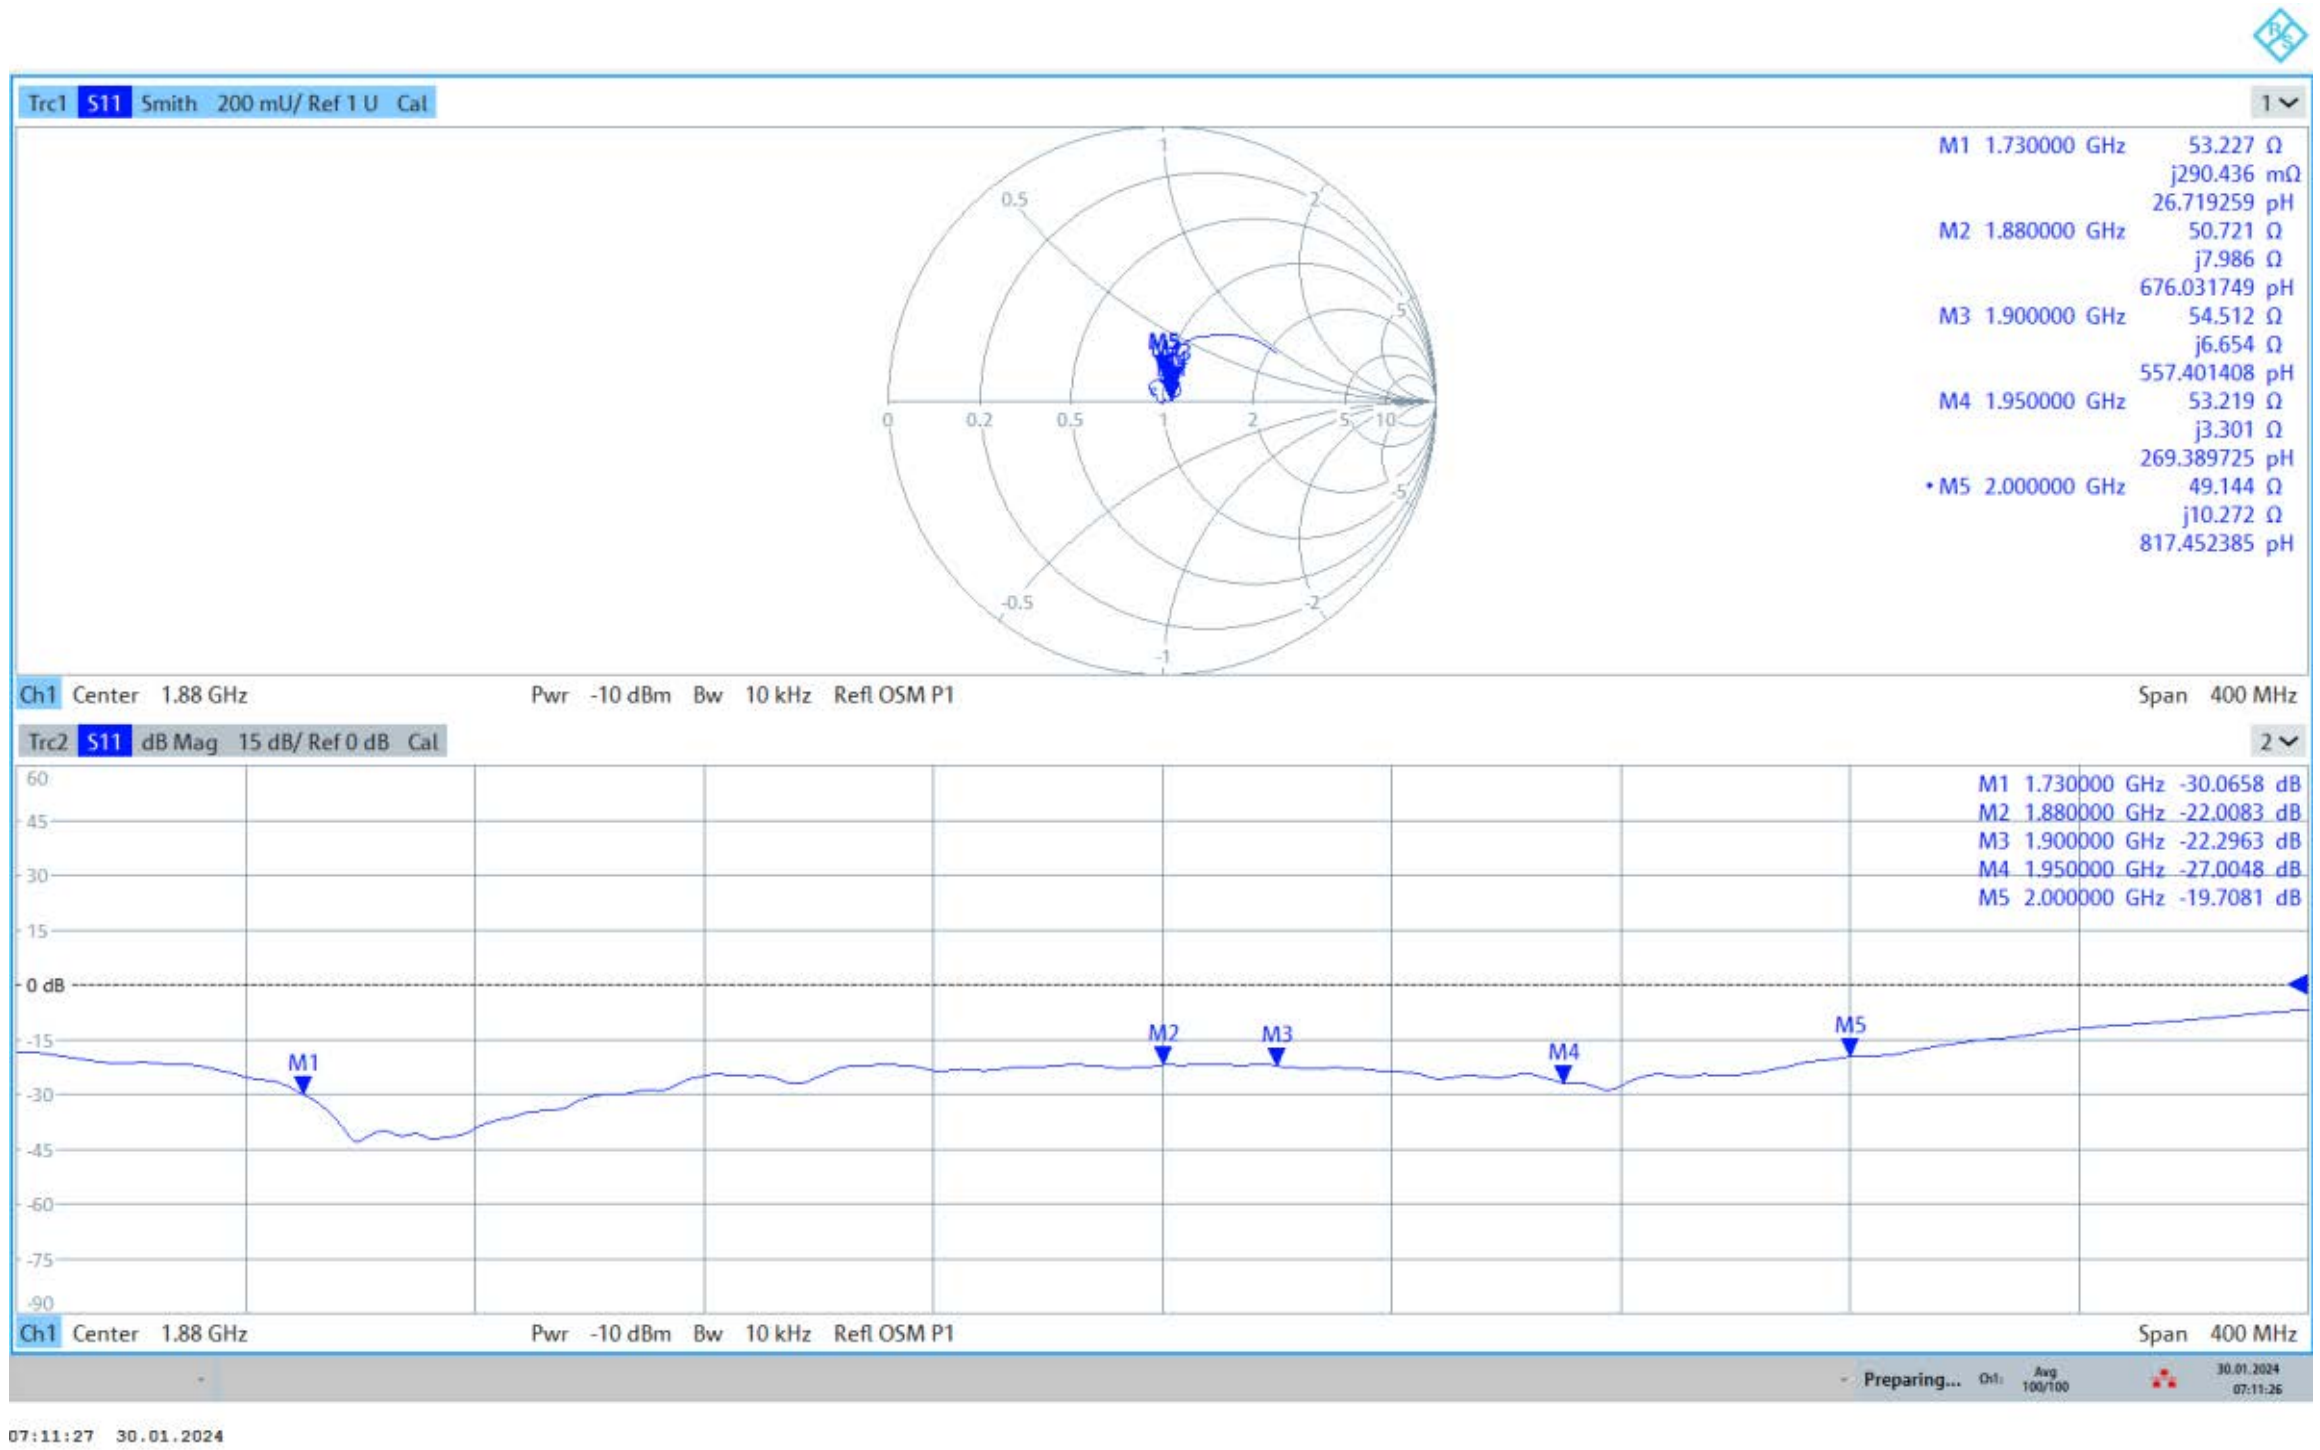
2) Impedance and Return/Loss

- Return/Loss is greater than the -20 dB cutoff and Impedance is within 5 Ω of previous value.

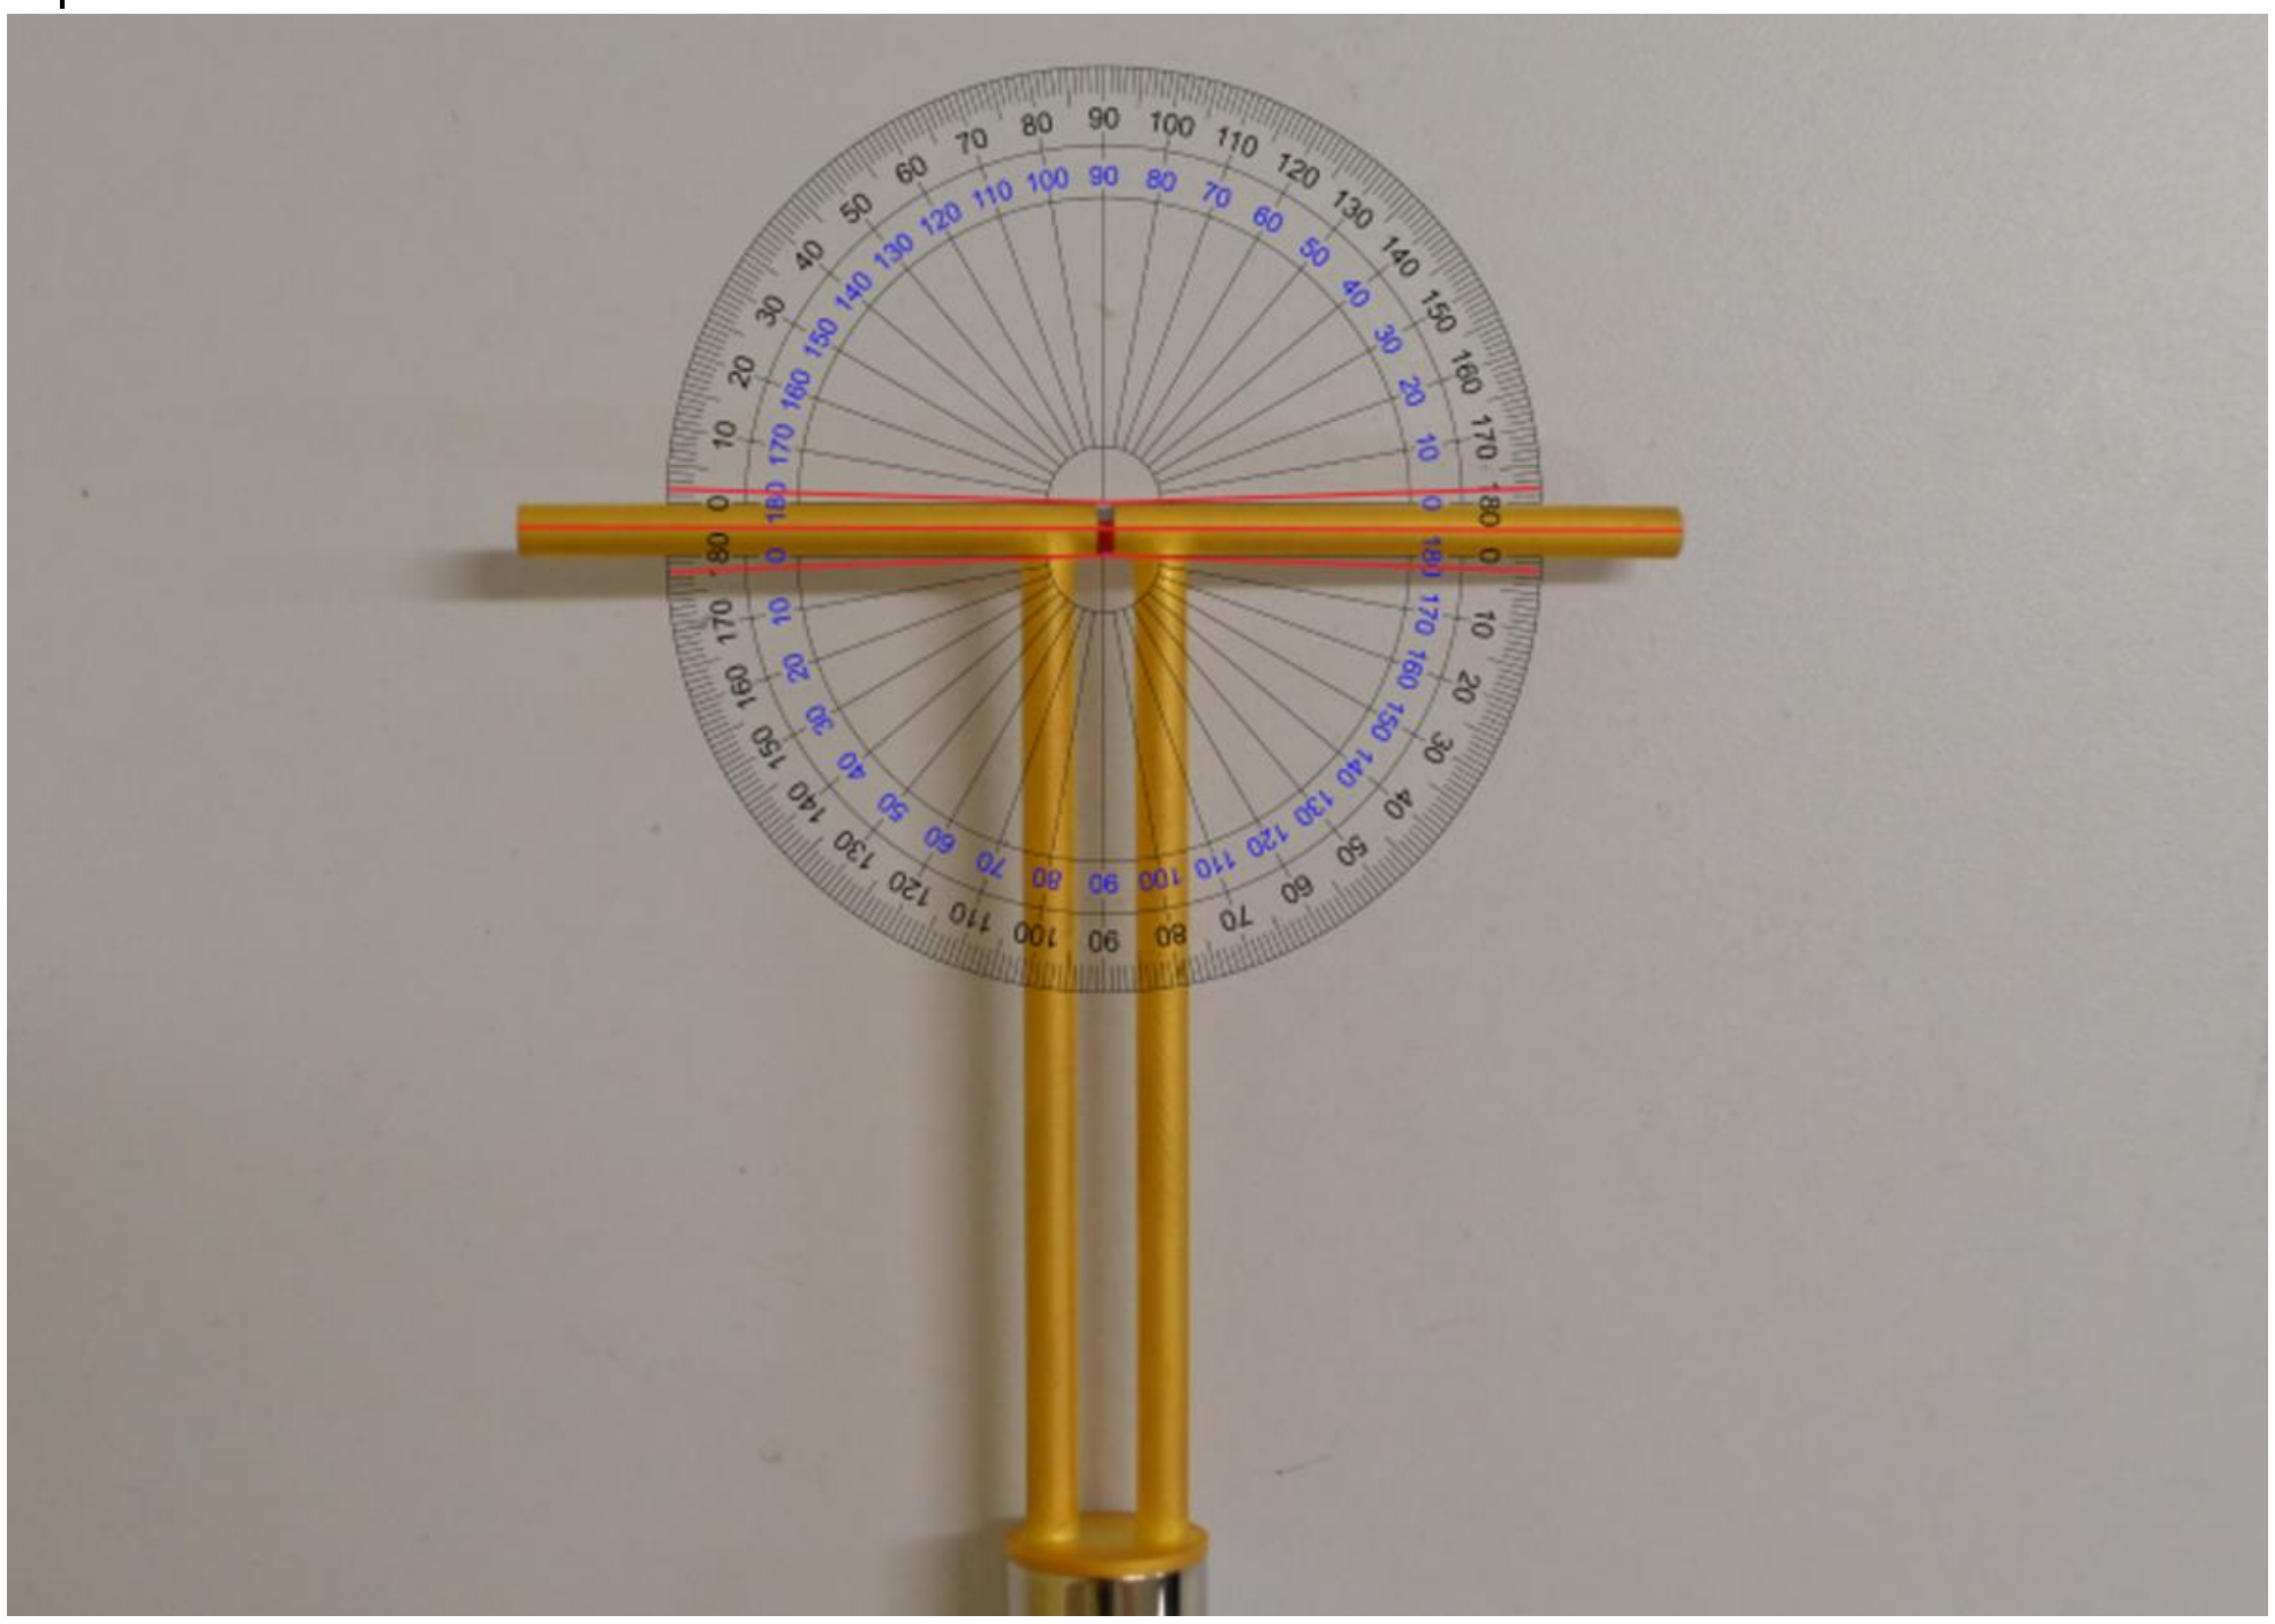
3) Dipole Arms

- The center red line indicates that the arms of the dipole fall within $\pm 2°$
