SUBJECT : Hyundai ImageQuest Co., Ltd.
FCC ID: PJIL19C0D072
Class II Permissive Change
Orig. Grant Date: September 16, 2004

FCC ID : PJIL19C0D072
Model No. / Type No.: L90D+ / L19C0D072

• Solution for EMI

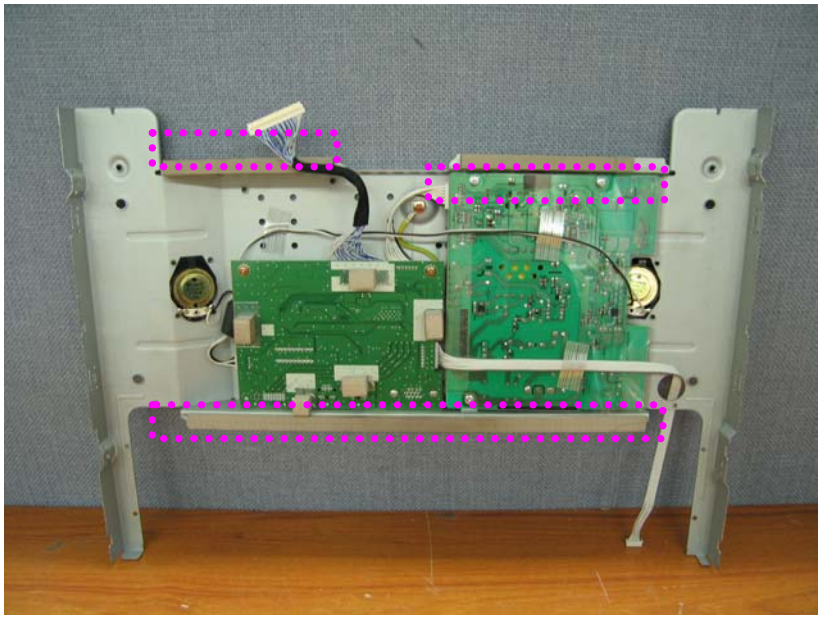
1. Attach a gasket to internal frame

2.Apply a ferrite Core to the Speaker Cable

1. Attach a gasket to internal frame
2.Apply a ferrite Core to the Speaker Cable
3. Attach a gasket to main board
4. Apply a strip of aluminum tape on the conductive strip to the frame.

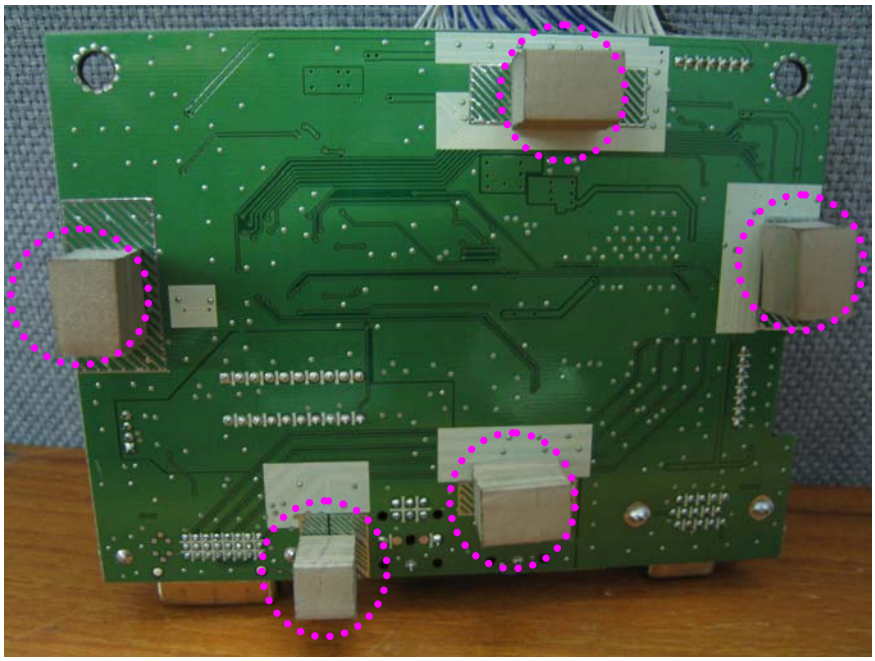
3. Attach a gasket to main board

4. Apply a strip of aluminum tape on the conductive strip to the frame.
