## DASY/EASY - Parameters of Probe: EX3DV4 - SN:3911

**PROBE REPAIR REPORT – SPEAG Production Center**

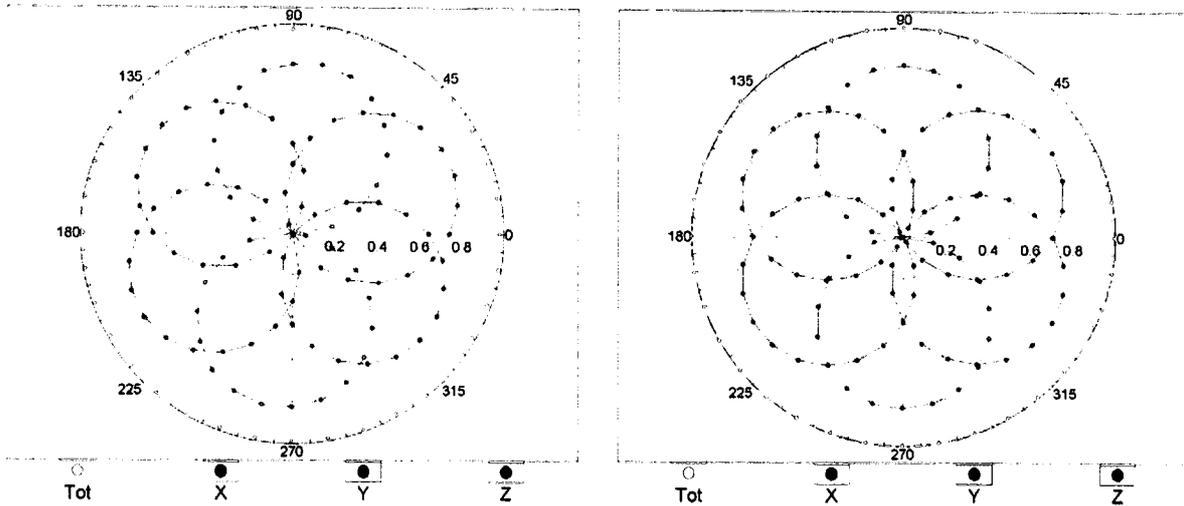
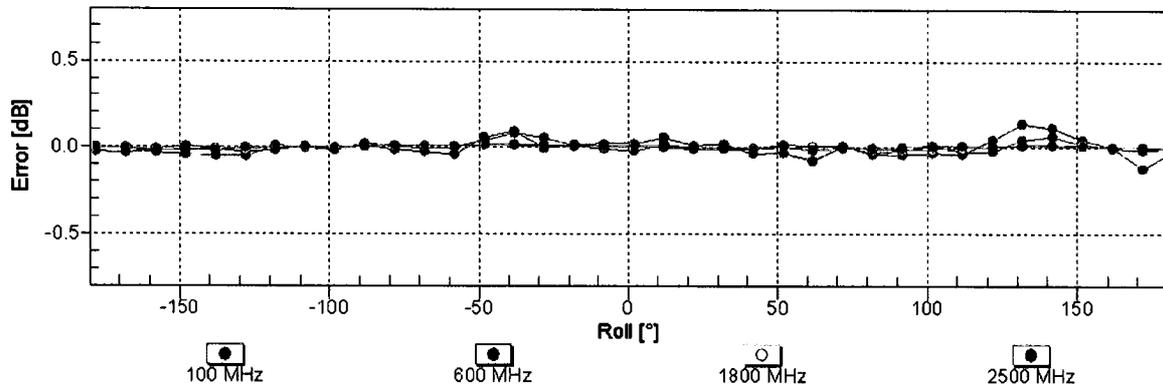
### Receiving Pattern ( $\phi$ ), $\theta = 0^\circ$

f=600 MHz,TEM

f=1800 MHz,R22

Uncertainty of Axial Isotropy Assessment:  $\pm 0.5\%$  (k=2)

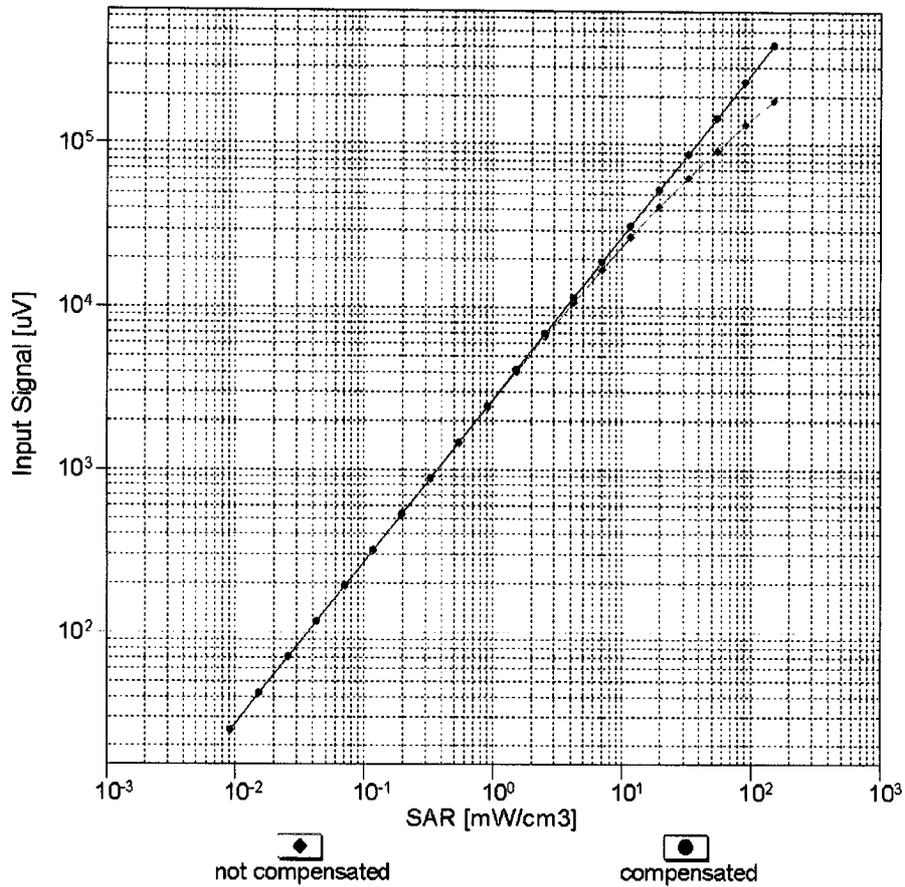
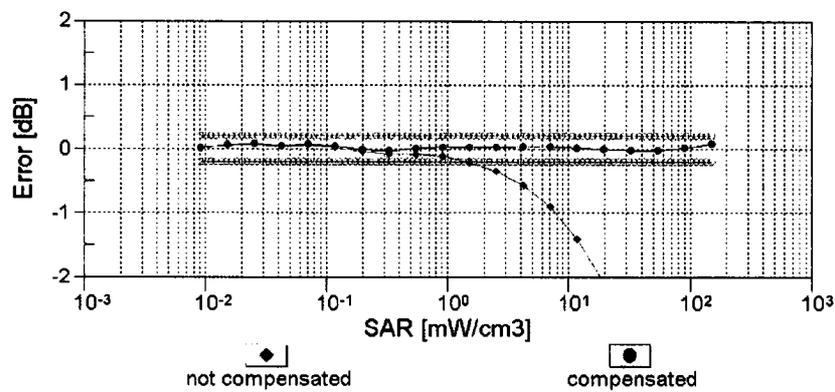
### Dynamic Range $f(SAR_{head})$ (TEM cell , $f_{eval}= 1900$ MHz)

Uncertainty of Linearity Assessment: ± 0.6% (k=2)

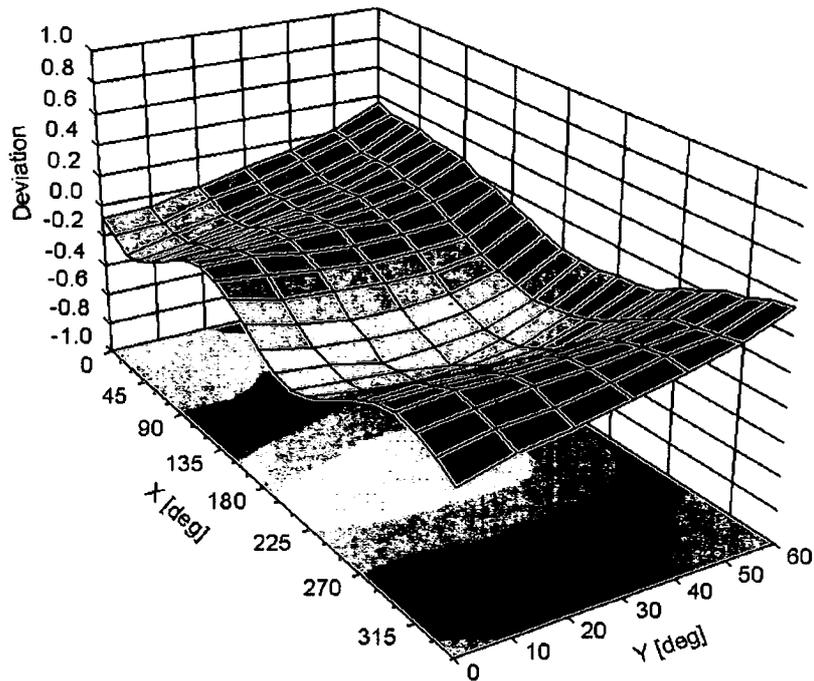
## Deviation from Isotropy in Liquid

Error ( $\phi, \theta$ ), f = 900 MHz

Uncertainty of Spherical Isotropy Assessment:  $\pm 2.6\%$  (k=2)
