In the design of the referenced device, P&G made intentional design choices which we understood would impact the efficiency for Band 5 and GSM 850. We note the follow construction features which caused this impact:

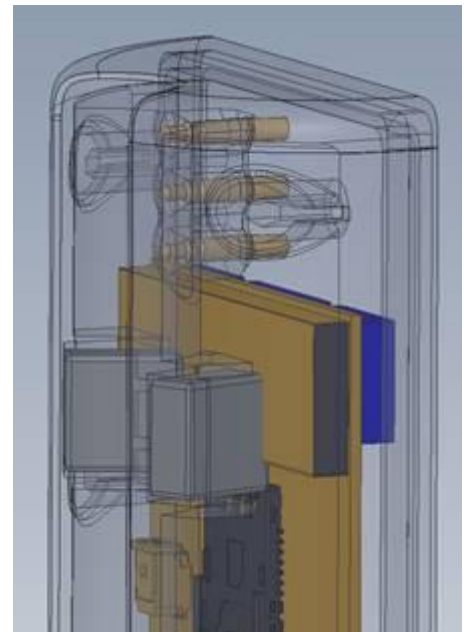
- Antenna, marked in blue, assembled on the base PCB (top) requires the area free of any components on the opposite side of the PCB (bottom), marked in yellow. However, it was not possible to keep this zone absolutely free of any components
- The following aspects affect the antenna efficiency negatively:
 - Two magnets “touching” the free zone
 - The magnetic field of the magnets
 - 3x wires soldered on the pins above the antenna (wires are not represented in 3D)
 - Docked handle (not shown in 3D)
 - Internal tests of the antenna without the housing and handle got better results, thus indicating that the poor efficiency is caused by the mechanical parts in the near environment of the antenna.
