# Service Manual

This document outlines the service manual for L5711AC

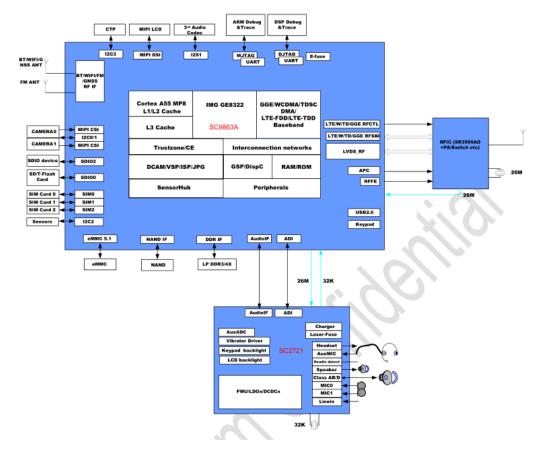
5.2.system.diagram

### 5.1.SC9863 system diagram.

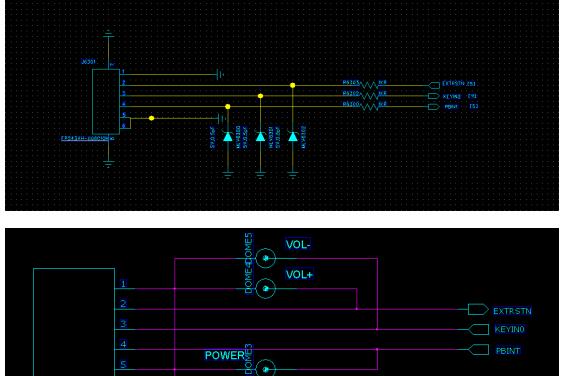
L5711AC provides a 3\*1 keyboard, See the figure below, the column lines connected to the CPU AND PMU port through internal. when the button is not pressed, all output is high. representing no key is pressed. Bound output is low, once any key is

pressed, the input line will be down, so that by reading the state of input lines that check whether keys be pressed.

- 1. Check if keypad and DOME are damaged, the assembly OK ,and foreign matter exist, etc;
- 2. heck if the surrounding components(mainly varistors) on the main board are damaged and have soldering issues, etc;
- 3. Replace with new keypad or side key, and verify agai
- 4. you still have not found the problem, then check whether the U0200 and U2100.

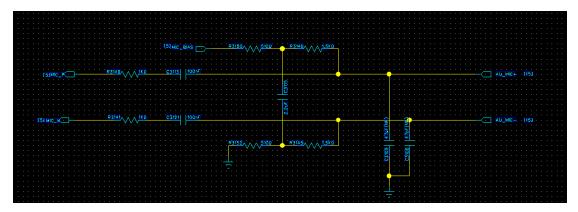
#### 5.4 Microphone function abnormity

4: Enter the call state (or engineering test mode), measuring if microphone's bias voltage is normal: the voltage is when the microphone works about 2.8V, and 0V when off;

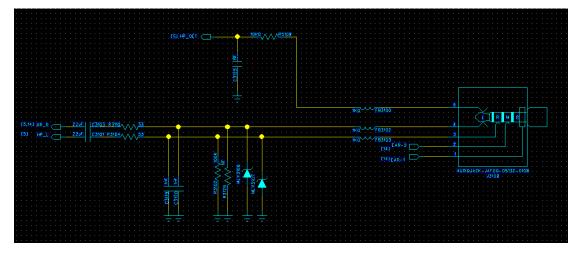
### 5.5.Headset function abnormity

4: Enter the Headset state ,measuring if Headset HP\_DET's voltage is normal: the voltage is when the Headset input about 0V, and 2.8V when Pull out;

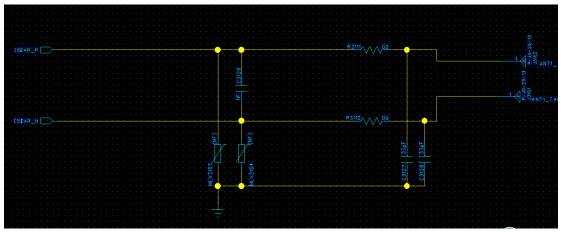
5.6. Receiver function abnormity.

- 1. Check if the receiver shrapnel's elasticity is well, and contact with PCB well;
- 2. Check whether the relevant components have soldering problems or not;
- 3. Replace with new receiver, and verify again;
- 4. If you still have not found the problem, then check whether the U0200 chip has soldering or performance problems or not.

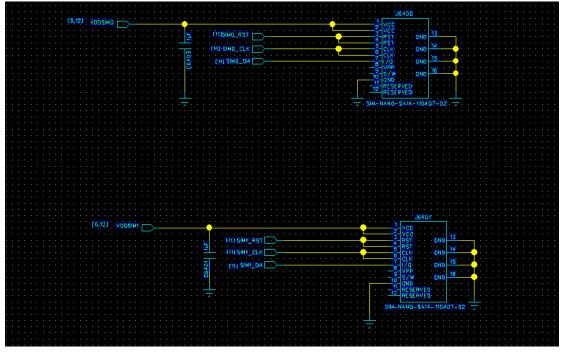
L5711ac has two SIM card connectors, supports dual SIM dual standby.

- 1. Check if the dual- cards' insertion direction is OK;
- 2. Check if the card connector metal contact points have problems, such as existing foreign matters or are rusting, etc;
- 3. Check if the SIM card connectors and components around have soldering problems;
- 4. If failed to find out problems, check whether U2100 chips have soldering or performance issues.

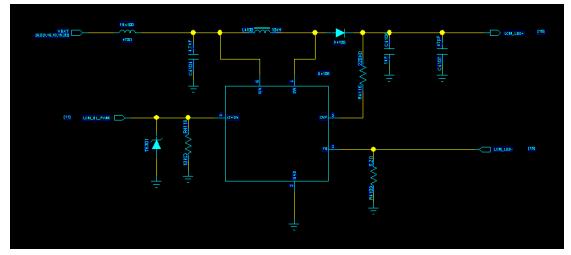
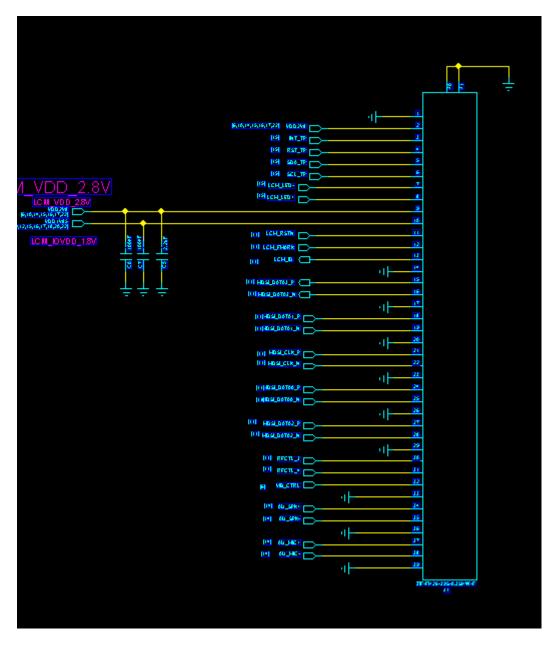
L5711AC LCD backlight is directly drive by U4100, LCD data and control lines connect to LCD interface through the capacitor, specific circuit as follows:

- 1. Check if the LCD is damaged, and J1 has soldering problems;
- 2. Check if t h e relevant components h ave soldering problems;
- 3. Replace with new LCD, and verify again;
- 4. If still failed to find out problems, check whether U2100 U4100 chip has soldering or performance problems.

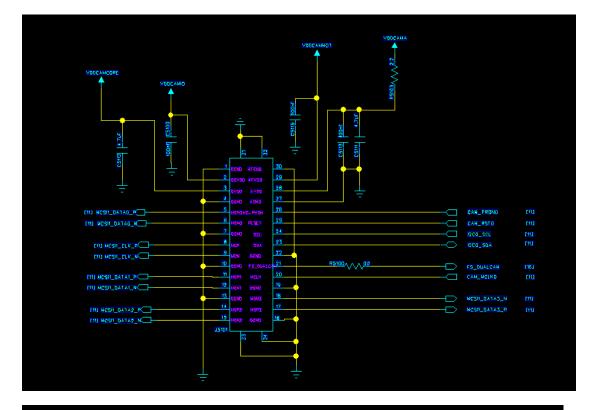
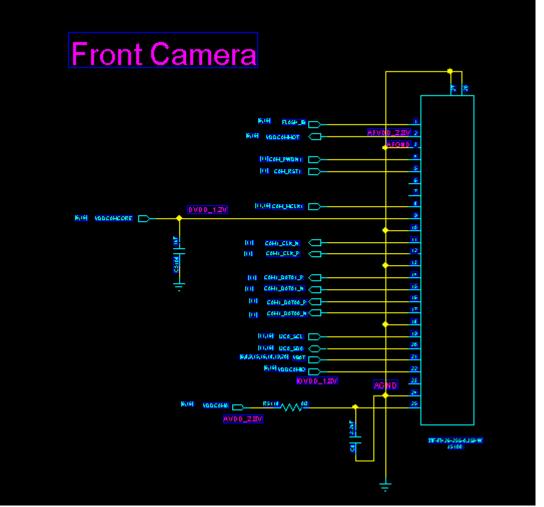
L5711AC configured with a 8 million pixels main and Front Sub camera. the data and control lines which connect to the main chip's camera interface irectly .The main camera's power supply is provided by U0200 ,Specific circuits as follows:

- 1. Check if the camera has quality problem, and Camera has assembly problem;
- 2. Check if the camera's power supply voltage AVDD DVDD is normal , and components around J5100 J5101 have soldering problems;
- 3. Replace with new camera, and verify again.
- 4. If still failed to find out problems, check whether U2100 chip has soldering or performance problems.

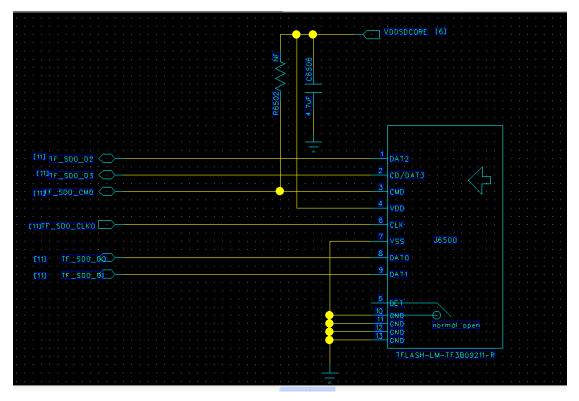
### 5.11. T card function abnormity

- 1. Check if the T card connector's has quality problem, metal contact points abnormal;
- 2. Check if T card connector and components around have soldering problems;
- 3. If still failed to find out problems, check whether U2100 chip has soldering or performance problems.

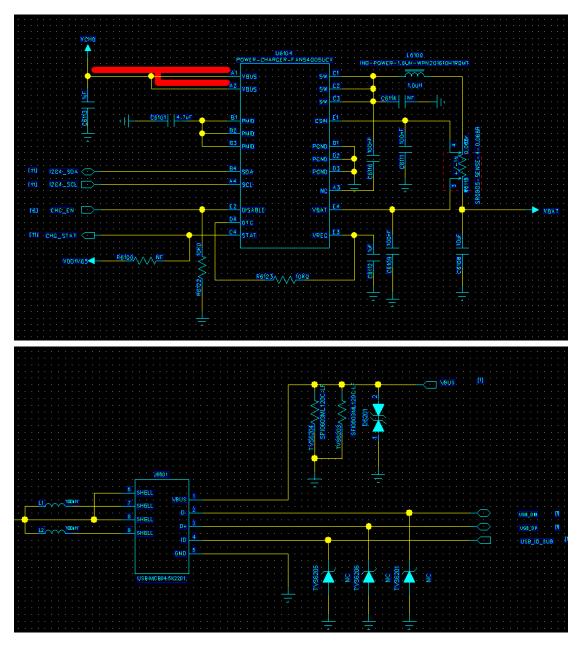
You can charge the phone through two methods: through hrough DC charger with about 1A charging current or through the USB cable connecting to a computer with about 450mA charging current. Both charging is controlled by U6104, Specific circuits as follows:

- 1. Check if the USB socket J6601 pins rust or have soldering problems;
- 2. Check if the battery connector's metal contact well or not, such as existing foreign matters, rusting or soldering badly, etc;
- 3. Check if the relevant components of the charging circuits have soldering problems;
- 4. Replace with U6104, and verify again;
- 5. If still failed to find out problems, check whether U0200 chip has soldering  $\,$  or performance  $\,$  problems\_{\circ}

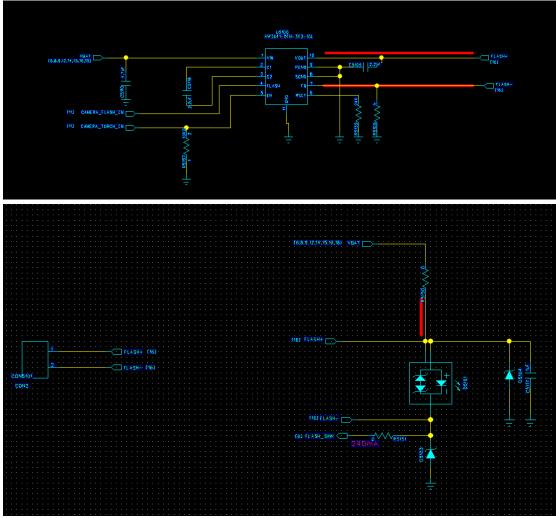
### 5.13. Camera flash.

- 1. Check if the relevant components have soldering problems;
- 2. Check if the FINGERPRINT is damaged, and D5101 has soldering problems;
- 4. Replace with D5101, and verify again;
- 5. If still failed to find out problems, check whether U2100 U5100 chip has soldering or performance problems  $_{\circ}$

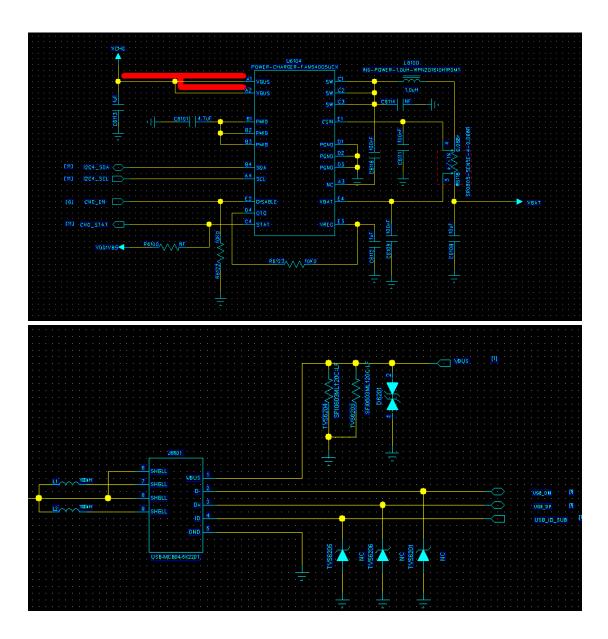
# a) OTG abnormity

- 1. Enter the otg state ,measuring if VCHG voltage is normal: the voltage is when the otg output about 5V.
- 2. Check if t h e relevant components h ave soldering problems; After the OTG is inserted, the USB\_ID PIN becomes normal when 1.8V becomes 0V.
- 3. If still failed to find out problems, check whether U6104 U2100 chip performance problems .
