5 FAQ

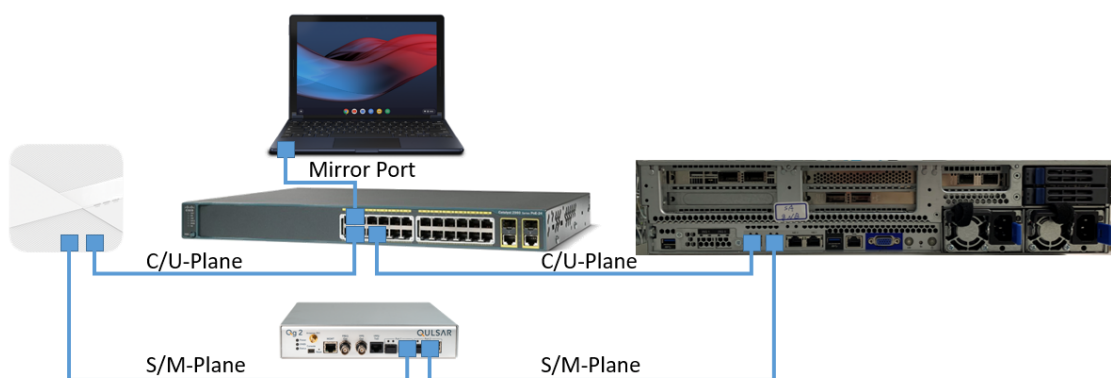
Figure 36 O-RU O-DU connectivity with Switch and GM

5.5 Can I add a Switch to connect O-RU and O-DU?

Yes. Please make sure following items:

- iii. The L2 switch should support VLAN with tag.
- iv. Those ports (connected to BBU and RU) should be in trunk mode
- v. Both VLAN 1 and VLAN 2 should be in those trunk ports
- vi. Should keep VLAN tag in those ports (DO NOT set untag)
- vii. Enable jumbo frames. Set frame size more than 9000 Bytes.

5.4 Can I add Switch between O-RU and GM?

Yes. But, please make sure Switch supports IEEE 1588 PTPv2.
