SD9 PCB Updates and comments

D.M. 8/10/2019

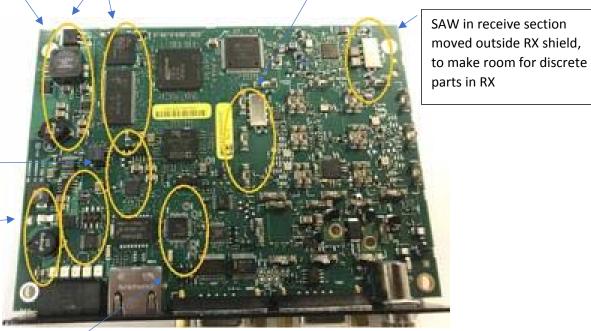
Moved power supply away from RF section

Memory/flash moved to right

When power supply moved to left, moved SAW filter closer to upconverter. Now under a shield

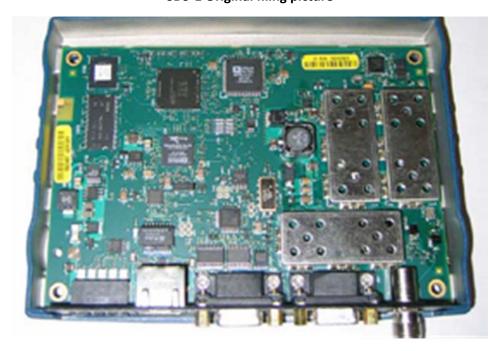
Same Ethernet drivers

Added DC/ESD input surge protection

CODEC moved slightly for production ease

No changes in the TRANSMIT section or TX parts changed.
