### 3.7 Antenna Installation & Alignment

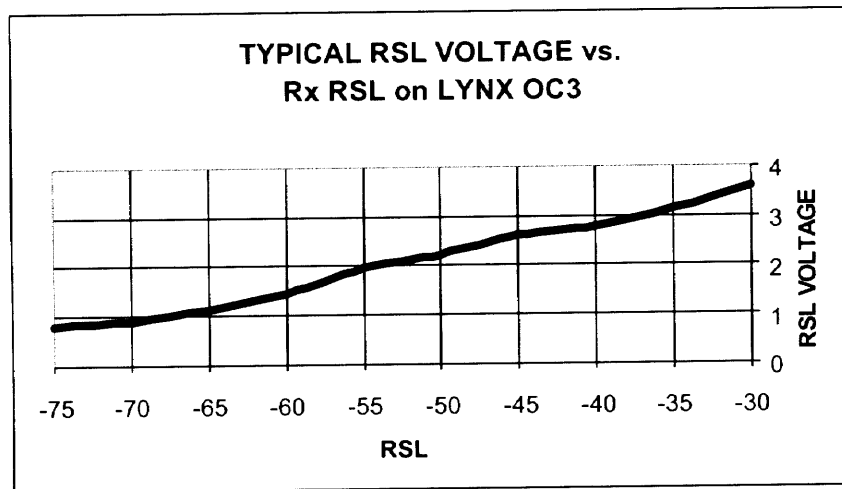
**Figure 3-7: Typical RSL Voltage versus Received Signal Level (RSL)**

The graph shown in Figure 3-7 shows the typical variation of RSL voltage as the receive signal level is increased from threshold to a higher level. There is some variation between *Lynx* receivers, but an approximate estimate of the potential RSL value may be made using this figure.

Unless special test equipment is available, two operating *Lynx* radios are required to align the antennas. The antenna is coarse aligned using visual sighting and then fine aligned using the receive signal level (RSL) voltage of the *Tsunami*. See figure 3-7.

The larger the antenna size, the more critical alignment becomes: for example, with a 2 foot dish, the antenna can be moved  $\pm 3$  degrees off the correct heading before the receive signal level drops by 3 dB. This compares with a 6-foot dish which may only be moved  $\pm 1$  degree for the same degradation.

Above 0 dBm RSL, the receiver may produce errors: however this level is rarely likely to be exceeded. A link budget calculation should be made to calculate the anticipated RSL as described in Section 3.3.3. During anomalous propagation conditions, the RSL may fade but will not increase up more than 10 dB (except in unusual very long paths which may fade up by 15 dB).

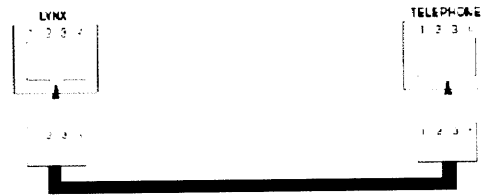
**Figure 3-8: Orderwire & VF Port Connection**

Orderwire Connection

VF Port Connection

1. Using a standard RJ-11 telephone cable, connect a standard electronic telephone (a touch tone phone, complete with dialer; a handset by itself will not work) to the Orderwire connector on the *Lynx* front panel. This connector is wired identically to a standard two-wire telephone jack, see Figure 3-8 for details.
2. With a telephone connected to each *Lynx* terminal on opposite ends of the link, either telephone can be used to "dial-up" the far-end location. The far-end terminal's internal ringer and the connected telephone will ring, and if answered, two-way full-duplex voice communication is established.

uses 2 digit addressing, and 0 dBm VF interface, it can be connected to a Lynx as shown in Figure 3-9.

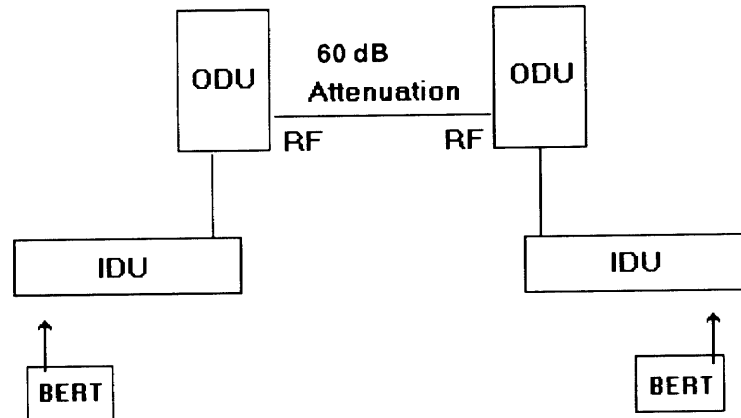
**Figure 4-1: Back-to-Back Test Configuration**

Back-to-back testing, as shown in Figure 4-1, is an ideal method of testing the *Lynx* radios. This testing eliminates link problems caused by auxiliary equipment, installation, or the radio path and isolates potential radio hardware problems. Back-to-back testing must be performed with both radios at the same location. The following test equipment is required:

*Use a coax cable with approximately 60dB attenuation*

When the equipment is connected as shown in Figure 4-1, both *Lynx* radios should have no alarm conditions. If these conditions have been met, then it is likely that the *Lynx* radio is operating in accordance to specifications. If errors or alarms occur during this test, verify that all configuration settings are properly set. If alarms or errors are still present, the radio is likely to be faulty.
