Lab-response to PBA 345953

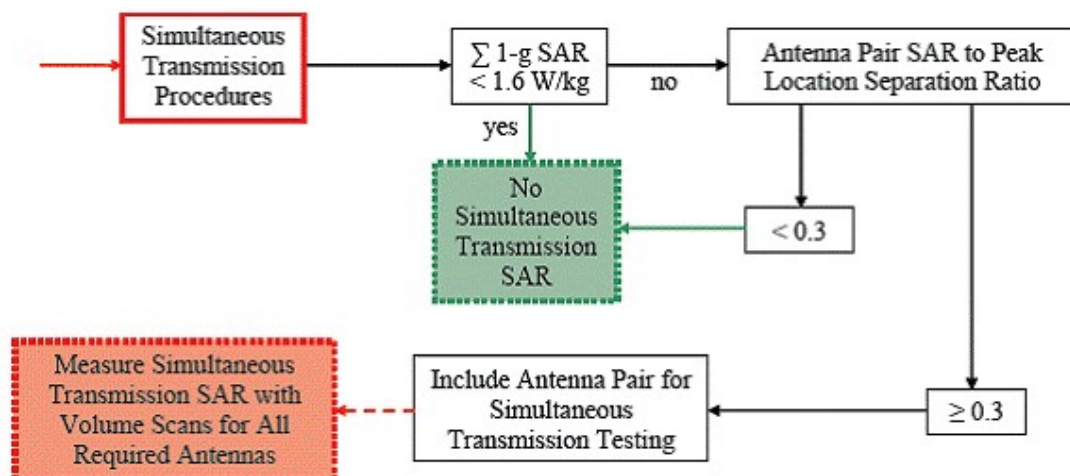
[SGS response] We follow FCC KDB648474, and calculate the summation of SAR on 2 transmitters to judge if simultaneous transmission is necessary, as below flow chart.

3) Please remove the adding of the WCDMA B2 and WLAN 802.11b SAR levels on page 8. They should be referenced separately and not added together. They do not combine to equal 1.78 W/kg.
