System Commissioning

Commissioning Process

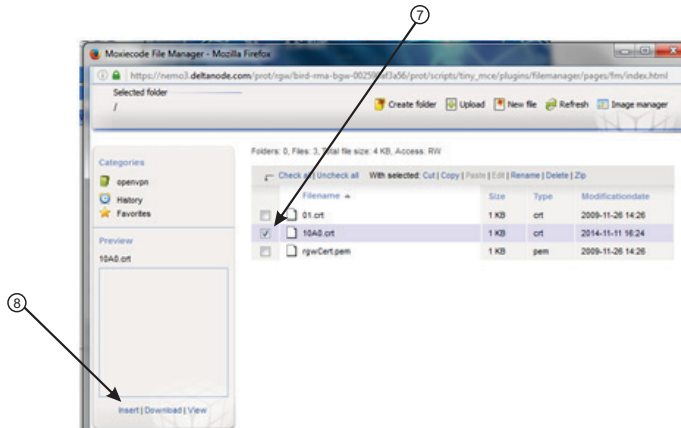
Figure 114 Certificate Selection

7. Select the check box next to the 10##.crt file. See [Figure 114](#).
8. Click "Insert"

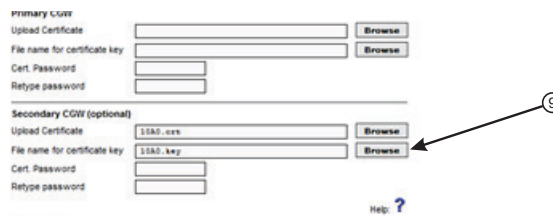
Figure 115 Key Entry

9. Select "Browse" for the File name for certificate key. See [Figure 115](#).

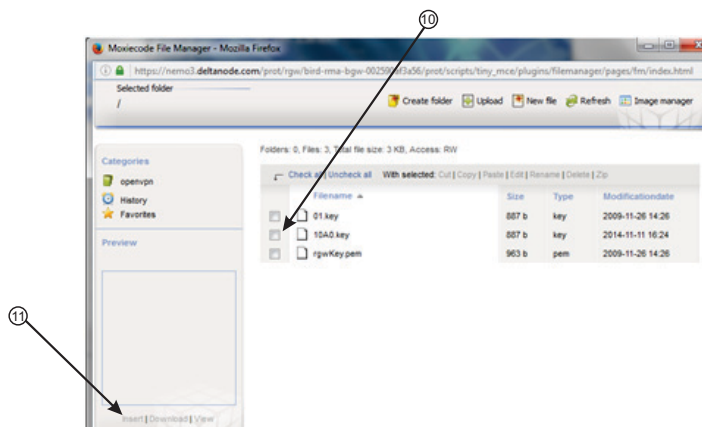
Figure 116 Key Selection

10. Select the check box next to the "10##.key" file. See [Figure 116](#).
11. Select "Insert"

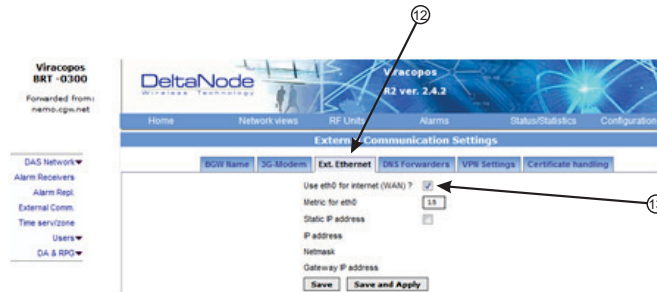
Figure 117 External Ethernet

12. Select Ext. Ethernet Tab
13. Select the check box for “Use eth0 for Internet (WAN).”
This ensures external Ethernet connections are allowed.

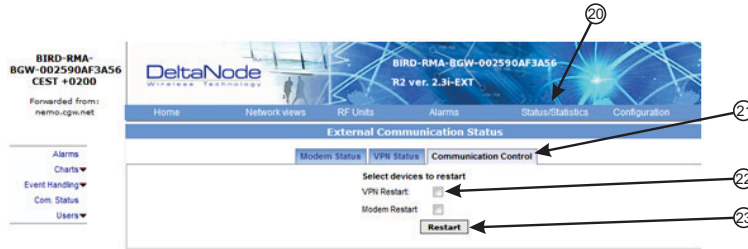
Figure 120 VPN Restart

20. Click on "Status/Statistics."
21. Select the "Communication Control" tab.
22. Select the check box next to "VPN Restart."
23. Click "Restart."

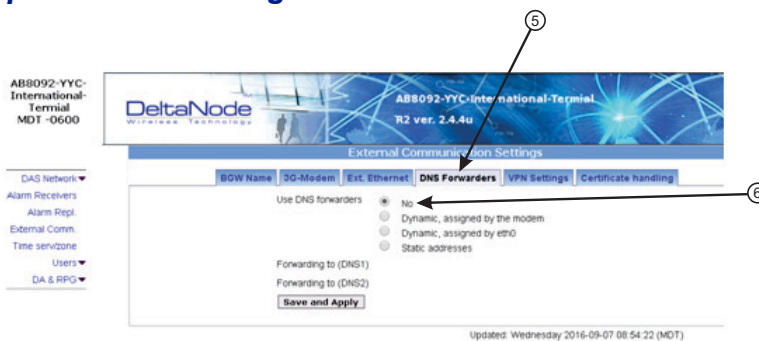
Figure 130 Stop DNS Forwarding

5. Select the DNS Forwarders tab. See [Figure 130 on page 107](#).
6. Select the "No" radio button.

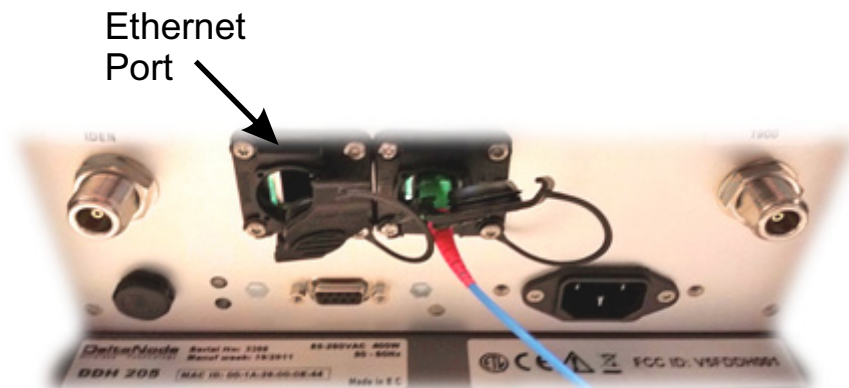
Figure 131 Remote Unit Ethernet Port

- Set laptop to a static IP address; something along the lines of
 - IP address 169.254.48.11
 - Subnet Mask 255.255.0.0
 - Gateway 169.254.0.1
- Connect RJ45 Ethernet cable to the laptop and the Ethernet port on the remote.

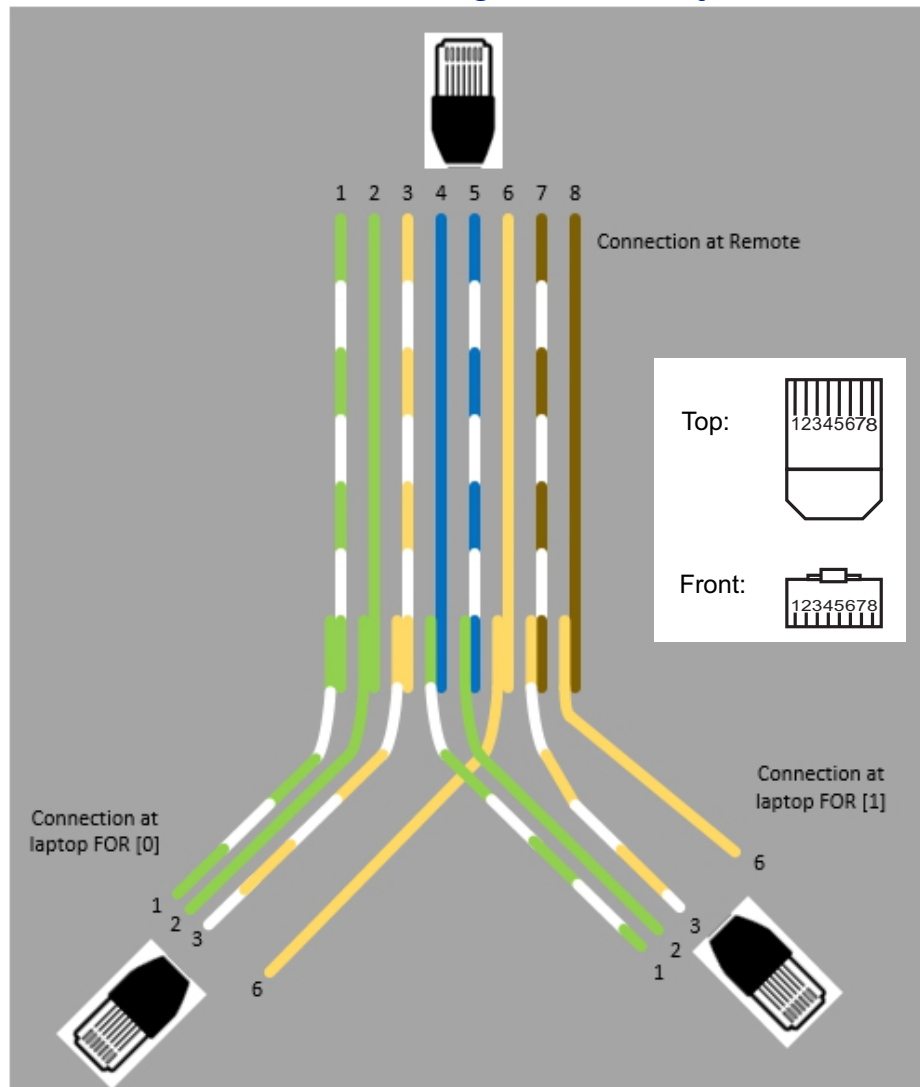
Figure 133 Custom Cable for Connecting to two FOR systems

1. Cut both Ethernet cables in half.
Three sections will be needed.
2. Strip back the insulation on each wire about 0.5 inch/13mm.
3. Twist the color pairs together as shown in [Figure 133 on page 110](#).
4. Use electrical tape to cover the connections so bare wire do not touch.
Unused cable strands can be cut.
5. Secure the splice with electrical tape so that stress does not pull the wire pairs apart.
6. Clearly mark each connector to distinguish which connector is attached to the remote and which connector plugs into the laptop for FOR [0] and FOR [1].

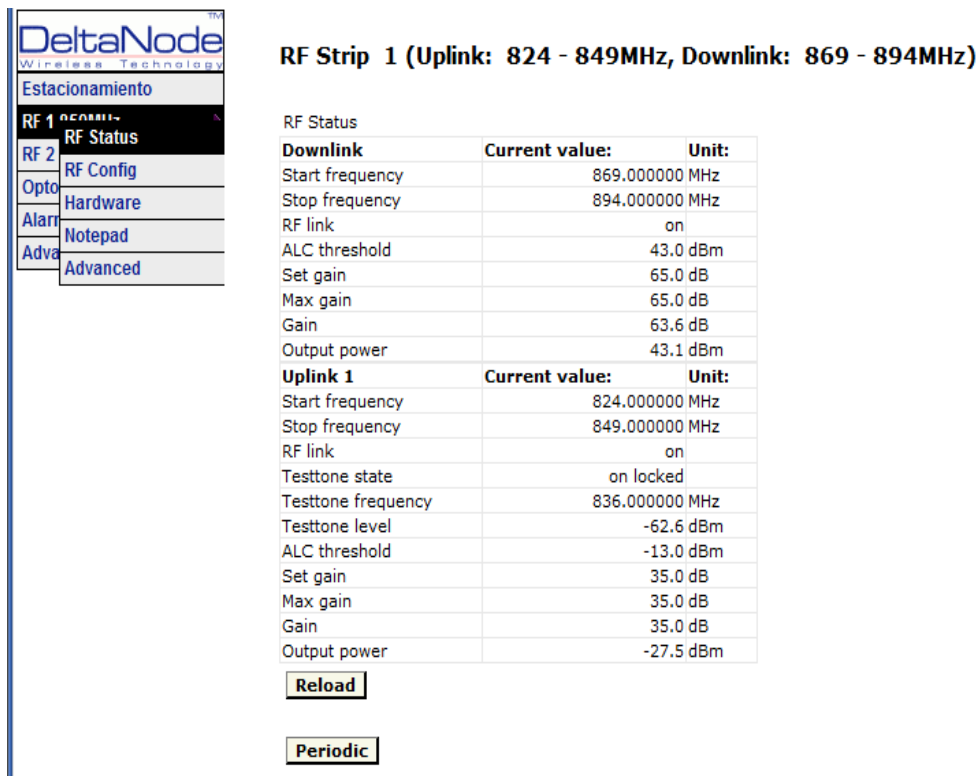
In this screen you should also turn RF on, set the gain to about 35 dB as a starting point and then turn on the uplink test tone. Note the frequency of the test tone, this is the frequency you should be measuring on your spectrum analyzer.

Turn on the spectrum analyzer, make sure it is connected to the right port on the right BIU and then find the frequency. A reasonable span is 1 MHz and the receiver band width can be set to 30 kHz or similar. Use the marker to measure the peak of the signal. Then go to the next screen on the remote unit, the RF Status screen.

RF Strip 1 (Uplink: 824 - 849MHz, Downlink: 869 - 894MHz)
