Operation description

The development and design of the - PCBA is based on SC9832A platform. The mainboard system mainly consists of the chip SC9832A + SC2723G2 + SC2342A, which are responsible for three part functions, namely, baseband, radio frequency and BLUETOOTH/FM chip. - PCBA is an all-in-one phone mainboard, which supports GSM, LTE and covers Bluetooth, Camera, FM functions, and so forth.

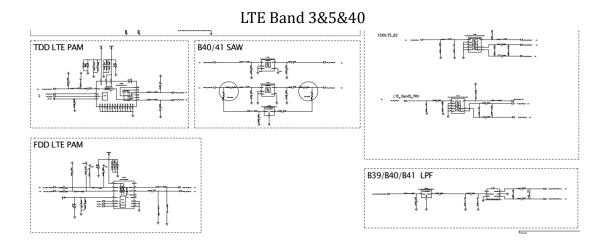
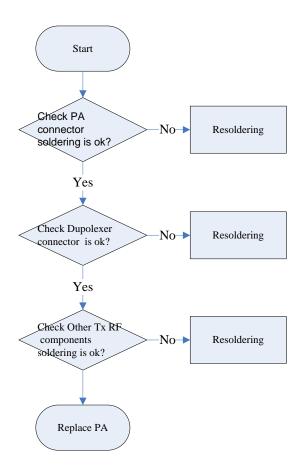
2.1 LTE RF power trouble

Check points

- -PA connector soldering
- -Duplexer connector soldering
- -Other Tx RF Component soldering

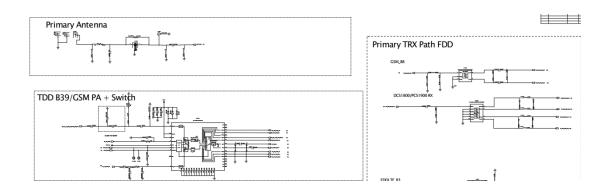
2.2 **GSM RF power trouble**

Check points

- -Tranceiver connector soldering
- -PA connector solderin

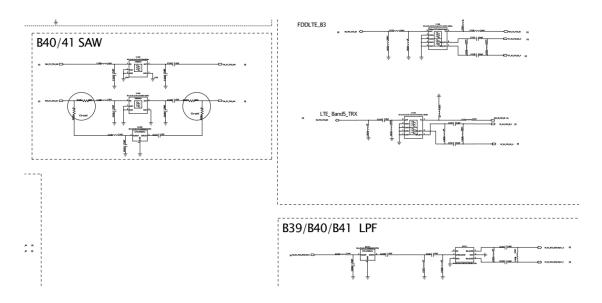
2.3 LTE RX trouble

Check points

- -Tranceiver connector soldering
- -Duplexer connector soldering
- -ASM switch connector soldering
- -Other Rx RF Component (L/C) soldering

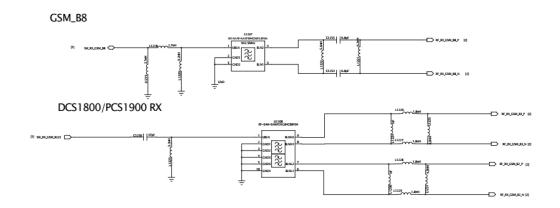
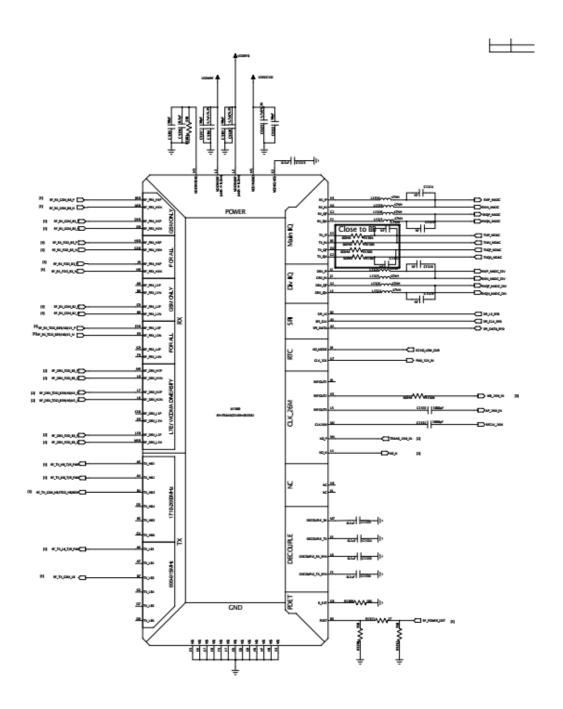
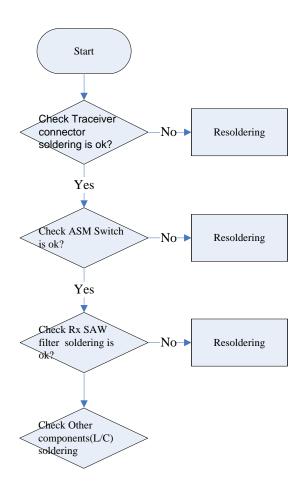
Primary TRX Path FDD

2.4 GSM RX trouble

Check points

- -Tranceiver connector soldering
- -ASM switch connector soldering
- -Rx SAW filter connector soldering
- -Other Rx RF Component (L/C) soldering

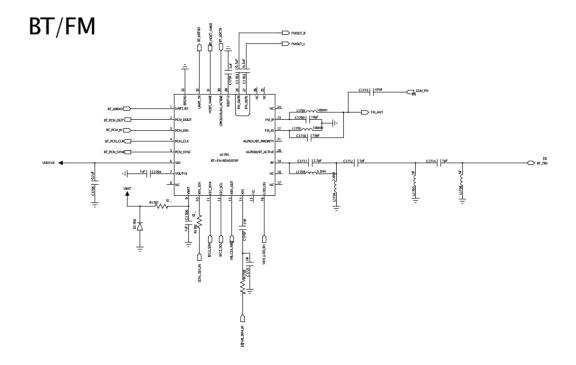
BT ANT

BT signal is entered by antenna, through U1700 2.4GHZ filter, filter sideband unwanted signal. The clock uses 26M clock.

Bluetooth does not need calibration, only need to check the function, if unable to search the device or Bluetooth can not be opened, check whether the U1700 is welding bad or body bad.

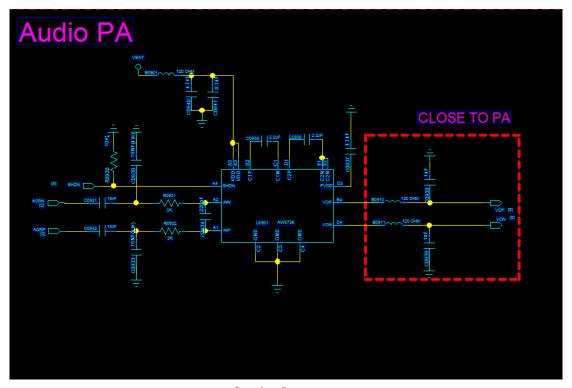
Speaker Loop

The - phone's speaker circuit is as follow

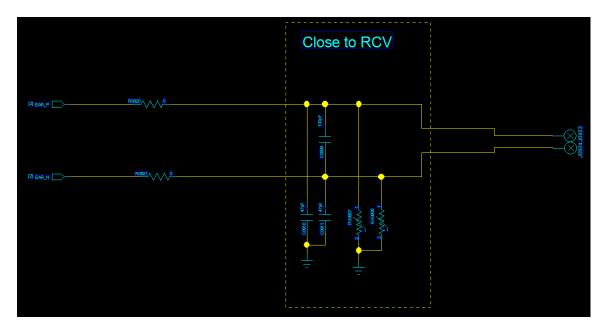
Receive Loop

- phone receiver is embedded in the mobile phone front shell through shrapnel and motherboard connection. Mainly used for the call. Receiver circuit diagram as shown below.

- 1, Receiver without sound:
- 1) Receiver assembly adverse, the shrapnel and board poor contact
- 2) Receive ontology bad
- 3) the volume settings or software problems
- 2, Receiver noise or volume:
- 1) Receiver incoming material, whether caused by pad short circuit
- 2) relevant components have solder skips
- 3) software problems

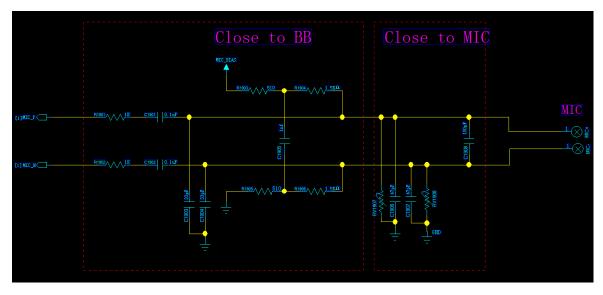
Main MIC

- 1 MIC unable to send words or recording:
- 1) MIC poor welding
- 2) MIC body bad
- 2 MIC noise or sound:
- 1) MIC ontology bad
- 2) software problems.

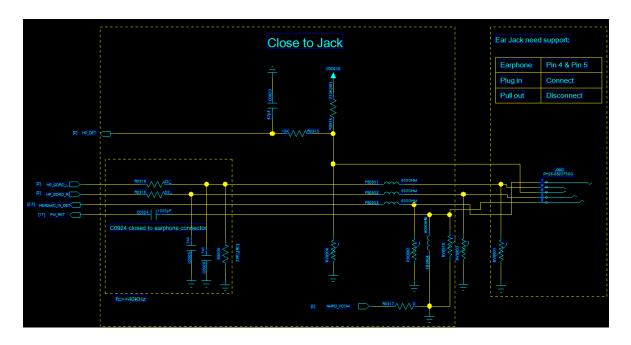
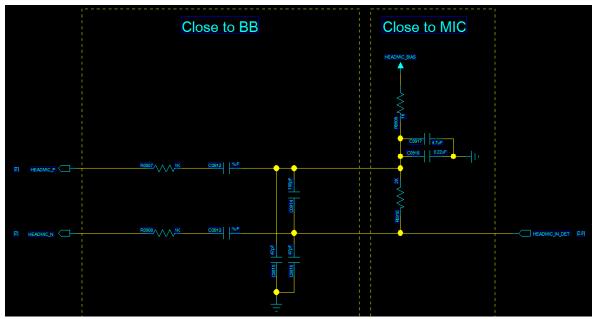
- 1, headphones only one channel sound:
- 1) the headset is not inserted in place
- 2) Relevant component Weld
- 3) Relevant component breakdown shorted to ground;
- 2, headphone left and right channels are no sound:
 - 1) the headset is not inserted in place
- 2) Relevant component breakdown on the short circuit
- 3, unplug the headphones bank borrowing does not recognize:
- 1) Relevant component Weld
- 2) whether headphones Block shrapnel and motherboard good contact
- 3) software reasons
- 4, headset MIC no transmitter:
 - 1) the headset is not inserted in place
- 2) Relevant component Weld
- 3) Relevant component breakdown on short-circuit;

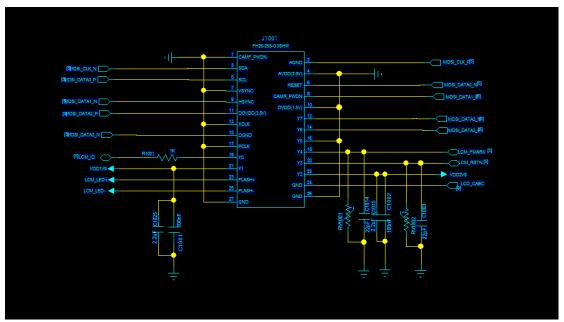
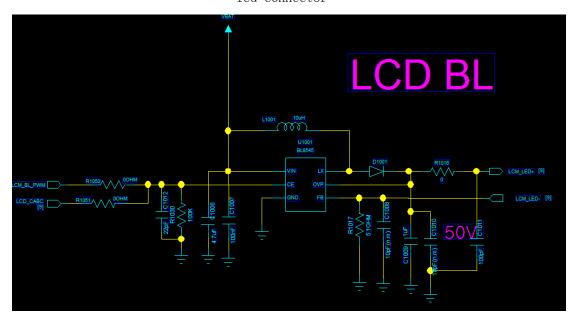
1cd connector

- 4.5-inch FWVGA LCD, The part of the circuit schematic as shown below. Common problems and causes of the LCD module:
- 1, LCD screen is blank
 - 1) LCD is not installed or and fixture poor contact
- 2) LCD backlight circuit is bad, check backlight so that the foot is pulled, check backlight IC whether Weld or shorted to ground
- 3) LCD itself fault.

- 2, LCD blurred screen and white screen. Description LCD backlight circuit OK, just shows abnormal. The cause of the malfunction is usually:
- 1) LCD connector poor contact, poor welding and fixture poor contact
- 2) related components Weld or even tin short circuit
- 3) software problems
- 3, LCD black spots, bright spots, black lines, stripes Failure: LCD ontology bad.

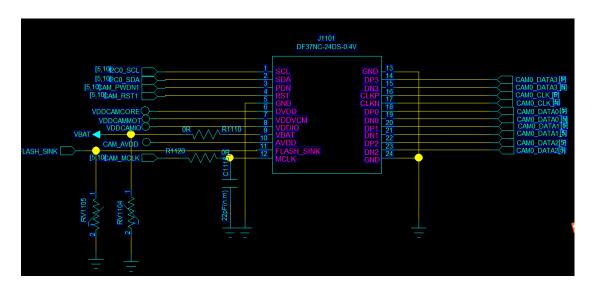
Back camera

- 1, Camera initialization failed, could not enter the Camera the main interface
- 1) Camera poor welding or poor contact
- 2) the Camera Ontology failure
- 3) Camera Power supply is not normal (Weld, or short-circuit led to)
- 4) related components welding problems
- 2, Camera Preview shows blurred screen or color is not normal
- 1) Camera poor welding or poor contact

- 2) related components welding
- 3) restore the factory settings after restart
- 3, Camera other problems, please replace the Camera try to confirm whether the Camera body has problems.

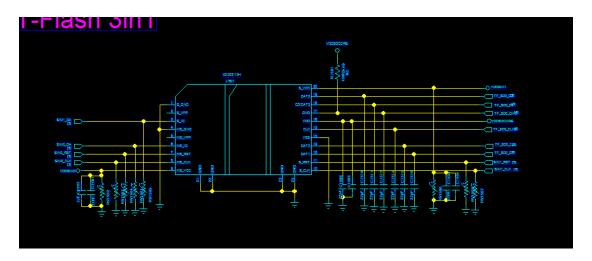
SIM card circuit

- SIM card module circuit is connected directly with PMIC through eight-path signal from SUIM slot. The major failure of the module does not know the card, the reason

- 1) USIM card GSM card and USIM deck poor contact
- 2) poor USIM card socket welding
- 3) software problem cause the phone to pick a card, change the card to confirm
- 4) SIM card holder exist Weld
- 5) card exceeds the itinerary or inserted upside
