Appendix B: Photographs of Test Setup

Product: 4K Wireless Document Camera

Model: DC200

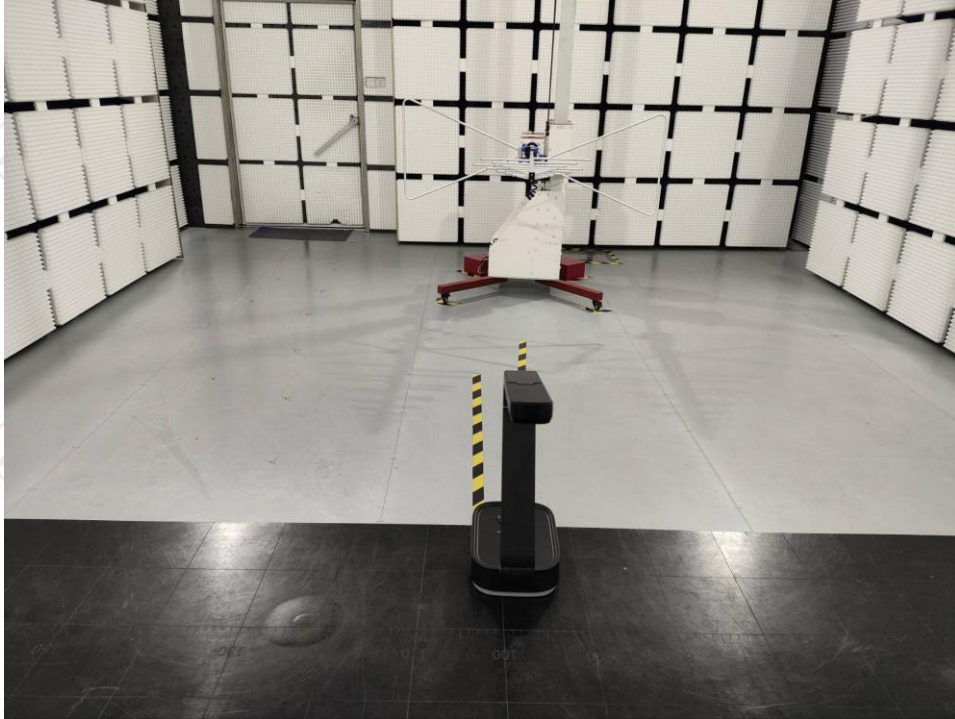
Radiated Emission

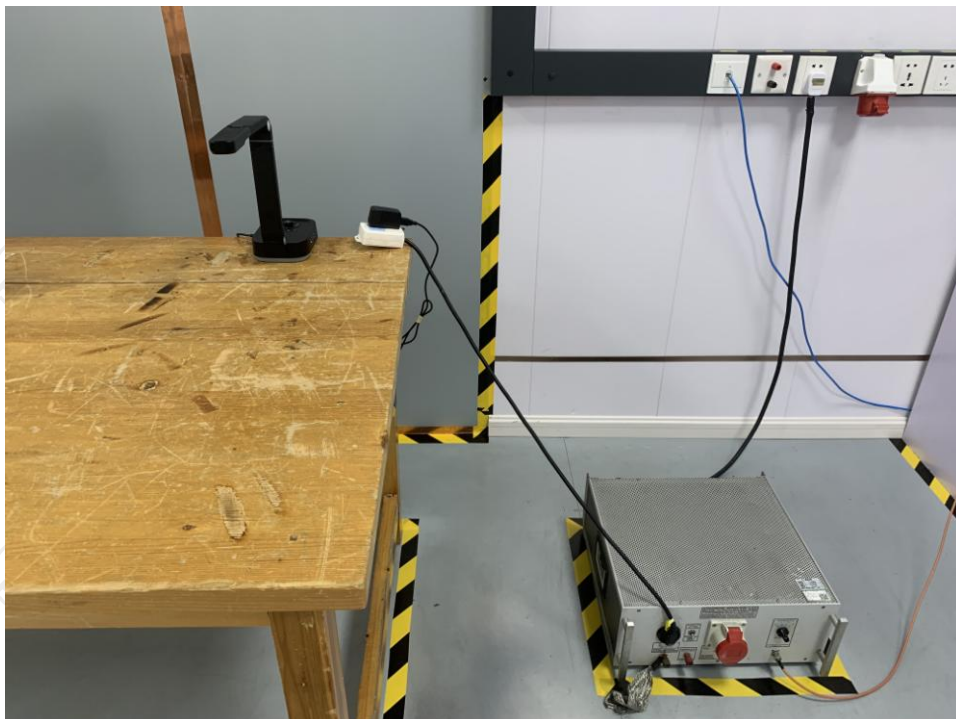
Conducted Emission
