802.11g

Band-edge Measurements for RF Conducted Emissions:

4.7 Antenna Requirement

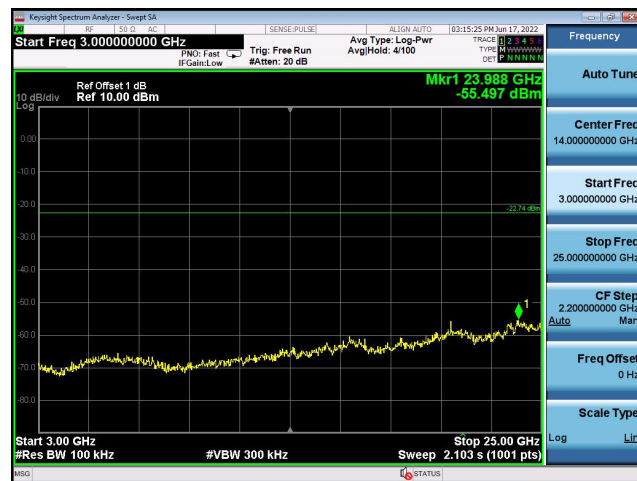
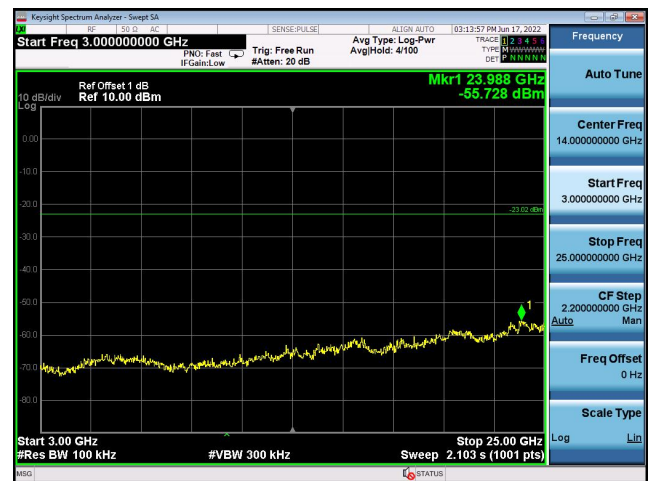
3GHz -25GHz

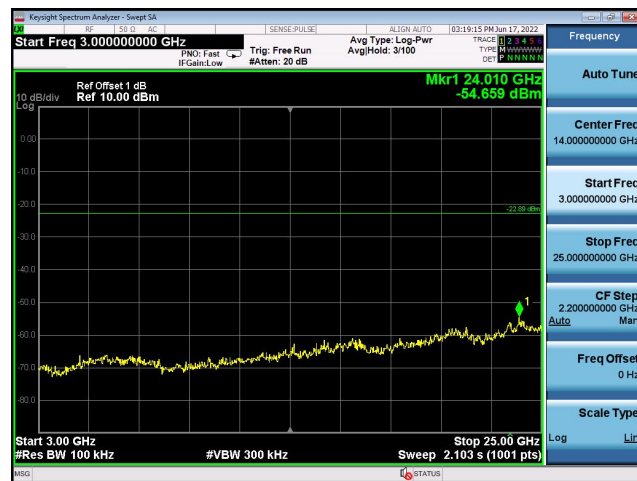
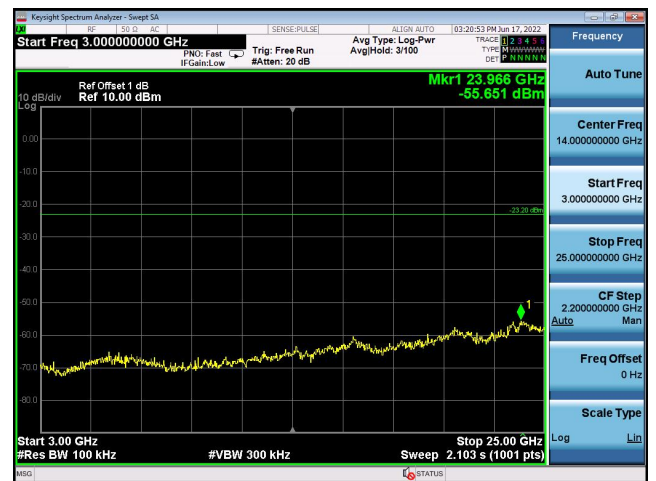
3GHz -25GHz

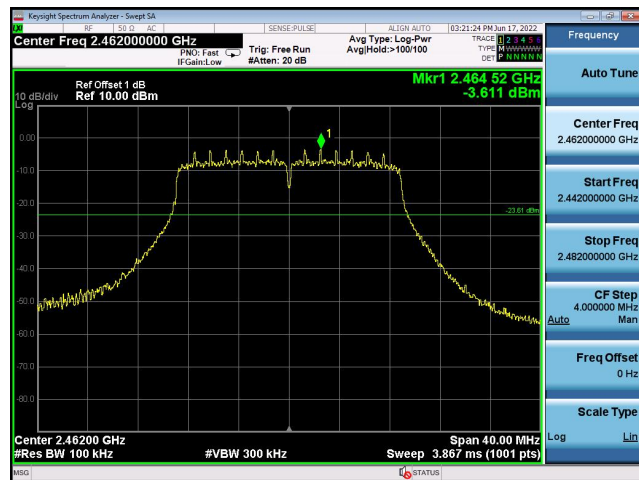
802.11n(HT20)

CH11

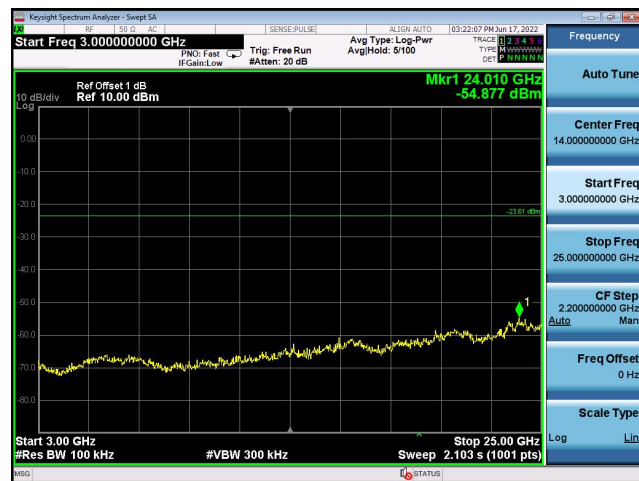
3GHz -25GHz
