# Photo Report on Test Setups

## BCP-01

**Report Reference:** MDE\_VIS\_1908\_FCC\_Photo\_Setups

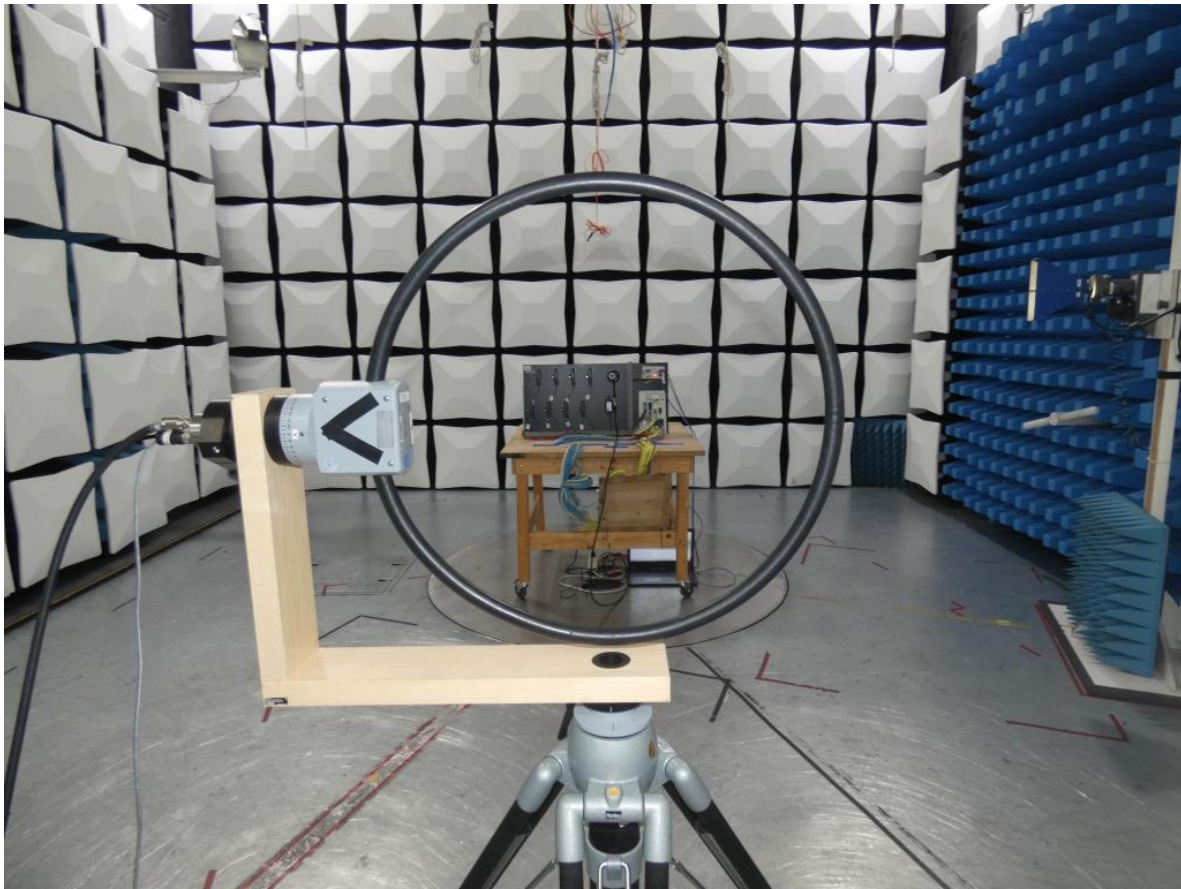
**Photo 1:** Test setup for radiated measurements (Enclosure, below 30 MHz, intentional radiator §15.209, ANSI C63.10)

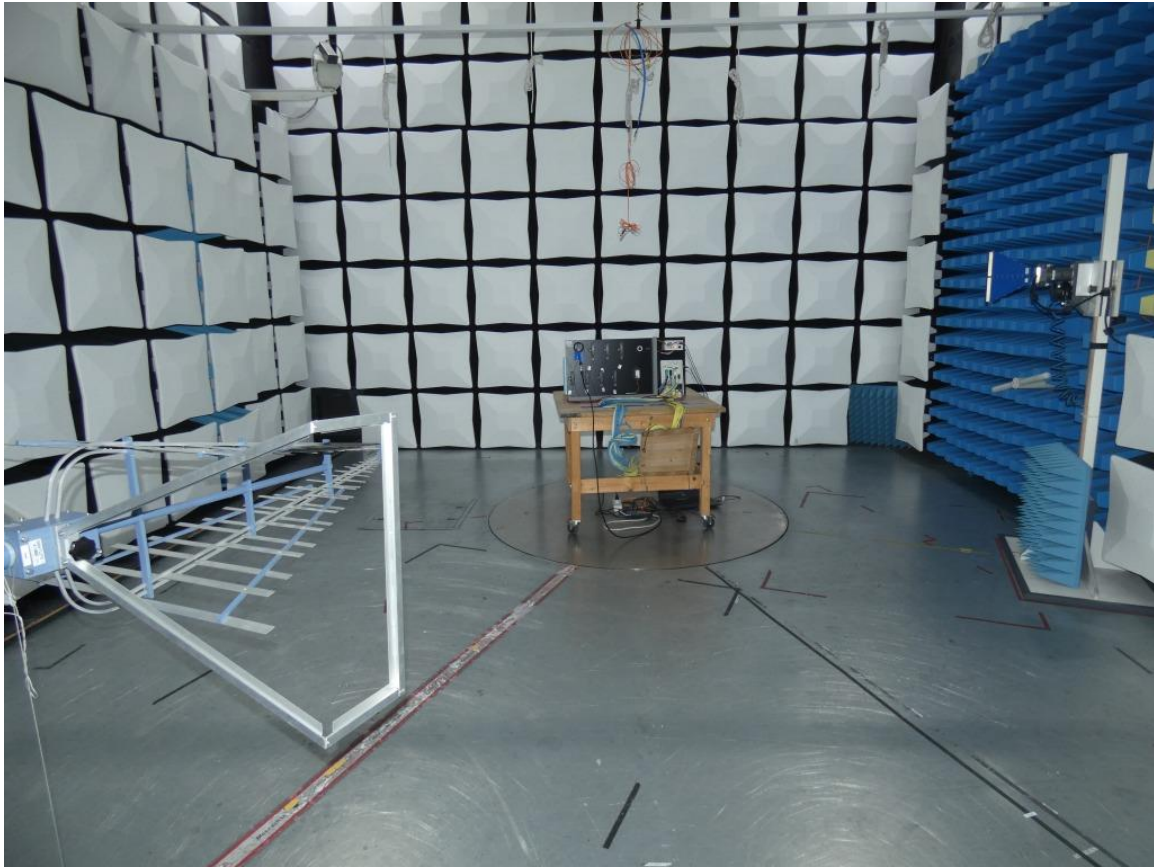
**Photo 2:** Test setup for radiated measurements (Enclosure, semi-anechoic chamber, 30 MHz to 1 GHz, intentional radiator §15.209, ANSI C63.10)
