10.7 APPENDIXH: CONDUCTED SPURIOUS EMISSION
Test Result

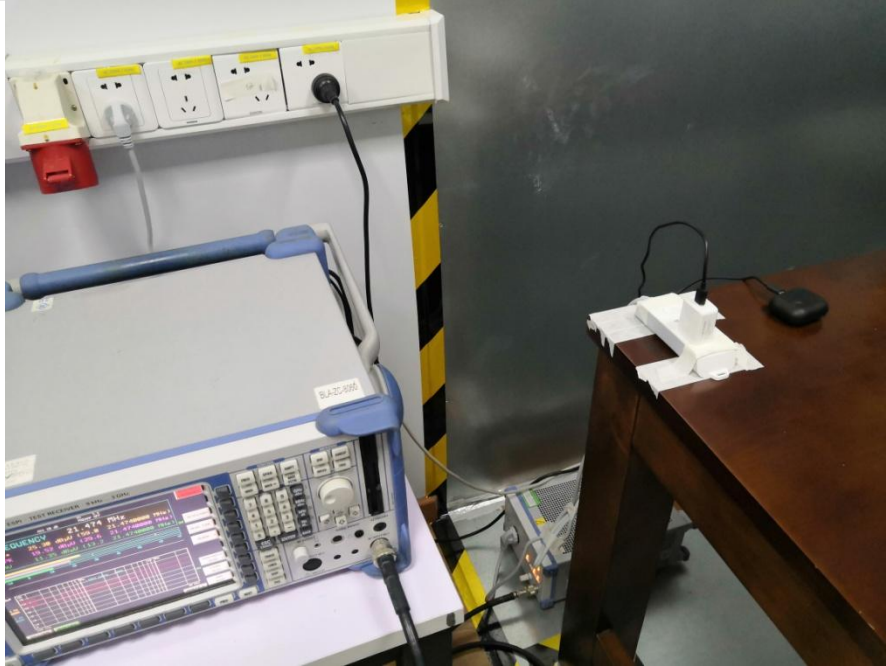
Conducted Emissions at AC Power Line (150kHz-30MHz)

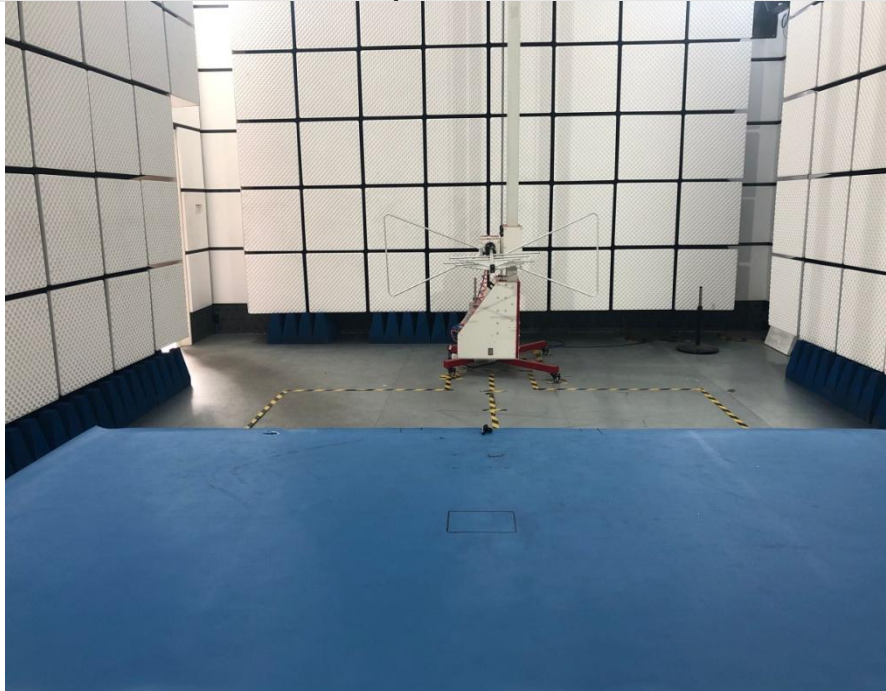
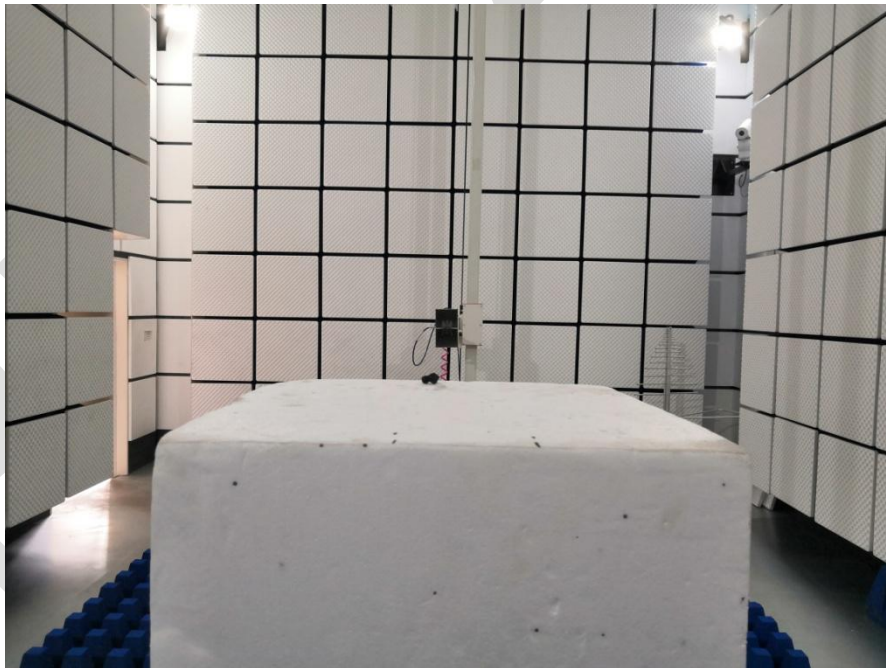
Radiated Spurious Emissions
