Test Setup Photos

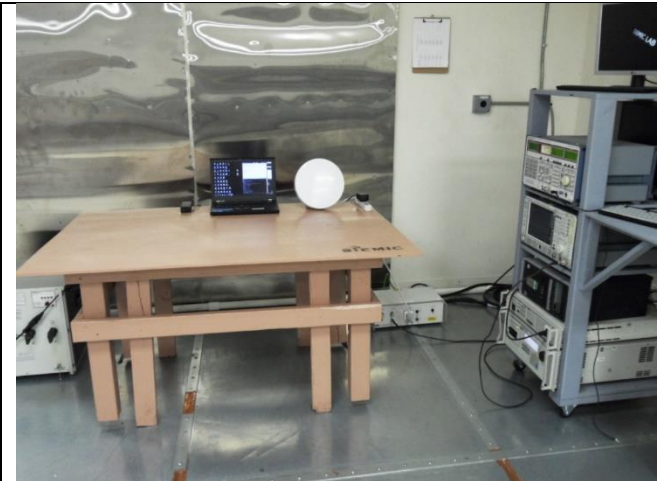
AC Line Conducted Emissions – Front View

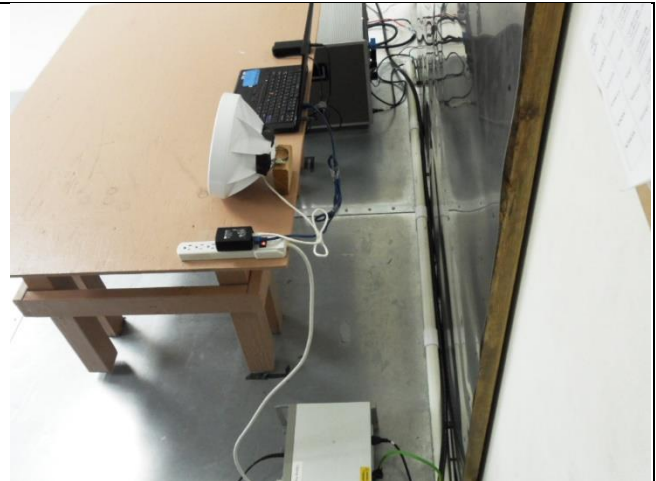
AC Line Conducted Emissions – Rear View

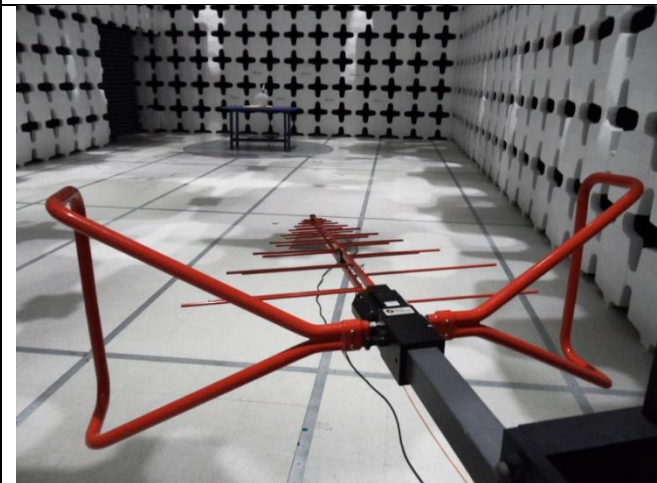
Radiated Emissions (<1GHz) – Front View

Note: The spurious emission in different EUT orientation was investigated, including the EUT standing up position and the laying down position. The EUT orientation shown in above setup photo is the worst case position.

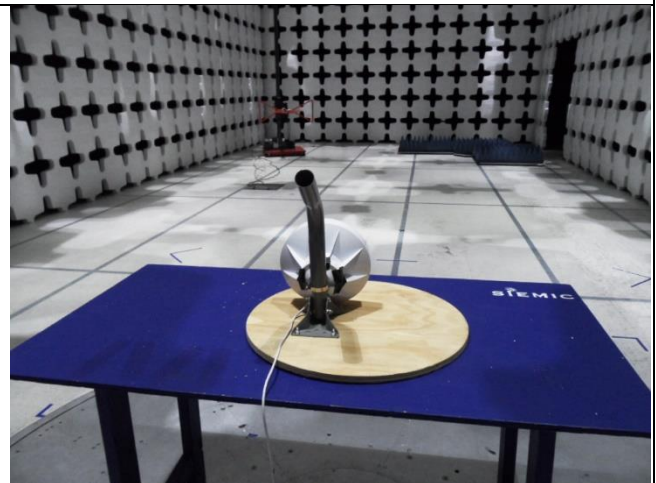
Radiated Emissions (<1GHz) – Rear View

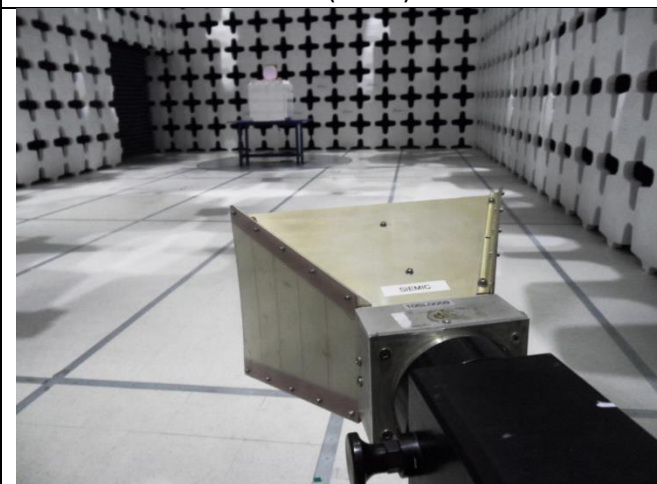
Radiated Emissions (>1GHz) – Front View

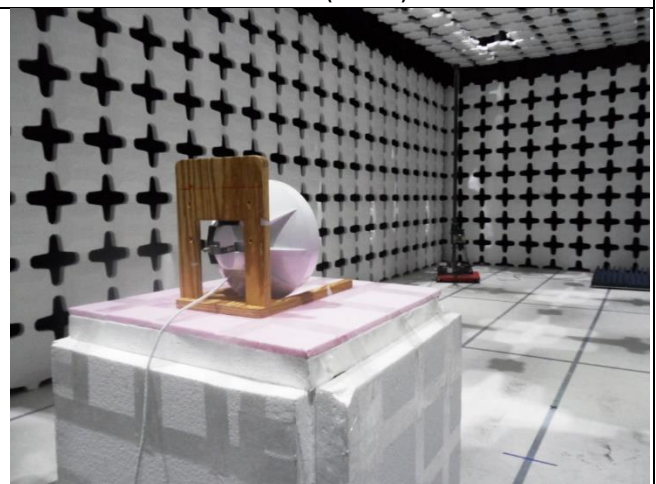
Radiated Emissions (>1GHz) – Rear View
