The Photos of SAR test

No. I18Z61172-SEM01

LTE/UMTS/GSM mobile phone

Model Name: 5059Z

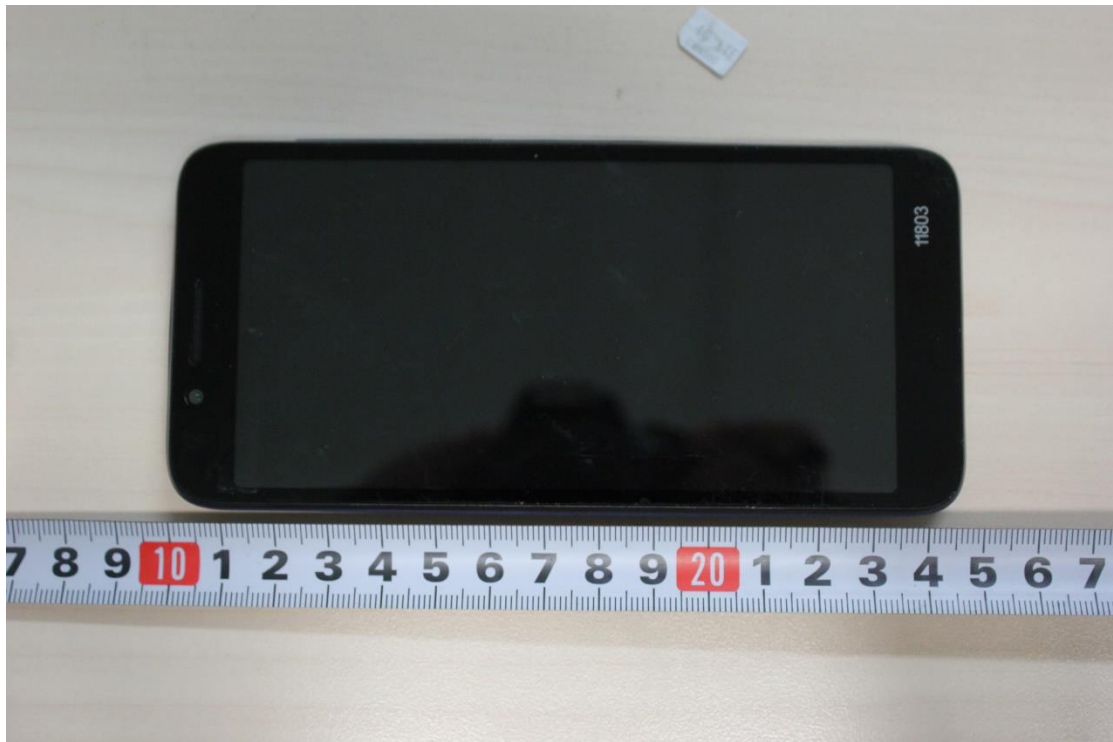
Picture 1: Constituents of the sample

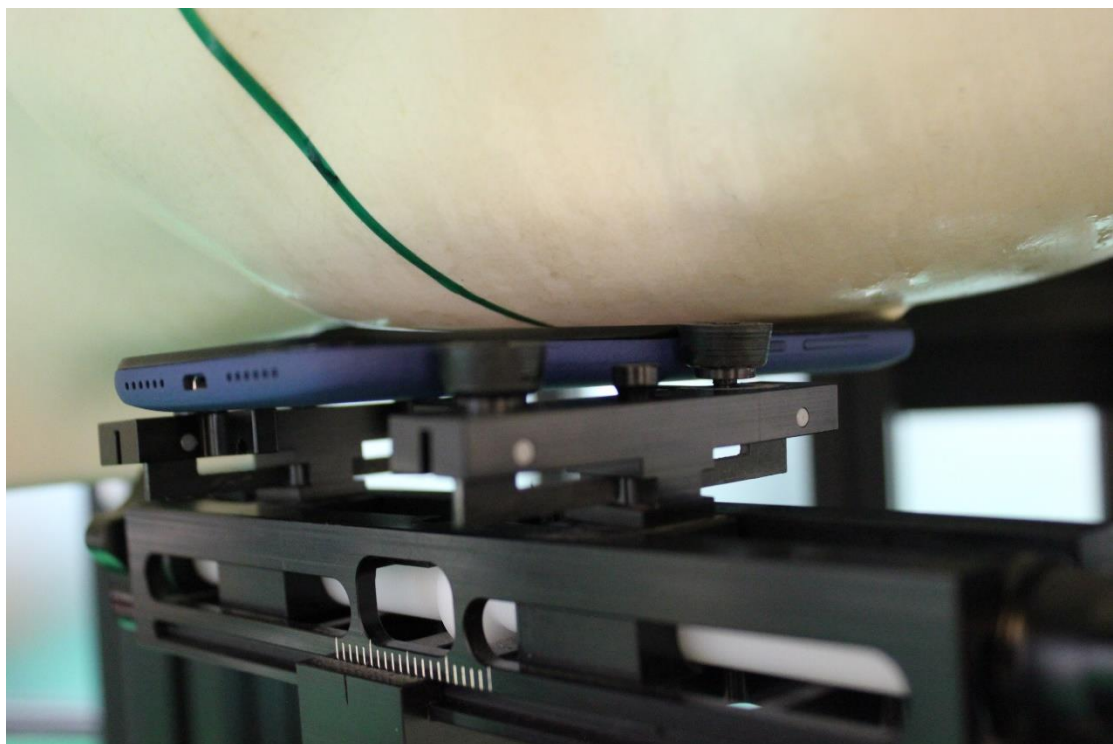
Picture 2: Left Hand Touch Cheek Position

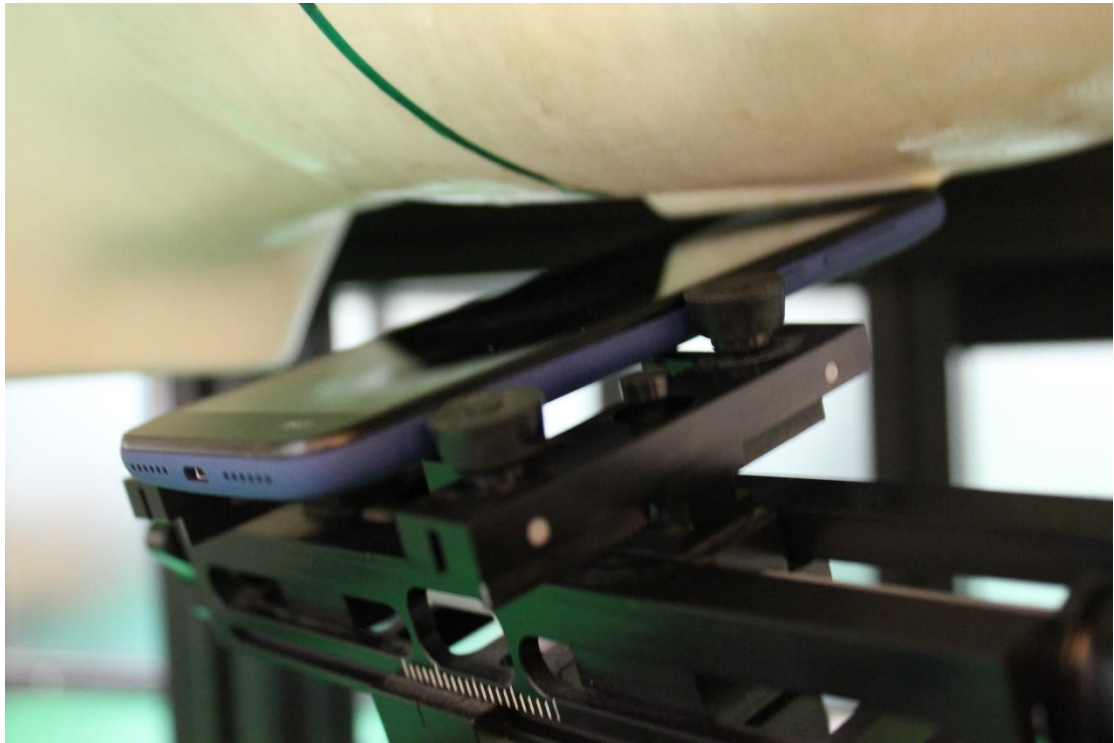
Picture 3: Left Hand Tilt 15° Position

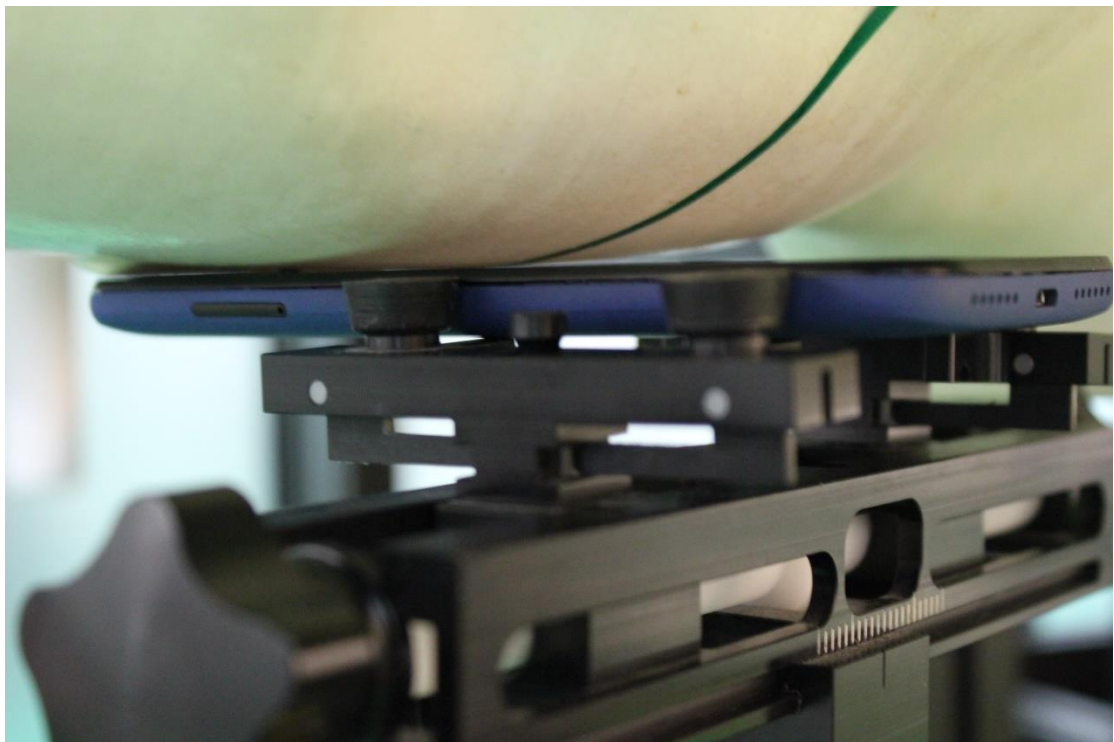
Picture 4: Right Hand Touch Cheek Position

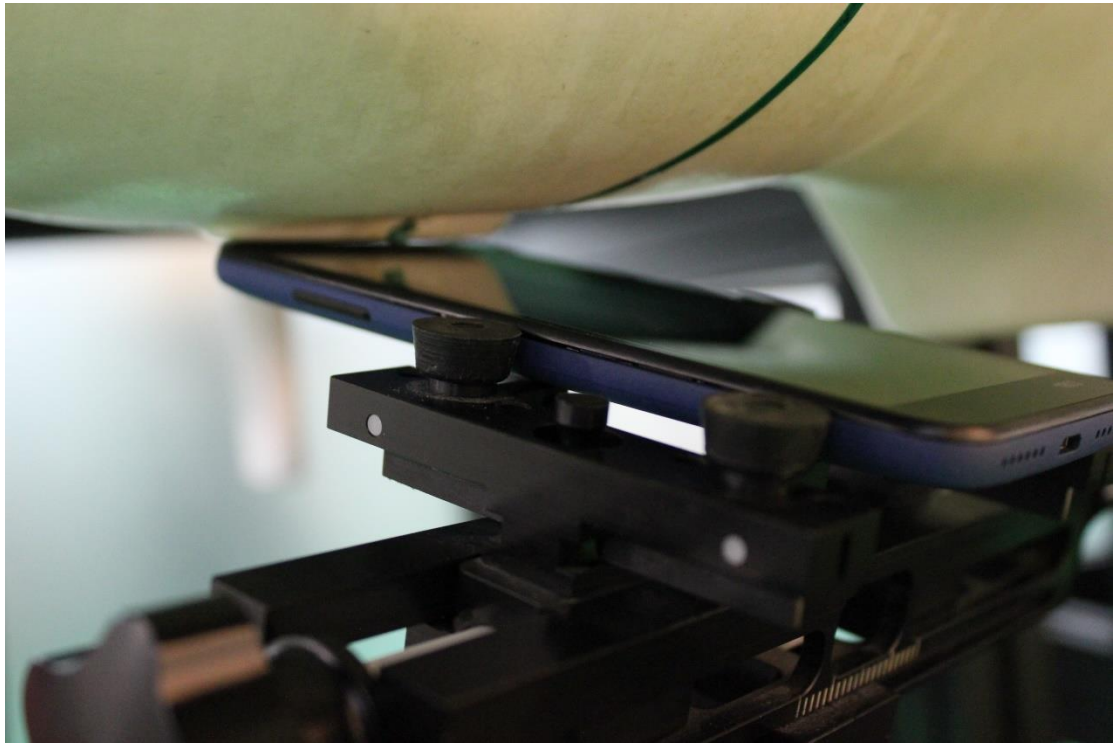
Picture 5: Right Hand Tilt 15° Position

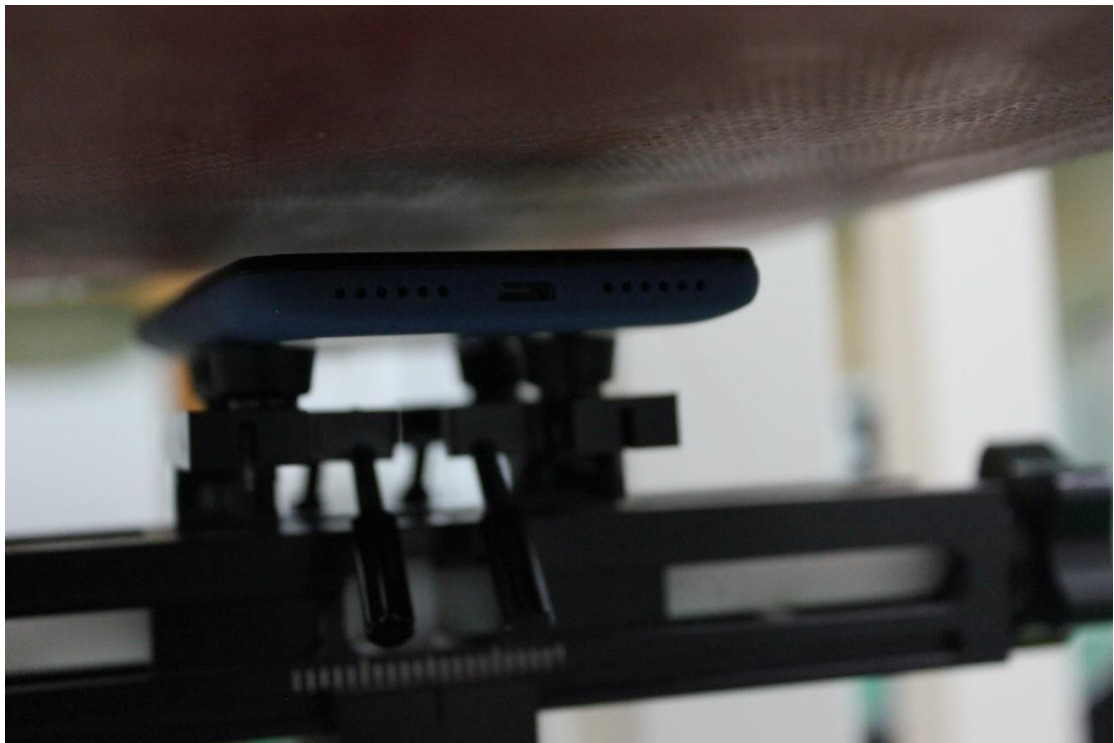
The Body SAR is tested at the following 6 test positions all with the distance =10mm between the EUT and the phantom bottom:

Picture 6: Front with 10mm

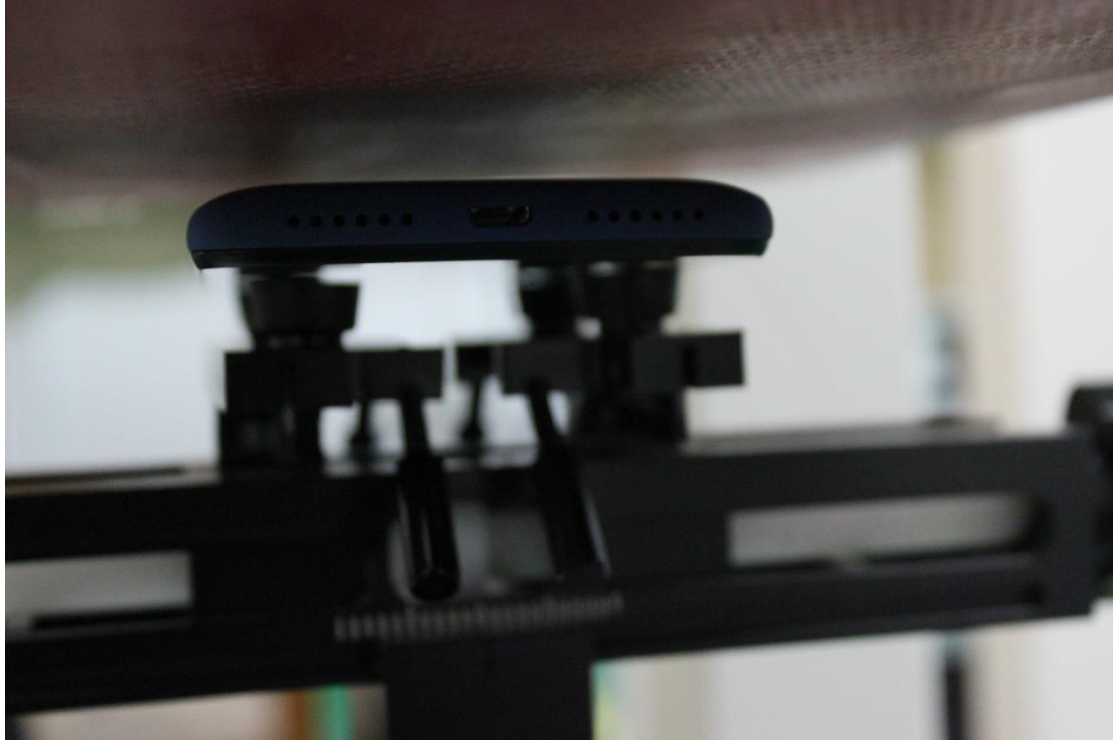
Picture 7: Rear with 10mm

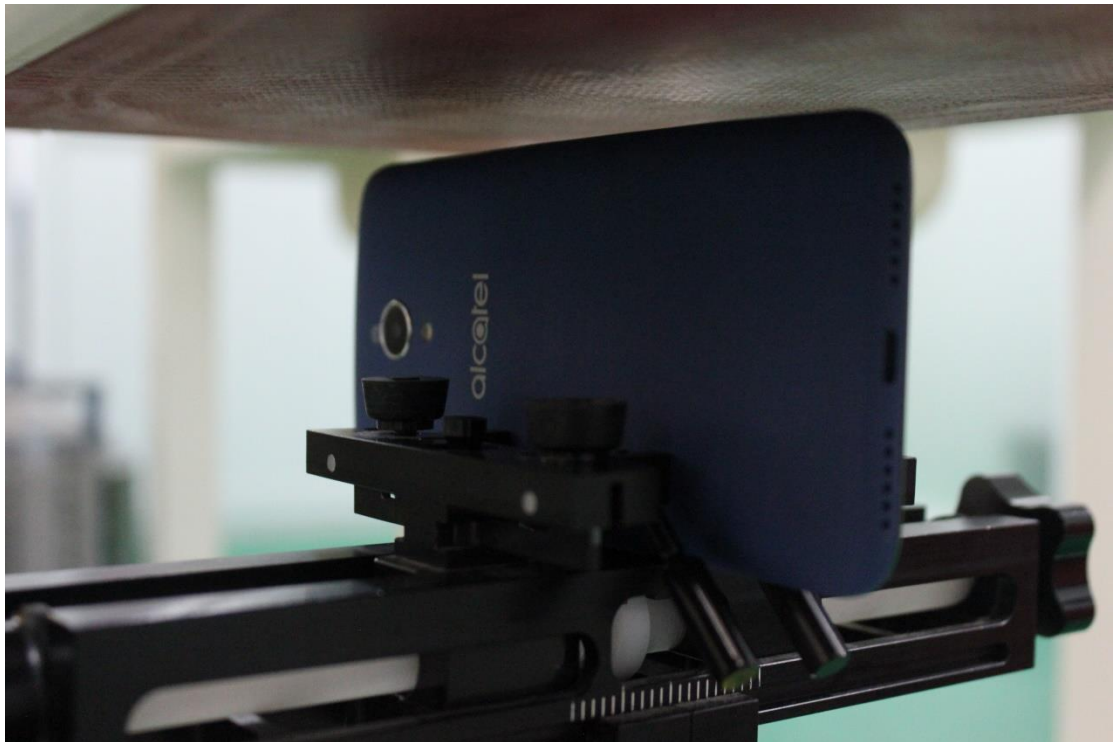
Picture 8: Left with 10mm

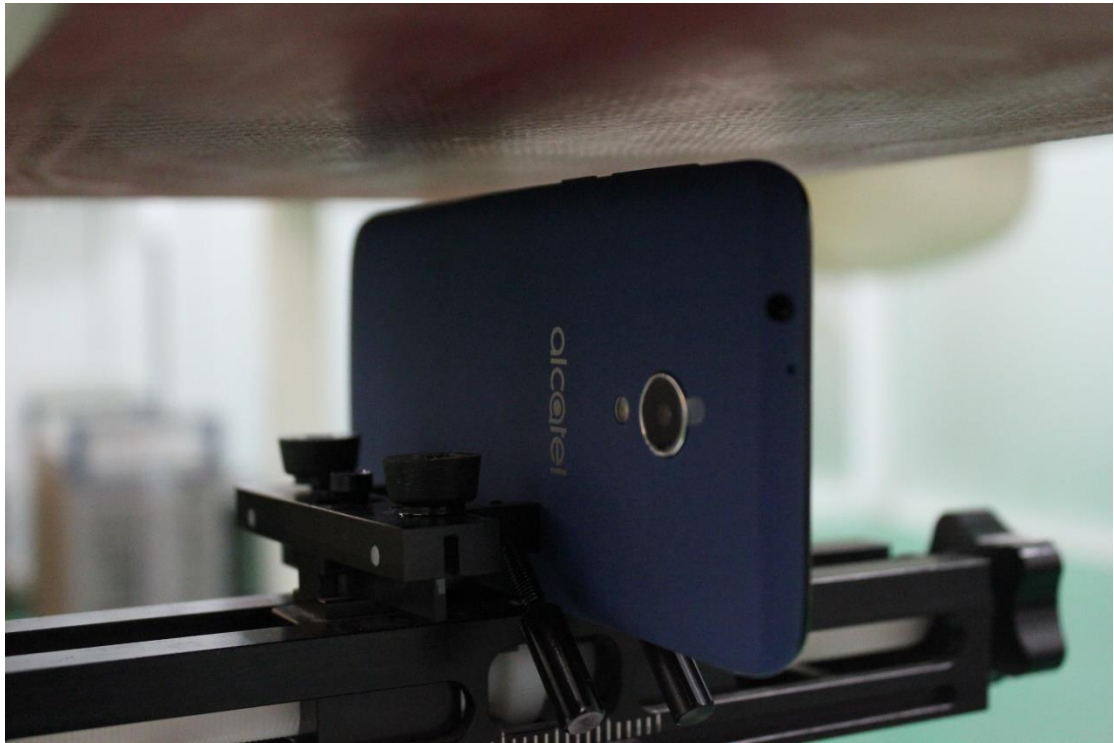
Picture 9: Right with 10mm

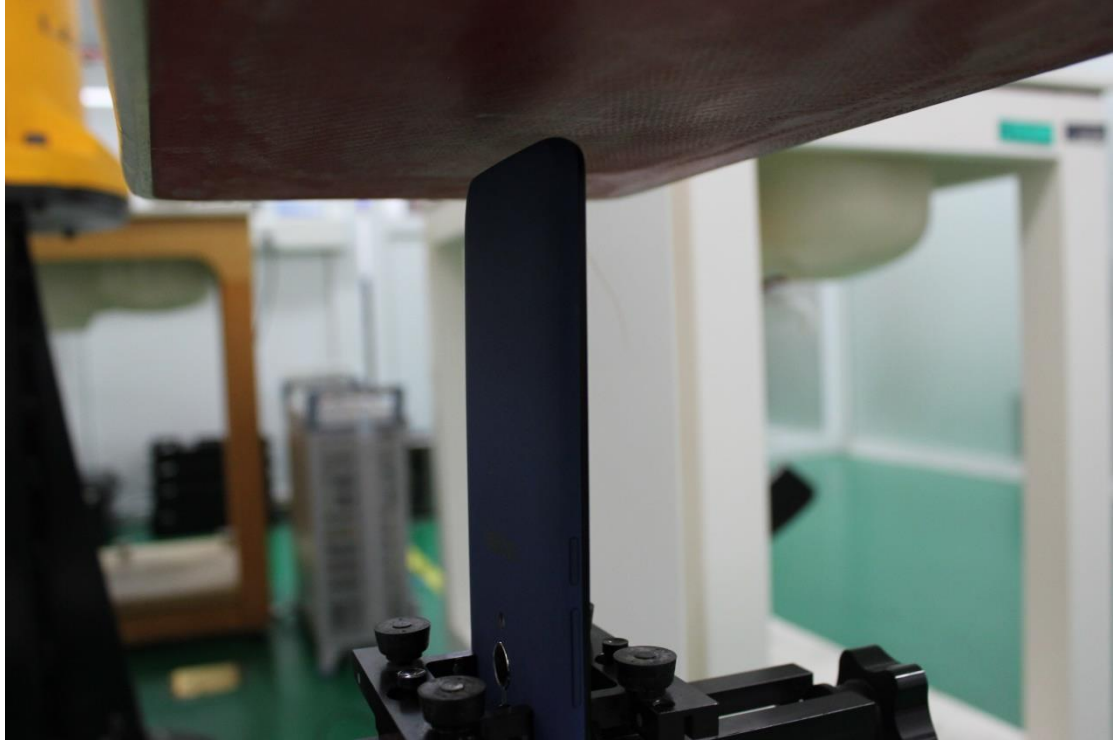
Picture 11: Bottom with 10mm
