The Photos of SAR test

No. I18Z60981-SEM01

LTE / UMTS / GSM mobile phone

Model Name: 5033X

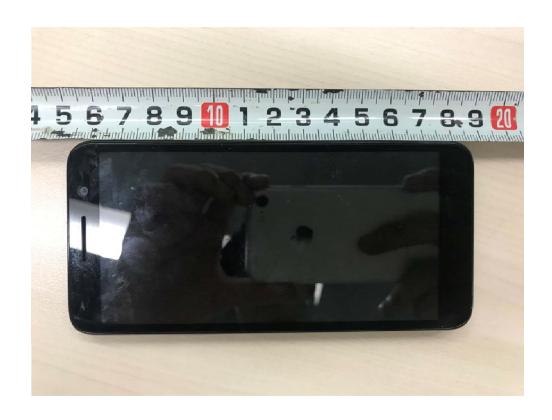
Picture - 1 Constituents of the sample

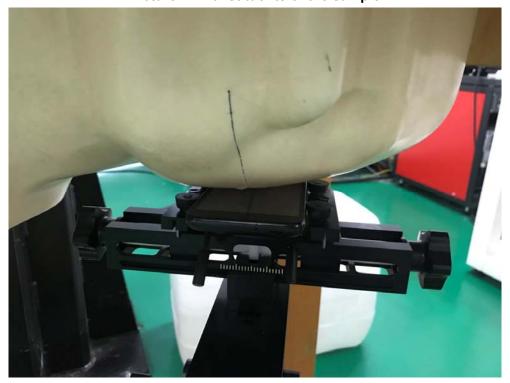
Picture - 2 Left Hand Touch Cheek Position

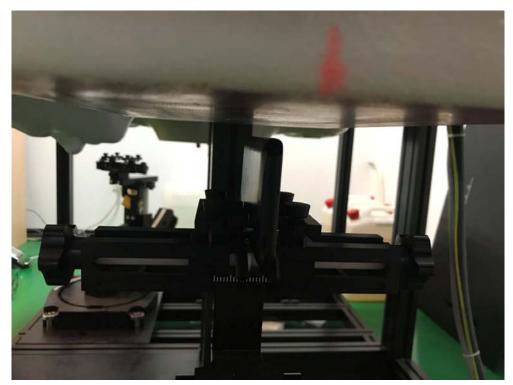
Picture - 8 Left edge 10mm

The Body SAR is tested at the following 7 test positions all with the distance =10mm between the EUT and the phantom bottom:

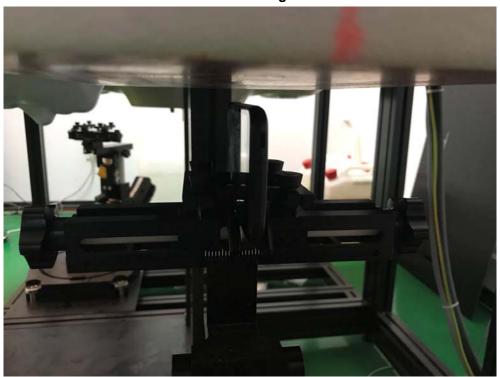
Picture - 9 Right edge 10mm

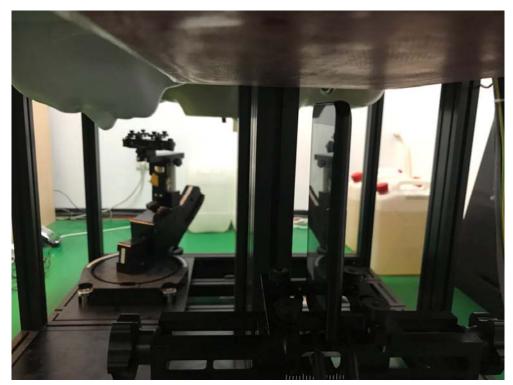
Picture - 10 Bottom edge 10mm
