# No. I20Z62335-SEM03

**TCL Communication Ltd.**

5G NR/LTE/WCDMA/GSM mobile phone

**Model Name: T810S**

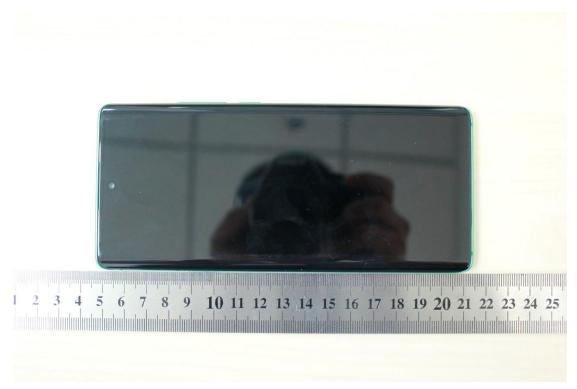
Picture 1: Constituents of the sample

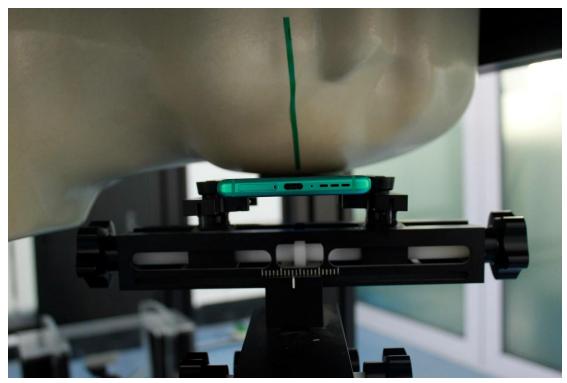
**Picture 2: Left Head Touch Cheek Position**

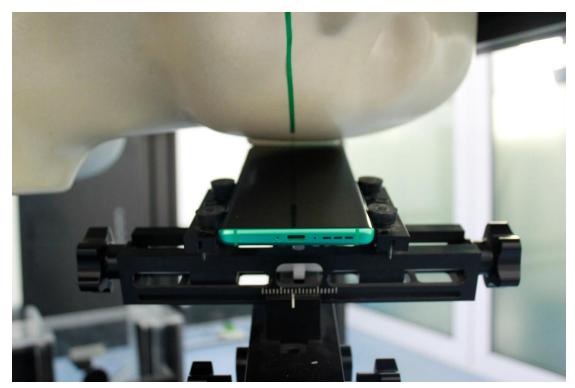
Picture 3: Left Head Tilt 15° Position

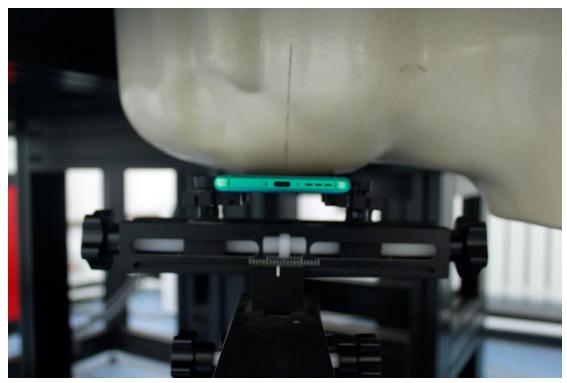
**Picture 4: Right Head Touch Cheek Position**

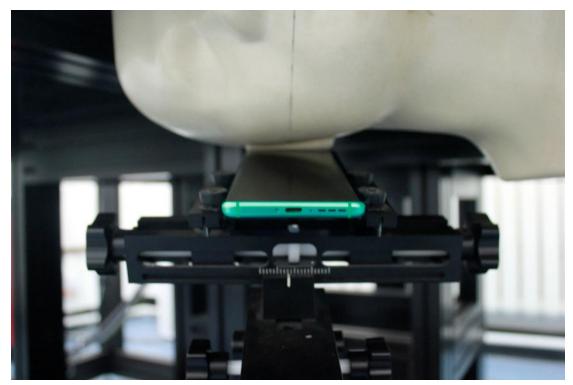
Picture 5: Right Head Tilt 15° Position

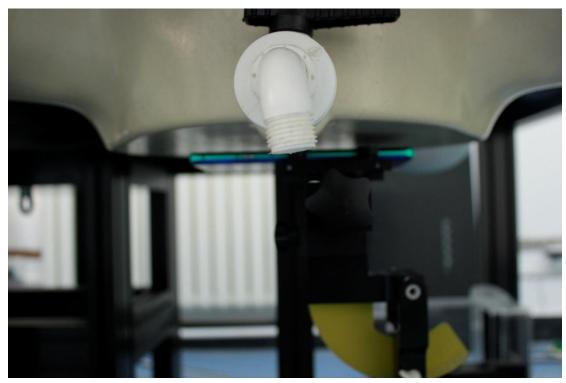
Picture 6: Front 10mm

The Body SAR is tested at the following 10 test positions all with the distance =0/10mm between the EUT and the phantom bottom:

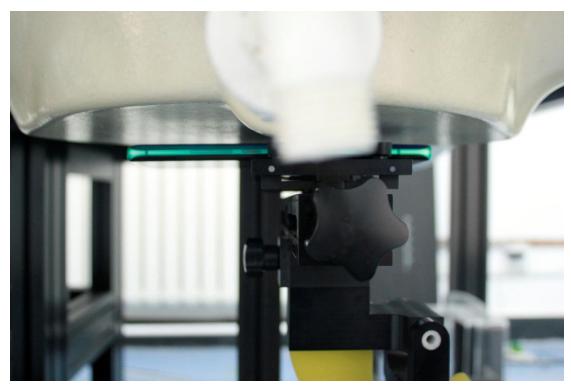
Picture 7: Rear 10mm

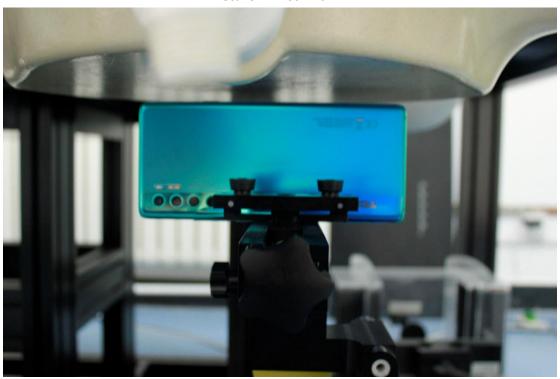
Picture 8: Left 10mm

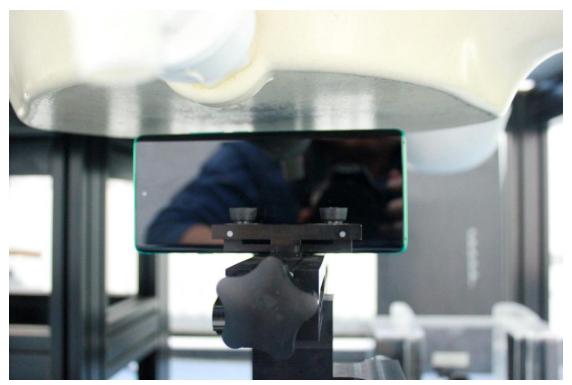
Picture 9: Right 10mm

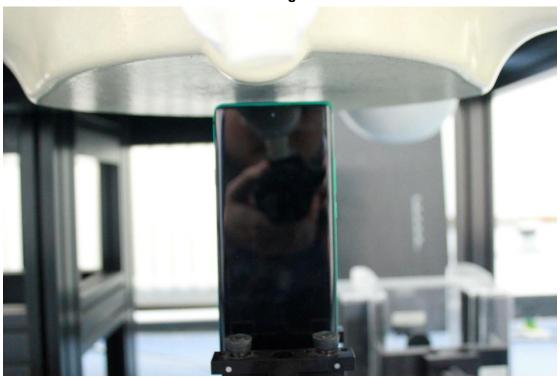
Picture 10: Top 10mm

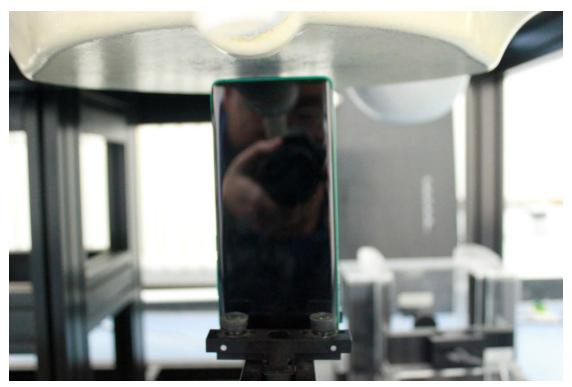
Picture 11: Bottom 10mm
