## Appendix E: Band edge measurements

## Appendix F: Conducted Spurious Emission

## Appendix G: Frequency Stability

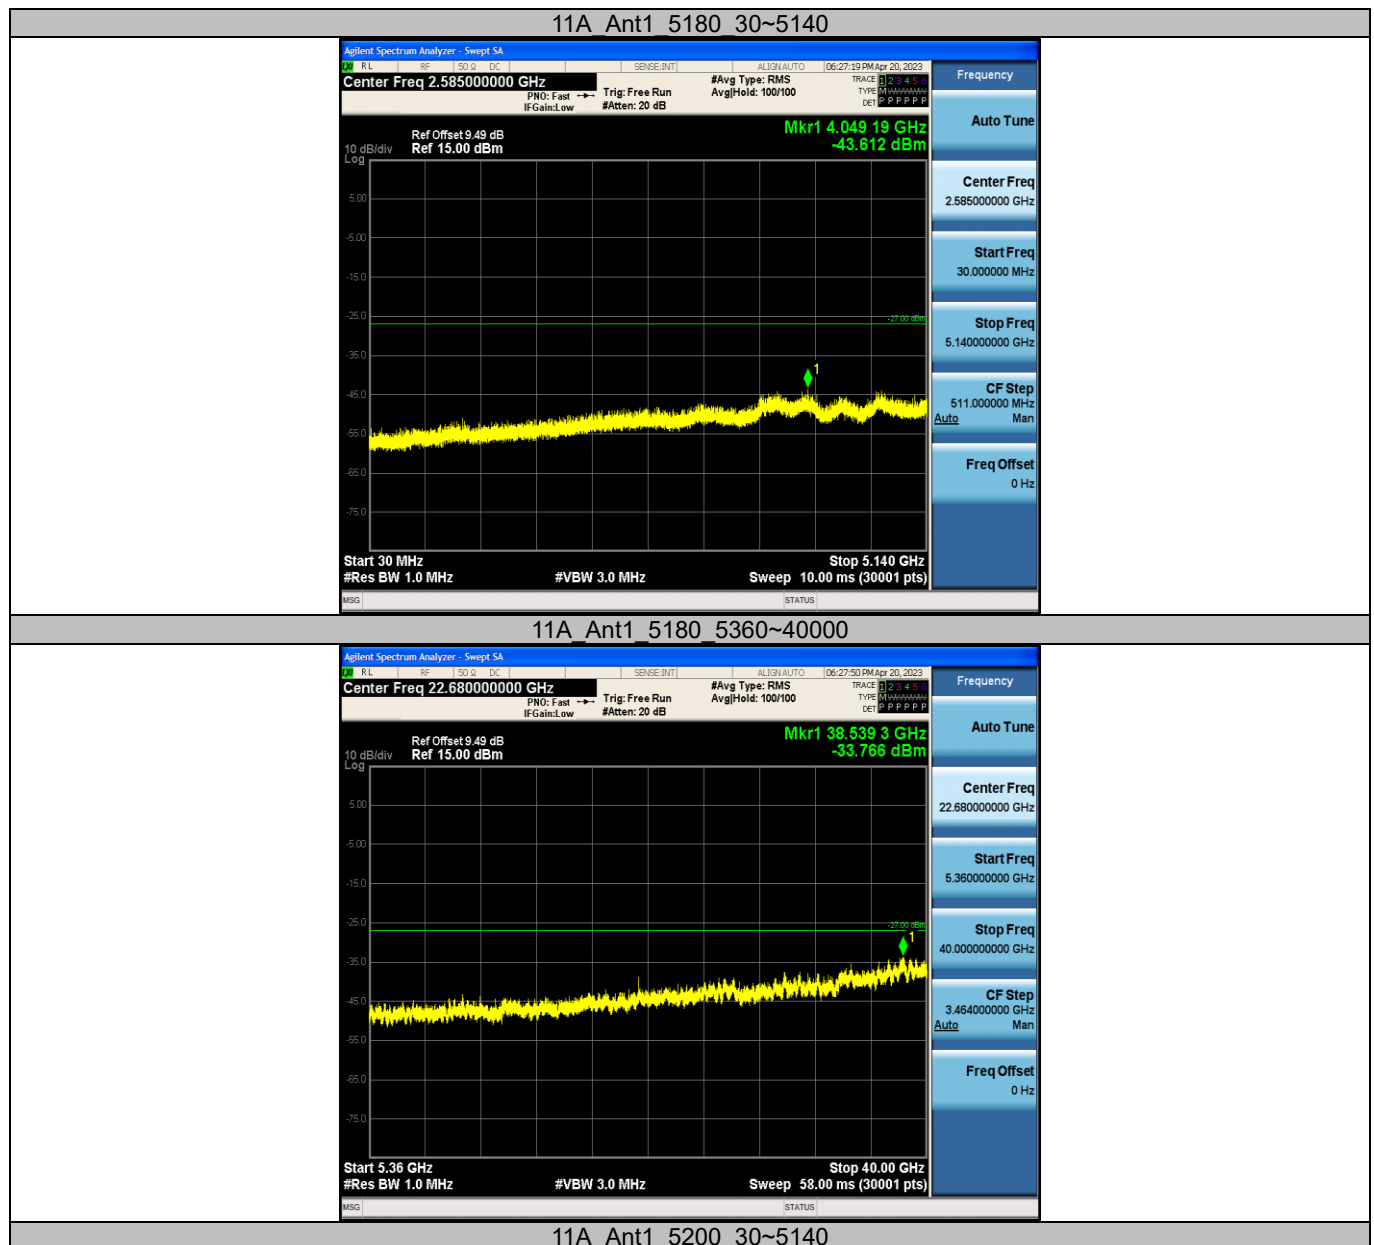
Test Graphs

Notes:

1. All modes were tested, data just shown the worst test mode.
2. Offset include antenna gain and cable factor.
