RF Conducted Spurious Emissions

**Appendix C: Photographs of EUT
Model: PLT1150
External Photos**

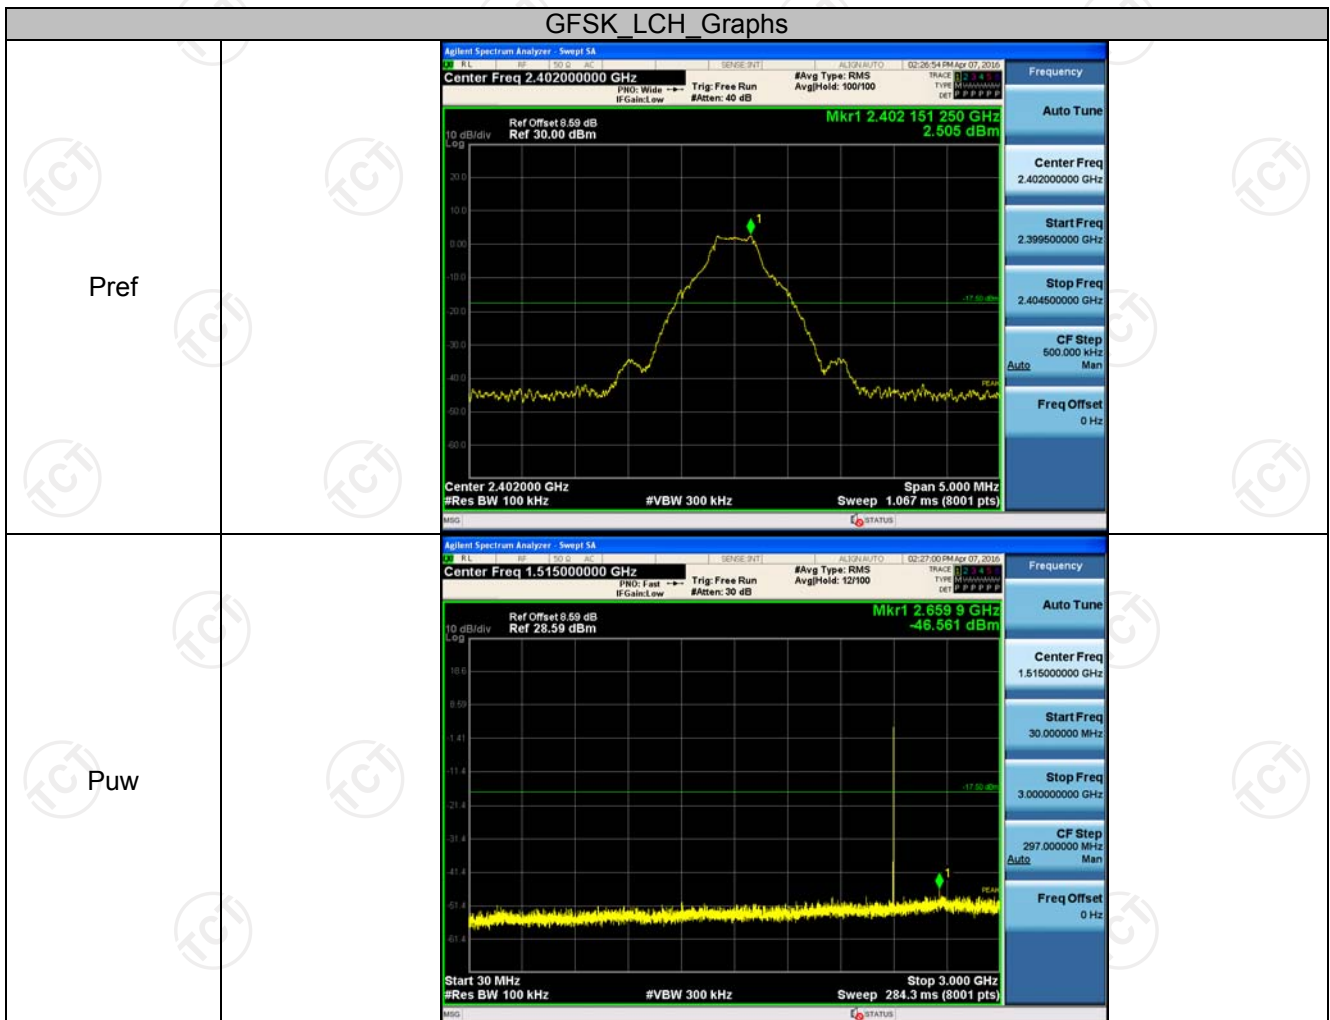
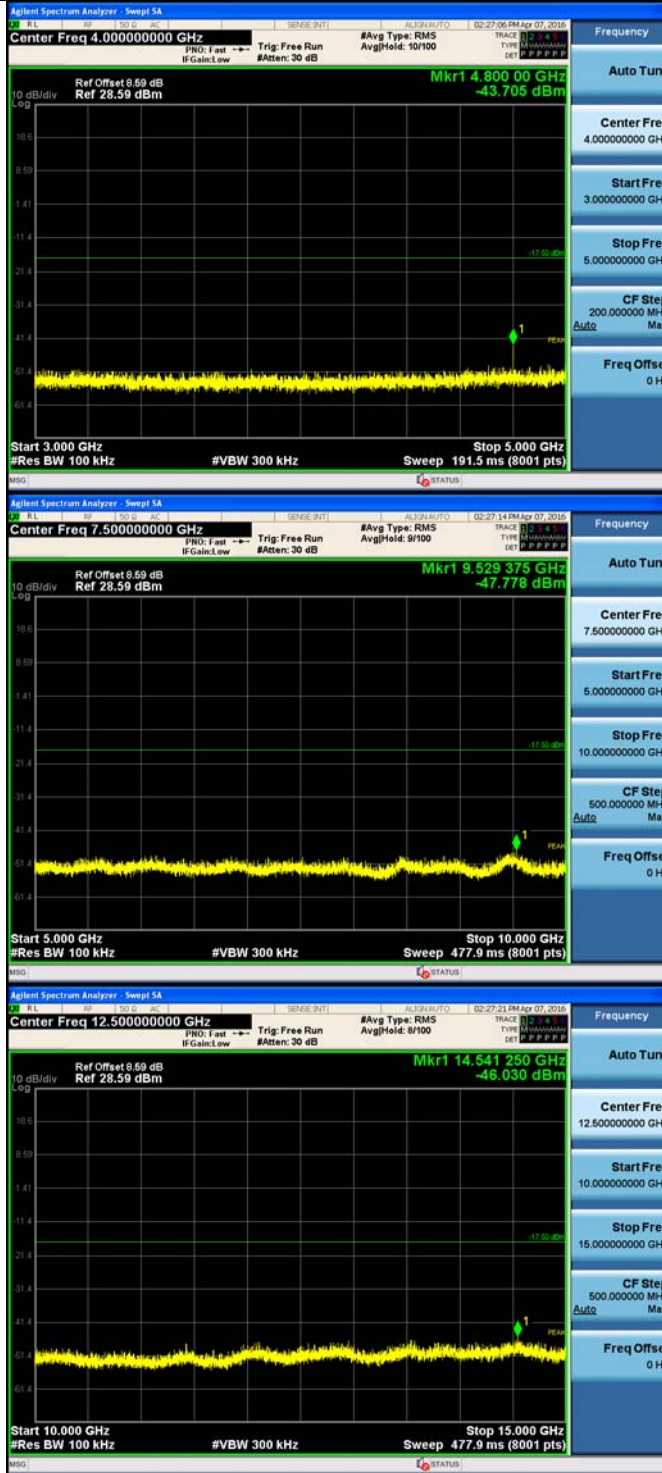
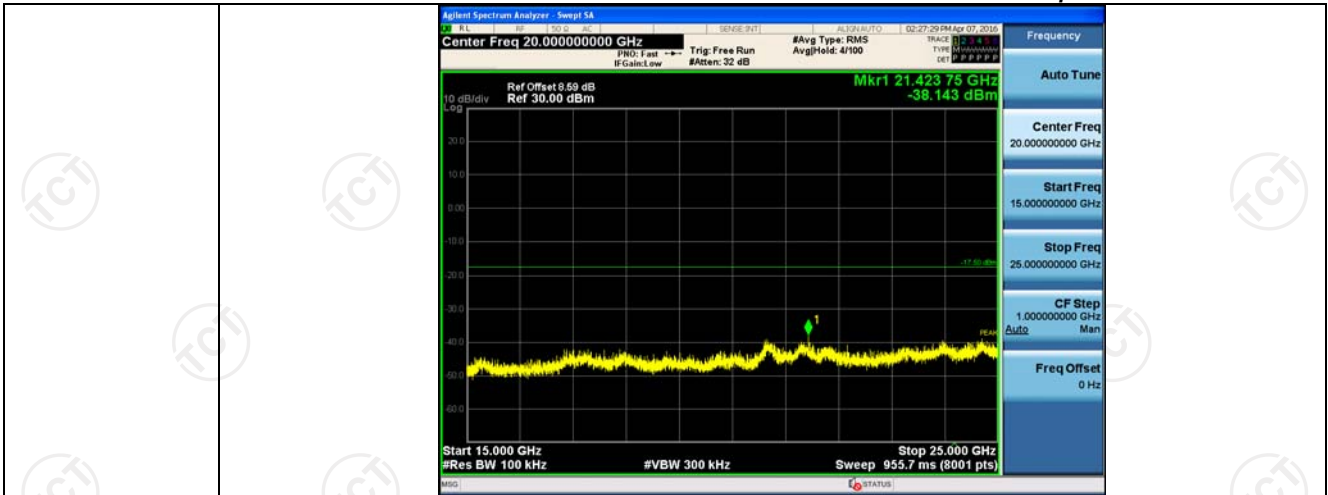
Test Graph

Mode	Channel	Pref [dBm]	Puw[dBm]	Verdict
GFSK	LCH	2.505	<Limit	PASS
GFSK	MCH	2.508	<Limit	PASS
GFSK	HCH	-0.237	<Limit	PASS
$\pi/4$ DQPSK	LCH	0.42	<Limit	PASS
$\pi/4$ DQPSK	MCH	1.921	<Limit	PASS
$\pi/4$ DQPSK	HCH	-1.631	<Limit	PASS
8DPSK	LCH	0.827	<Limit	PASS
8DPSK	MCH	1.553	<Limit	PASS
8DPSK	HCH	-1.916	<Limit	PASS
