Registration number: W6D21707-17252-C-54
FCC ID: 2AD37JWR2100

Appendix

Measurement diagrams

1. Spurious Emissions radiated
2. Mask

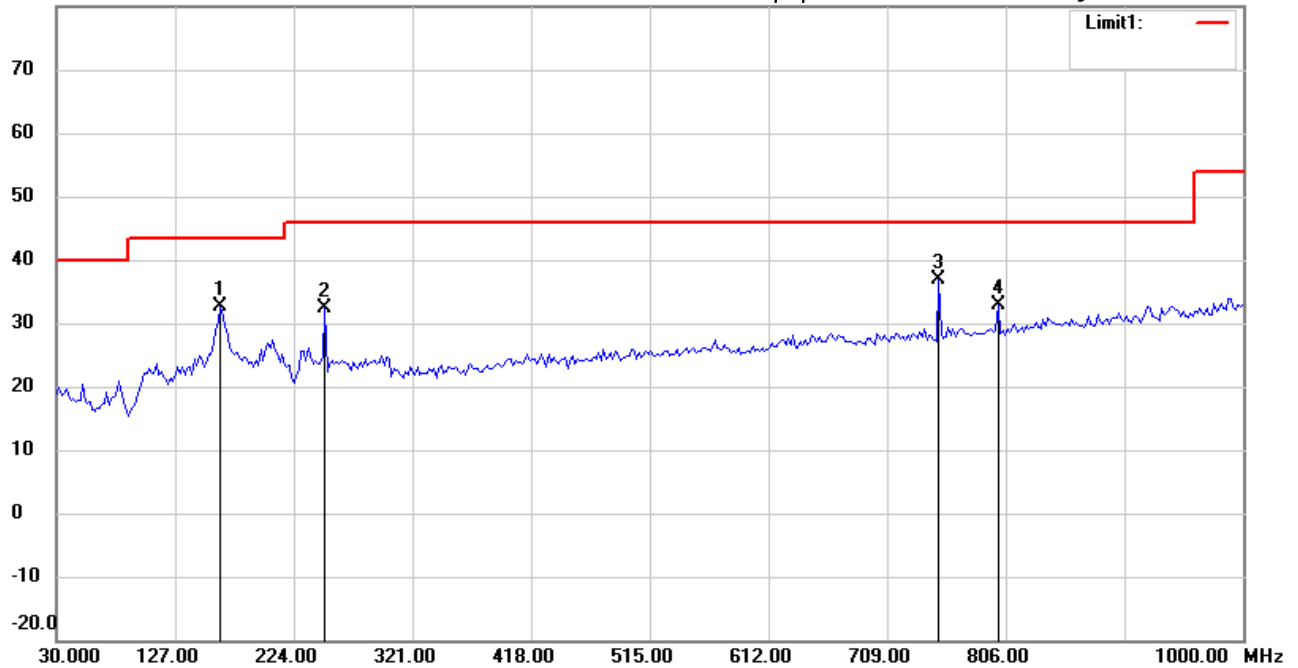
Site : Chamber

Condition : FCC_part 15 RE-Class E_30-1000MHz

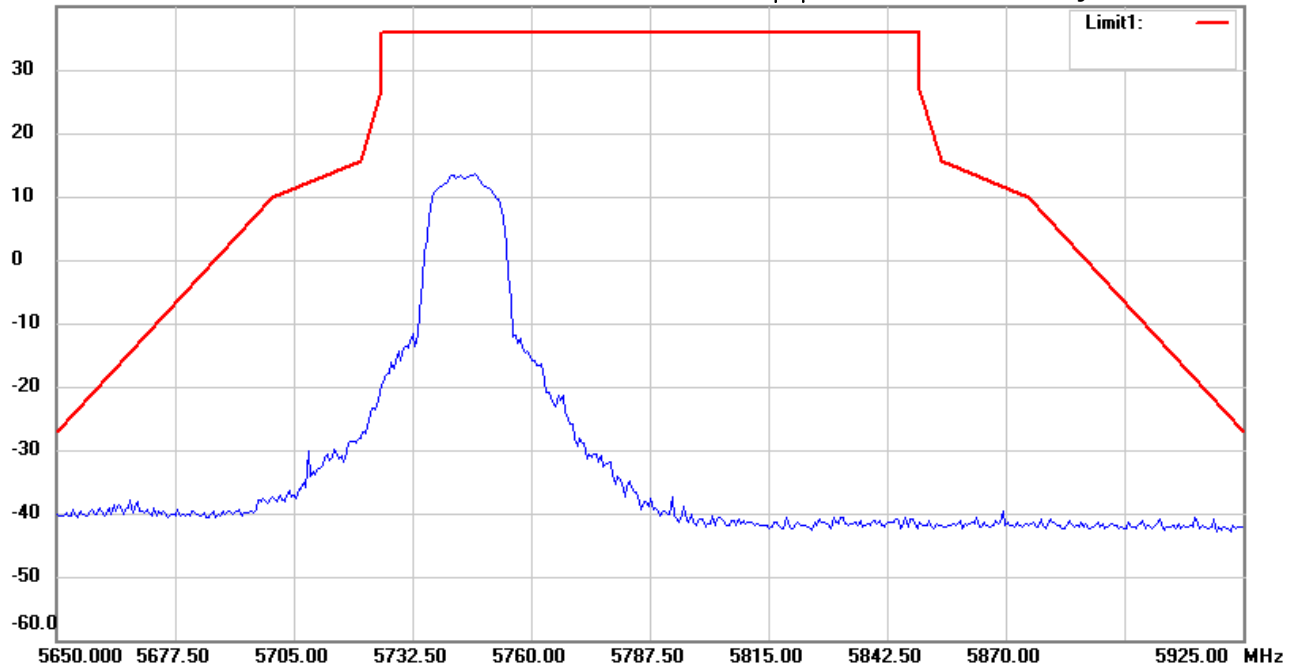
Site : Chamber

Condition : FCC_5G Band4 Mask
