EXHIBIT 4

Section 2.1033 (b)(14) SETUP DRAWINGS OR PHOTOGRAPHS

APPLICANT: Nokia

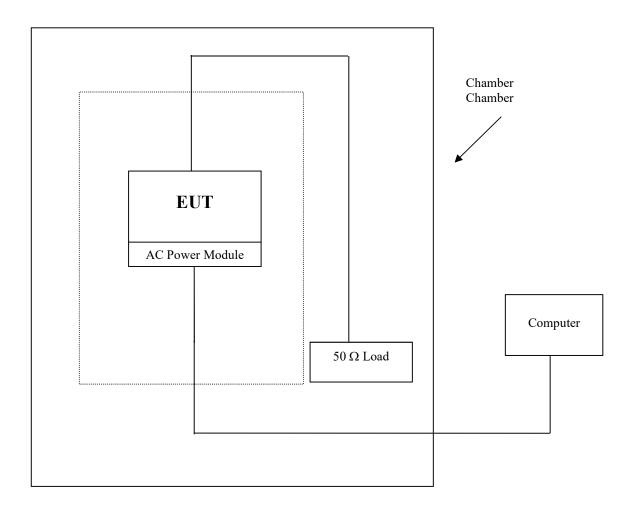
Figure 1. Setup Diagram of Conducted Test for RF Output Power, Power Spectrum Density, Occupied Bandwidth and Unwanted Emissions.

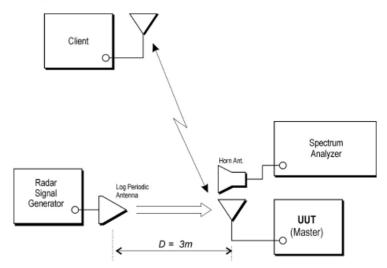
Figure 2. Setup Diagram of Radiated Test

Master with injection at the Master

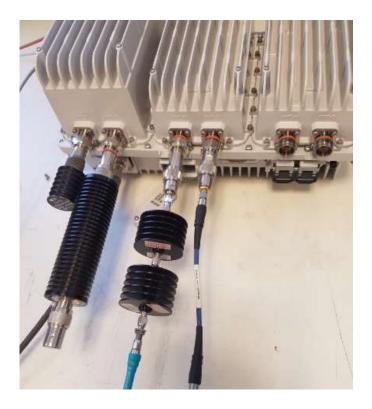
Figure 3. The Setup Diagram of DFS Test

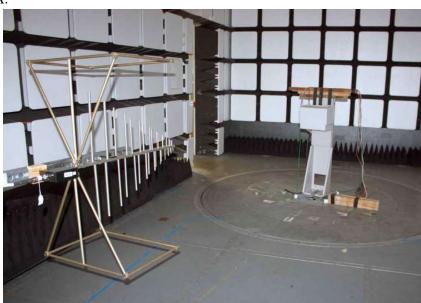
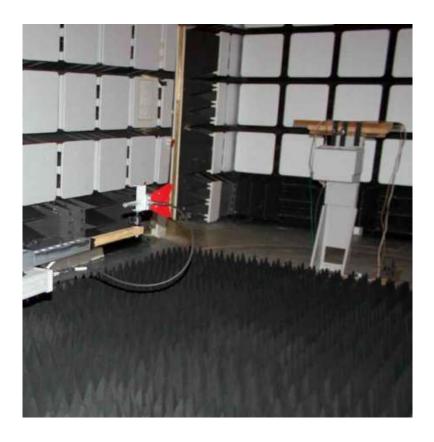
FA2WA:

Figure 4. Photo of RF Conducted Tests

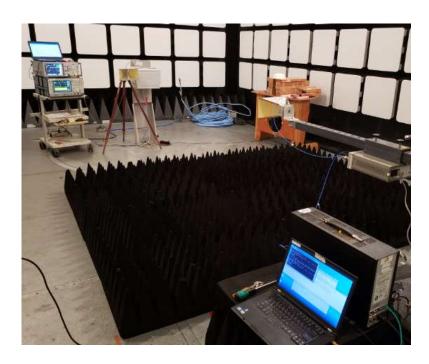
Figure 5. Photos of Radiated Tests

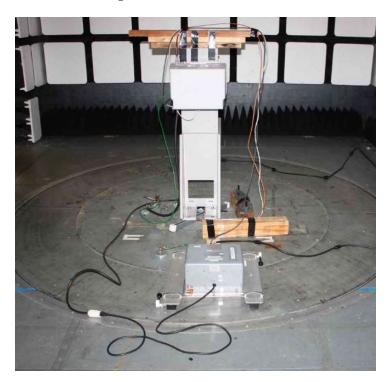
Figure 6. Photos of DFS Tests
