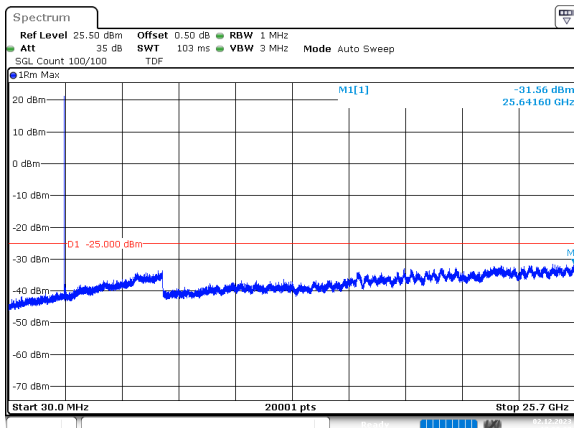
15MHz_15kHz_2535MHz_DFT-s-OFDM QPSK_RB1@0
-31.56 dBm

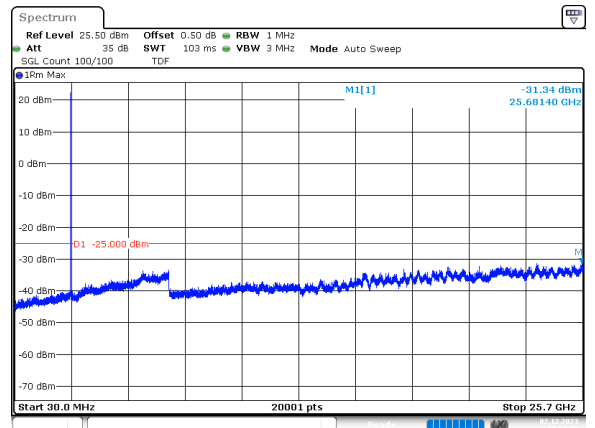
15MHz_15kHz_2535MHz_DFT-s-OFDM QPSK_RB1@78
-31.34 dBm

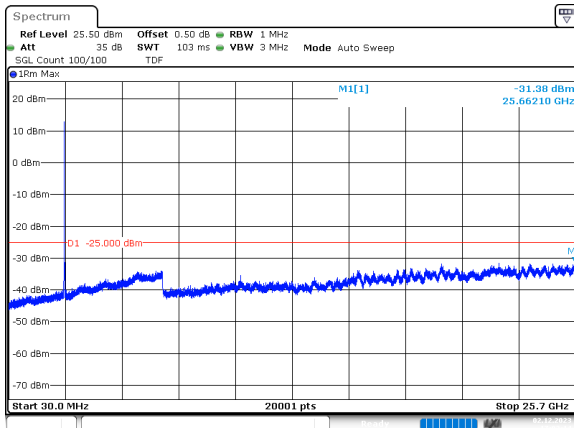
15MHz_15kHz_2535MHz_DFT-s-OFDM QPSK_RB75@0
-31.38 dBm

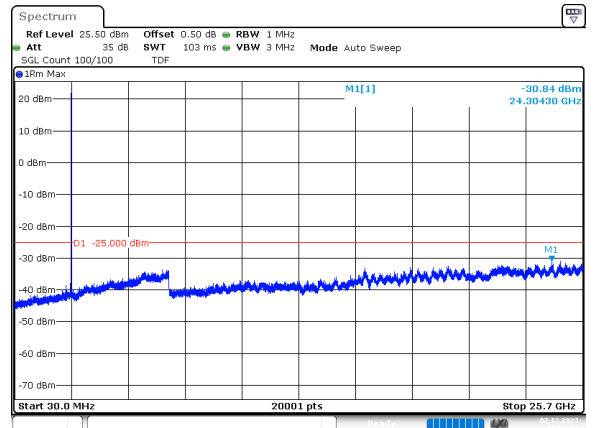
15MHz_15kHz_2562.5MHz_DFT-s-OFDM QPSK_RB1@0
-30.84 dBm

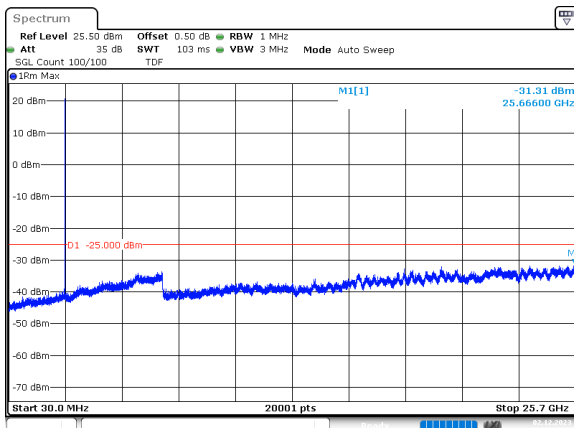
15MHz_15kHz_2562.5MHz_DFT-s-OFDM QPSK_RB1@78
-31.31 dBm

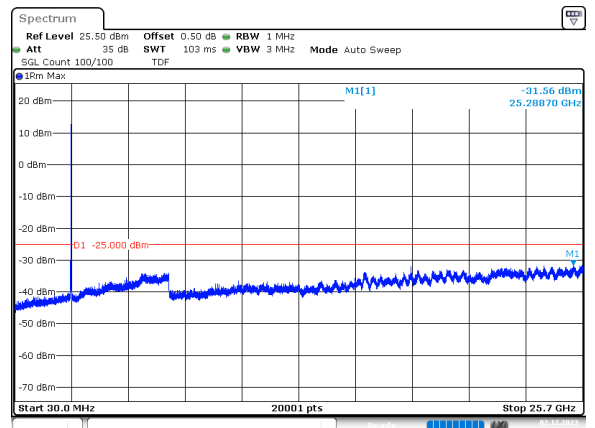
15MHz_15kHz_2562.5MHz_DFT-s-OFDM QPSK_RB75@0
-31.56 dBm

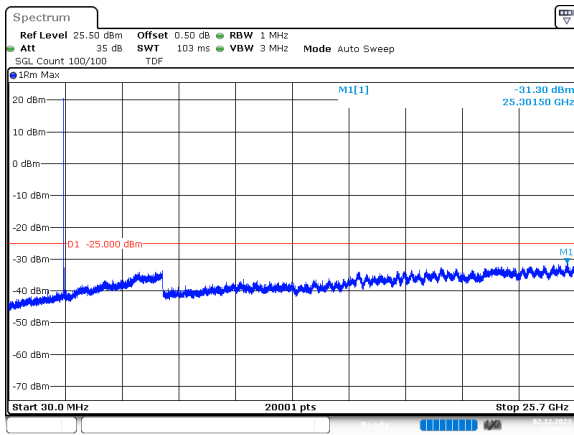
20MHz_15kHz_2510MHz_DFT-s-OFDM QPSK_RB1@0
-31.30 dBm

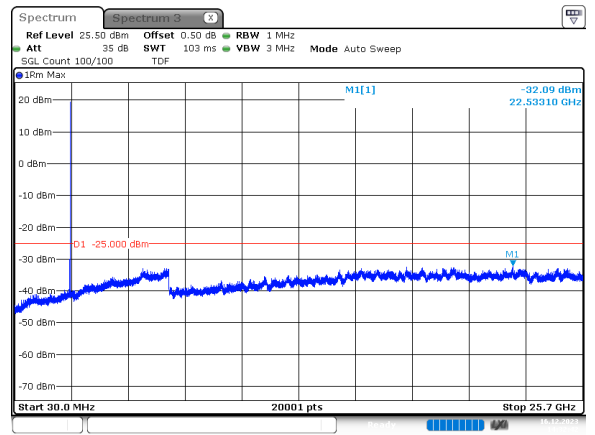
20MHz_15kHz_2510MHz_DFT-s-OFDM QPSK_RB1@105
-32.09 dBm

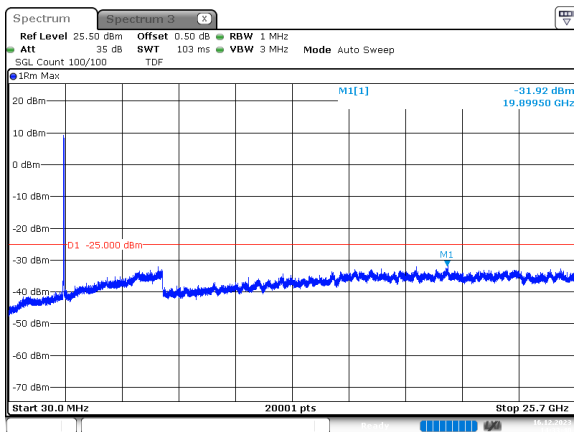
20MHz_15kHz_2510MHz_DFT-s-OFDM QPSK_RB100@0
-31.92 dBm

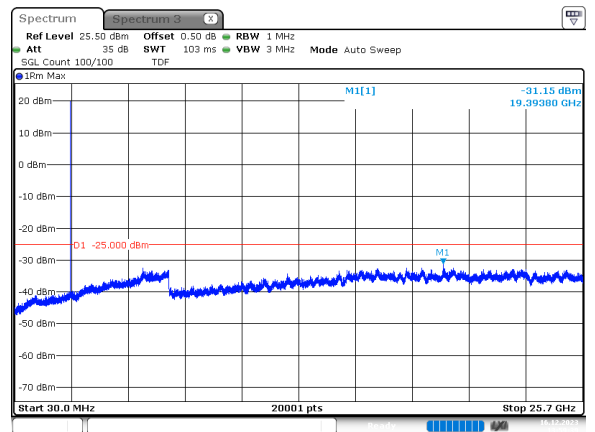
20MHz_15kHz_2535MHz_DFT-s-OFDM QPSK_RB1@0
-31.15 dBm

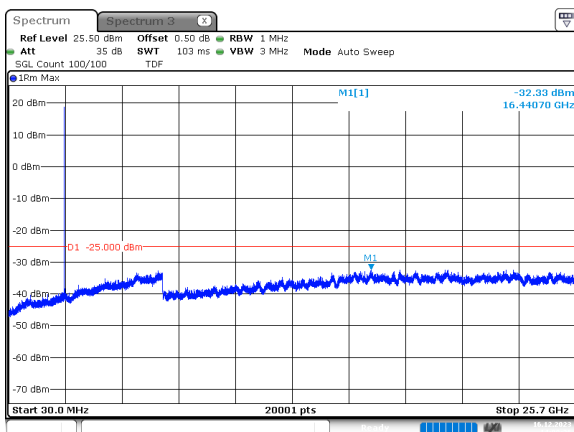
20MHz_15kHz_2535MHz_DFT-s-OFDM QPSK_RB1@105
-32.33 dBm

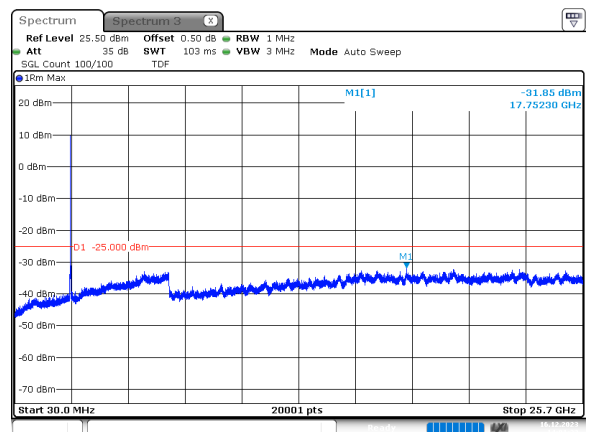
20MHz_15kHz_2535MHz_DFT-s-OFDM QPSK_RB100@0
-31.85 dBm

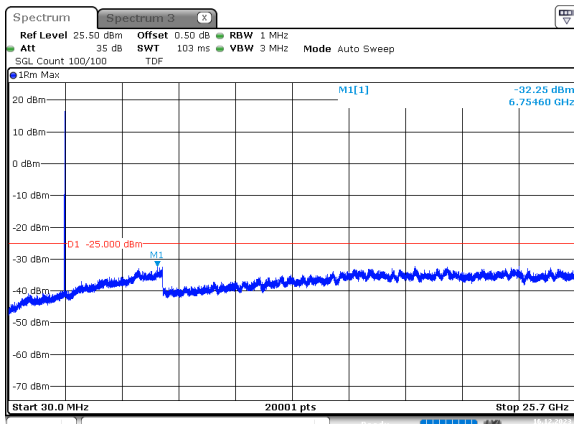
20MHz_15kHz_2560MHz_DFT-s-OFDM QPSK_RB1@0
-32.25 dBm

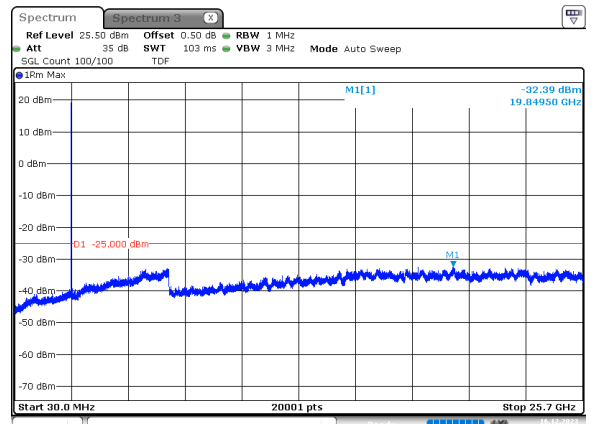
20MHz_15kHz_2560MHz_DFT-s-OFDM QPSK_RB1@105
-32.39 dBm

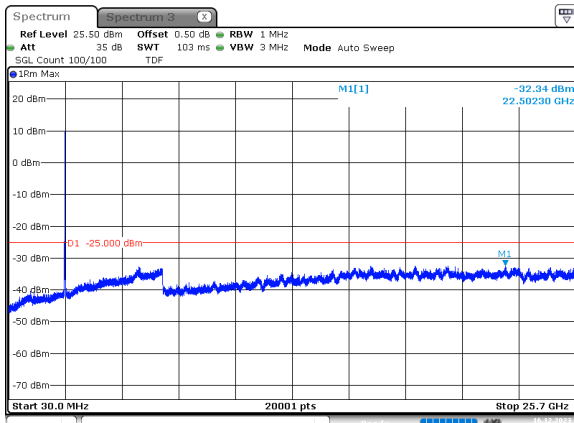
20MHz_15kHz_2560MHz_DFT-s-OFDM QPSK_RB100@0
-32.34 dBm

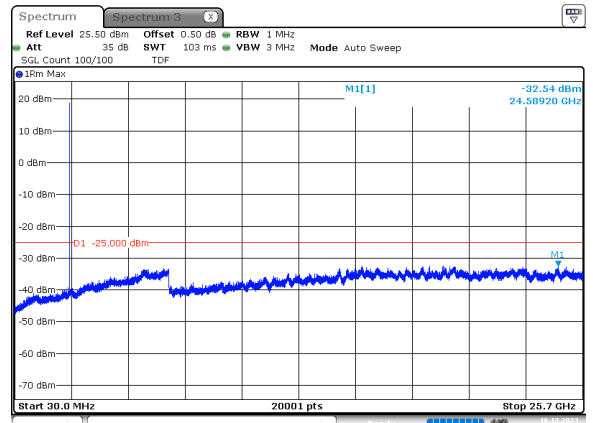
5MHz_15kHz_2502.5MHz_DFT-s-OFDM QPSK_RB1@0
-32.54 dBm

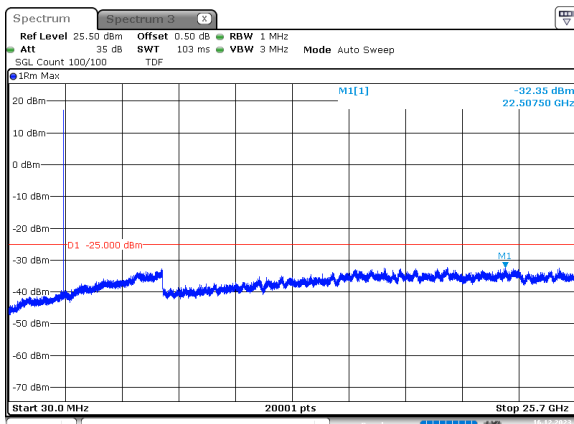
5MHz_15kHz_2502.5MHz_DFT-s-OFDM QPSK_RB1@24
-32.35 dBm

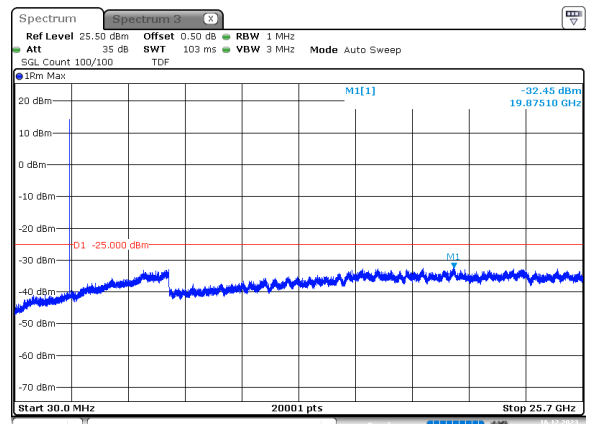
5MHz_15kHz_2502.5MHz_DFT-s-OFDM QPSK_RB25@0
-32.45 dBm

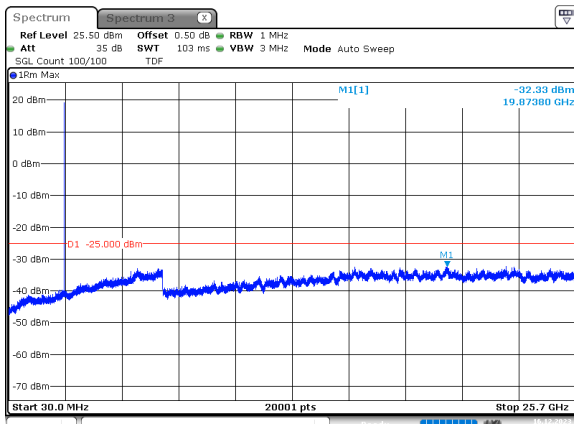
5MHz_15kHz_2535MHz_DFT-s-OFDM QPSK_RB1@0
-32.33 dBm

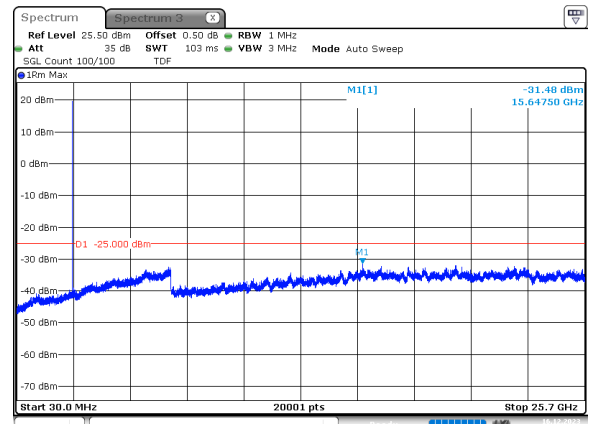
5MHz_15kHz_2535MHz_DFT-s-OFDM QPSK_RB1@24
-31.48 dBm

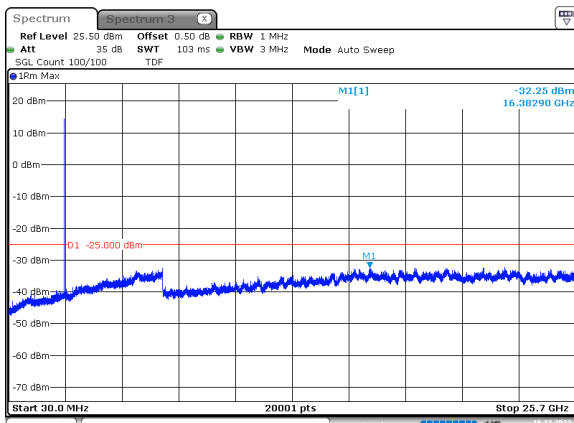
5MHz_15kHz_2535MHz_DFT-s-OFDM QPSK_RB25@0
-32.25 dBm

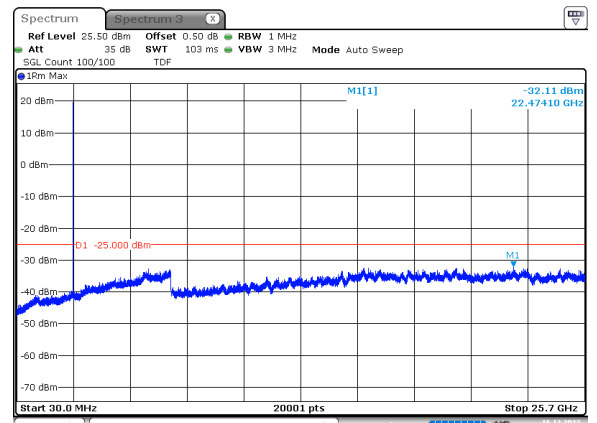
5MHz_15kHz_2567.5MHz_DFT-s-OFDM QPSK_RB1@0
-32.11 dBm

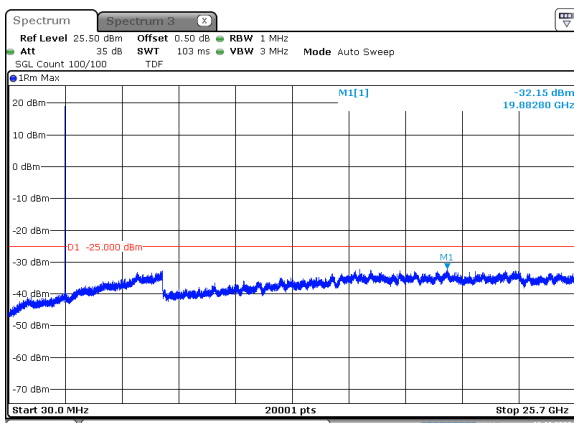
5MHz_15kHz_2567.5MHz_DFT-s-OFDM QPSK_RB1@24
-32.15 dBm

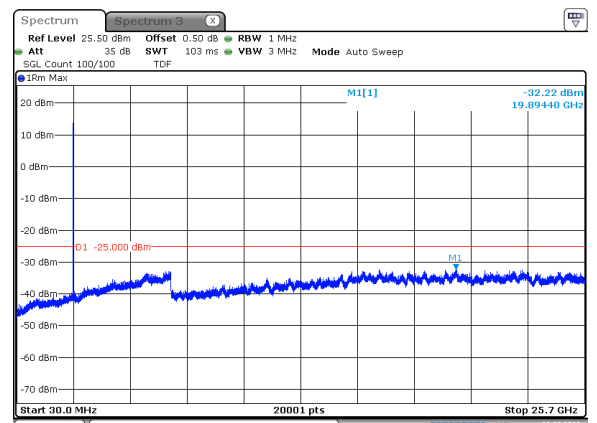
5MHz_15kHz_2567.5MHz_DFT-s-OFDM QPSK_RB25@0
-32.22 dBm
