n77\_1

ProjectNo.:CR231167220-RF Tester:One Luo  
Date: 21.JAN.2024 16:22:02

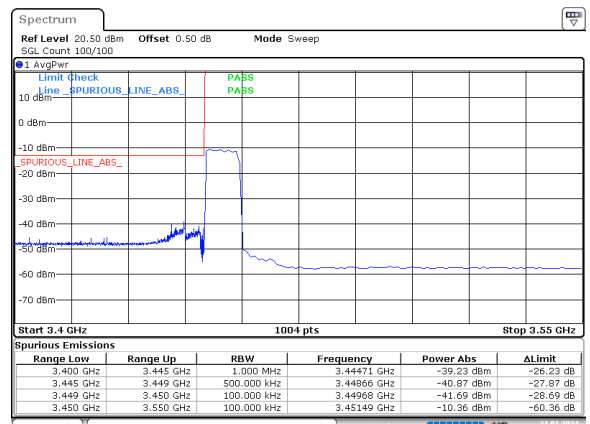
10MHz\_15kHz\_3455MHz\_DFT-s-OFDM QPSK\_RB50@0&-39.23 dBm

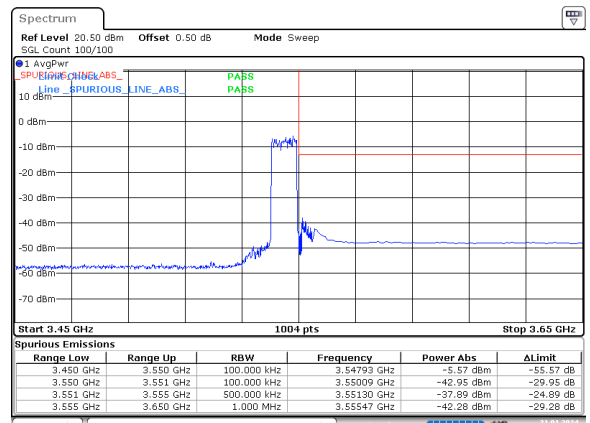
10MHz\_15kHz\_3545MHz\_DFT-s-OFDM QPSK\_RB50@0&-37.89 dBm

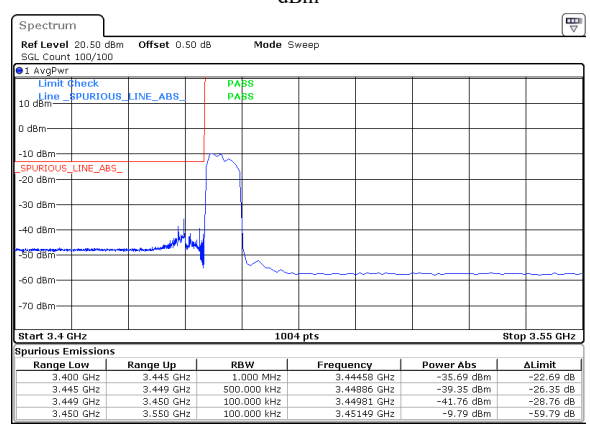
10MHz\_30kHz\_3455MHz\_DFT-s-OFDM QPSK\_RB24@0&-35.69 dBm

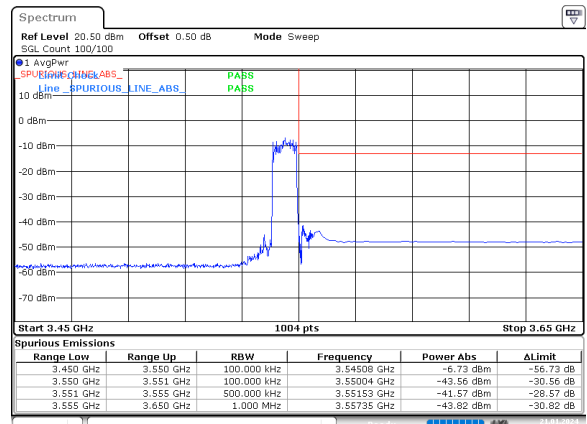
10MHz\_30kHz\_3545MHz\_DFT-s-OFDM QPSK\_RB24@0&-41.57 dBm

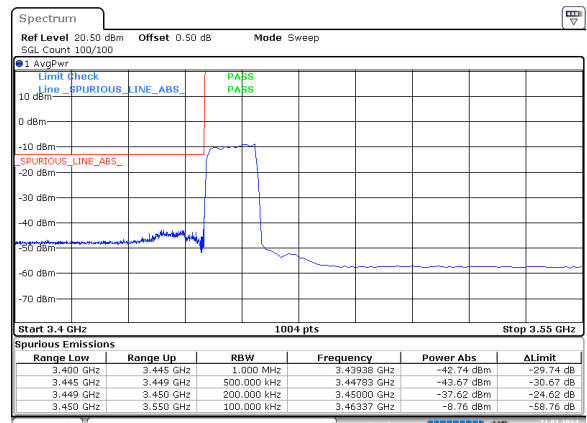
15MHz\_15kHz\_3457.5MHz\_DFT-s-OFDM QPSK\_RB75@0&-37.62 dBm

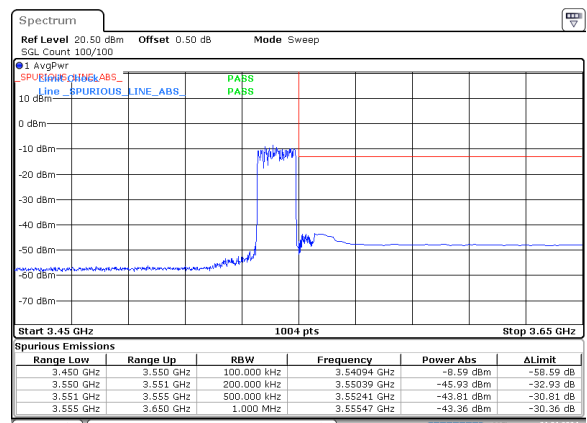
15MHz\_15kHz\_3542.5MHz\_DFT-s-OFDM QPSK\_RB75@0&-43.36 dBm

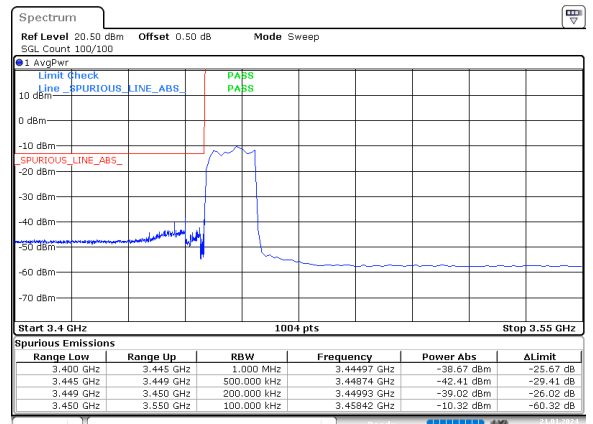
15MHz\_30kHz\_3457.5MHz\_DFT-s-OFDM QPSK\_RB36@0&-38.67 dBm

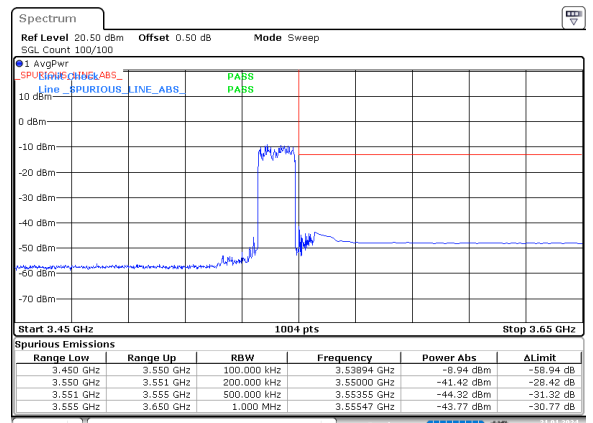
15MHz\_30kHz\_3542.5MHz\_DFT-s-OFDM QPSK\_RB36@0&-41.42 dBm

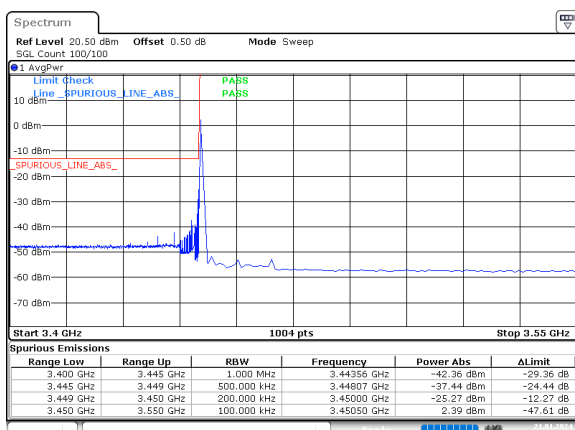
20MHz\_15kHz\_3460MHz\_DFT-s-OFDM QPSK\_RB1@0&-25.27 dBm

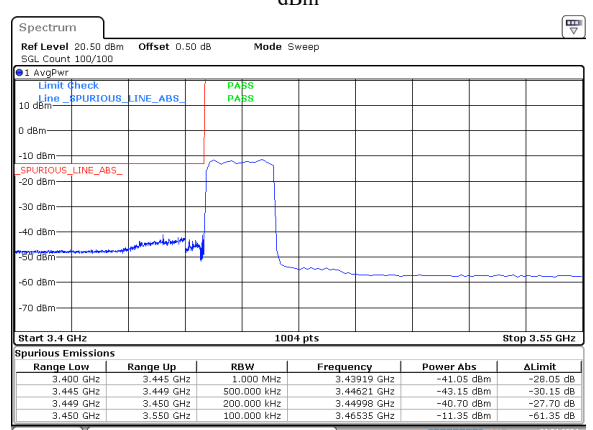
20MHz\_15kHz\_3460MHz\_DFT-s-OFDM QPSK\_RB100@0&-40.70 dBm

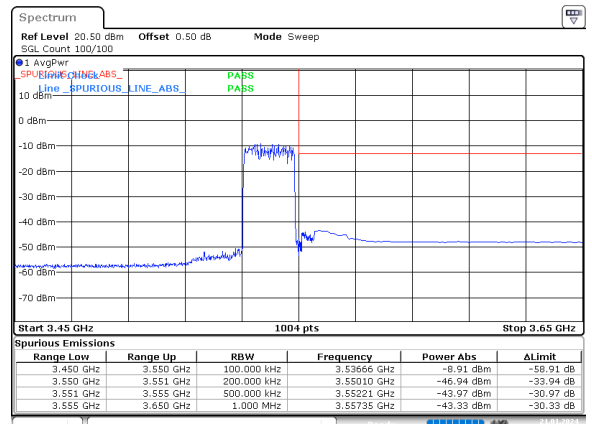
20MHz\_15kHz\_3540MHz\_DFT-s-OFDM QPSK\_RB100@0&-43.33 dBm

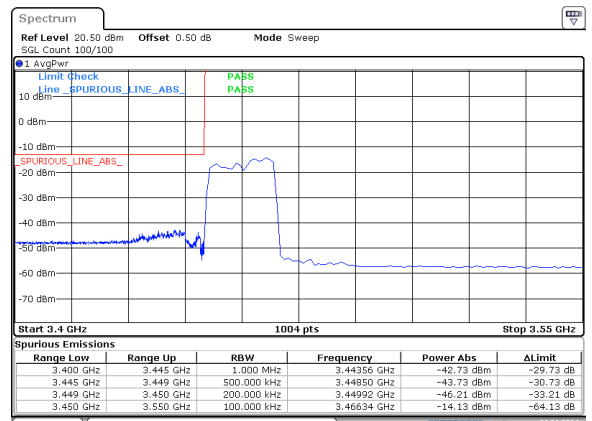
20MHz\_30kHz\_3460MHz\_DFT-s-OFDM QPSK\_RB50@0&-42.73 dBm

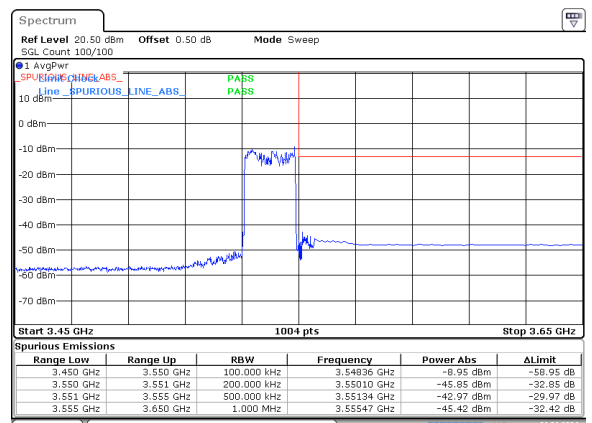
20MHz\_30kHz\_3540MHz\_DFT-s-OFDM QPSK\_RB50@0&-42.97 dBm

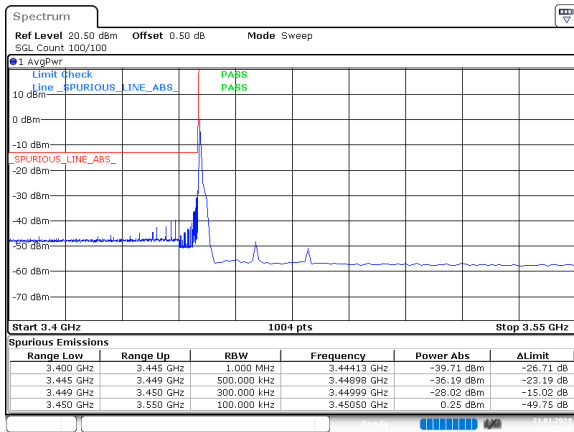
30MHz\_15kHz\_3465MHz\_DFT-s-OFDM QPSK\_RB1@0&-28.02 dBm

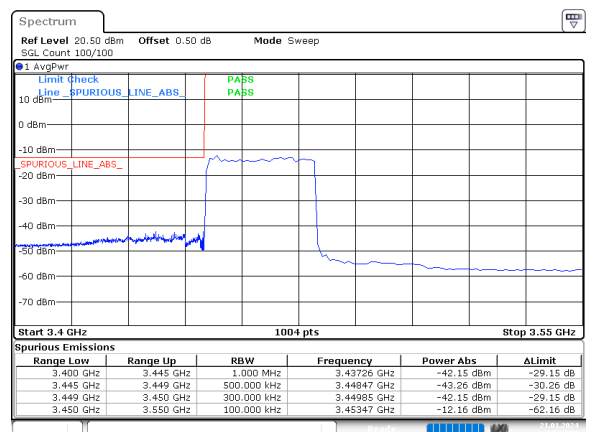
30MHz\_15kHz\_3465MHz\_DFT-s-OFDM QPSK\_RB160@0&-42.15 dBm

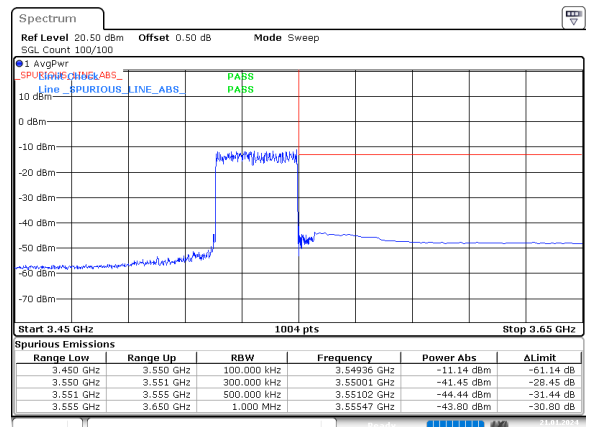
30MHz\_15kHz\_3535MHz\_DFT-s-OFDM QPSK\_RB160@0&-41.45 dBm

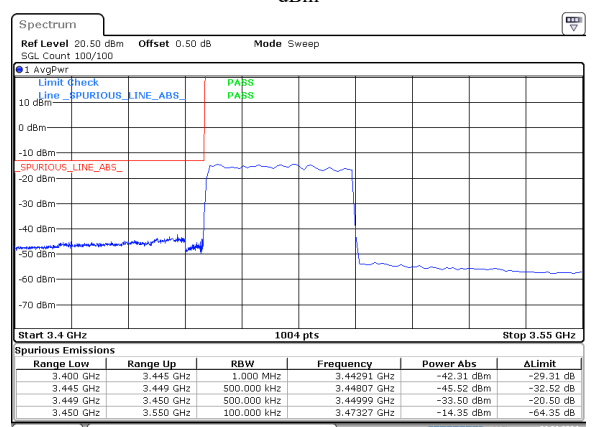
40MHz\_15kHz\_3470MHz\_DFT-s-OFDM QPSK\_RB216@0&-33.50 dBm

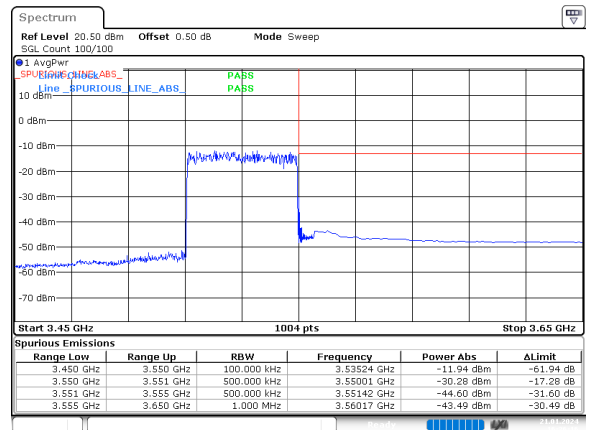
40MHz\_15kHz\_3530MHz\_DFT-s-OFDM QPSK\_RB216@0&-30.28 dBm

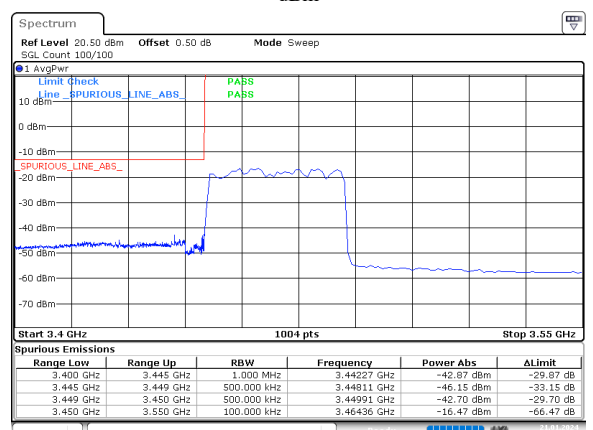
40MHz\_30kHz\_3470MHz\_DFT-s-OFDM QPSK\_RB100@0&-42.70 dBm

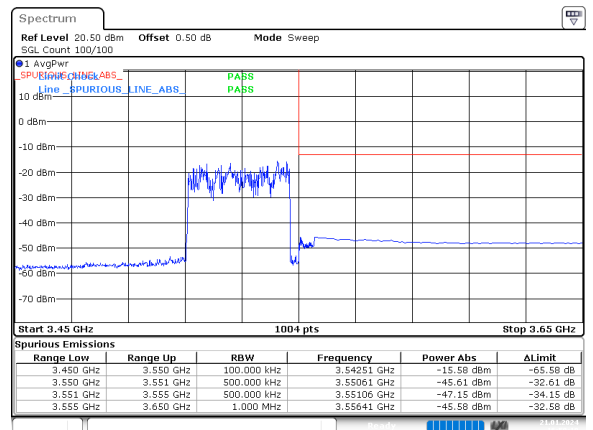
40MHz\_30kHz\_3530MHz\_DFT-s-OFDM QPSK\_RB100@0&-45.58 dBm

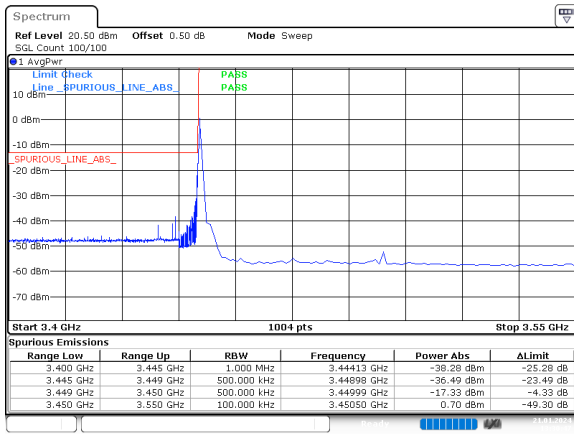
50MHz\_15kHz\_3475MHz\_DFT-s-OFDM QPSK\_RB1@0&-17.33 dBm

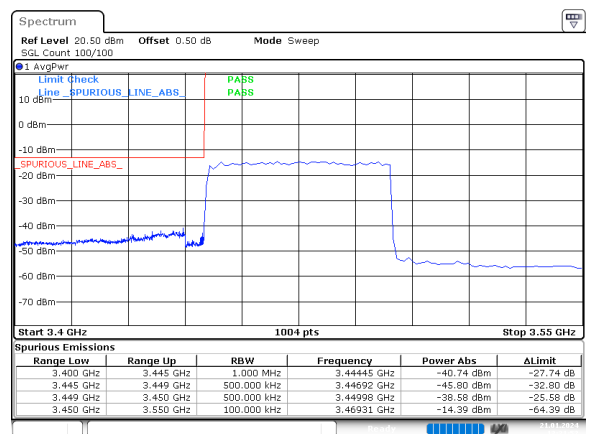
50MHz\_15kHz\_3475MHz\_DFT-s-OFDM QPSK\_RB270@0&-38.58 dBm

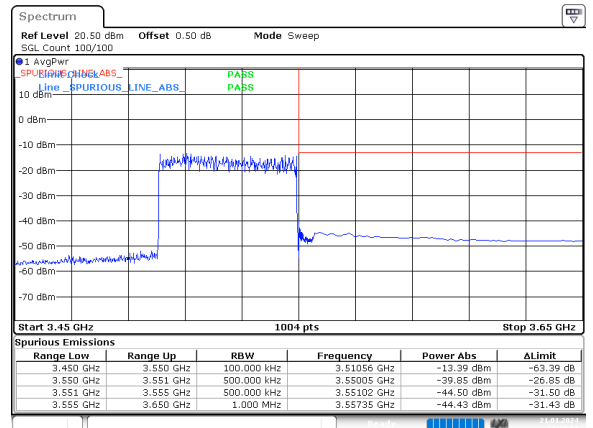
50MHz\_15kHz\_3525MHz\_DFT-s-OFDM QPSK\_RB270@0&-39.85 dBm

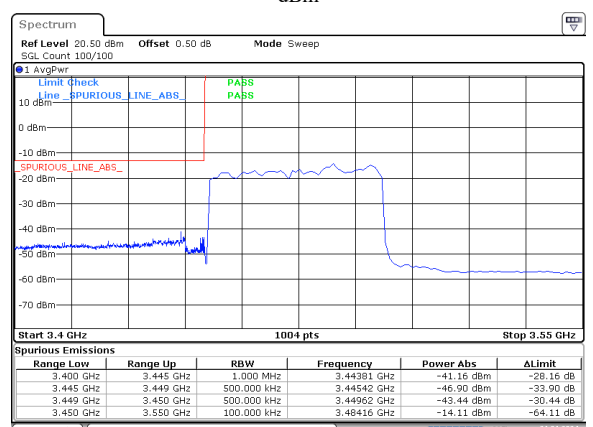
50MHz\_30kHz\_3475MHz\_DFT-s-OFDM QPSK\_RB128@0&-41.16 dBm

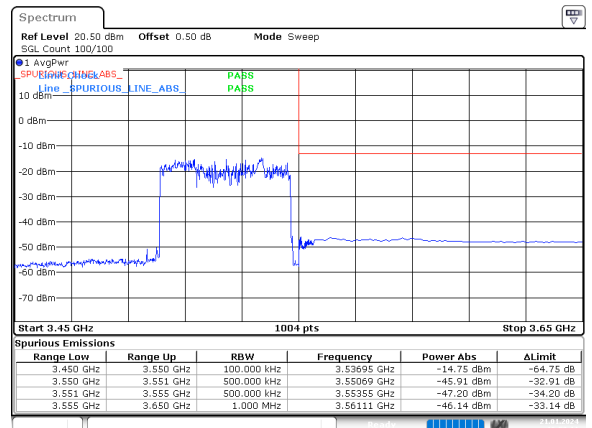
50MHz\_30kHz\_3525MHz\_DFT-s-OFDM QPSK\_RB128@0&-45.91 dBm

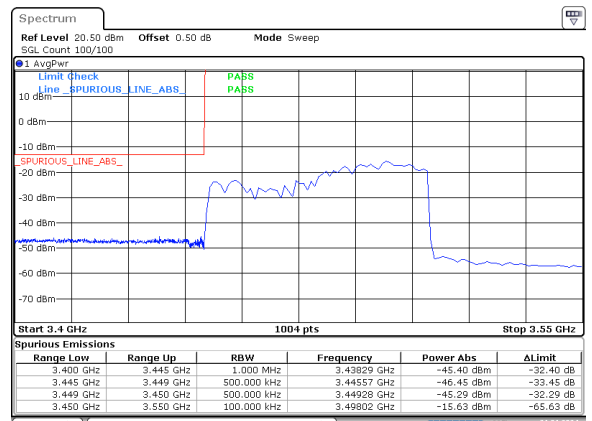
60MHz\_30kHz\_3480MHz\_DFT-s-OFDM QPSK\_RB162@0&-45.29 dBm

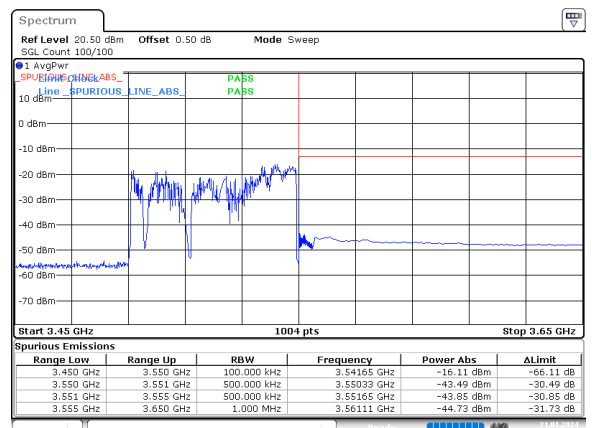
60MHz\_30kHz\_3520MHz\_DFT-s-OFDM QPSK\_RB162@0&-43.49 dBm

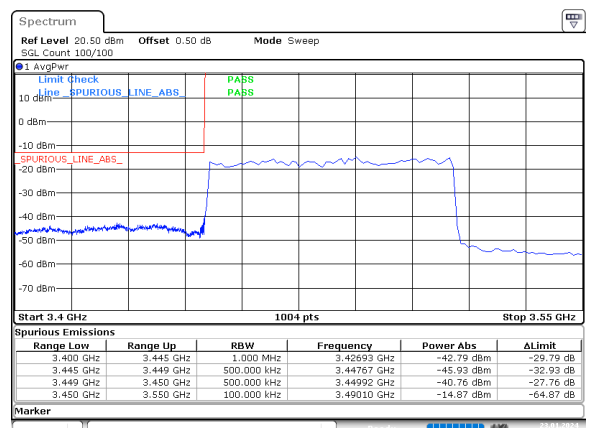
70MHz\_30kHz\_3485MHz\_DFT-s-OFDM QPSK\_RB180@0&-40.76 dBm

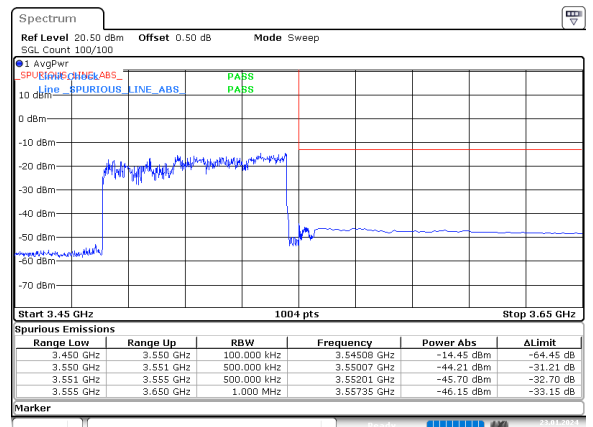
70MHz\_30kHz\_3515MHz\_DFT-s-OFDM QPSK\_RB180@0&-44.21 dBm

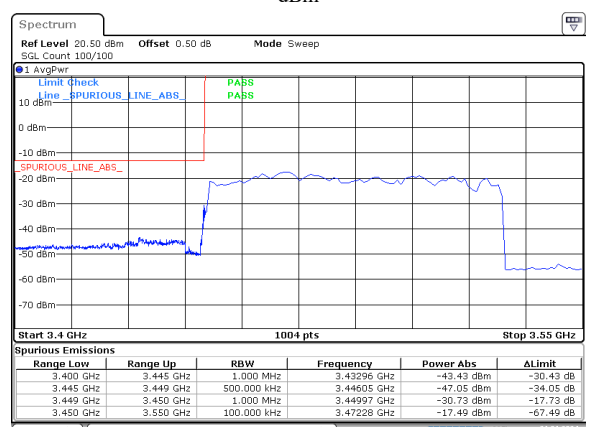
80MHz\_30kHz\_3490MHz\_DFT-s-OFDM QPSK\_RB216@0&-30.73 dBm

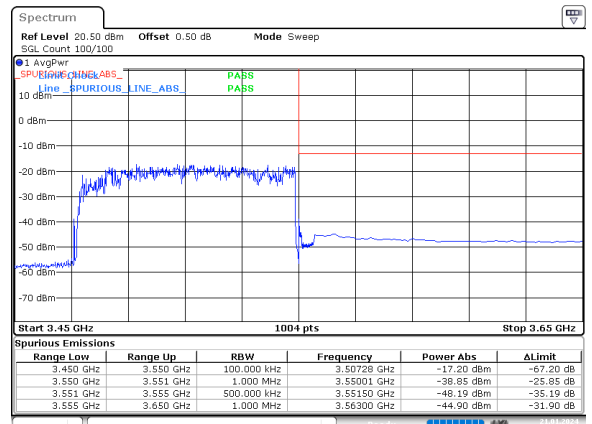
80MHz\_30kHz\_3510MHz\_DFT-s-OFDM QPSK\_RB216@0&-38.85 dBm

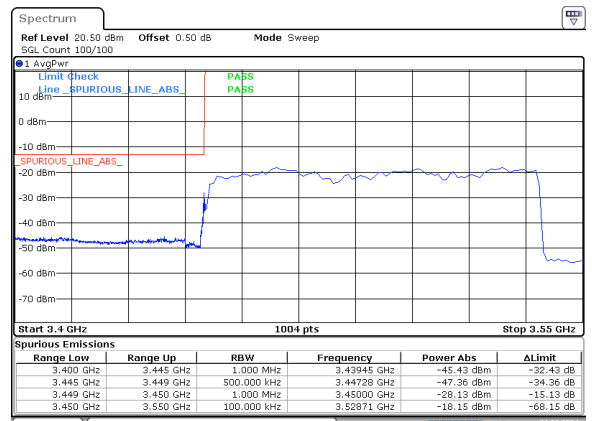
90MHz\_30kHz\_3495MHz\_DFT-s-OFDM QPSK\_RB243@0&-28.13 dBm

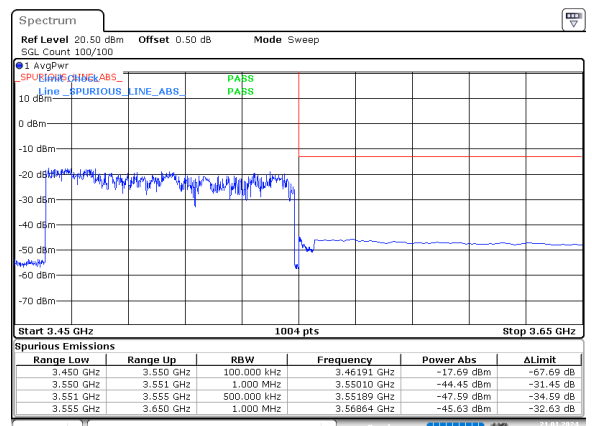
90MHz\_30kHz\_3505MHz\_DFT-s-OFDM QPSK\_RB243@0&-44.45 dBm

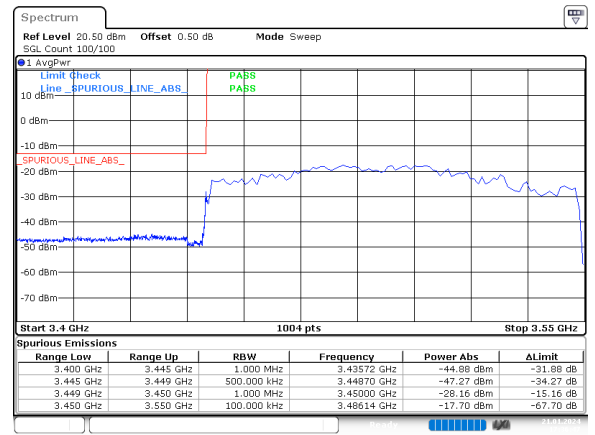
100MHz\_30kHz\_3500MHz\_DFT-s-OFDM QPSK\_RB270@0&-28.16 dBm

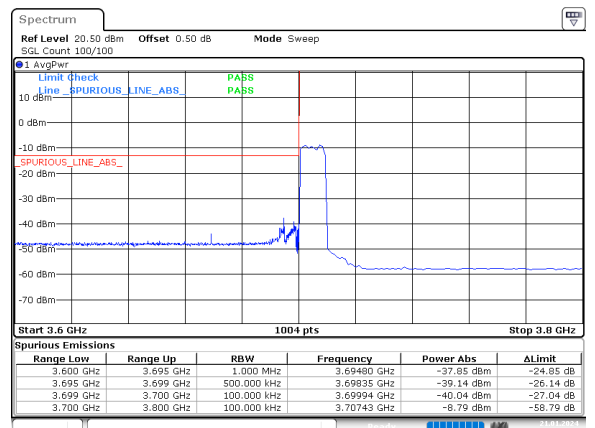
10MHz\_15kHz\_3705MHz\_DFT-s-OFDM QPSK\_RB50@0&-37.85 dBm

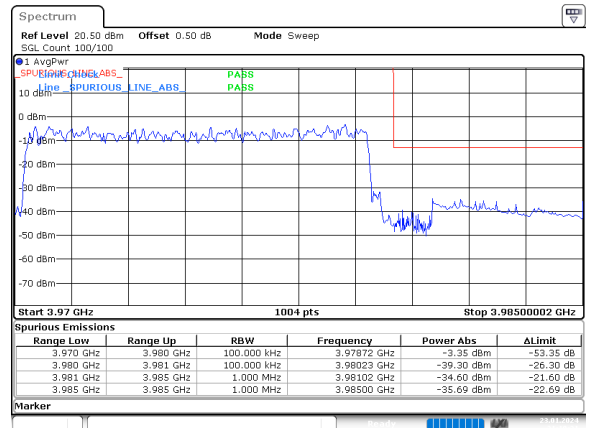
10MHz\_15kHz\_3975MHz\_DFT-s-OFDM QPSK\_RB50@0&-34.60 dBm

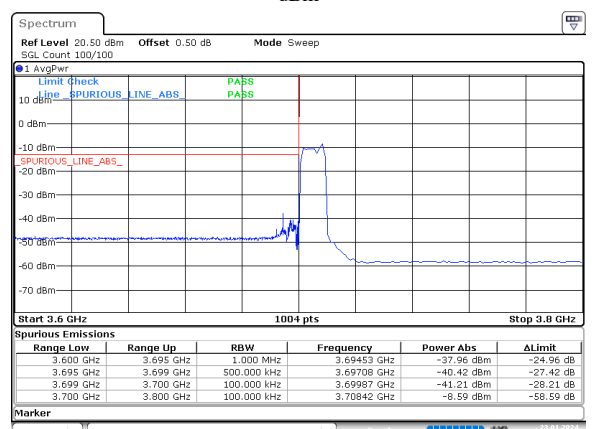
10MHz\_30kHz\_3705MHz\_DFT-s-OFDM QPSK\_RB24@0&-37.96 dBm

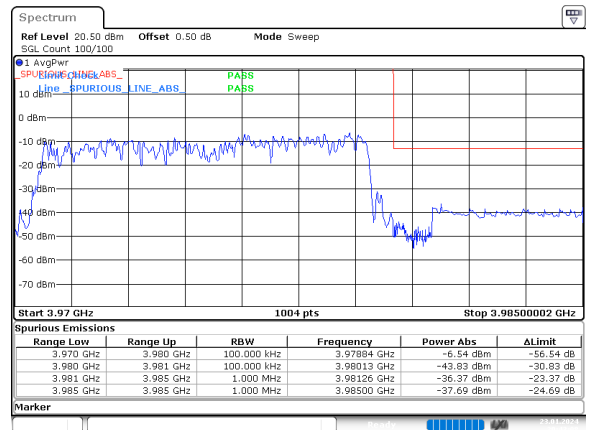
10MHz\_30kHz\_3975MHz\_DFT-s-OFDM QPSK\_RB24@0&-36.37 dBm

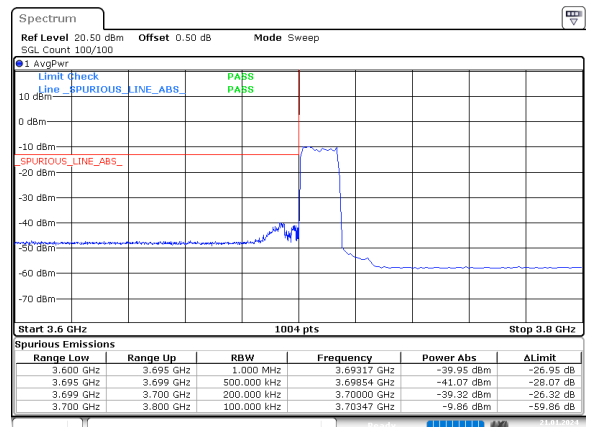
15MHz\_15kHz\_3707.5MHz\_DFT-s-OFDM QPSK\_RB75@0&-39.32 dBm

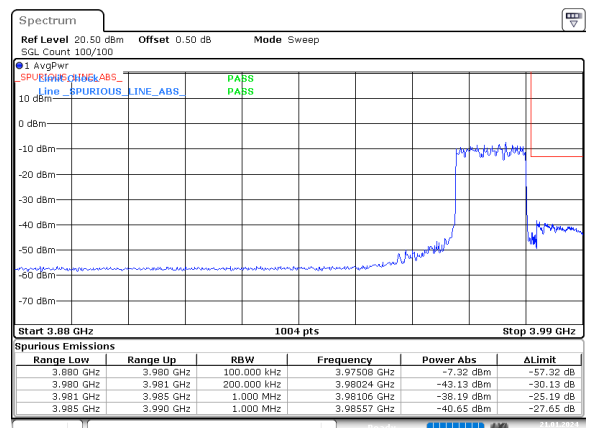
15MHz\_15kHz\_3972.5MHz\_DFT-s-OFDM QPSK\_RB75@0&-38.19 dBm

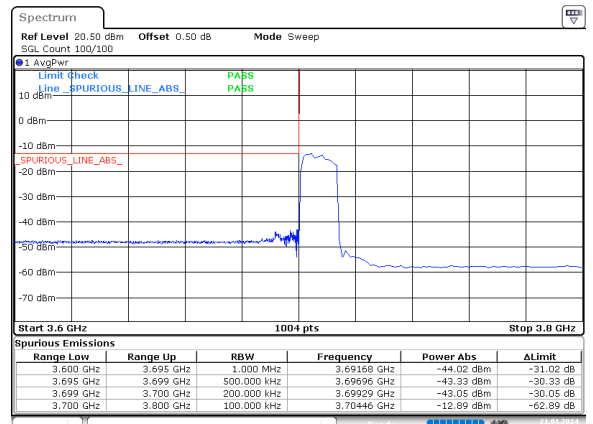
15MHz\_30kHz\_3707.5MHz\_DFT-s-OFDM QPSK\_RB36@0&-43.05 dBm

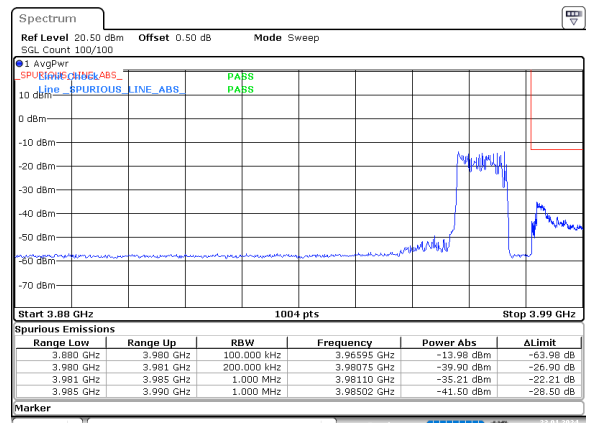
15MHz\_30kHz\_3972.5MHz\_DFT-s-OFDM QPSK\_RB36@0&-35.21 dBm

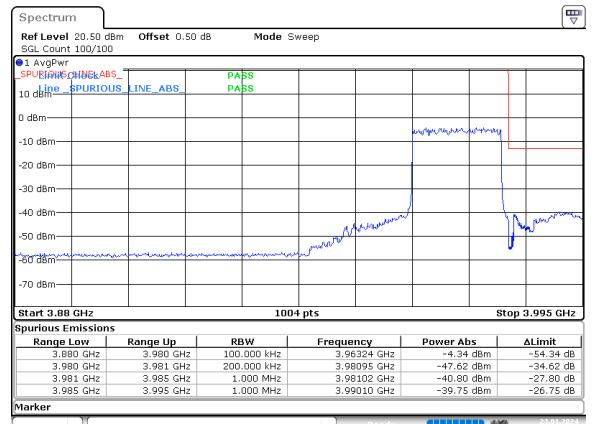
20MHz\_15kHz\_3970MHz\_DFT-s-OFDM QPSK\_RB100@0&-39.75 dBm

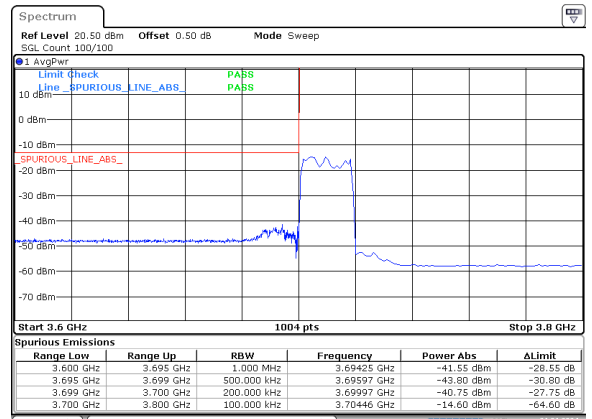
20MHz\_30kHz\_3710MHz\_DFT-s-OFDM QPSK\_RB50@0&-40.75 dBm

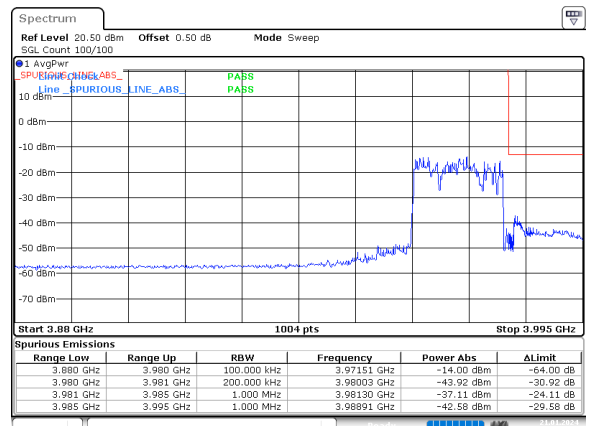
20MHz\_30kHz\_3970MHz\_DFT-s-OFDM QPSK\_RB50@0&-37.11 dBm

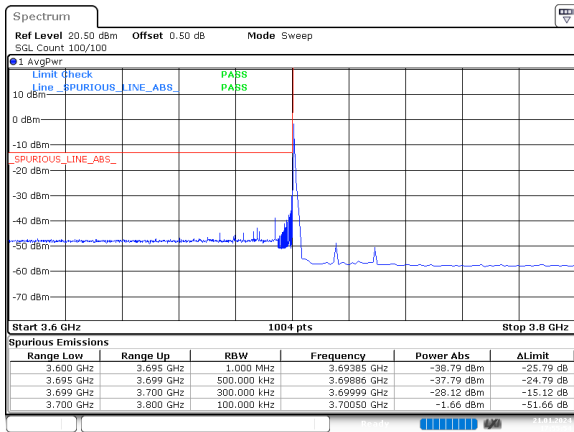
30MHz\_15kHz\_3715MHz\_DFT-s-OFDM QPSK\_RB1@0&-28.12 dBm

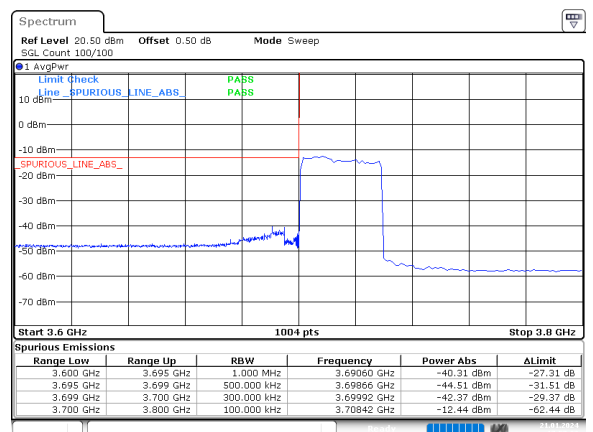
30MHz\_15kHz\_3715MHz\_DFT-s-OFDM QPSK\_RB160@0&-40.31 dBm

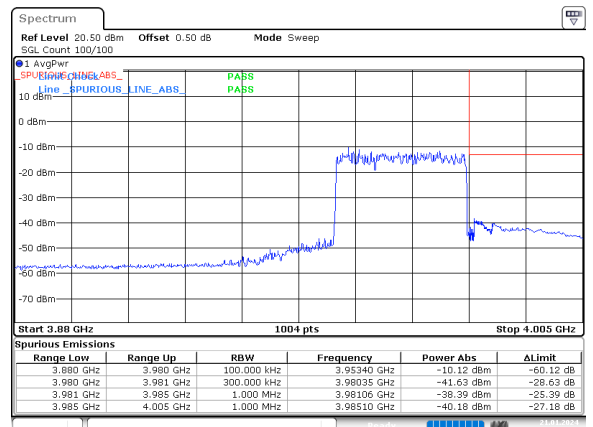
30MHz\_15kHz\_3965MHz\_DFT-s-OFDM QPSK\_RB160@0&-38.39 dBm

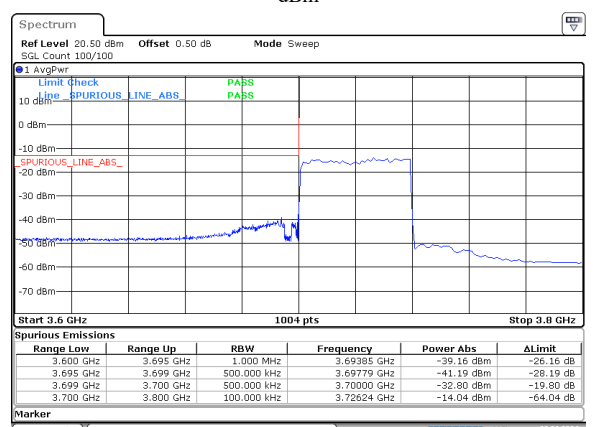
40MHz\_15kHz\_3720MHz\_DFT-s-OFDM QPSK\_RB216@0&-32.80 dBm

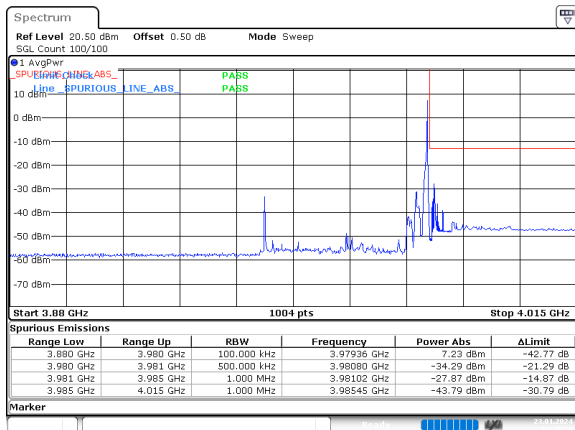
40MHz\_15kHz\_3960MHz\_DFT-s-OFDM QPSK\_RB1@215&-27.87 dBm

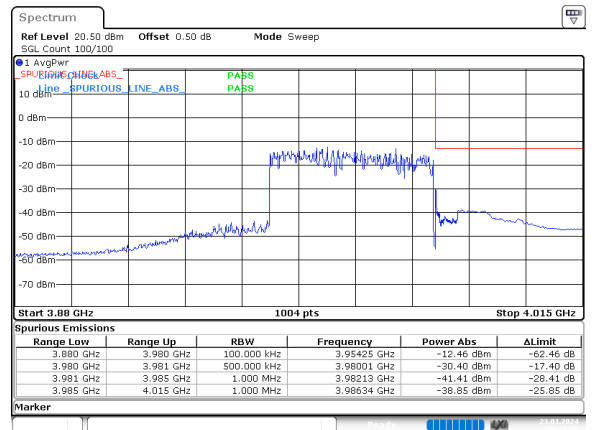
40MHz\_15kHz\_3960MHz\_DFT-s-OFDM QPSK\_RB16@0&-30.40 dBm

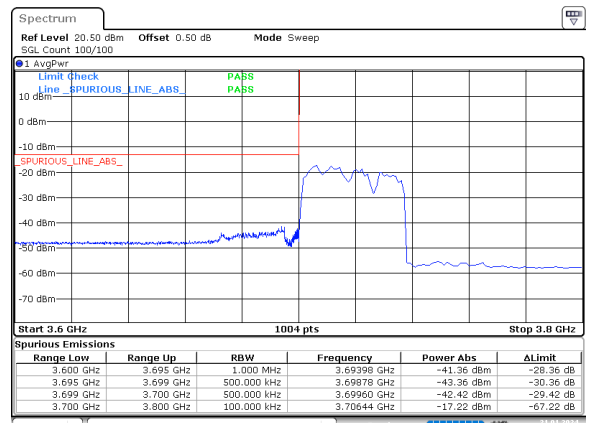
40MHz\_30kHz\_3720MHz\_DFT-s-OFDM QPSK\_RB100@0&-41.36 dBm

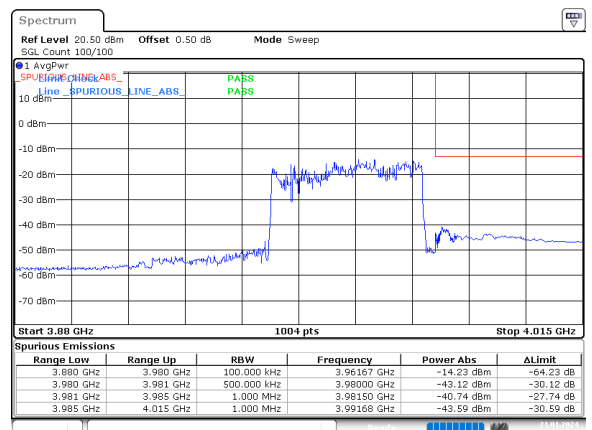
40MHz\_30kHz\_3960MHz\_DFT-s-OFDM QPSK\_RB100@0&-40.74 dBm

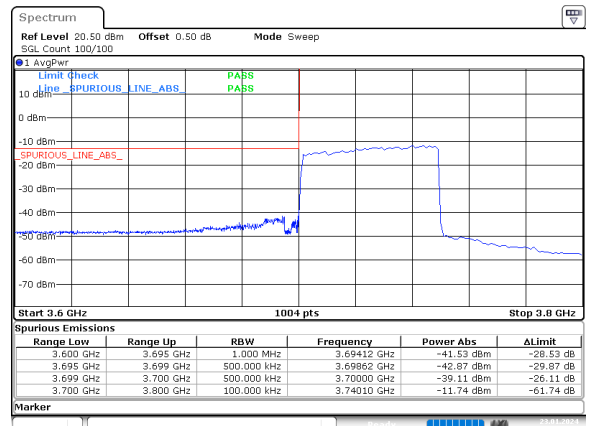
50MHz\_15kHz\_3725MHz\_DFT-s-OFDM QPSK\_RB270@0&-39.11 dBm

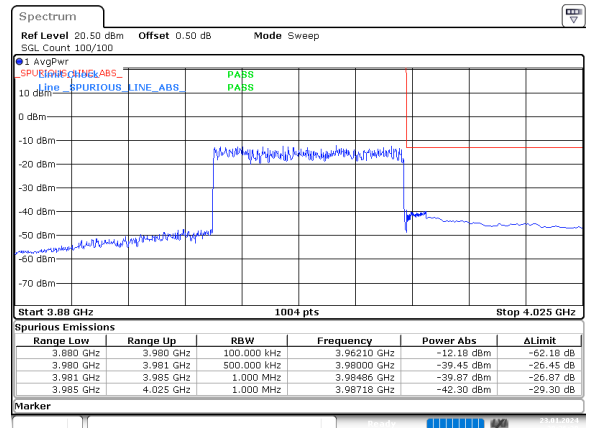
50MHz\_15kHz\_3955MHz\_DFT-s-OFDM QPSK\_RB270@0&-39.45 dBm

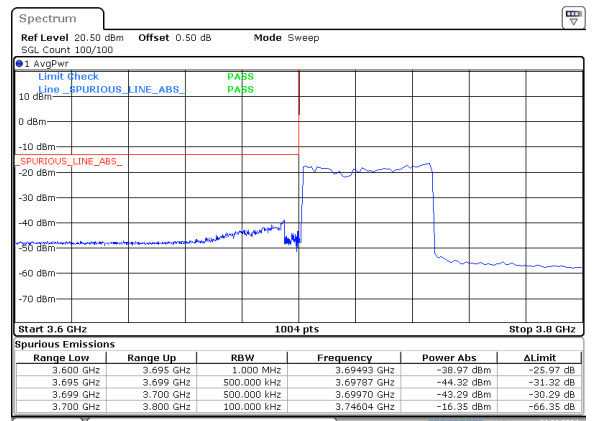
50MHz\_30kHz\_3725MHz\_DFT-s-OFDM QPSK\_RB128@0&-38.97 dBm

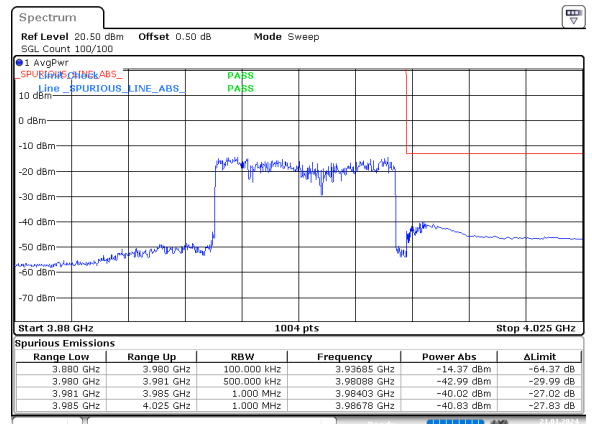
50MHz\_30kHz\_3955MHz\_DFT-s-OFDM QPSK\_RB128@0&-40.02 dBm

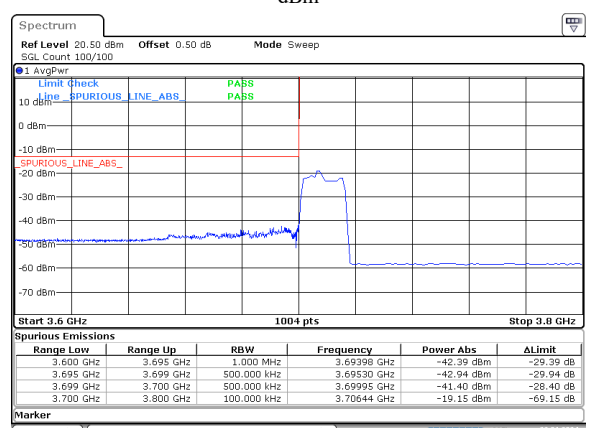
60MHz\_30kHz\_3730MHz\_DFT-s-OFDM QPSK\_RB162@0&-41.40 dBm

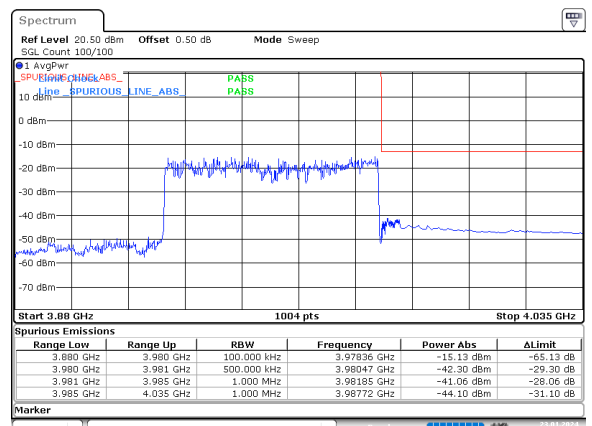
60MHz\_30kHz\_3950MHz\_DFT-s-OFDM QPSK\_RB162@0&-41.06 dBm

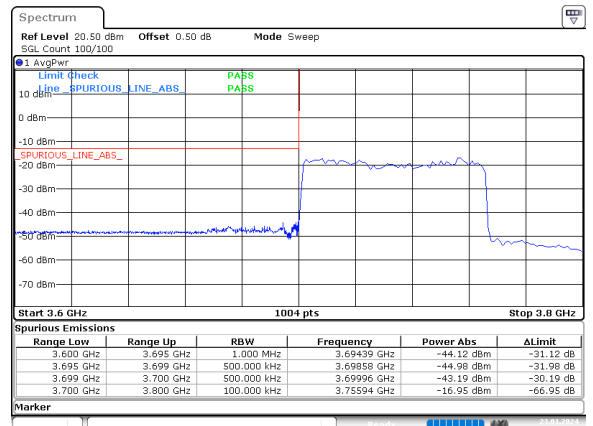
70MHz\_30kHz\_3735MHz\_DFT-s-OFDM QPSK\_RB180@0&-43.19 dBm

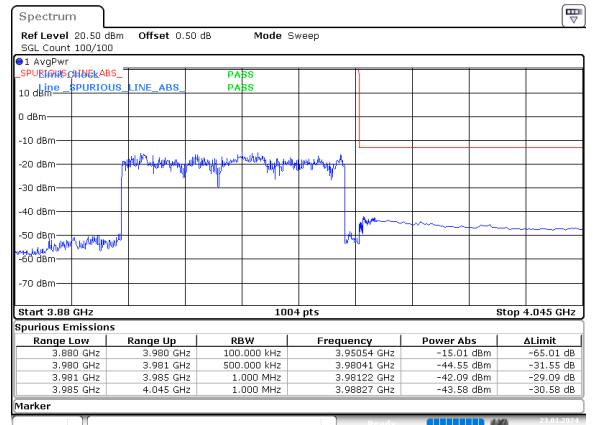
70MHz\_30kHz\_3945MHz\_DFT-s-OFDM QPSK\_RB180@0&-42.09 dBm

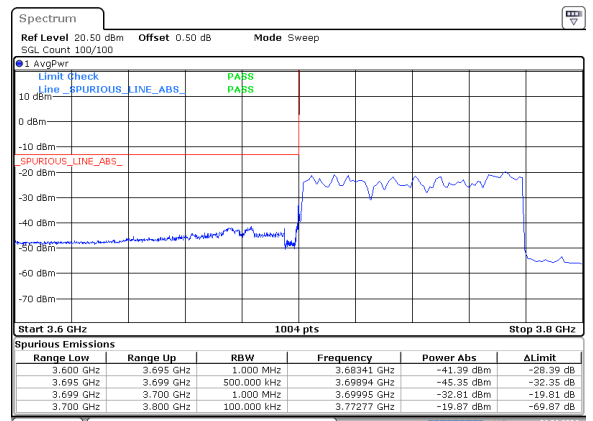
80MHz\_30kHz\_3740MHz\_DFT-s-OFDM QPSK\_RB216@0&-32.81 dBm

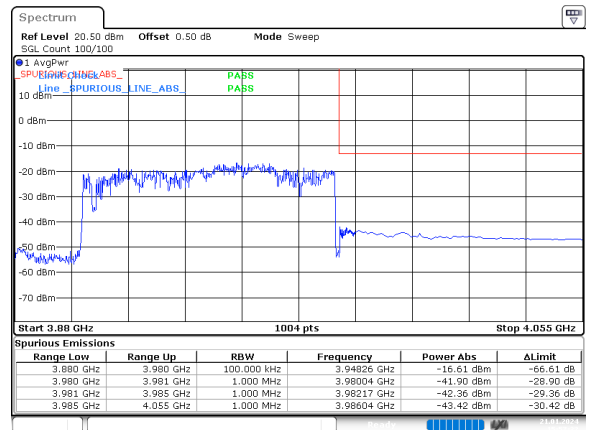
80MHz\_30kHz\_3940MHz\_DFT-s-OFDM QPSK\_RB216@0&-41.90 dBm

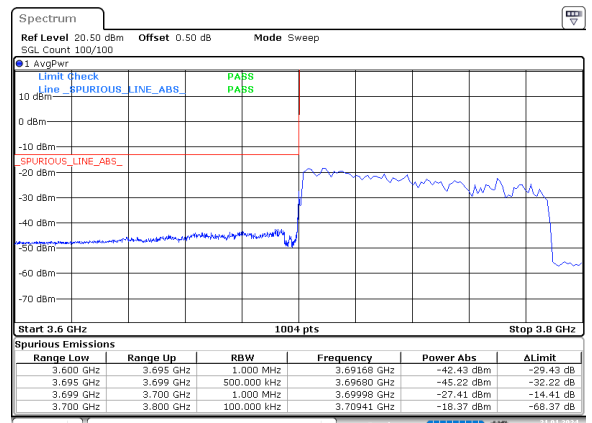
90MHz\_30kHz\_3745MHz\_DFT-s-OFDM QPSK\_RB243@0&-27.41 dBm

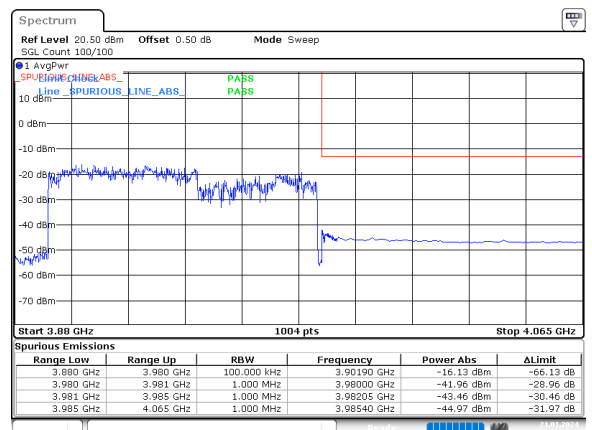
90MHz\_30kHz\_3935MHz\_DFT-s-OFDM QPSK\_RB243@0&-41.96 dBm

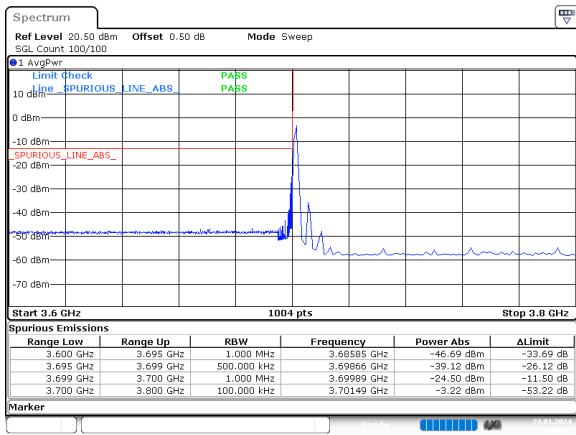
100MHz\_30kHz\_3750MHz\_DFT-s-OFDM QPSK\_RB1@0&-24.50 dBm

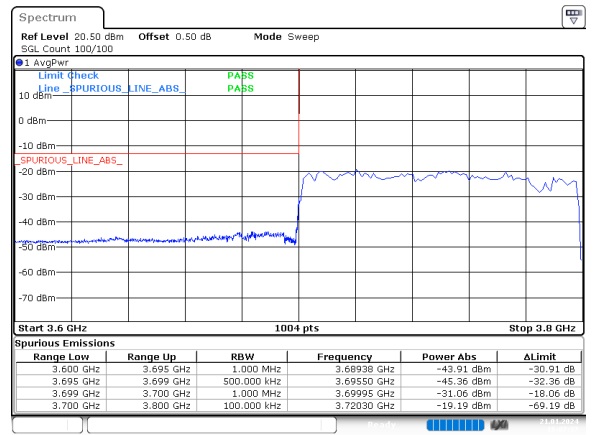
100MHz\_30kHz\_3750MHz\_DFT-s-OFDM QPSK\_RB270@0&-31.06 dBm

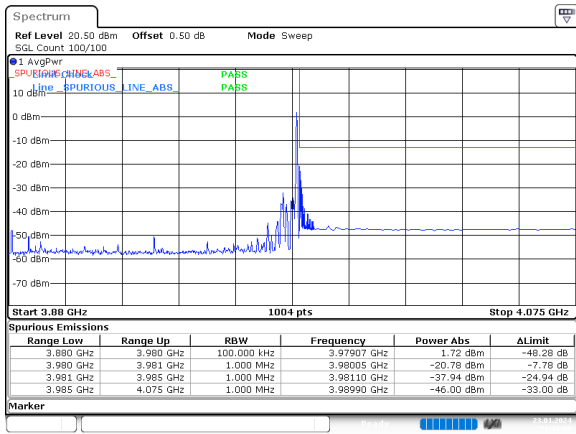
100MHz\_30kHz\_3930MHz\_DFT-s-OFDM QPSK\_RB1@272&-20.78 dBm

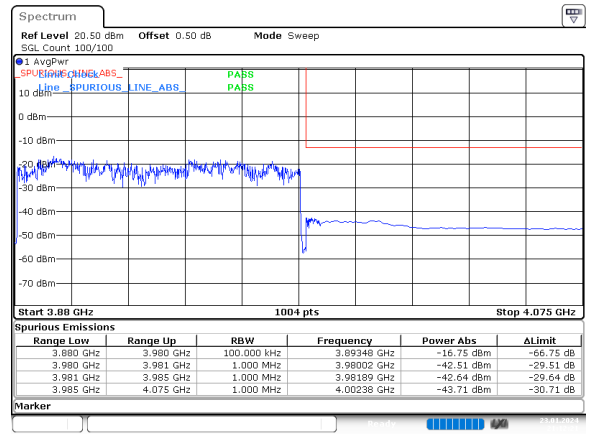
100MHz\_30kHz\_3930MHz\_DFT-s-OFDM QPSK\_RB270@0&-42.51 dBm
