Report No. 141207-1

**Compliance Testing Report of the
“E10G” Microwave Communications Transceiver to
FCC Part 15 (B) Class B (ANSI C63.4:2003) and
FCC Part 15 (C) Para 15.249 (ANSI C63.4:2003)**

EM Clarity Pty Ltd

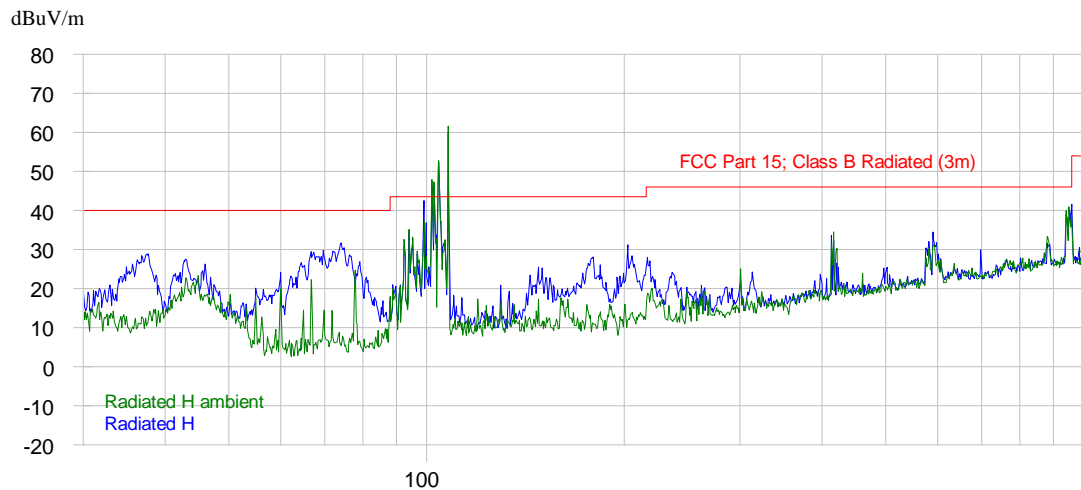
(Start = 30.00, Stop = 1000.00) MHz

Note: Signals exceeding the limit level in the plot were ambients.

Figure 1a. Radiated Emissions, 0.6m dish - 30 MHz to 1000 MHz (Horizontal)

The radiated peak emission trace results are shown in Figures 1a to 8b. The radiated testing was performed at an antenna-to-EUT distance of 3 metres. Peak values only were measured, except where the disturbances approached the limit. At these points, the QP detector was used. The resolution bandwidth was 120 kHz and the video bandwidth was 300 kHz for measured emissions from 30 MHz to 1 GHz. The resolution bandwidth was 1 MHz and the video bandwidth was 1 MHz for measured emissions above 1 GHz.

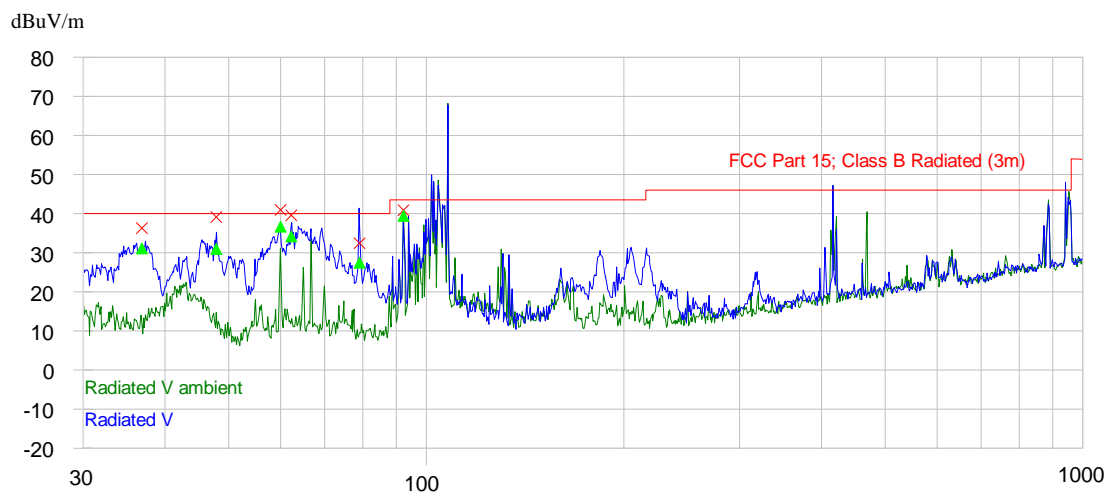
(Start = 30.00, Stop = 1000.00) MHz

Frequency MHz	Peak dBuV/m	QP dBuV/m
36.871	36.3	31.1
47.879	39.1	30.9
59.978	40.9	36.6
62.293	39.5	34.2
79.082	32.4	27.4
92.295	40.8	39.4

Note: Signals exceeding the limit level in the plot were ambients.

Figure 1b. Radiated Emissions, 0.6m dish - 30 MHz to 1000 MHz (Vertical)

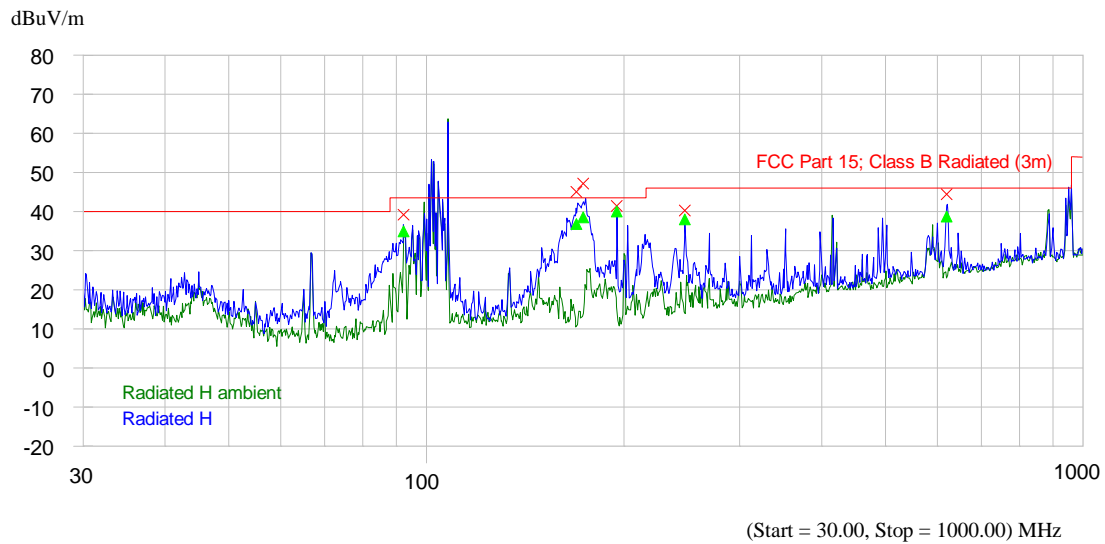
Frequency MHz	Peak dBuV/m	QP dBuV/m
169.199	45.0	36.8
173.337	47.1	38.5
194.989	41.4	40.0
247.493	40.2	38.0
92.325	39.2	34.9
619.901	44.4	38.7

Note: Signals exceeding the limit level in the plot were ambients.

**Figure 2a. Radiated Emissions, 1.2m dish - 30 MHz to 1000 MHz
(Horizontal)**

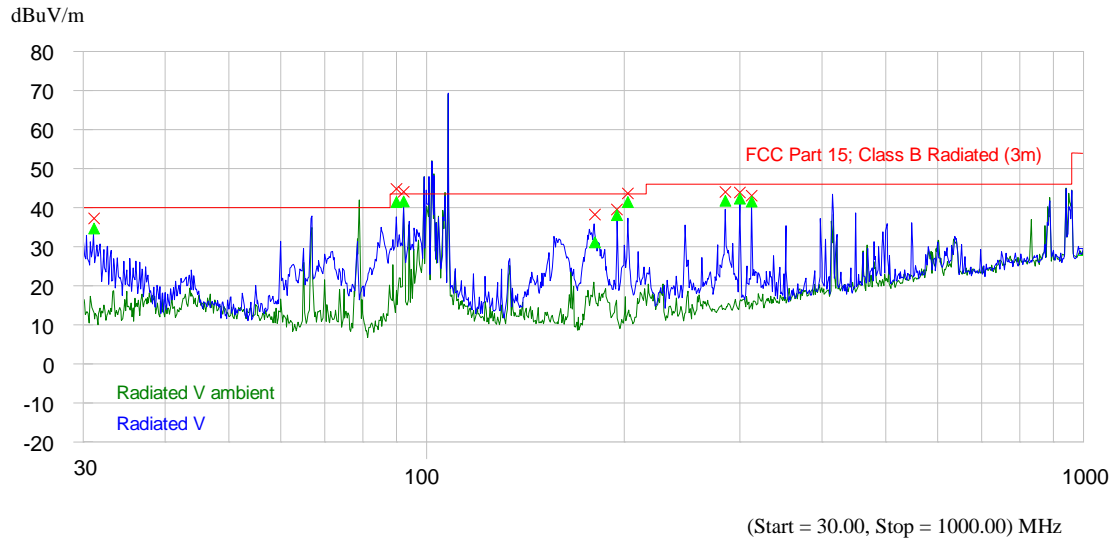
Frequency MHz	Peak dBuV/m	QP dBuV/m
31.178	37.2	34.6
92.286	44.1	41.6
89.975	44.8	41.4
180.389	38.2	31.1
194.982	39.5	38.1
202.484	43.6	41.4
284.983	44.0	41.8
299.988	43.9	42.3
312.492	43.1	41.6

Note: Signals exceeding the limit level in the plot were ambients.

**Figure 2b. Radiated Emissions, 1.2 m dish - 30 MHz to 1000 MHz
(Vertical)**

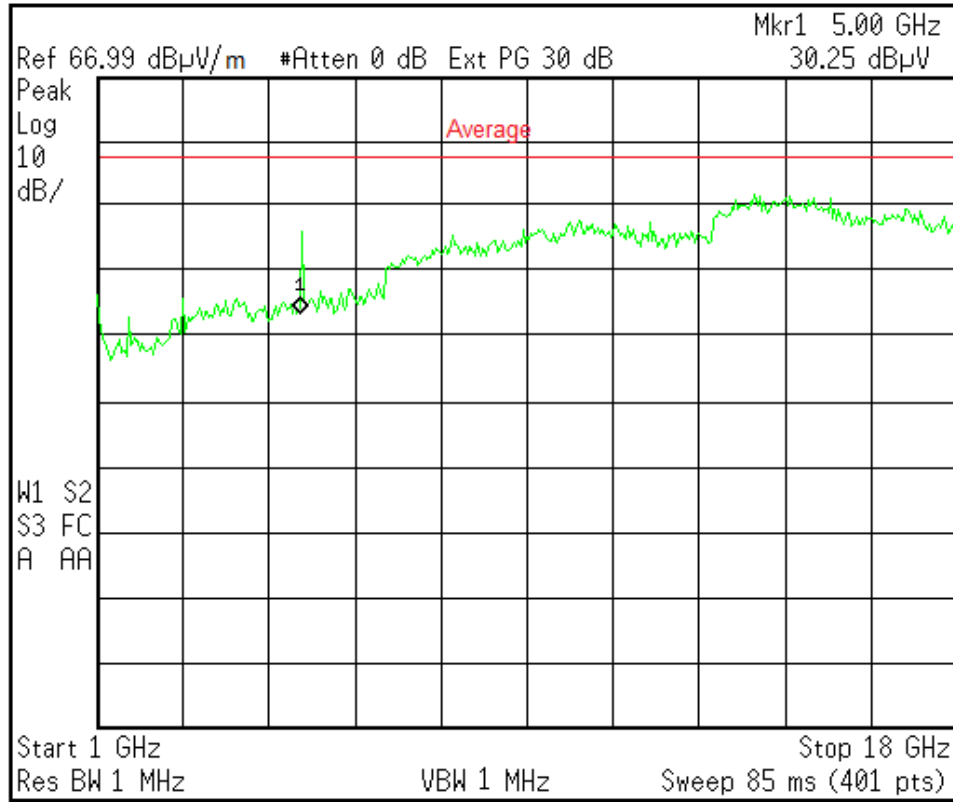
Figure 3a. Radiated Emissions, 1.2m dish - 1 GHz to 18 GHz (Vertical)

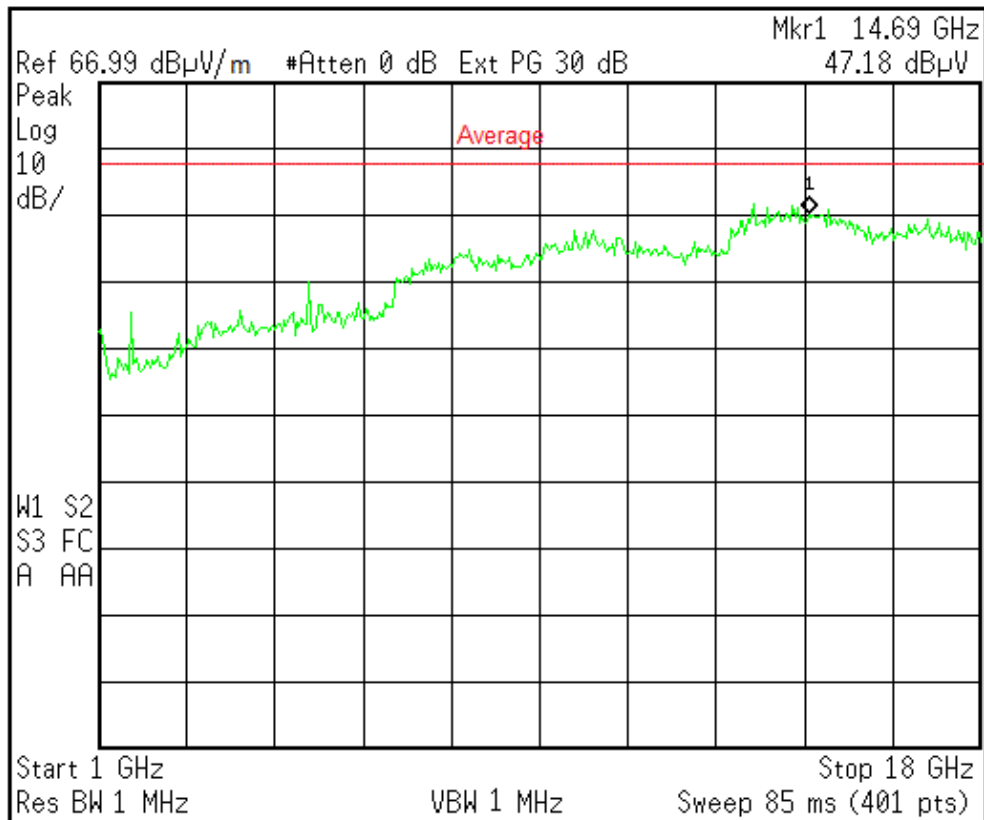
Figure 3b. Radiated Emissions, 1.2m dish - 1 GHz to 18 GHz (Horizontal)

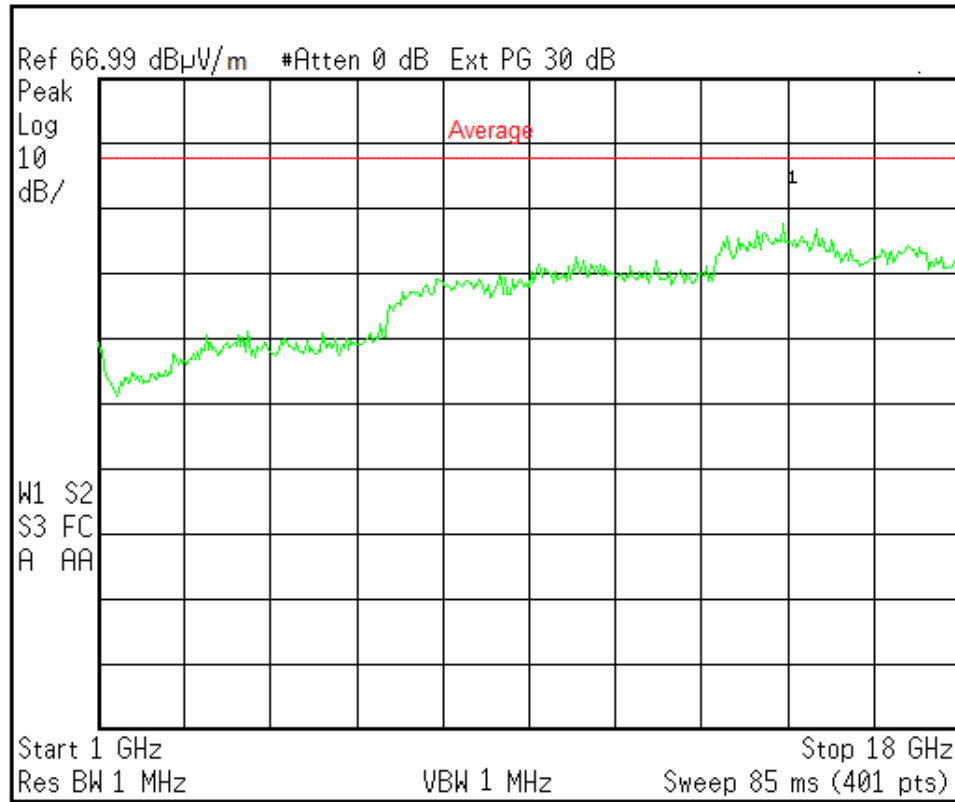
Figure 4a. Radiated Emissions, 0.6m dish - 1 GHz to 18 GHz (Vertical)

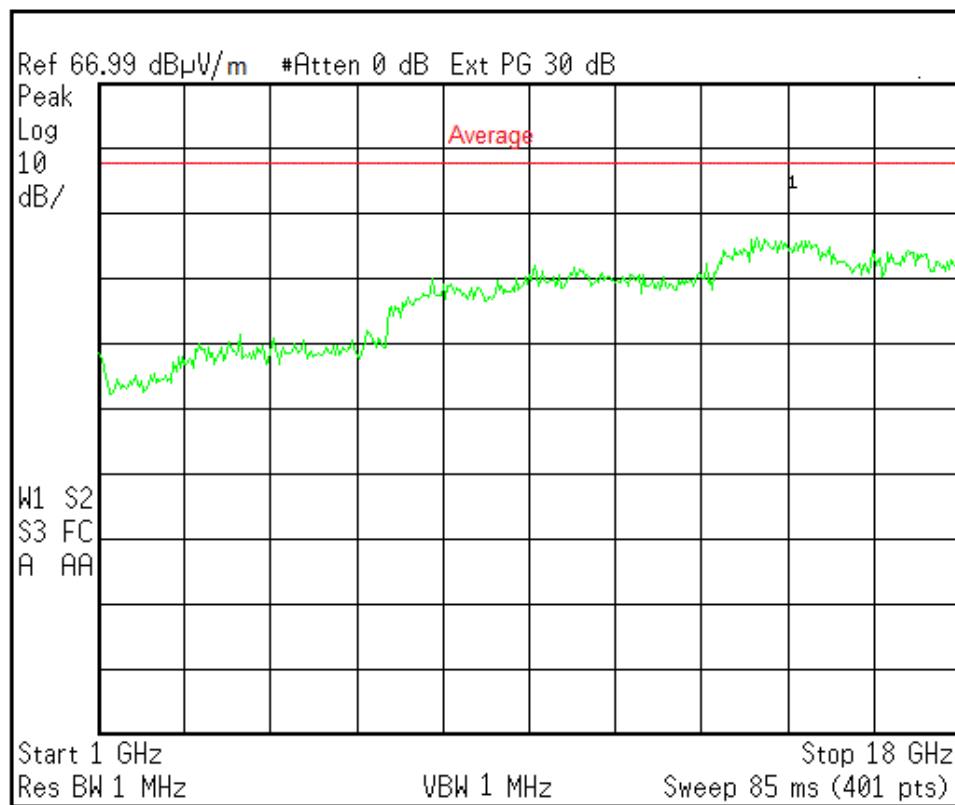
Figure 4b. Radiated Emissions, 0.6m dish - 1 GHz to 18 GHz (Horizontal)

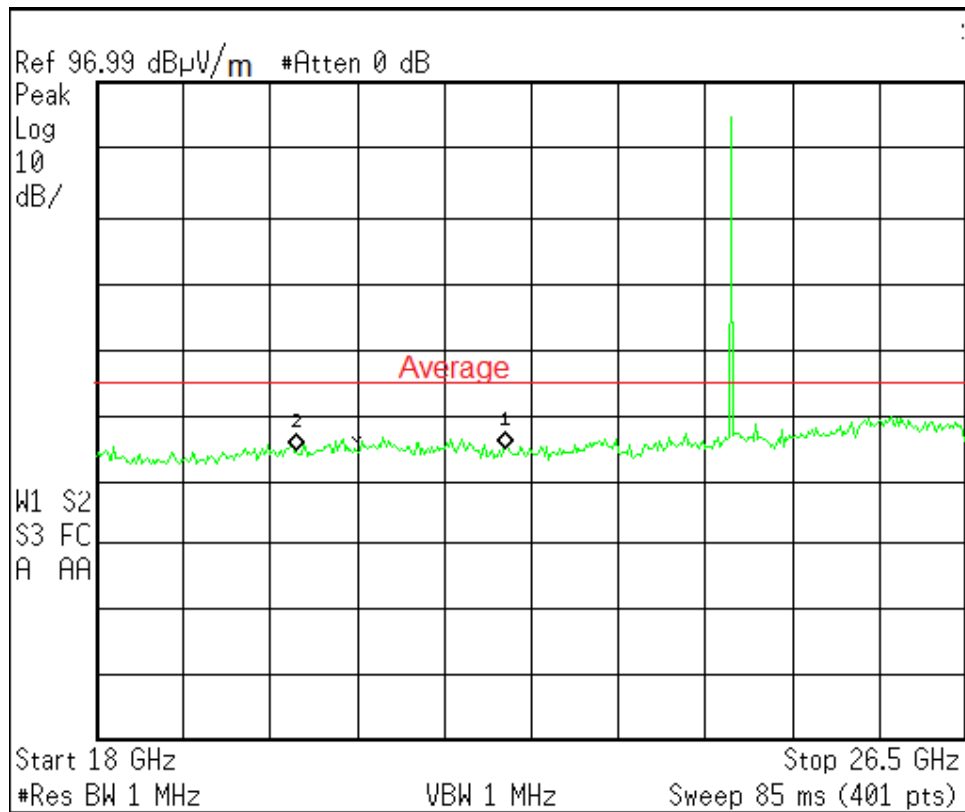
Figure 5a. Radiated Emissions, 1.2m dish - 18 GHz to 26.5 GHz (Vertical)

Note: The signal exceeding the limit at 24 GHz is the intentional emitter

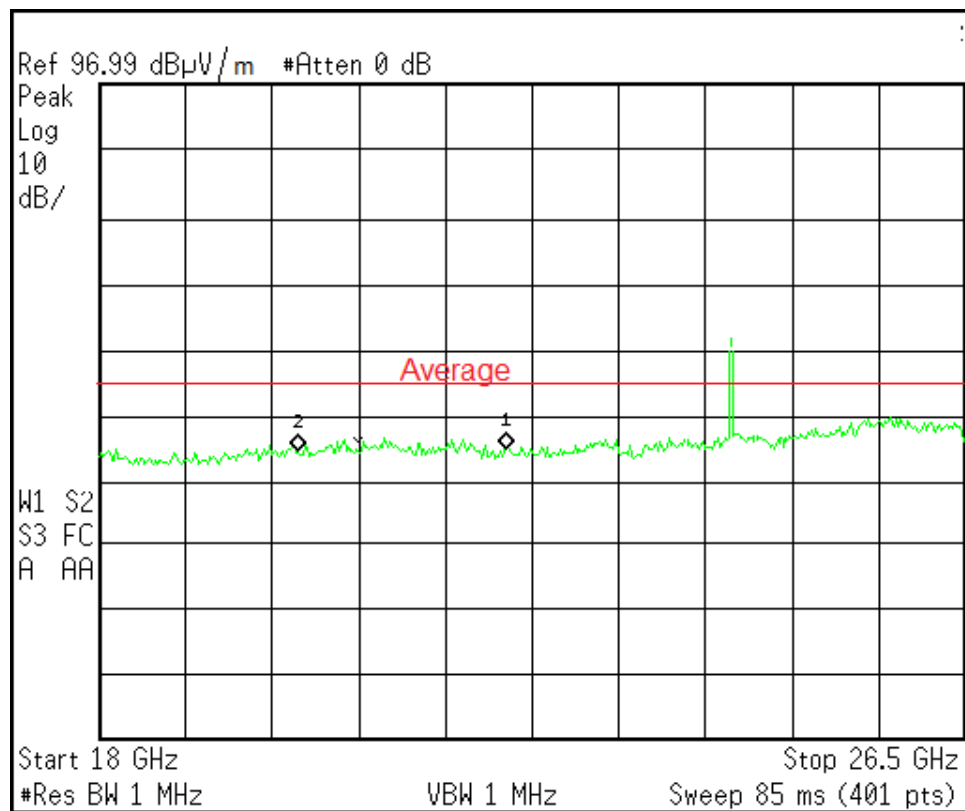
Figure 5b. Radiated Emissions, 1.2m dish - 18 GHz to 26.5 GHz (Horizontal)

Note: The signal exceeding the limit at 24 GHz is the intentional emitter

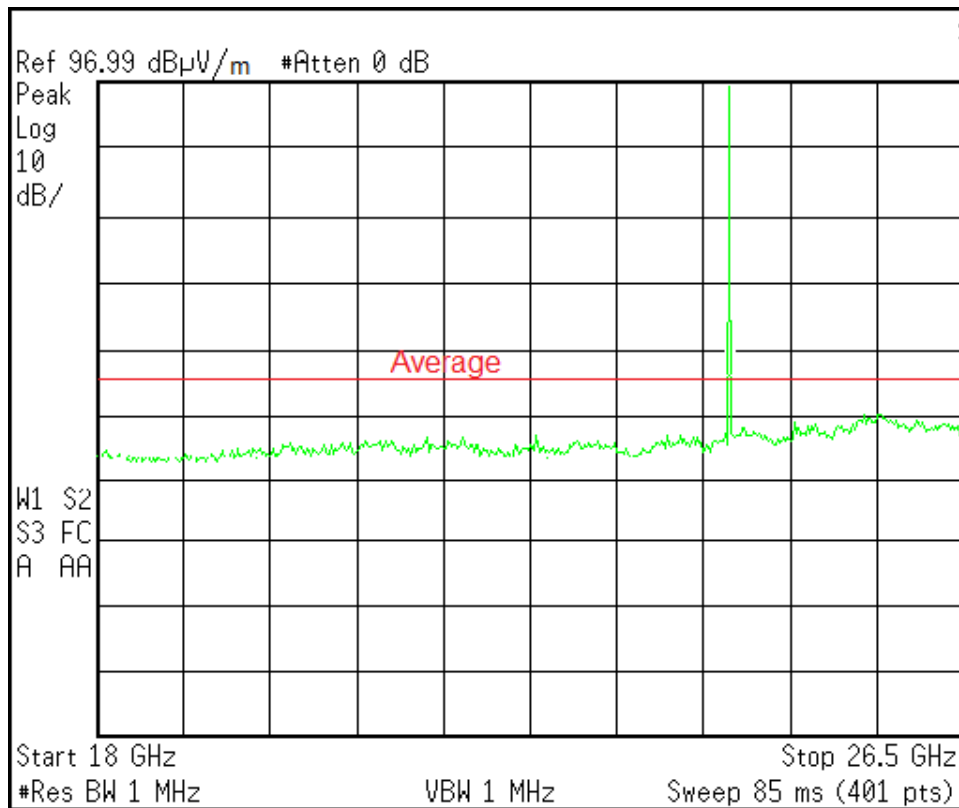
Figure 6a. Radiated Emissions, 0.6m dish - 18 GHz to 26.5 GHz (Vertical)

Note: The signal exceeding the limit at 24 GHz is the intentional emitter

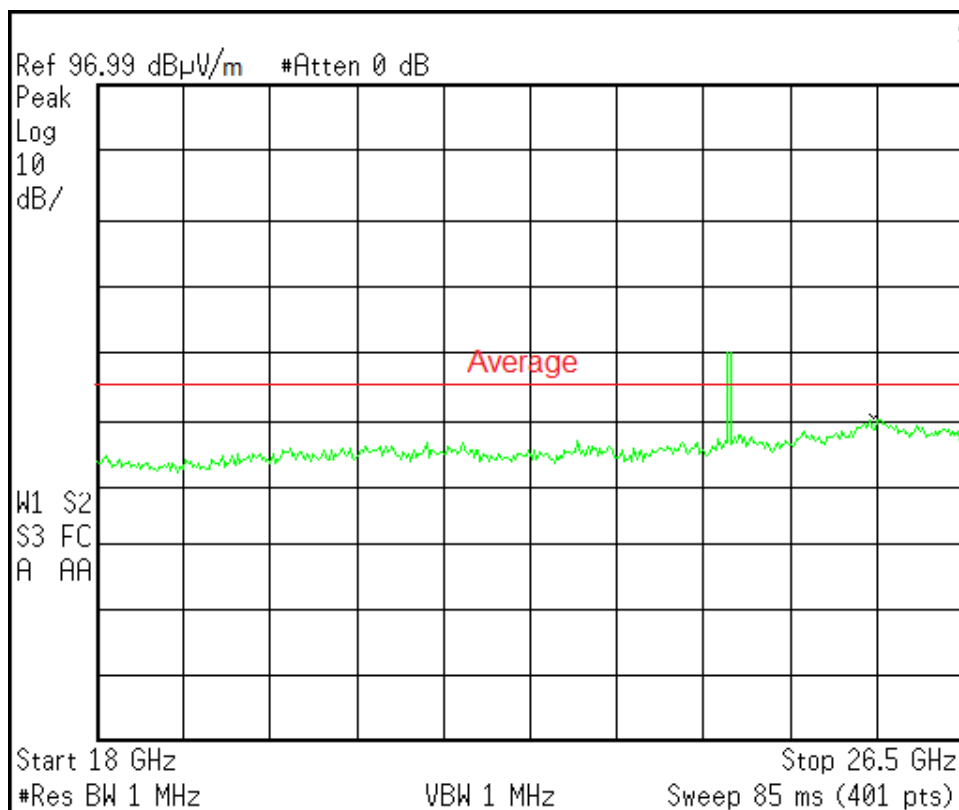
Figure 6b. Radiated Emissions, 0.6m dish - 18 GHz to 26.5 GHz (Horizontal)

Note: The signal exceeding the limit at 24 GHz is the intentional emitter

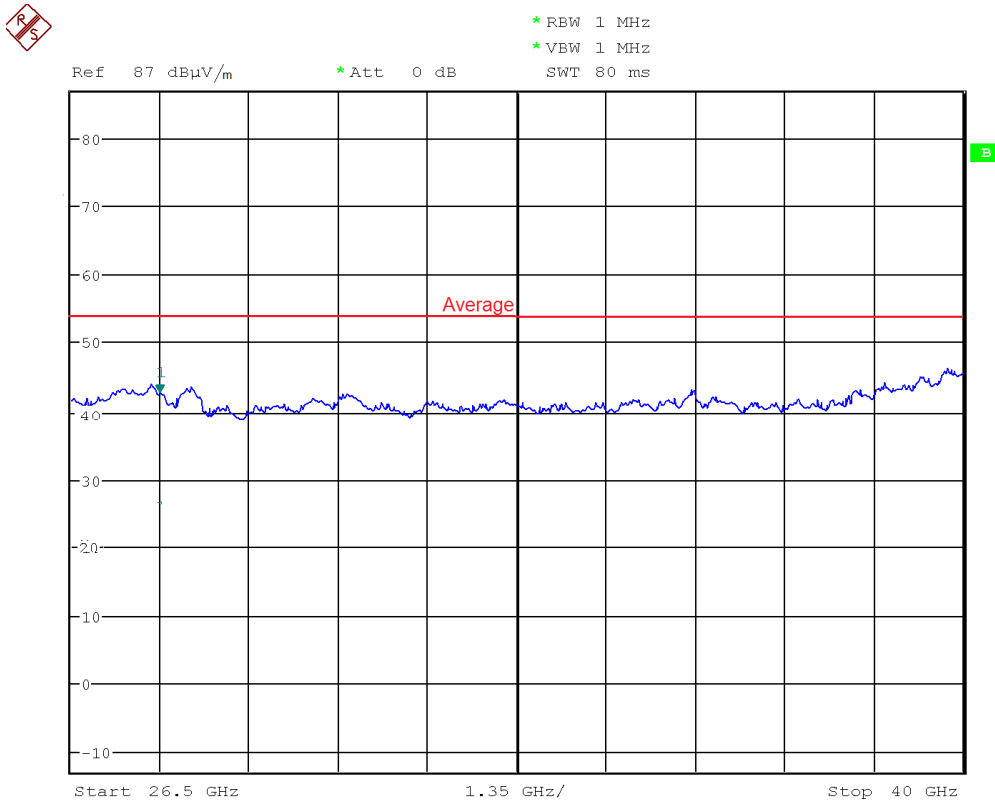
Figure 7a. Radiated Emissions, 1.2m dish - 26.5 GHz to 40 GHz (Vertical)

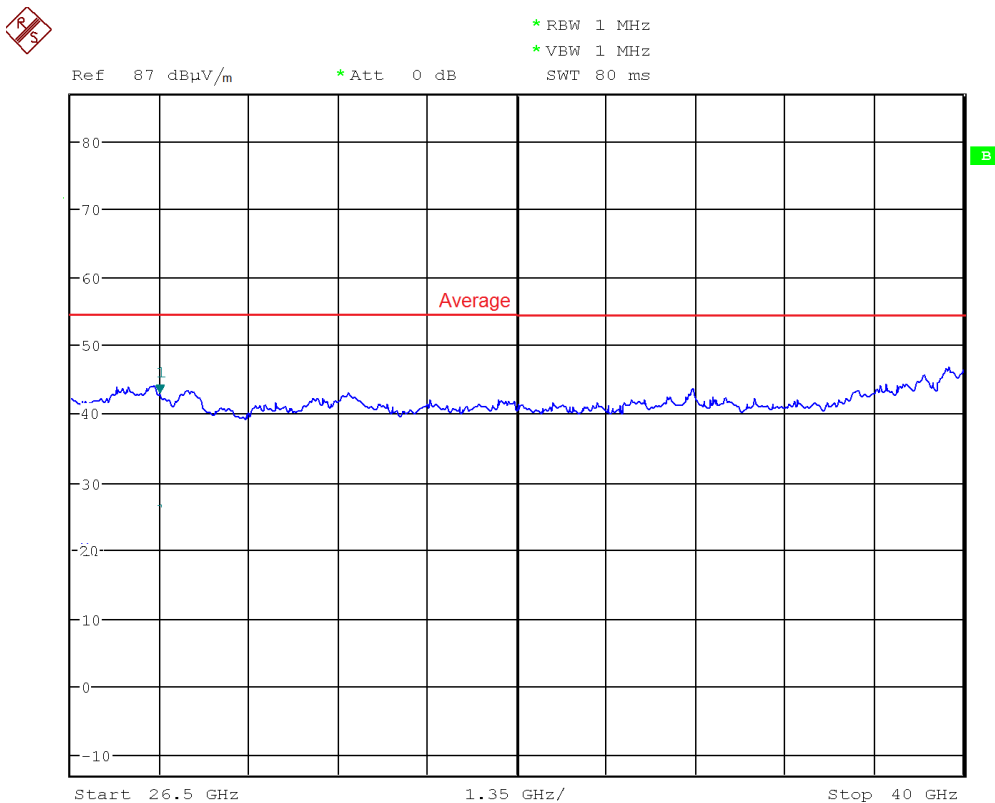
Figure 7b. Radiated Emissions, 1.2m dish - 26.5 GHz to 40 GHz (Horizontal)

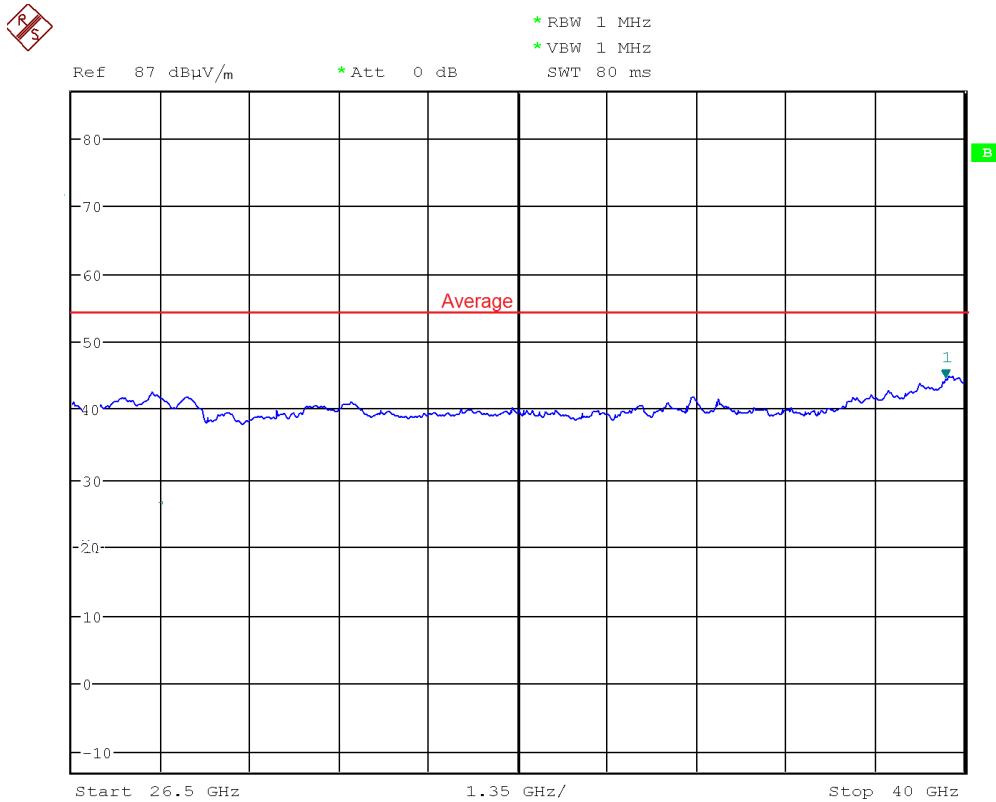
Figure 8a. Radiated Emissions, 0.6m dish - 26.5 GHz to 40 GHz (Vertical)

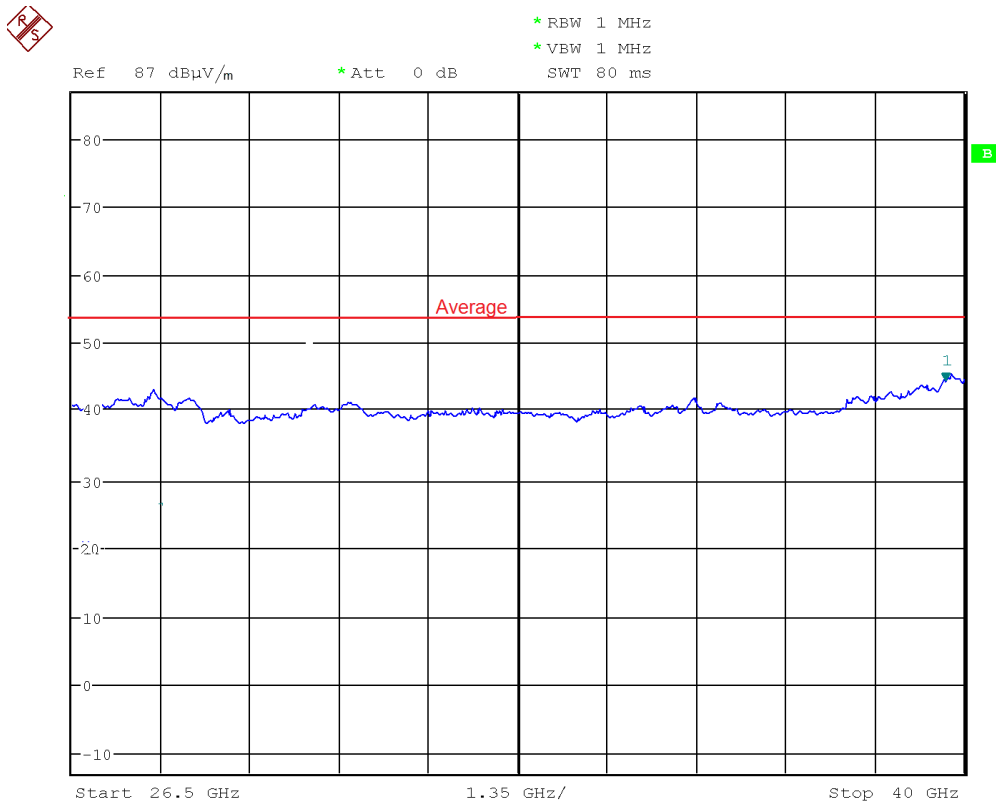
Figure 8b. Radiated Emissions, 0.6m dish - 26.5 GHz to 40 GHz (Horizontal)

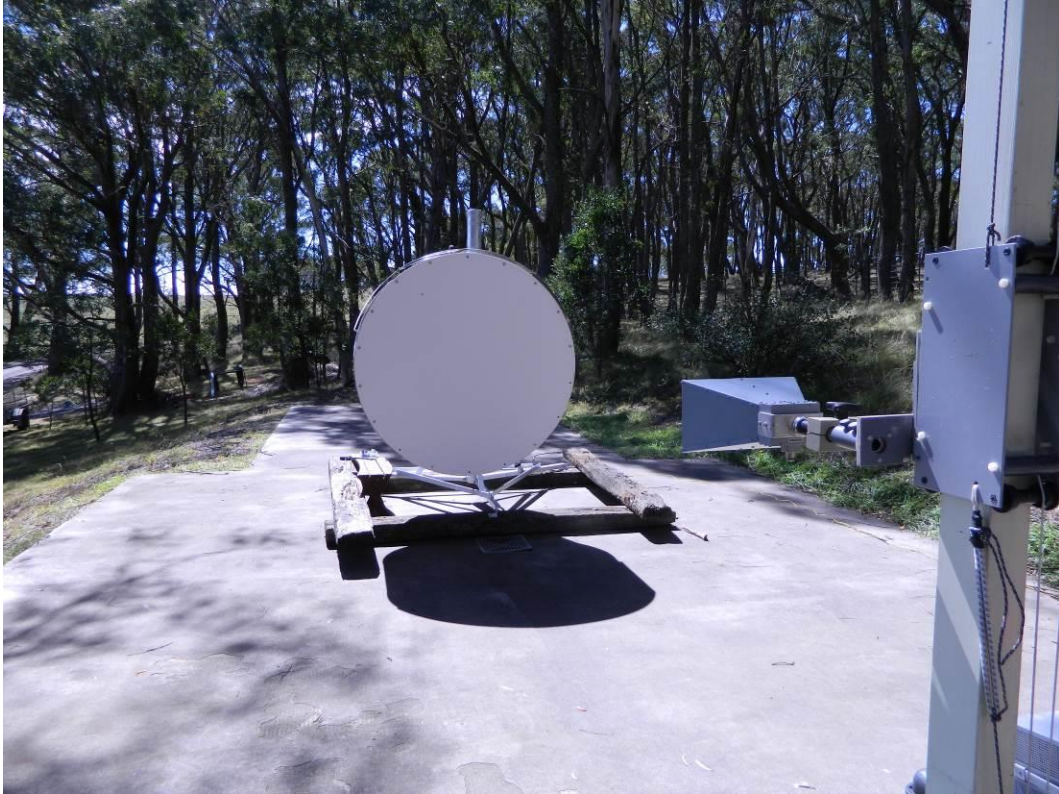
Photo 1 - EUT (1.2m dish) at the open area test site (OATS)

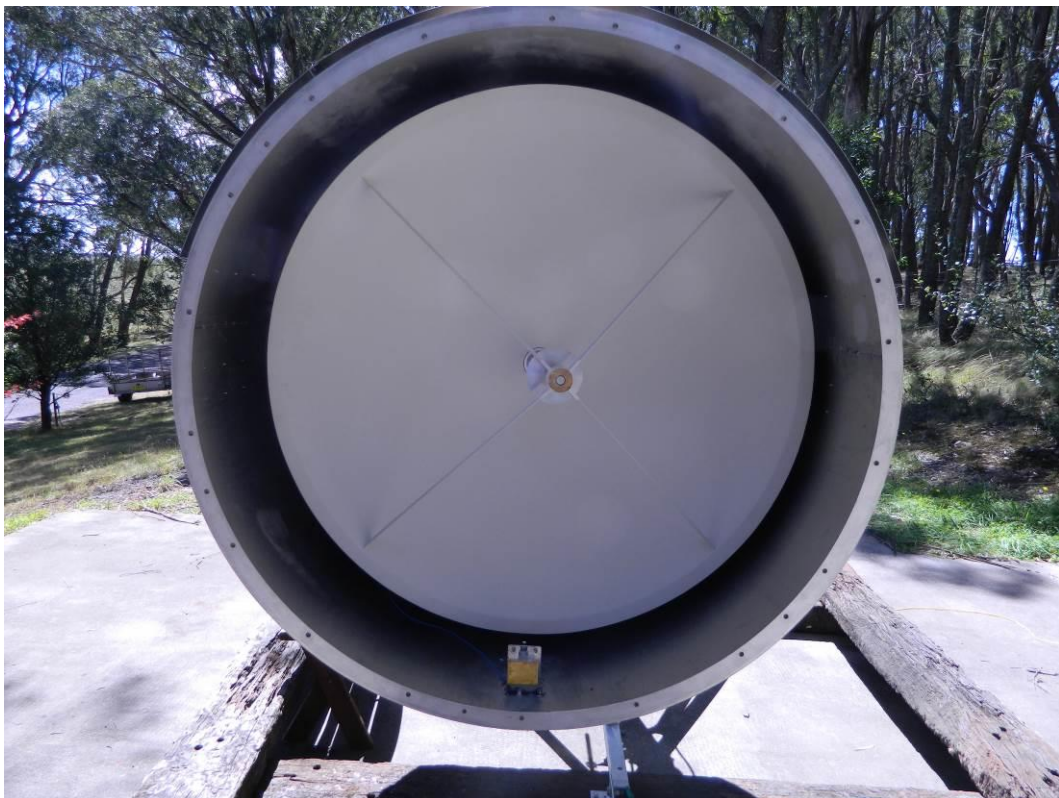
Photo 2 - Front internal view of 1.2m dish

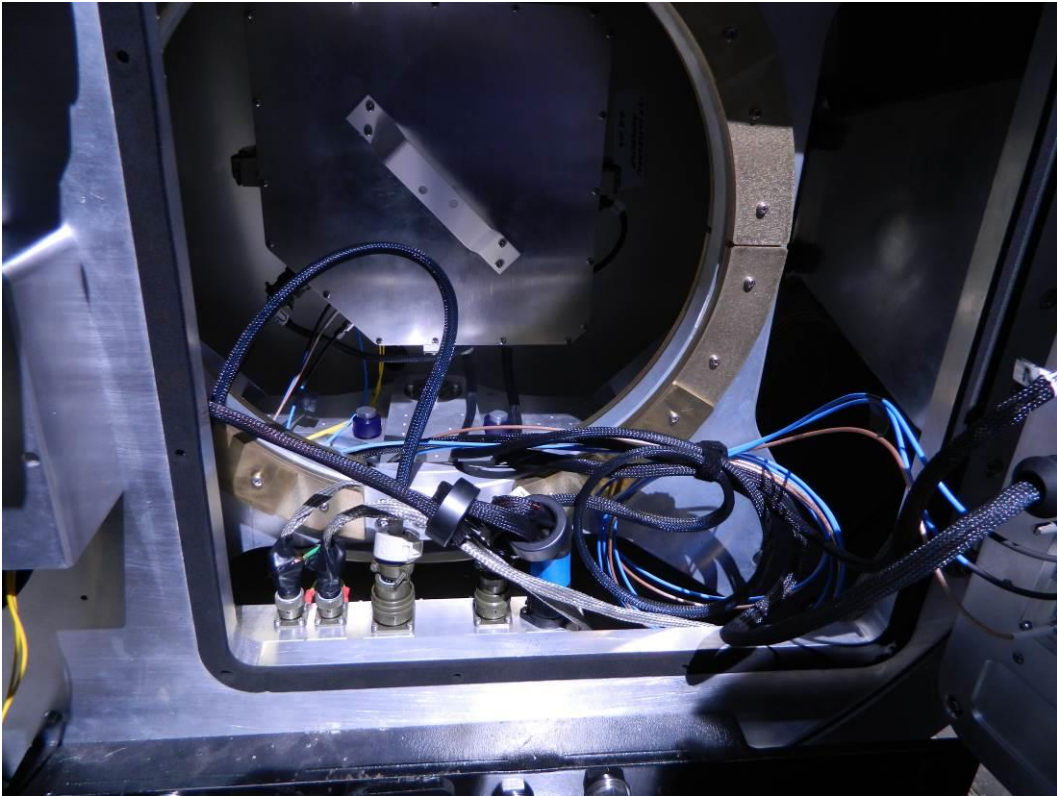
Photo 5 - EUT internal rear view, 1.2m dish

5.1 E10G-7282-2512 (1.2m Dish), refer section 10 – photos 5 and 6

- Clip on ferrite fitted to the control module PCO cable, next to the panel connector, make - Ferroxcube, part number - CSA26/13/29-4S2F-EN.
- Solid ferrite ring fitted to the control module PIN cable, next to the panel connector. Quantity 2 (2 turns) of ferrite, supplier – Wurth Electronics, part number – 7427015.
- Clip on ferrite fitted to the ENC cable on the control module next to the panel connector, make - Richco, part number – MTFC 231114T.
- Conductive braid fitted to the length of the ME and Ma cables on the control module.

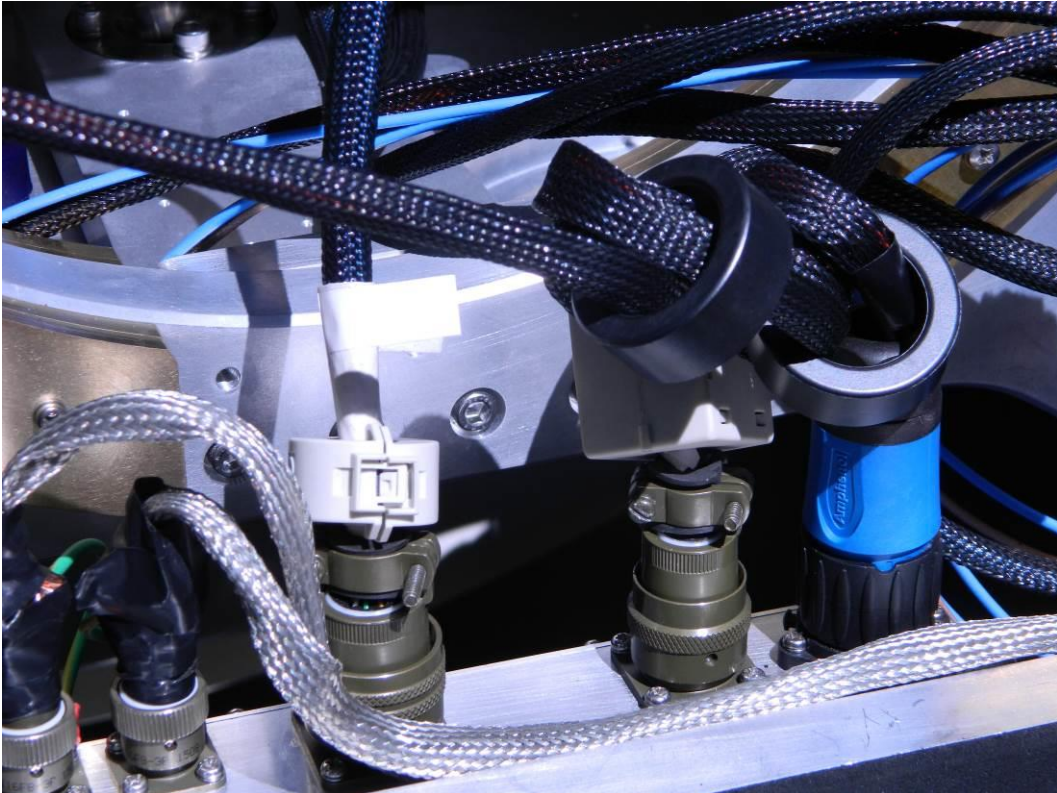
Photo 6 - Close up of ferrites on the cables, 1.2m dish

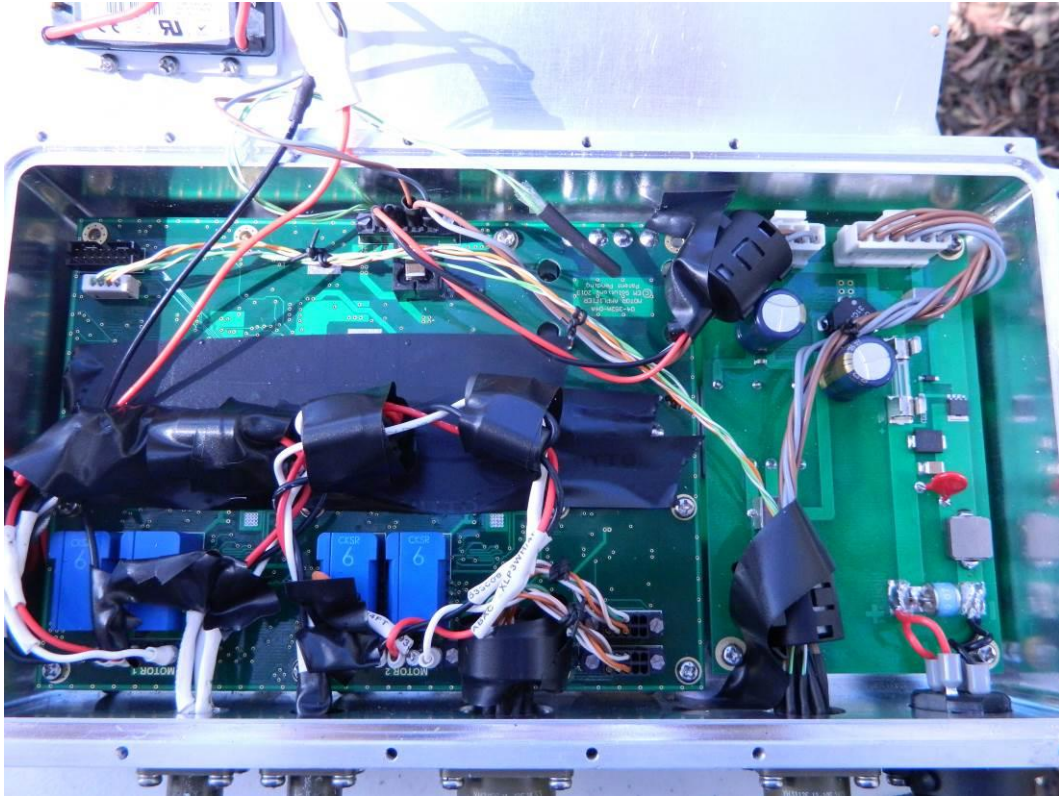
Photo 7 - Internal view of control module, 1.2m dish

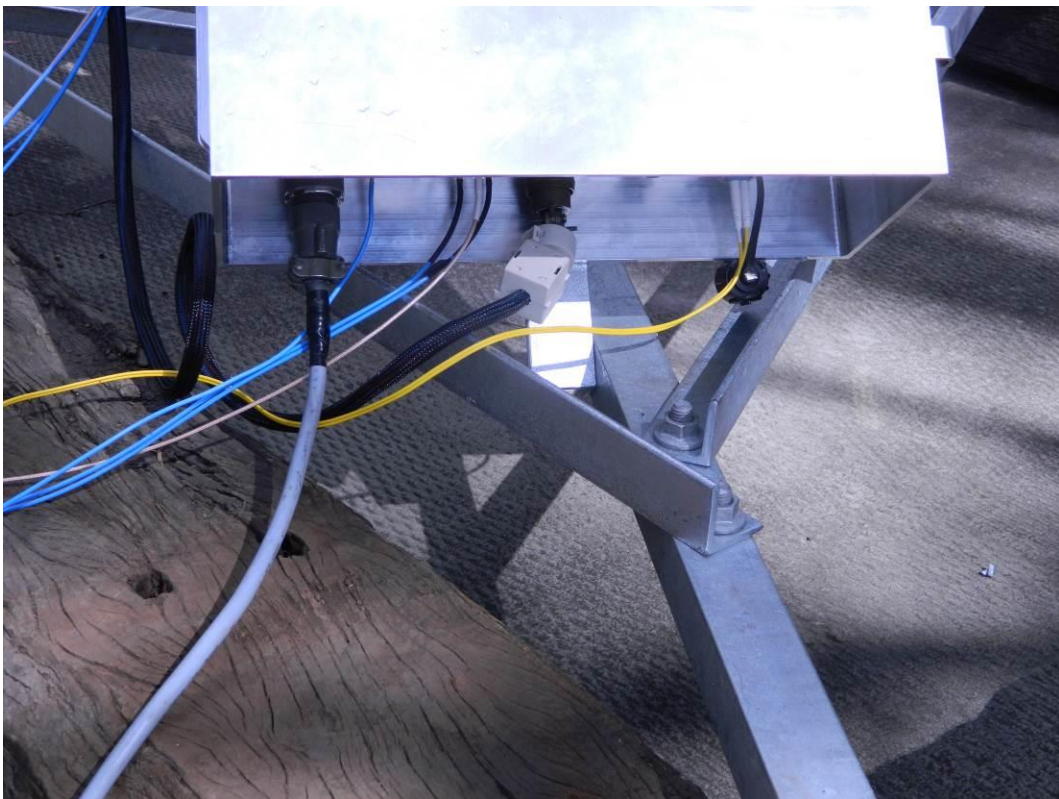
Photo 10 - Close up of cables connected to the electronics enclosure EUT (0.6m dish)

5.2 E10G-7282-2506 (0.6m Dish), refer section 10 – photo 10

- The following two clips on ferrites fitted to the control cable connected between the control module and the antenna. The two ferrites were fitted next to the panel mounted connector on the control module. Make - Ferroxcube, part number - CSA26/13/29-4S2F-EN and make - Richco, part number - MTFC 231114T.
