4.EUT TEST PHOTOS

5. PHOTOGRAPHS OF EUT CONSTRUCTIONAL

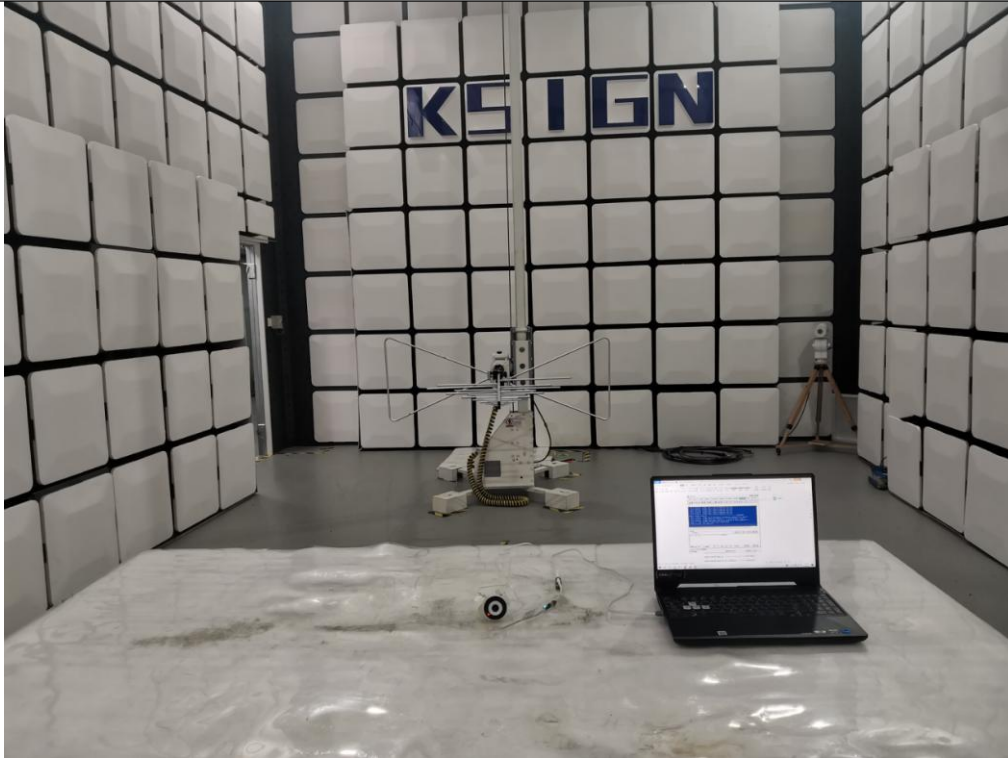
Radiated Measurement (Below 1GHz)

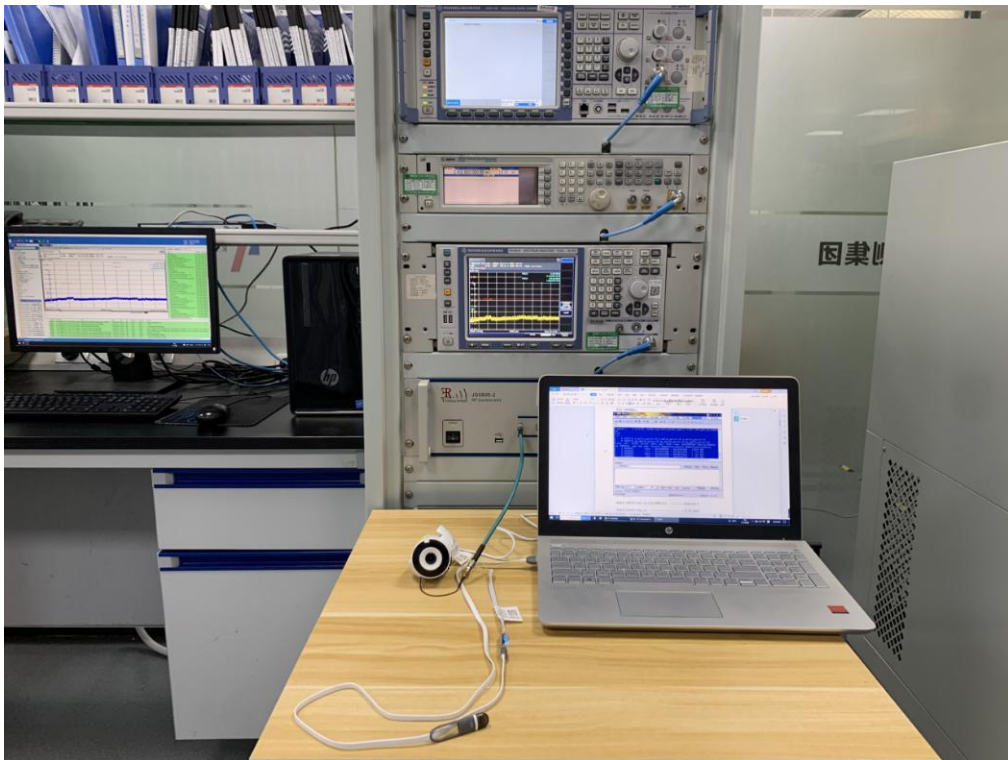
RF Conducted
