# RF TEST REPORT

# Report No.: FCC\_IC\_RF\_SL17032201-SEV-019 Supersede Report No.: NONE

Applicant	;	Trek Bicycle Corporation				
HostProduct Name	•••	Bcycle				
Module Model No.		MFRFID1				
Test Standard	• •	CC 15.225 RSS-210 Issue 9: 2016				
Test Method	:	FCC 15.225 ANSI C63.10 2013 RSS Gen Issue 4 2014				
FCC ID	;	2AHXDMFRFID1				
IC ID	;	21334-MFRFID1				
Dates of test	•••	12/08/2017-12/27/2017				
Issue Date	;	12/27/2017				
Test Result	Test Result     :     ⊠ Pass     □ Fail					
Equipment complied with the specification[X]Equipment did not comply with the specification[]

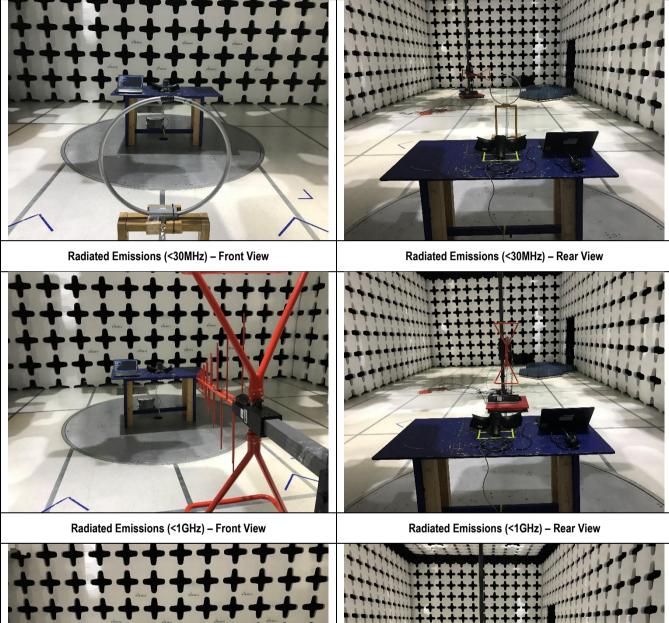
#### 6.6 EUT Test Setup Photos

Radiated Emissions (>1GHz) – Front View

Radiated Emissions (>1GHz) – Rear View

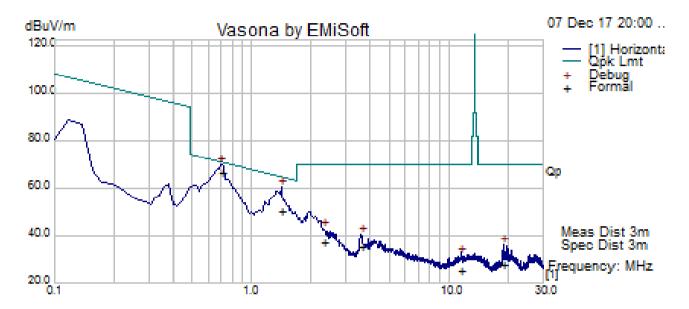
Test specification:	Radiated Spurious Emissions	Radiated Spurious Emissions				
Mains Power:	10V DC					
Tested by:	Vijay Chaudhary	⊠ Pass □ Fail				
Test Date:	12/07/2017					
Remarks:	125KHz <i>f</i> = 100kHz – 30MHz plot, and loop antenna at 0 degree

Frequency MHz	Raw dBuV	Cable Loss	AF dB	Level dBuV/m	Measurement Type	Pol (0/90)	Hgt cm	Azt Deg	Limit dBuV/m	Margin dB	Pass /Fail
0.70	40.4	10.2	15.68	66.27	Quasi Max	0	99	4	70.69	-4.42	Pass
1.39	29.44	10.24	10.22	49.91	Quasi Max	0	99	20	64.7	-14.79	Pass
2.32	20.24	10.29	6.42	36.95	Quasi Max	0	99	319	69.54	-32.6	Pass
3.58	20.98	10.31	3.48	34.77	Quasi Max	0	99	54	69.54	-34.77	Pass
18.93	15.93	10.71	1.1	27.74	Quasi Max	0	99	245	69.54	-41.8	Pass
11.47	13.20	10.55	1.58	25.34	Quasi Max	0	99	327	69.54	-44.21	Pass

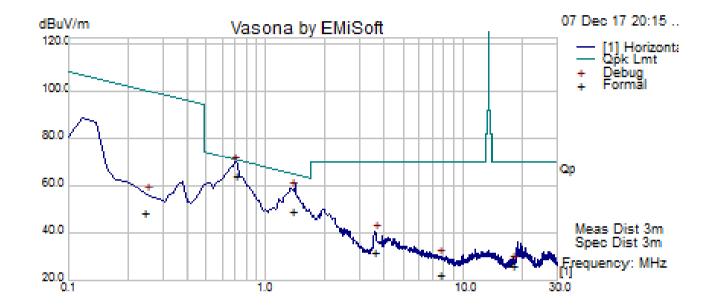
Test specification:	Radiated Spurious Emissions	Radiated Spurious Emissions				
Mains Power:	10V DC					
Tested by:	Vijay Chaudhary	Result:	⊠ Pass □ Fail			
Test Date:	12/07/2017					
Remarks:	125KHz <i>f</i> = 100kHz – 30MHz plot, an	125KHz <i>f</i> = 100kHz – 30MHz plot, and loop antenna at 90 degrees

Frequency MHz	Raw dBuV	Cable Loss	AF dB	Level dBuV/m	Measurement Type	Pol (0/90)	Hgt cm	Azt Deg	Limit dBuV/m	Margin dB	Pass /Fail
0.70	38.12	10.2	15.66	63.98	Quasi Max	90	99	286	70.68	-6.69	Pass
1.35	28.43	10.23	10.43	49.09	Quasi Max	90	99	265	64.94	-15.84	Pass
3.57	17.75	10.31	3.49	31.54	Quasi Max	90	99	290	69.54	-38.00	Pass
7.63	9.51	10.46	2.01	21.98	Quasi Max	90	99	208	69.54	-47.56	Pass
17.99	13.67	10.68	1.21	25.56	Quasi Max	90	99	291	69.54	-43.99	Pass
0.24	13.51	10.18	24.55	48.24	Quasi Max	90	99	90	99.83	-51.59	Pass

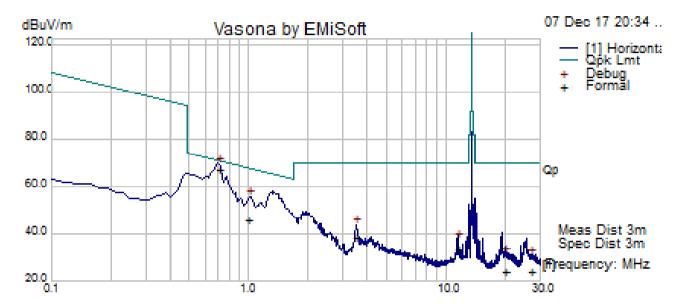
Test specification:	Radiated Spurious Emissions	Radiated Spurious Emissions				
Mains Power:	10V DC					
Tested by:	Vijay Chaudhary	Result:	⊠ Pass □ Fail			
Test Date:	12/07/2017					
Remarks:	13.56MHz <i>f</i> = 100kHz – 30MHz plot, a	13.56MHz <i>f</i> = 100kHz – 30MHz plot, and loop antenna at 0 degree

Frequency MHz	Raw dBuV	Cable Loss	AF dB	Level dBuV/m	Measurement Type	Pol (0/90)	Hgt cm	Azt Deg	Limit dBuV/m	Margin dB	Pass /Fail
0.70	40.94	10.2	15.67	66.81	Quasi Max	0	99	327	70.68	-3.87	Pass
0.99	22.66	10.21	12.85	45.72	Quasi Max	0	99	352	67.68	-21.96	Pass
3.50	24.03	10.31	3.61	37.95	Quasi Max	0	99	231	69.54	-31.59	Pass
11.40	21.07	10.55	1.59	33.21	Quasi Max	0	99	111	69.54	-36.34	Pass
19.82	12.42	10.72	0.96	24.1	Quasi Max	0	99	199	69.54	-45.44	Pass
27.07	11.92	10.82	0.87	23.61	Quasi Max	0	99	241	69.54	-45.93	Pass

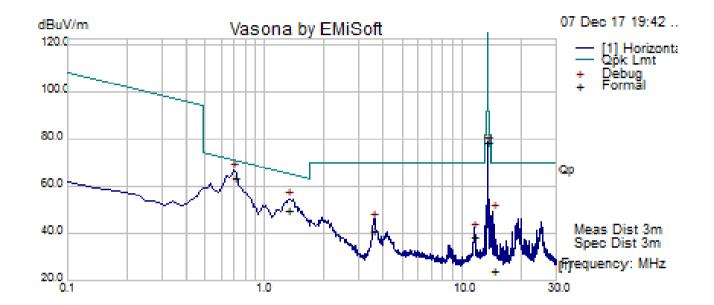
Test specification:	Radiated Spurious Emissions	Radiated Spurious Emissions				
Mains Power:	10V DC					
Tested by:	Vijay Chaudhary	Result:	⊠ Pass □ Fail			
Test Date:	12/07/2017					
Remarks:	13.56 MHz <i>f</i> = 100kHz – 30MHz plot,	13.56 MHz <i>f</i> = 100kHz – 30MHz plot, and loop antenna at 90 degrees

Frequency MHz	Raw dBuV	Cable Loss	AF dB	Level dBuV/m	Measurement Type	Pol (0/90)	Hgt cm	Azt Deg	Limit dBuV/m	Margin dB	Pass /Fail
0.70	37.26	10.2	15.64	63.1	Quasi Max	90	99	279	70.66	-7.56	Pass
1.30	28.51	10.23	10.72	49.46	Quasi Max	90	99	279	65.27	-15.81	Pass
14.43	11.44	10.62	1.68	23.74	Quasi Max	90	99	284	69.54	-45.81	Pass
3.57	27.00	10.31	3.49	40.8	Quasi Max	90	99	312	69.54	-28.75	Pass
11.54	25.82	10.55	1.59	37.95	Quasi Max	90	99	339	69.54	-31.59	Pass
13.56	65.66	10.62	1.67	77.95	Quasi Max	90	99	82	124.92	-46.97	Pass

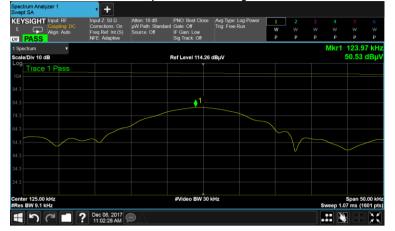
# Loop antenna at 0 degree

Frequency (kHz)	Amplitude (dBµV)	Limit(dBµV)
123.97	50.53	106

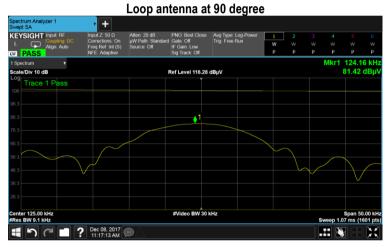
Frequency (kHz)	Amplitude (dBµV)	Limit(dBµV)
124.16	81.42	106

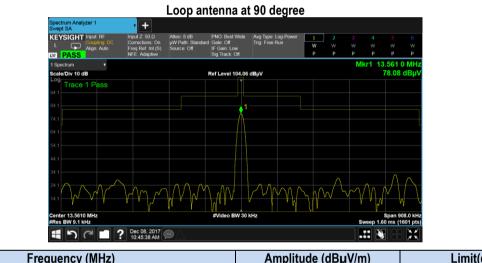
Frequency (MHz)	Amplitude (dBµV/m)	Limit(dBµV)
13.5610	78.08	84

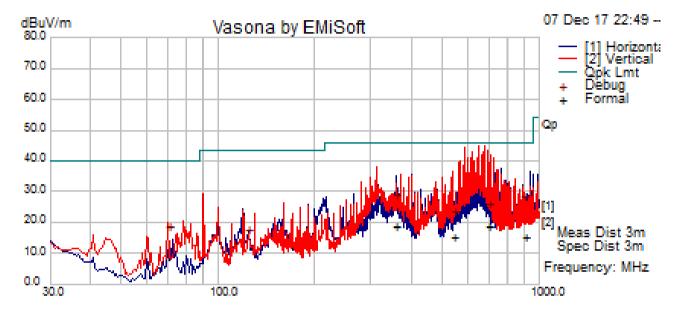
# f=30MHz – 1000MHz Measurements

Test specification:	Radiated Emissions	Radiated Emissions			
Mains Power:	10V DC				
Tested by:	Vijay Chaudhary	Result:	⊠ Pass □ Fail		
Test Date:	12/07/2017				
Remarks:	N/A		·

Frequency MHz	Raw dBµV/m	Cable Loss	AF dB	Level dBµV/m	Measurement Type	Pol	Hgt cm	Azt Deg	Limit dBµV/m	Margin dB	Pass /Fail
357.67	29.75	13.87	-21.91	21.71	Quasi Max	Н	102	205	46	-24.29	Pass
900.26	33.31	16.68	-13.6	36.39	Quasi Max	V	336	112	46	-9.61	Pass
699.48	44.12	15.66	-16.05	43.73	Quasi Max	Н	187	142	46	-2.27	Pass
70.00	19.38	11.7	-28.22	2.86	Quasi Max	Н	266	4	40	-37.14	Pass
540.62	37.77	14.86	-18.64	33.99	Quasi Max	V	121	255	46	-12.01	Pass
123.37	18.90	12.27	-22.8	8.37	Quasi Max	V	130	93	43.5	-35.13	Pass

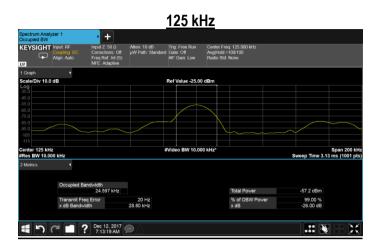
Frequency (kHz)	Occupied Bandwidth (KHz)	
125.00	24.597
